**K-168.03**

**RE: Letter Report for the Pineridge Village Trailer Park Lagoon Assessment**

CODE: K-168.03	PROJECT: KEASCHELL PARKS LTD PINERIDGE VILLAGE LAGOON ASSESSMENT
DESIGNED BY: SC	TITLE: LAGOON SLOPE REPAIR LAYOUT PLAN
DRAWN BY: SC	
REVIEWED BY: OW	
SCALE: 1:1000	DATE: 16/01/20
PLAN: 01	SHEET: 01 of 01

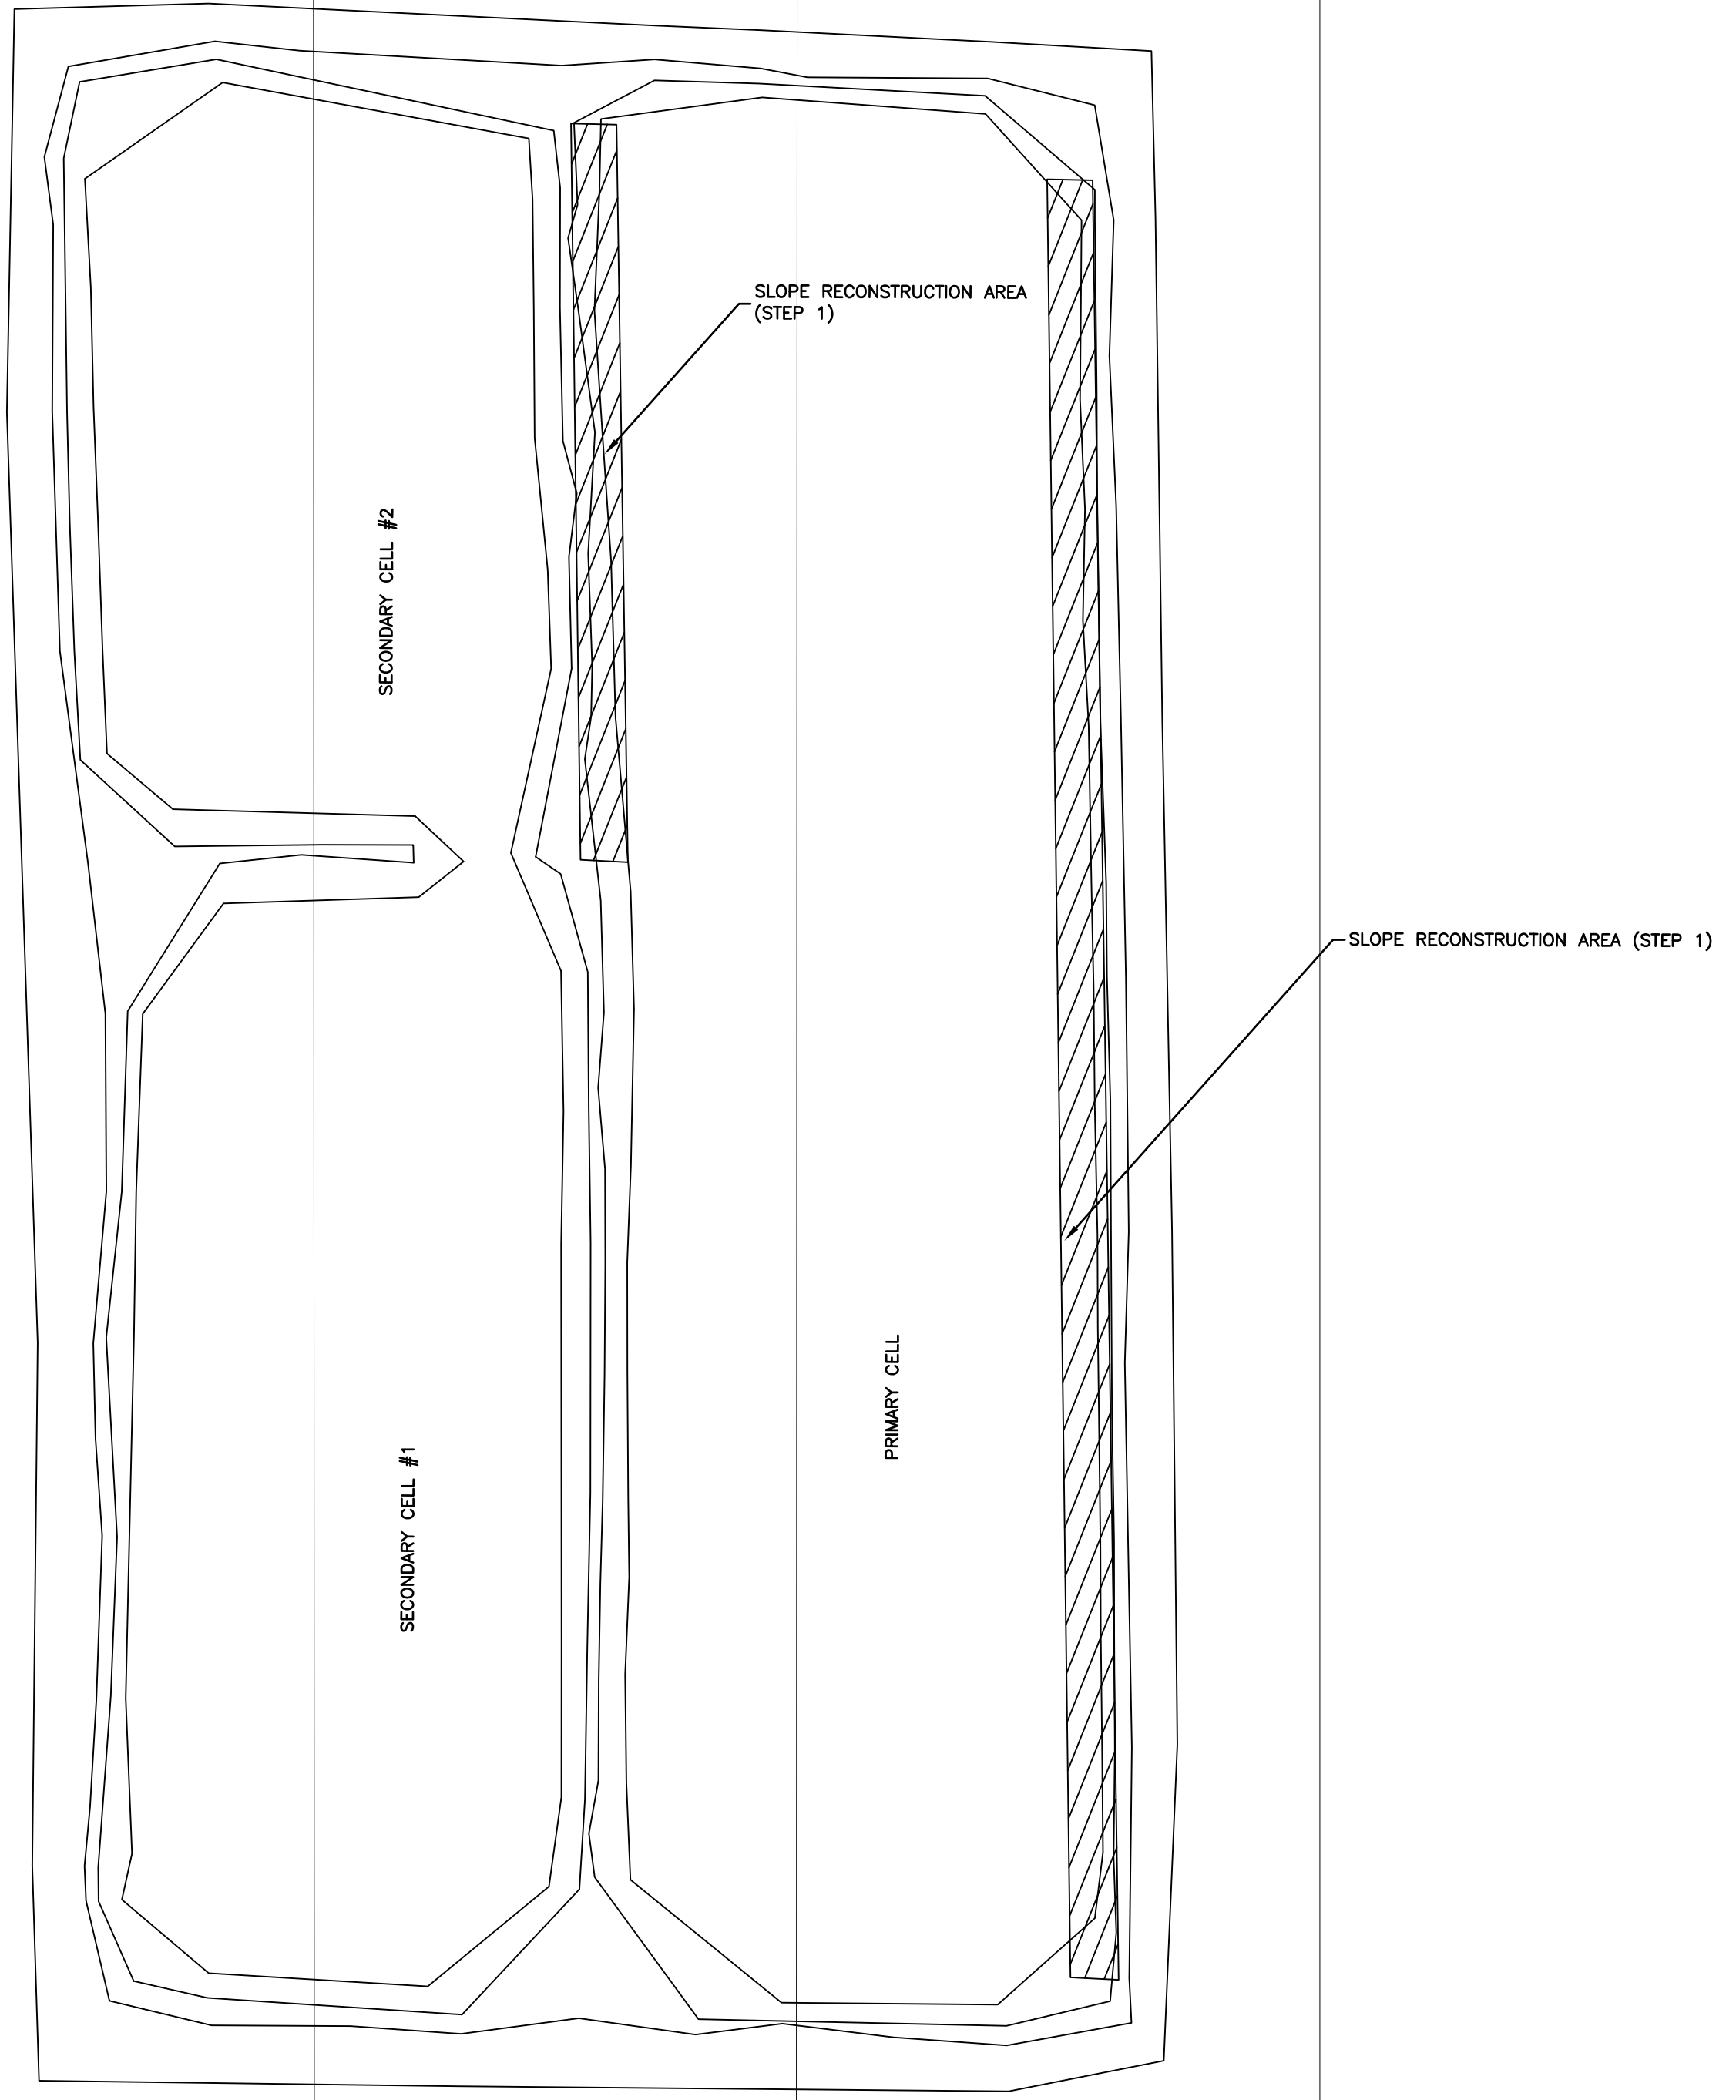
DIKE SLOPE RECONSTRUCTION LOCATION

Based on site observations and the GPS survey, the inner slope of the primary cell north dike has experienced significant erosion which has changed the slope to steeper than 3H:1V. There was only minor erosion detected on the inner slope of the primary cell south dike that also requires repair. The location of erosion is indicated on the attached plan. While there was only minor erosion indicated by the survey of the south dike inner slope, it was observed that erosion is occurring along the full length of this dike, but at a slower rate than the north dike. The erosion along the inner slope consisted of a 0.4 m – 0.8 m near vertical drop in the dike slope beginning at an average of 0.5 m below the top of dike, as seen in the photos attached. From the bottom of the drop the dike appeared to continue at a 4:1 or 5:1 slope to the cell floor, due to accumulation of eroded soils.

Based on the topographic survey, the dikes will require approximately 525 m<sup>3</sup> of soil material to reconstruct the inner dike slopes to 3H:1V. While the inner dike slopes have experienced erosion, it is unlikely that the lagoon liner has been compromised, given the nature of the lagoon construction. The full cross section of the lagoon dikes were constructed with compacted high plastic clay material, with no distinct vertical cut-off wall. As the entire 3 m thickness of the centre of dike is not affected by the erosion, it is likely that a minimum 1 m thickness of soil material at  $1 \times 10^{-7}$  cm/sec or less is still maintained.

The soil material required for the inner slope repair could likely be obtained from the lagoon owner's land surrounding the lagoon cells, as the geotechnical investigation from the 1988 lagoon expansion indicated consistent high plastic clay soils at the site. To add soil material to the inner slopes, the lagoon owner would need to ensure that construction works occur shortly after the lagoon cells are discharged and liquid levels are low, and allowing the inner slopes to dry slightly. Drier conditions on the inner slopes would make compacting the soils on the slope more effective. Shaping of the inner dikes would also be required prior to placing the soil material, for ease of construction and compaction.

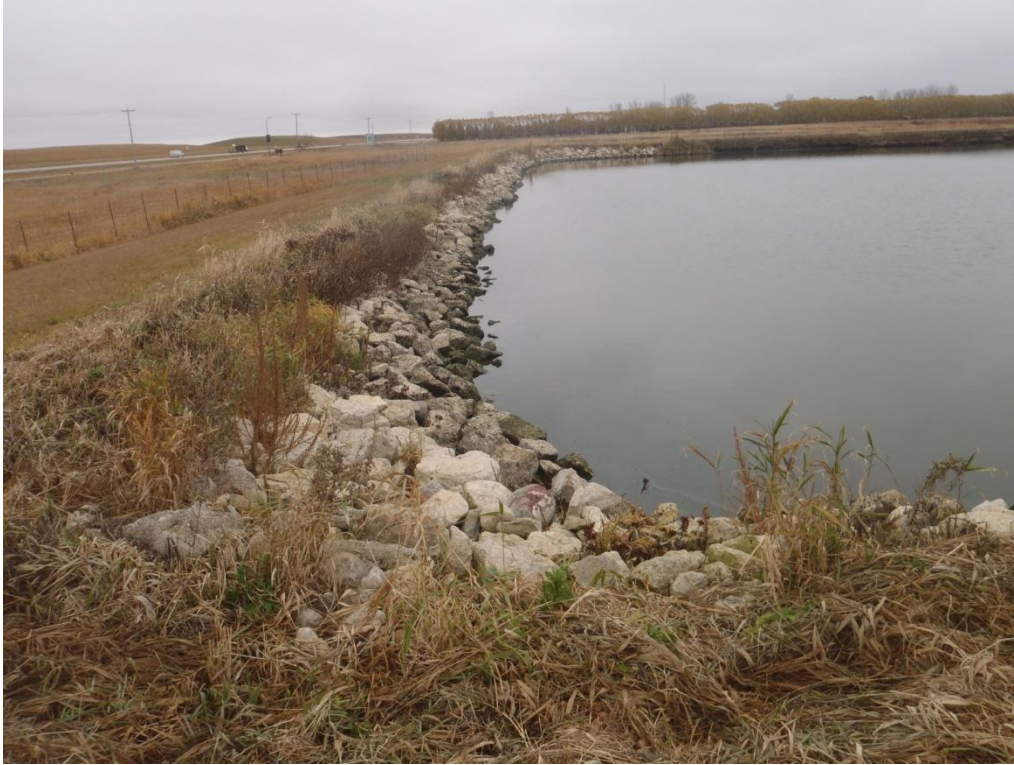
Photo 1: Existing rip rap stone on west slope of primary cell

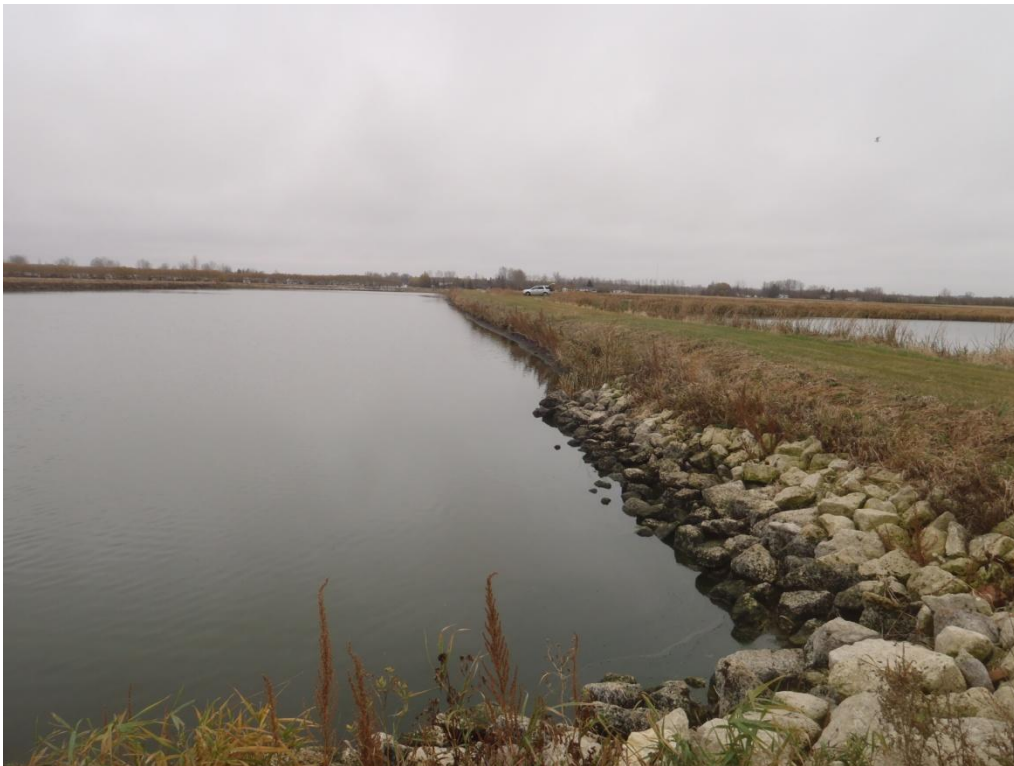
Photo 2: Erosion on south slope of primary cell

This step requires adding a layer of rip rap stone on the repaired and unrepaired inner slope of the primary cell south dike. This step is also recommended, however as this dike has not experienced erosion at the same rate as the north dike, it can be completed after the north slope is covered in rip rap, if the owner wishes to complete the works in phases.

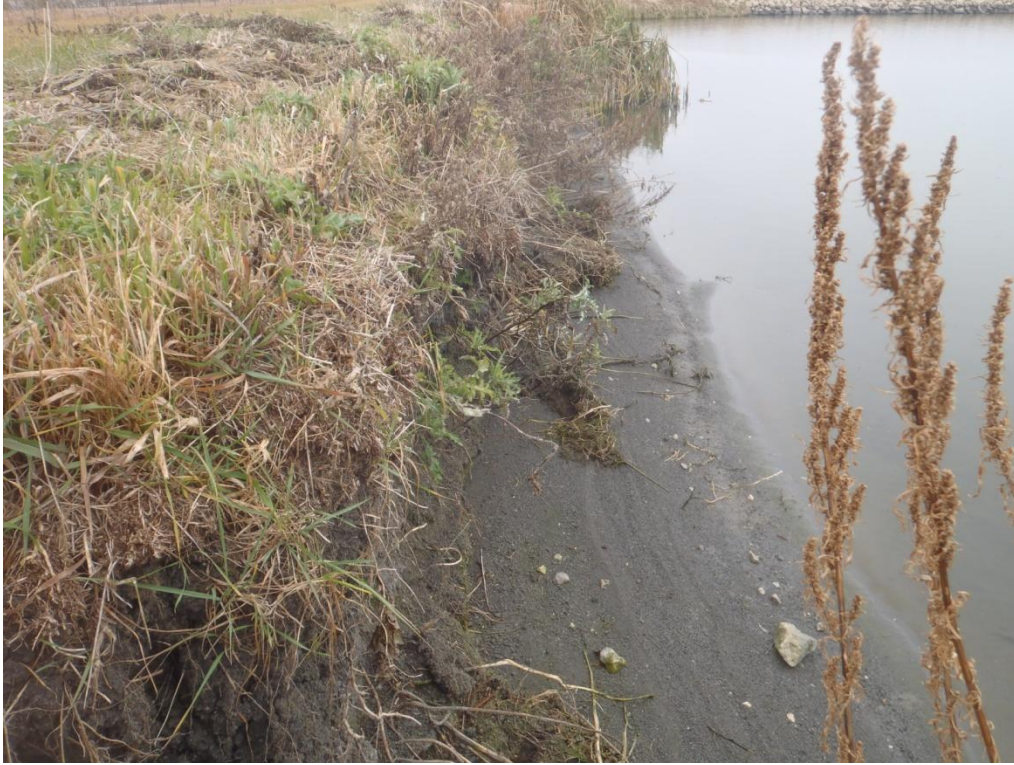
Photo 3: Erosion on north slope of primary cell

This step requires adding a layer of rip rap stone on the repaired slope of the primary cell north dike. This step is recommended, due to the extent of the erosion experienced on that slope.

Rip rap stone would be placed on the inner slope to reduce/prevent soil erosion from wave action. A non-woven geotextile would first be placed on the dike slope prior to placing the rip rap stone. The minimum recommended amount of rip rap would extend from 0.6 m above the high water level to the discharge pipe invert depth (0.3 m above the cell floor). The rip rap stone would consist of 150 mm to 300 mm clean limestone or granite rock, depending on local availability. If similar rip rap stone material as that utilized on the east and west dike slopes could be obtained, that would also be suitable.

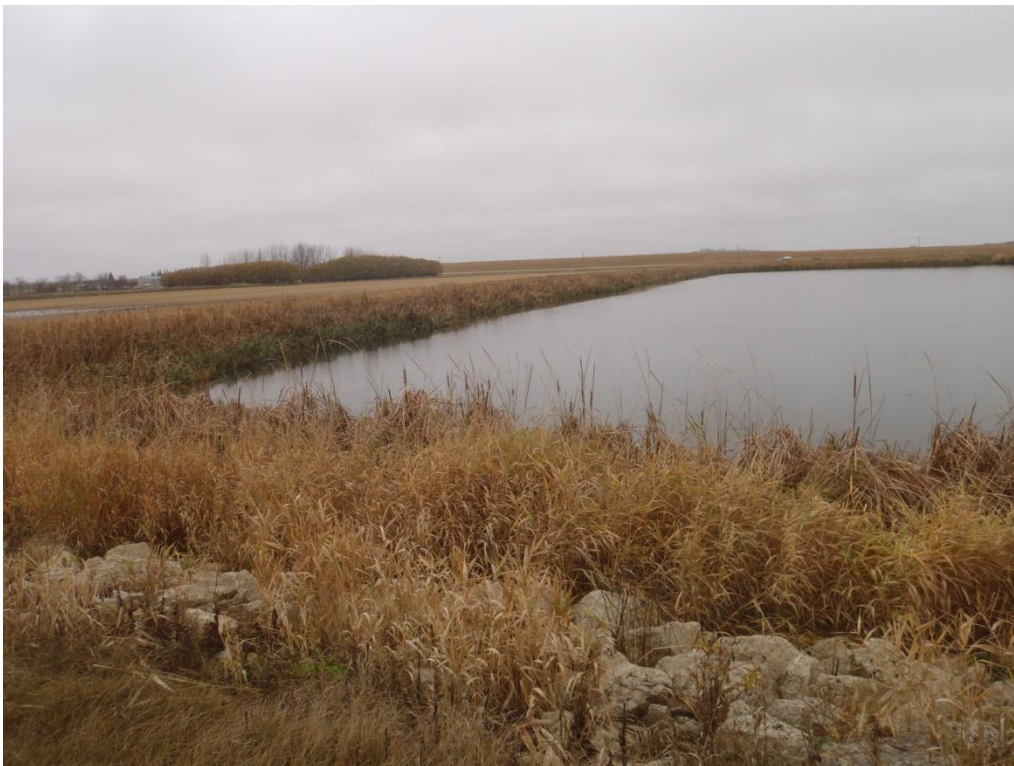
Photo 4: Vegetation growth on slopes of Secondary Cell #2

The inner slopes of the secondary cell dikes have not experienced any significant erosion requiring repair. The vegetation growing on the inner dikes however does require regular trimming to a height of no more than 0.3 m, to ensure the roots do not create permeable channels through the dikes. The small ruts on the intercell dike top also requires some minor repairs for ease of future grass maintenance.

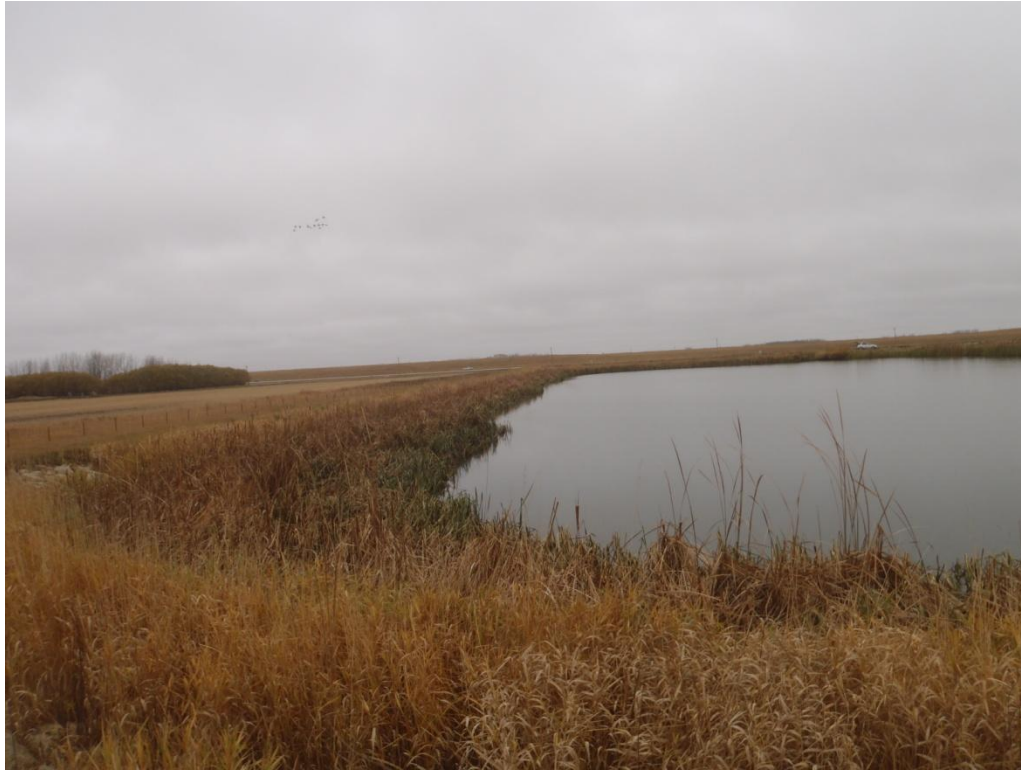
Photo 5: Vegetation growth on slopes of Secondary Cell #1

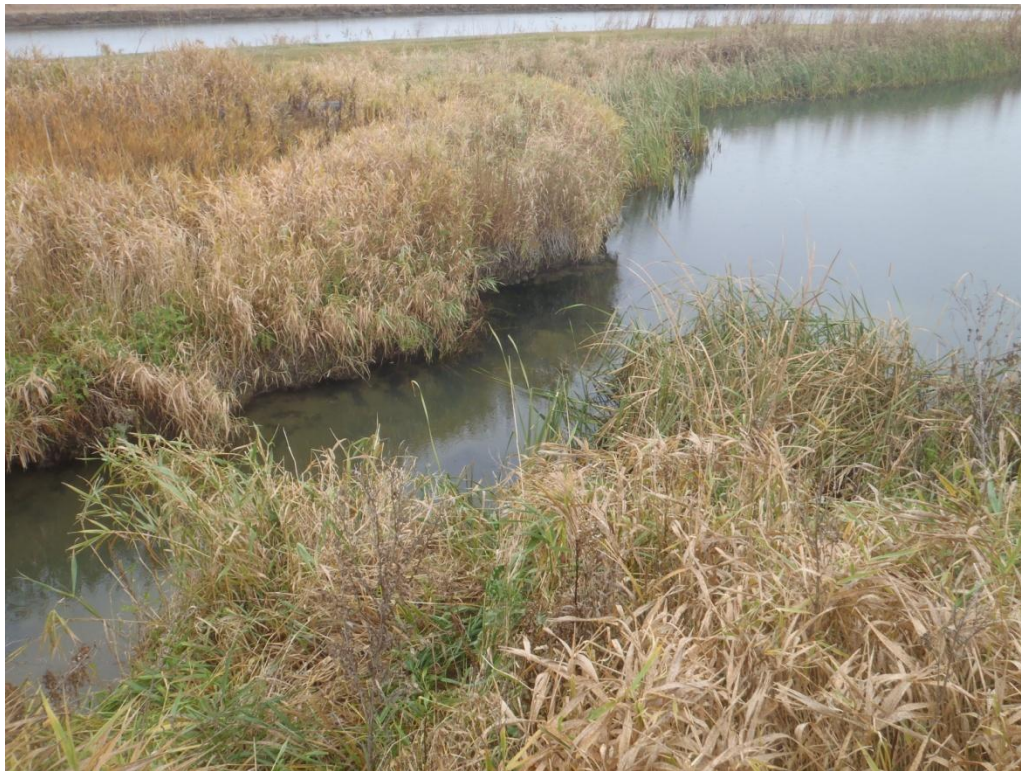
Photo 6: Portion of dike removed between Secondary Cells #1 and #2
