Re: Rural Municipality of Brokenhead – Upgrading and Repair of Existing Lagoon Dikes

1.0 Lagoon Assessment

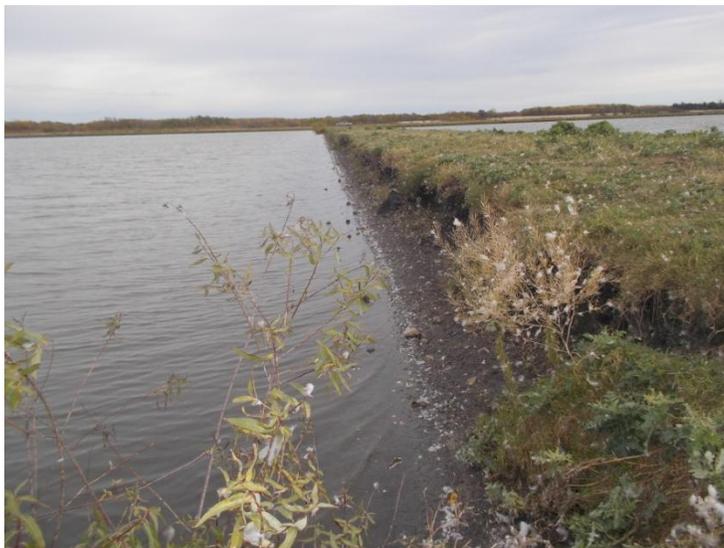
Erosion was observed on the storage cell 1 and 2 dikes. The erosion consisted of a 0.5 – 0.6 m near vertical drop in the dike slope starting from an elevation of approximately 237.0 m (0.2 m below the top of dike elevation) as seen in the following photo. From the bottom of the drop the dike appeared to continue at a 4:1 or 5:1 slope. Only the top vertical 1.0 m of dike could be observed due to the liquid level in the cells.

Figure 1 – Storage Cell 2 dike at the Storage Cell 1 – 2 intercell dike

The existing dikes will be repaired as part of the lagoon expansion works. The liquid level of the existing cells will be lowered by discharging or transferring liquid into the new storage cell. The dike side slopes must be allowed to dry. Clay material would be hauled and placed on the inner dike slopes to repair the vertical drop at the top of the existing cells. The clay material would be compacted to 96% standard proctor density. The existing dike slopes below the vertical drop will not be altered. Clay to repair the dikes would be obtained from the new cell excavation or a borrow area.

After dike repair, rip rap would be placed on the inner dikes of the existing primary cell and both secondary cells. A non-woven geotextile would be placed and secured on the dike slope and covered with rip rap rock. The rip rap would be placed 0.6 m above and below the high water level in the cells. The rip rap spec will call for 150 – 300 mm clean limestone or granite rock placed 300 mm thick with larger and smaller rock uniformly distributed.
