Manitoba Transportation and Infrastructure

IN-SERVICE ROAD SAFETY REVIEW – PTH 1 AND PTH 5 INTERSECTION

FINAL REPORT

DECEMBER 2023

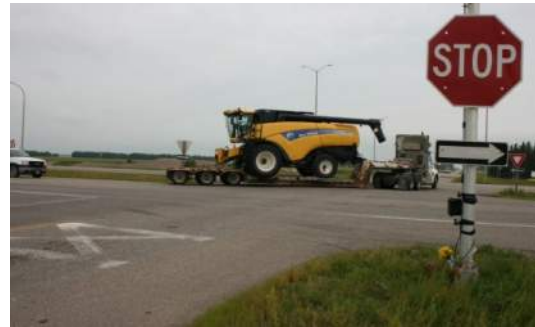
Several vehicles were observed occupying the narrow median at the same time. This provides significant opportunities for conflict, including conflicting vehicle orientations while waiting in the median and the potential for queuing traffic to extend into the high speed through lanes. Vehicles occupying the median also create sightline obstructions for other vehicles.

Truck making eastbound left blocking access to the median

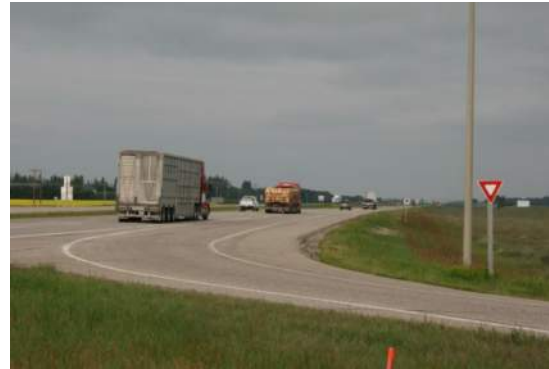
Although both right-turn (taper-type) acceleration lanes on PTH 1 may meet provincial geometric guidelines, TAC recommends a longer parallel speed change lane on high-speed facilities such as PTH 1. During the site investigation, vehicles were observed merging onto the mainline lanes at speeds much lower than the approaching mainline traffic. This can result in significant speed differential and an increased risk of collision.

Southbound to westbound channelized right-turn lane with taper-type acceleration lane

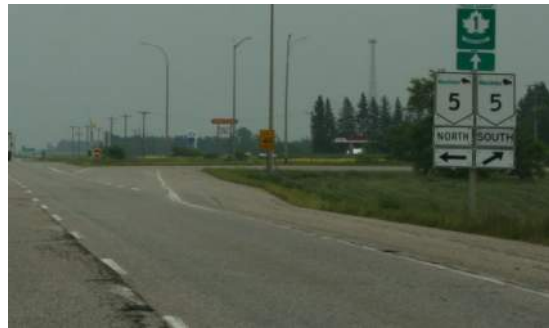
The right-turn deceleration lanes provided at this intersection feature a taper-type lane with a 40 km/h exit advisory speed. Vehicles were observed slowing down on the mainline lanes prior to entering the deceleration lane. This may result in speed differentials in advance of the intersection and an increased risk of rear-end collision.

Eastbound to southbound channelized right-turn lane with taper-type deceleration lane

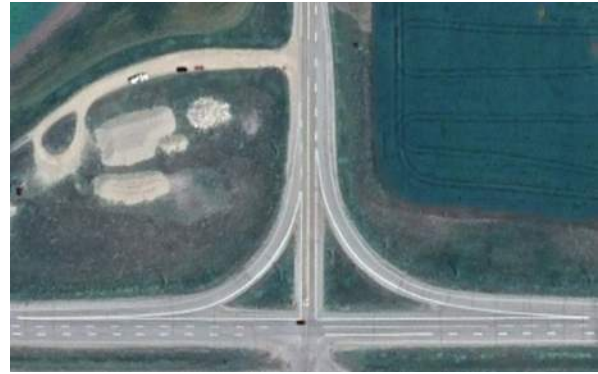
The close proximity of these intersections (located within the right turn merge and diverge points and the main intersection area of influence) may cause conflicts between through traffic and vehicles turning to/from the service road, especially if there are northbound or southbound queues at the intersection. During the site visit, queues were occasionally observed to extend to the service roads when there were limited gaps available in traffic on PTH 1.

The proximity of these intersections may also distract PTH 5 drivers' attention from the PTH 1 intersection.

Service Road, north of intersection

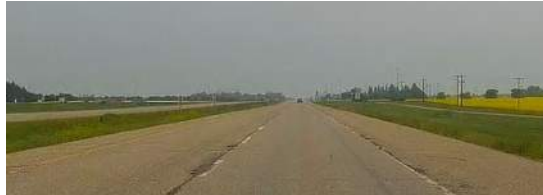
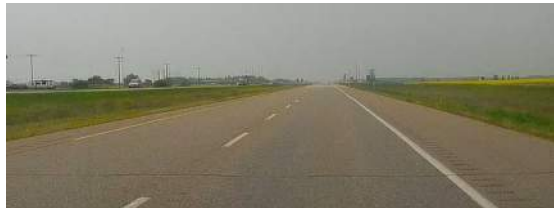
| Comment #10 | |

| Comment #10 | |
|--|---|
| <p>When approaching the intersection on PTH 1, there is little contrast between the mainline lanes and the intersection. Also, drivers on PTH 1 are provided with limited advanced warning of the approaching intersection with PTH 5. As a result, the intersection conspicuity is limited.</p> <p>Given the east-west orientation of PTH 1, sunlight glare may impair driver vision on the approach to the intersection at certain times of the day.</p> | <p style="text-align: center; color: #4F81BD;">PTH 1 eastbound approach to intersection</p> <p style="text-align: center; color: #4F81BD;">PTH 1 westbound approach to intersection</p> |

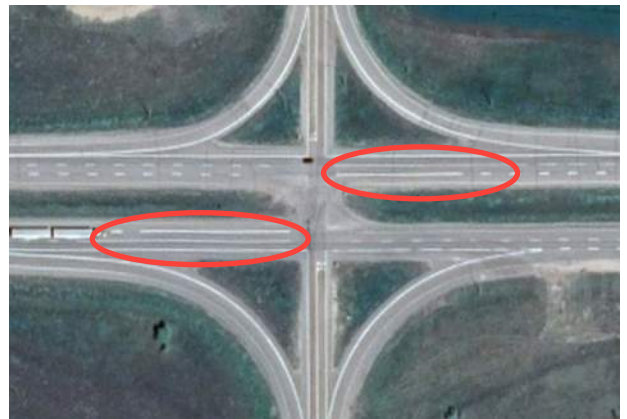
The solid line pavement markings provided between the mainline travel lanes (including the left turn lanes) immediately in advance of the intersection (on both eastbound and westbound approaches) are approximately 55 metres in length. This short length may encourage drivers to perform a passing manoeuvre on the immediate approach and within the intersection as was observed during field observations.

Solid line on approach in advance of the intersection

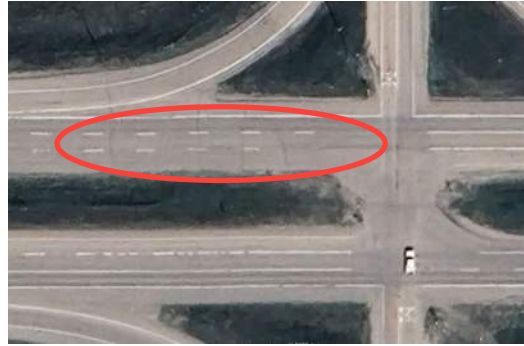
A left-turn acceleration lane is provided in the westbound direction on PTH 1. During the site investigation, northbound left turning vehicles were observed turning directly into the westbound mainline travel lanes or only used the left-turn acceleration lane for a short distance. The left-turn acceleration lane is currently delineated with dashed line, which may encourage drivers to merge into the high-speed mainline lane directly or shortly after entering the acceleration lane. This behaviour can result in significant speed differential and an increased risk of collision.

Dashed line pavement marking delineation for westbound left-turn acceleration lane

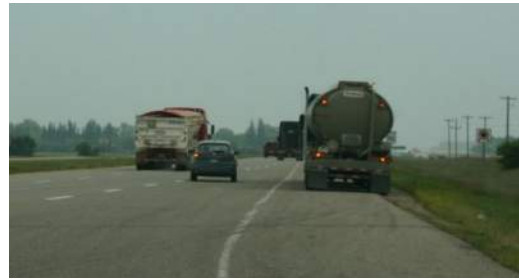
During the field review, trucks stopped on the roadway shoulder were observed on all quadrants of the intersection at the end of the channelized right-turn lanes. These locations are currently posted with “No stopping” signs.

Trucks stopped on the shoulder limit opportunities for evasive maneuvers at the end of the ramp tapers.

Truck stopped at end of right-turn channel on northwest corner

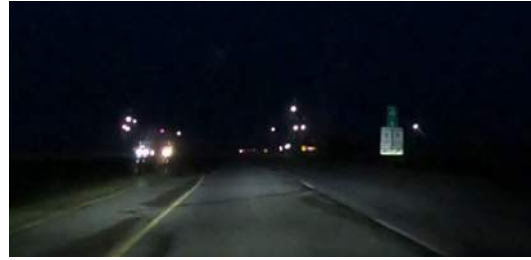
- Illumination at the intersection is limited. This creates shadowed areas within the intersection and limits intersection conspicuity when approaching the intersection on PTH 1 in both the eastbound and westbound directions.
- There is no direct illumination of the PTH 1 left-turn lanes and the median cross-over.
- Deteriorated pavement markings offer reduced positive guidance to drivers at night.
- Several signs were observed to have low reflectivity.
- Some headlight glare was observed from opposing traffic on both PTH 1 and PTH 5 approaches to the intersection. Of particular concern is the following:
 - Glare from opposing PTH 1 traffic while a vehicle is waiting in the median left turn lane.
 - PTH 5 traffic stopped in the median to cross or turn left onto PTH 1 experience glare from opposing traffic on the opposite leg of PTH 5.

Approaching intersection on PTH 1 while travelling eastbound at night

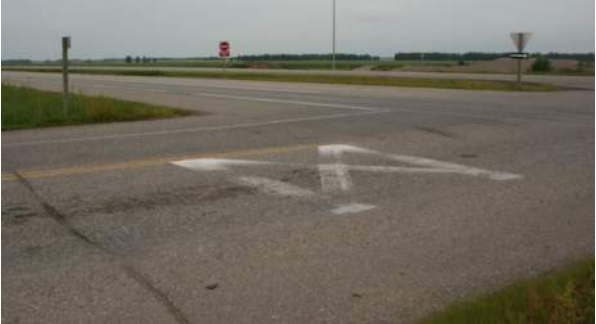
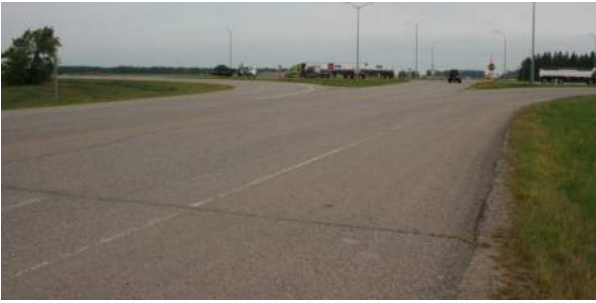
| Comment #23 | |

| Comment #23 | |
|--|--|
| <p>In general, line painting is deteriorated. As a result, the effectiveness of positive guidance offered to drivers is reduced. This contributes to increased driver workload and risk of driver error.</p> | <p>Example of pavement marking deterioration at stop line</p> <p>Example of pavement marking deterioration on northbound approach</p> |

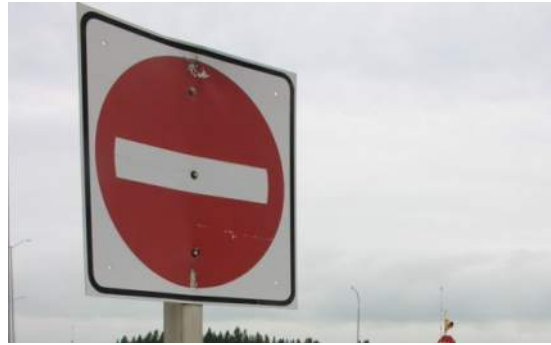
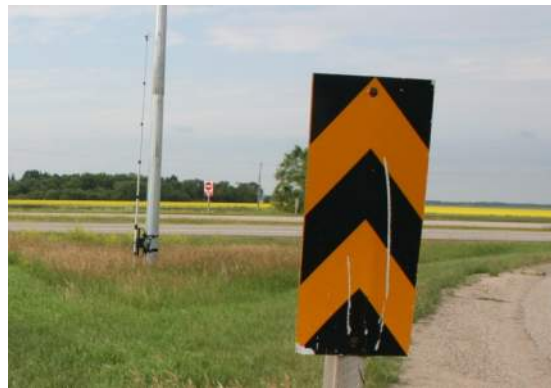
Comment #24

Some signs on the approaches to the intersection were deteriorated, damaged, or exhibited low reflectivity at night. This can reduce sign effectiveness and contributes to increased driver workload and risk of driver error.

Example of Sign deterioration

Example of Sign Deterioration

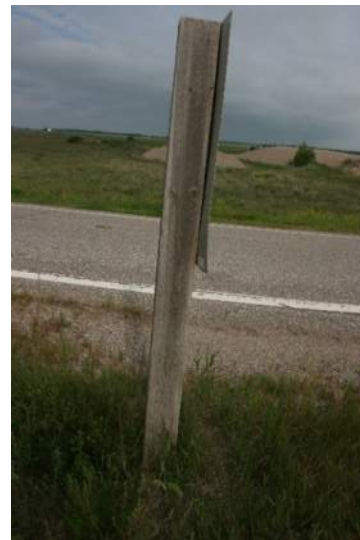
Comment #25

Several signs located within the intersection clear zone are mounted on single 6x4 inch (15x10cm) wooden posts that are not equipped with shear holes. As such, these posts present a roadside hazard as they would be less likely to give way if impacted.

Example of Sign without shear holes

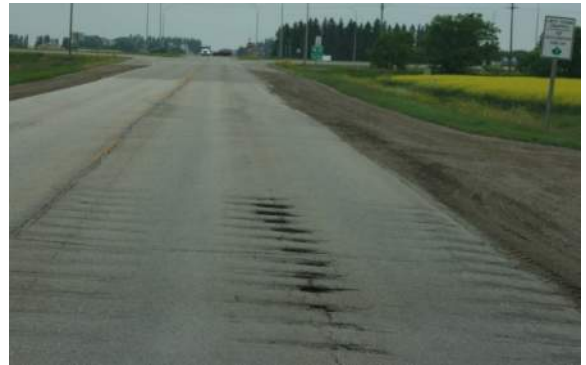
Comment #26

The transverse rumble strips on both PTH 5 approaches to the intersection are worn in the wheel paths. This may impact their effectiveness.

The shoulder rumble strips on PTH 1 are also worn and should be reviewed for refurbishing.

Transverse Rumble strips on the northbound approach

Since conducting the field review, MTI has refurbished the transverse rumble strip installations on PTH 5 (full lane width).

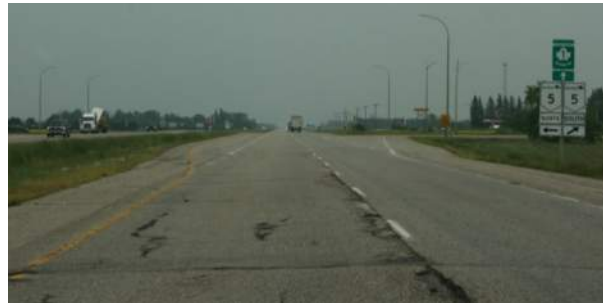
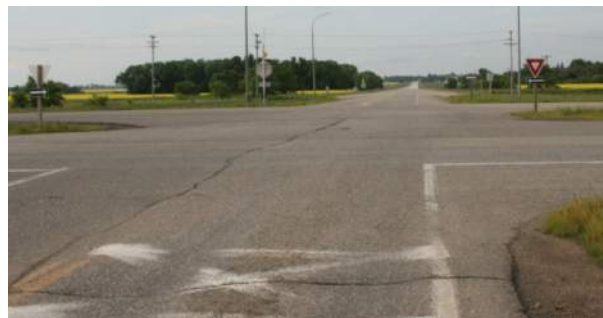
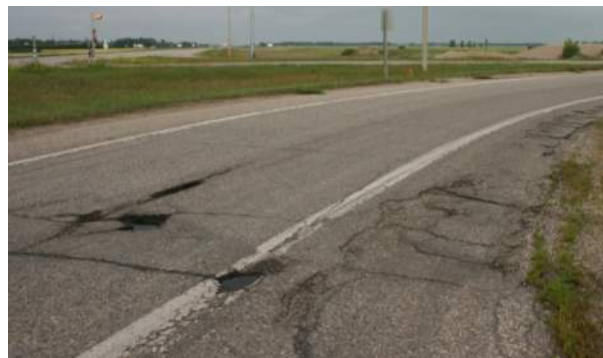
Pavement on the approaches to the intersection exhibit cracking and other surface deterioration. These discontinuities may impact surface drainage and contribute to further pavement deterioration.

Pavement cracking on the eastbound approach

Pavement cracking at intersection (facing south)

Pavement cracking at the right-turn channel at the northeast corner

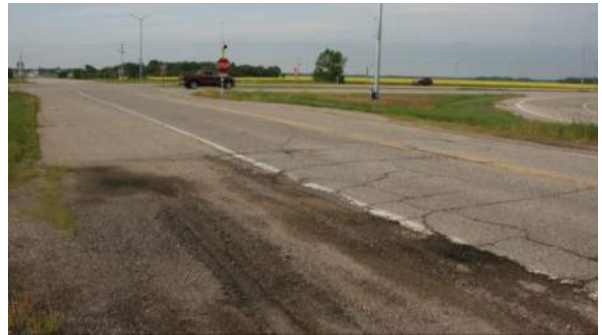
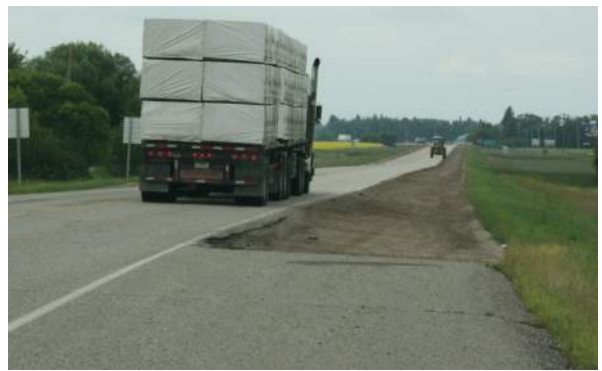
Comment #28

At several locations on PTH 5, the granular shoulders have deteriorated. This condition creates shoulder discontinuities that may impact drainage and vehicle stability.

Gravel shoulder deterioration on the north leg

Gravel shoulder deterioration on the south leg

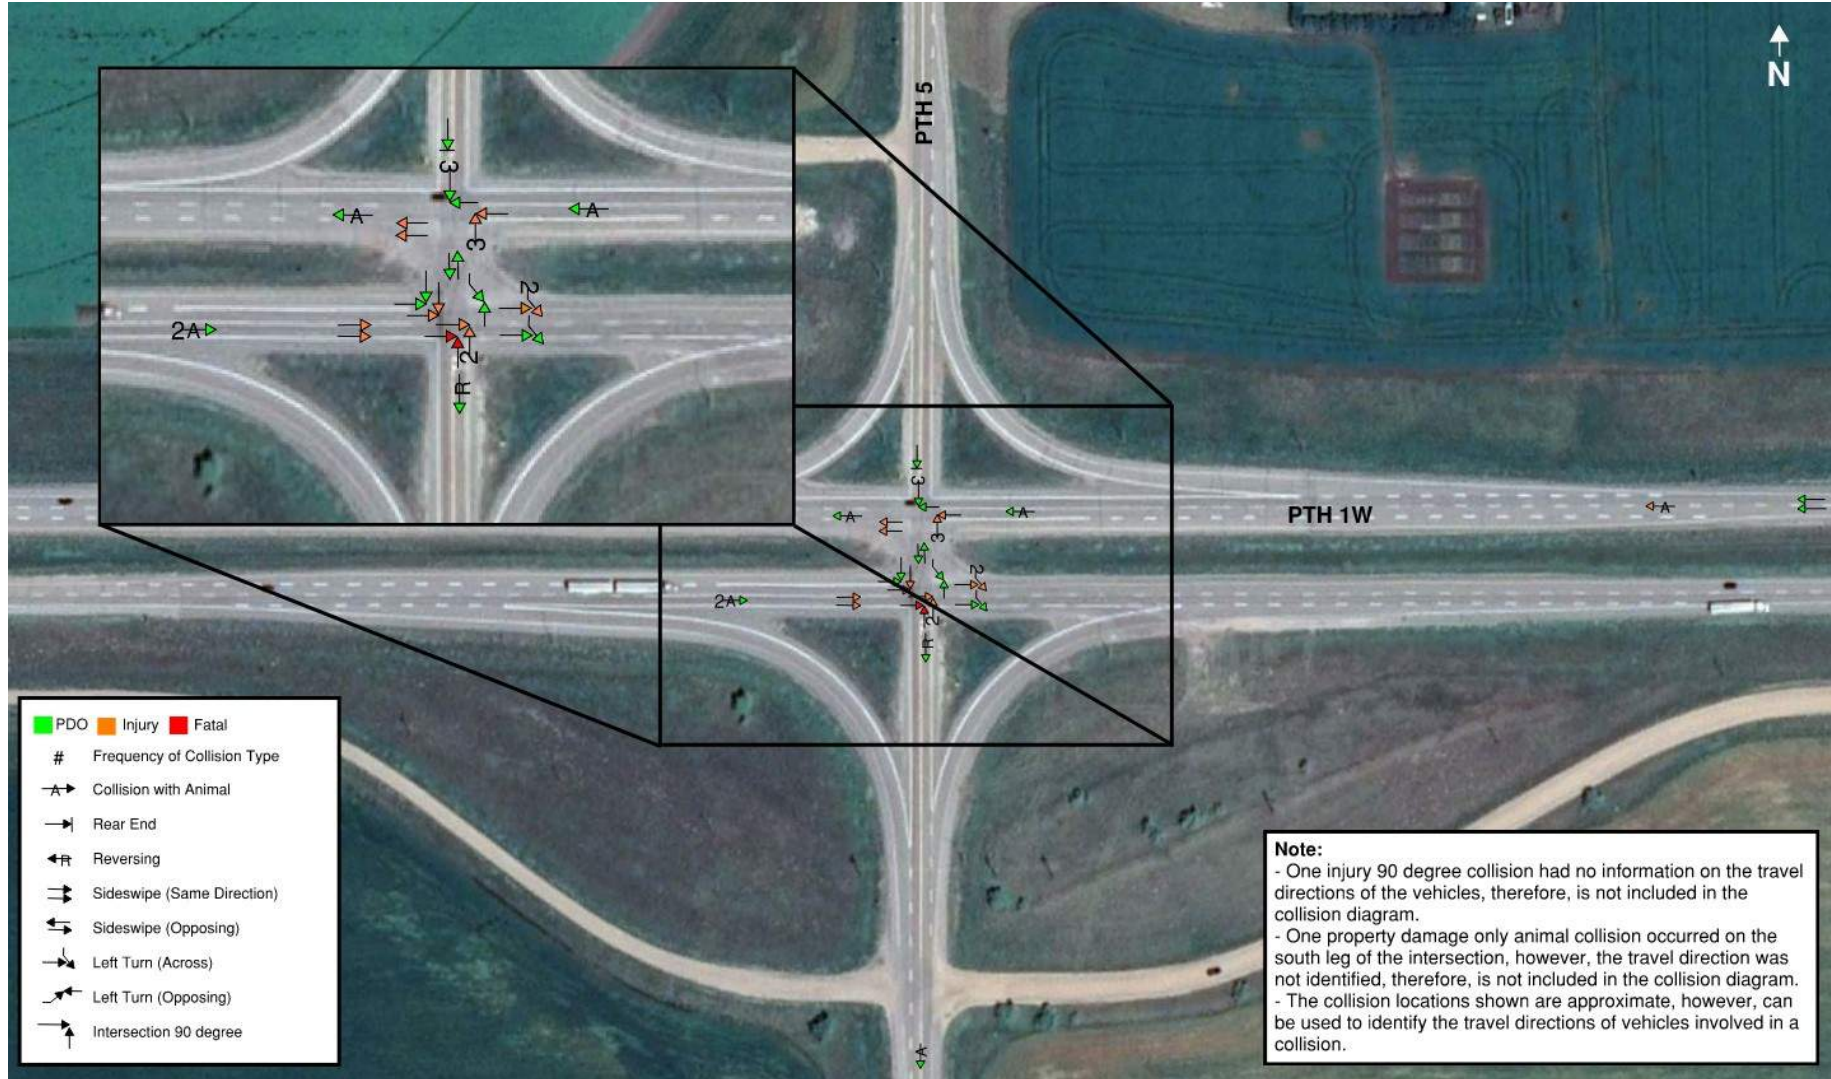
Figure 4.1: Collision Diagram

Key findings from an examination of the collision diagram ([Figure 4.1](#)) include the following:
