Anderson TIA Terrestrial Shoreline Survey Memo

Anderson TIA Expansion NOA:
Terrestrial Shoreline Survey

Memo

Subject: Anderson Tailings Impoundment Area - Terrestrial Shoreline Survey
Hudbay Minerals Inc. – Anderson Tailings Impoundment Area Expansion Notice of Alteration

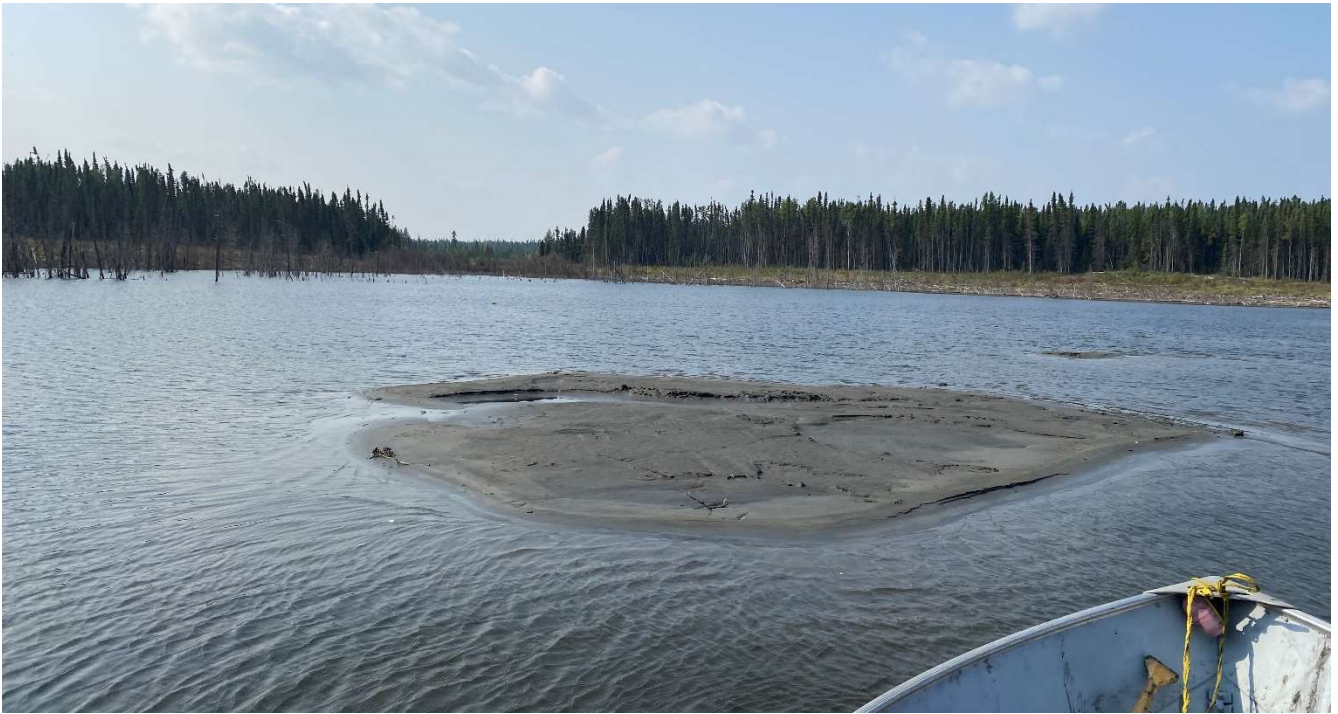
The aquatic environment immediately downstream of the natural inflow into Anderson TIA, located in the furthest southwest portion of the Anderson TIA, is characterized by many partially submerged dead standing trees. This area is shallow with very little aquatic shoreline vegetation. A series of beaver dams are located just upstream of the inflow into Anderson TIA. At the time the survey was conducted water levels were well below the top of the existing dams, with no apparent flow into Anderson TIA. The beaver dams are highly vegetated with typical riparian vegetation (aquatic sedges and grasses, Typha sp., Equisetum sp., etc.) and exhibit a high concentration of algal growth, indicating healthy nutrient levels in the upstream waters.

Figure 1 – Anderson TIA Upstream Inflow, Exposed Tailings, and Surrounding Area

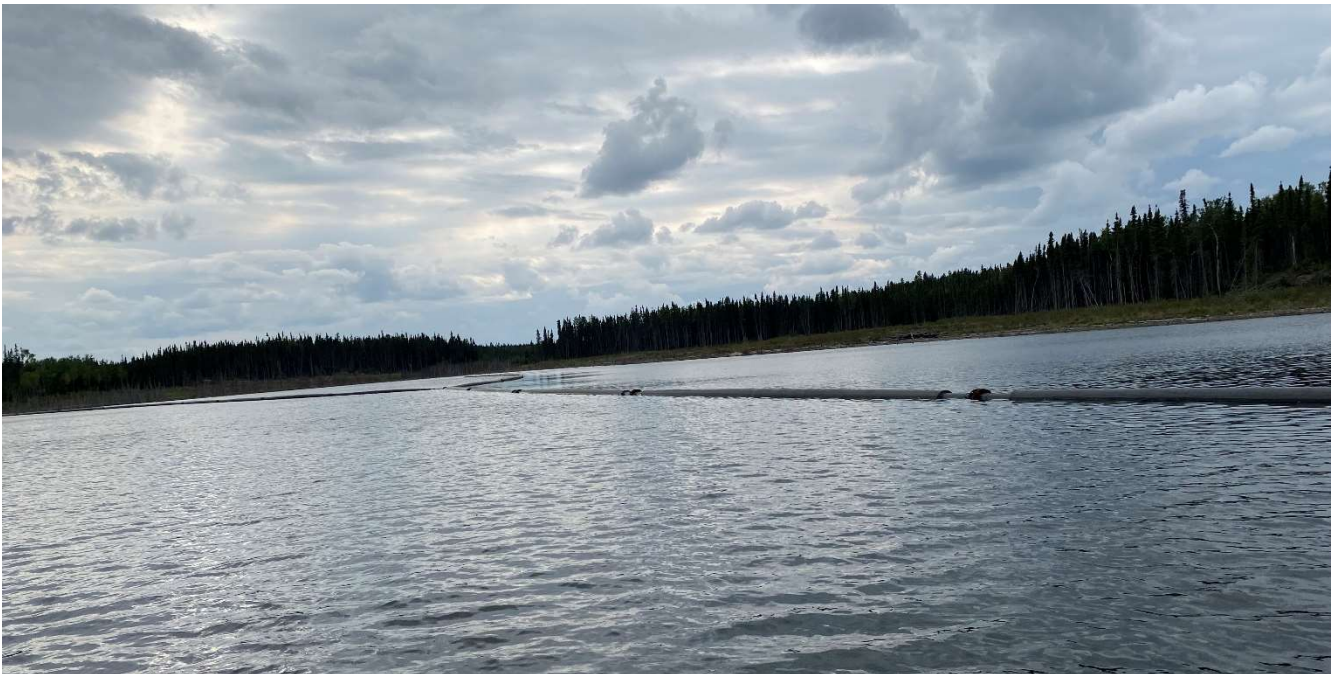
Figure 2 – Anderson TIA Upstream Inflow and Nearby Tailings Pipes

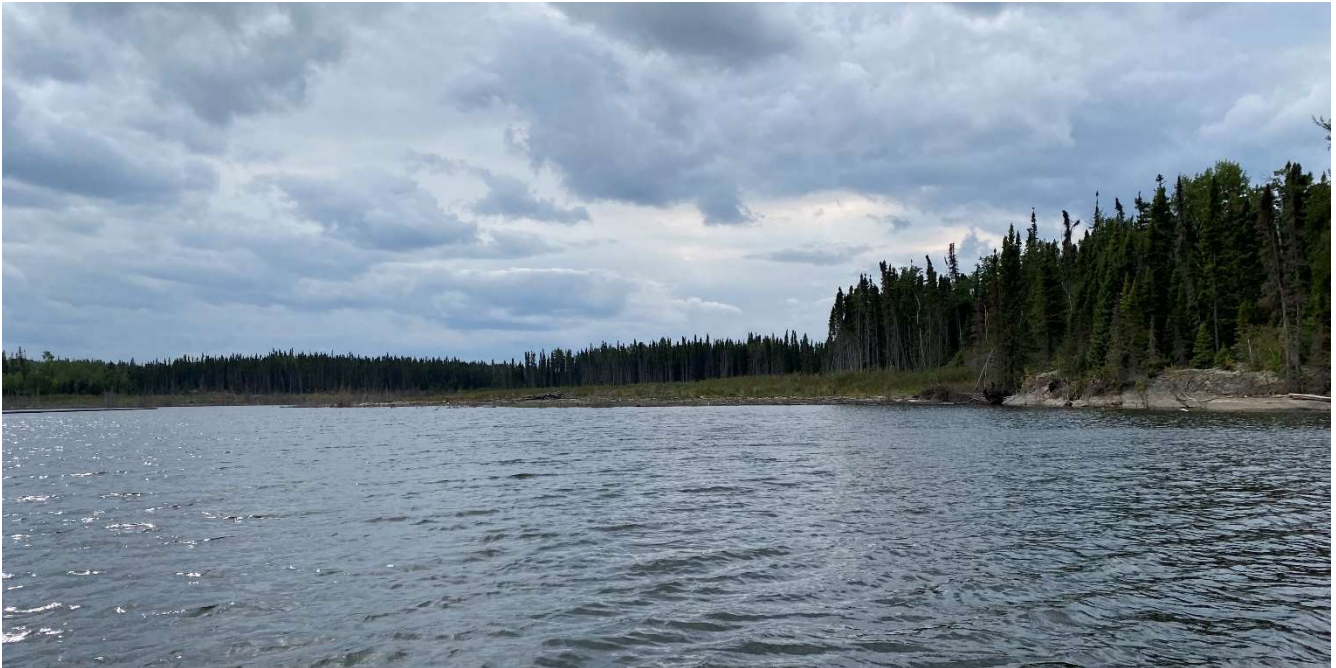
The aquatic shoreline had little sign of riparian vegetation, with no submerged or emergent aquatic vegetation within the shallowest portions of the shoreline. Many cleared and fallen trees, along with dead standing trees in the water, were present along the shoreline, creating an irregularly sloped benthic environment. The immediate terrestrial shoreline is gradually sloped and was recently cleared of vegetation in 2021. Numerous dead trees were present, with grasses and small shrubs beginning to regreen the area. The terrestrial shoreline environment was cleared for approximately 100 m to 200 m back from waterfront, transitioning into a mature forest stand dominated by black spruce, trembling aspen, and balsam poplar, with some birch and jack pine present.

Figure 3 – Anderson TIA Shoreline Type 1 - Heavily Cleared Terrestrial Shoreline

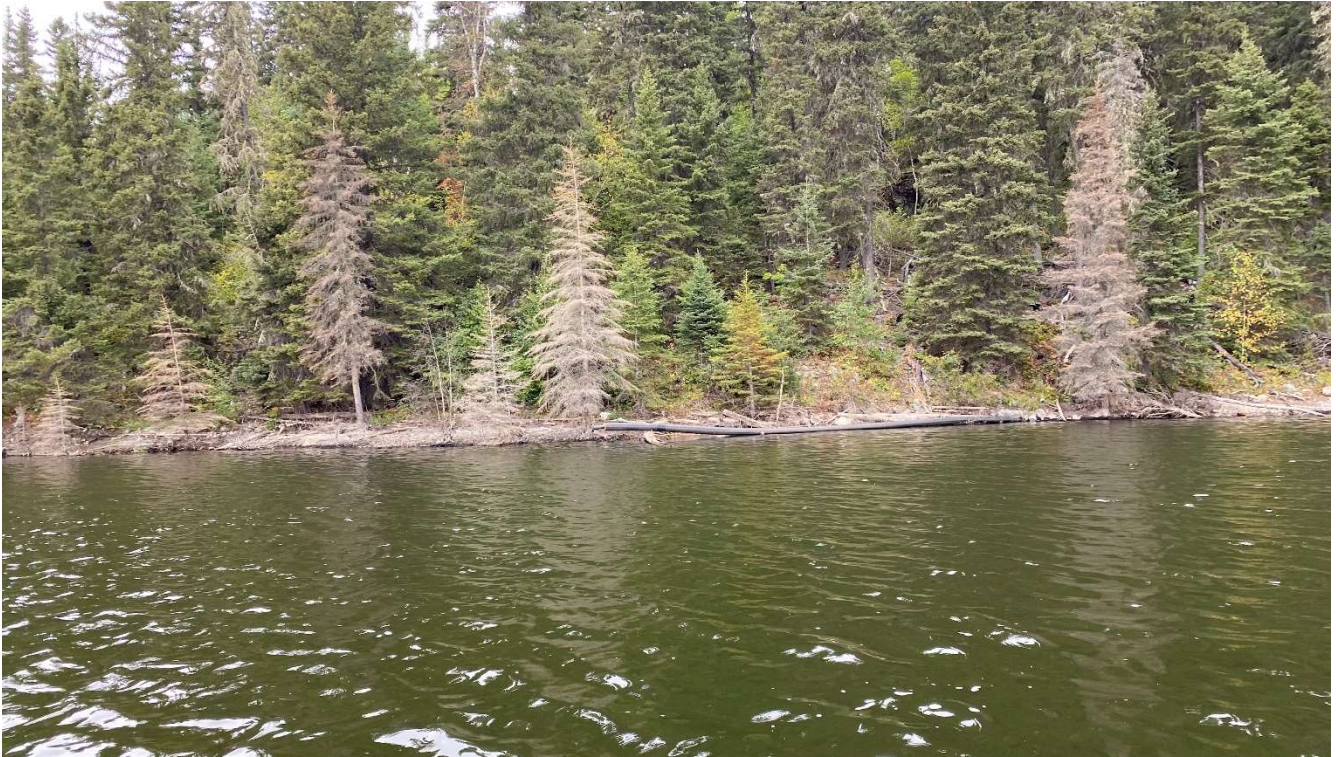
The aquatic shoreline is deep relative to other more gradual shorelines found throughout Anderson TIA. The aquatic shoreline showed little-to-no riparian vegetation. The immediate terrestrial shoreline environment was mostly vegetated with small to medium sized bedrock outcrops, with shallow soil layers. Dead standing and dying trees were observed along the shoreline, likely due to the inconsistent and fluctuating water levels in Anderson TIA. A typical boreal forest stand composed of black spruce, trembling aspen, balsam poplar, and jackpine, was present along the terrestrial the shoreline. This terrestrial shoreline was typical of the Anderson TIA prior to the clearing of much of the shoreline in 2020-2021.

Figure 4 – Anderson TIA Shoreline Type 2 - Typical Terrestrial ATIA Shoreline

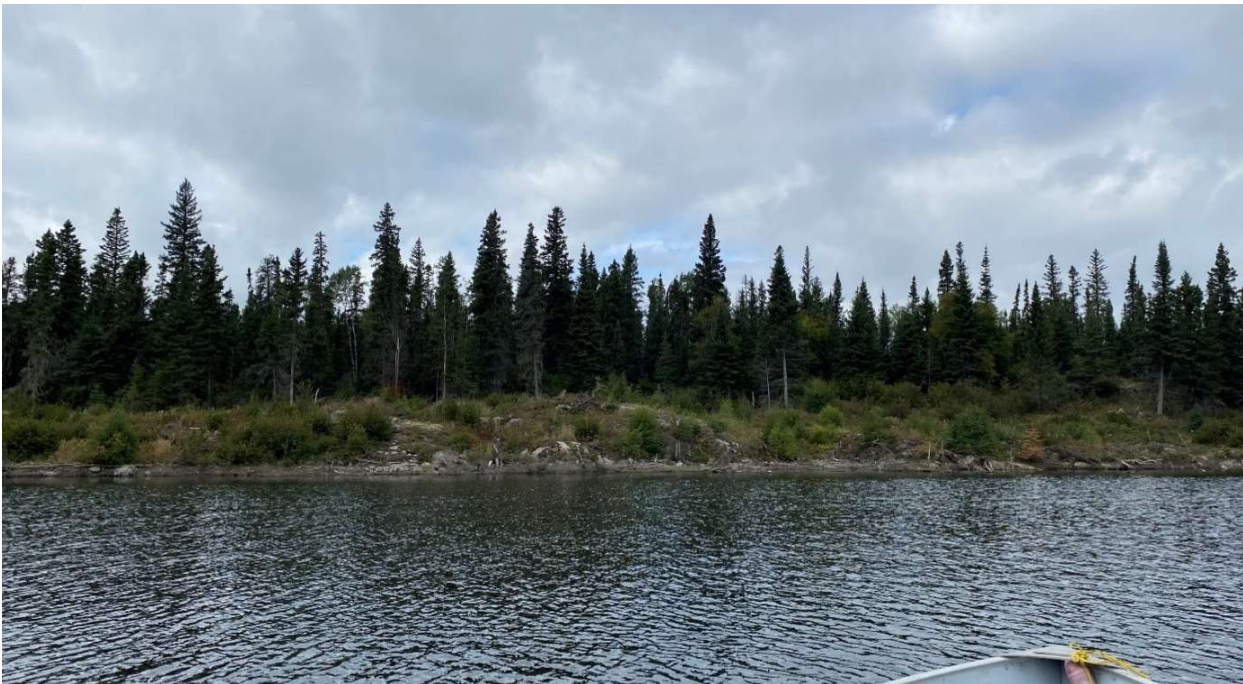
The aquatic shoreline environment was shallow with a gradual slope leading to the cleared shoreline. Little emergent and submerged aquatic vegetation was present in the Anderson TIA near the shoreline, with little-to-no sign of riparian vegetation along the shoreline. Dead fallen trees resulting from previous forest clearing were present within the Anderson TIA, and along the terrestrial shoreline. Approximately 50 m to 100 m of terrestrial vegetation was cleared, before transitioning to a mature forest stand of black spruce, balsam poplar, and trembling aspen. The cleared terrestrial area was beginning to regrow with low brush and juvenile trees (< 1 m) interspersed throughout the area.

Figure 5 – Anderson TIA Shoreline Type 3 - Cleared Terrestrial Shoreline with Short Shrubs

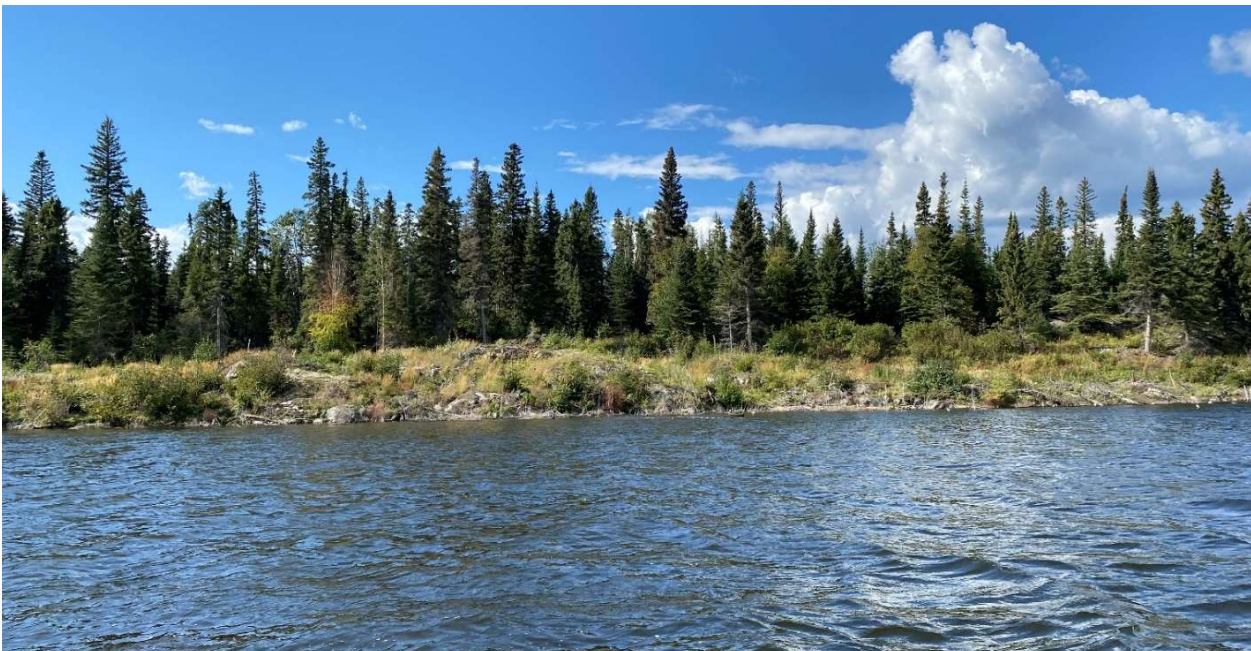
Figure 6 – Anderson TIA Shoreline Type 3 – Clear Terrestrial Shoreline with Mature Forest

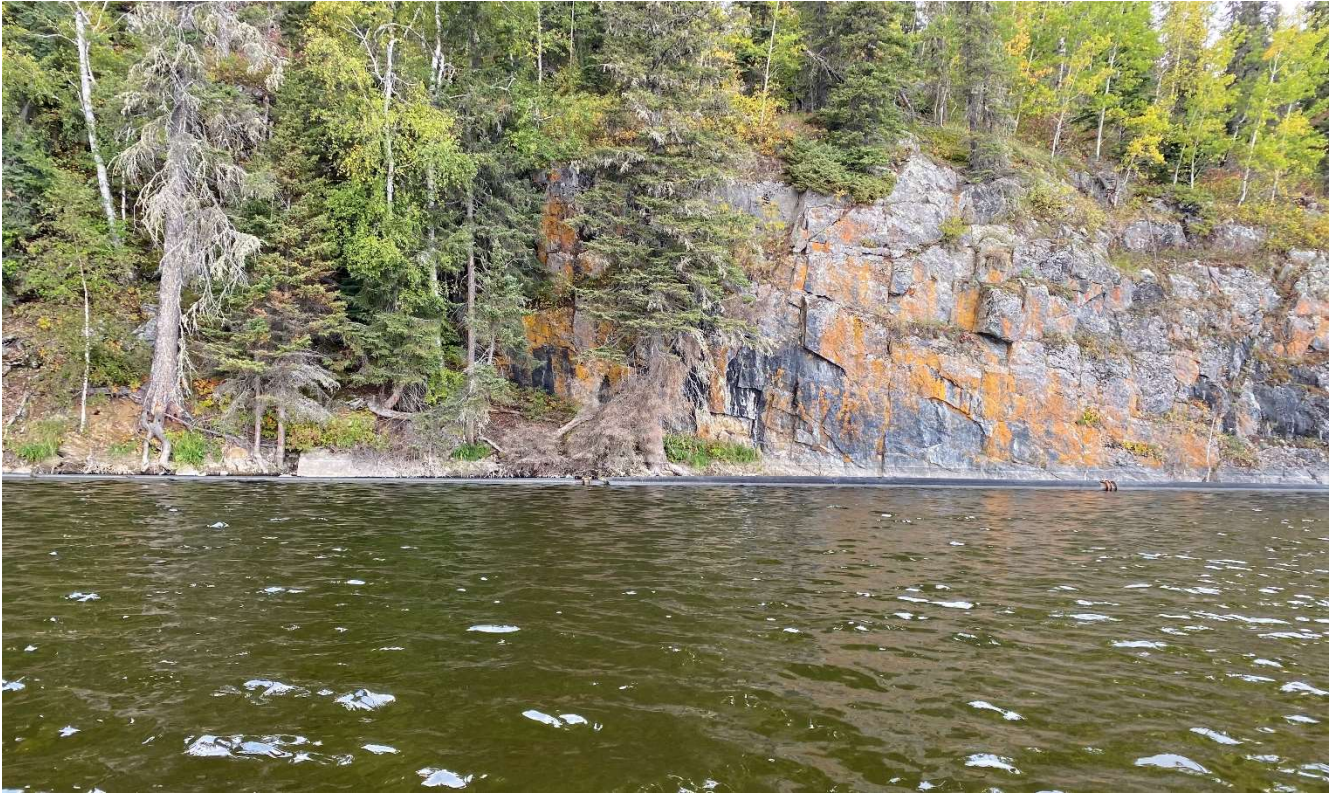
The aquatic shoreline environment was mostly bare, with no signs of emergent or submerged vegetation. Dead standing and fallen trees resulting from previous forest clearing and fluctuating water levels were present within the waters of the Anderson TIA. The terrestrial shoreline was composed of a mixture of steep grades and bedrock cliffs. Some trees and shrubs were present amongst the high grades and outcrops, growing from shallow topsoil layers. In higher areas where the slope became more gradual a mature forest composed of trembling aspen and balsam poplar was present.

Figure 7 – Anderson TIA Shoreline Type 4 - Large Rocky Outcrops Common to this Area

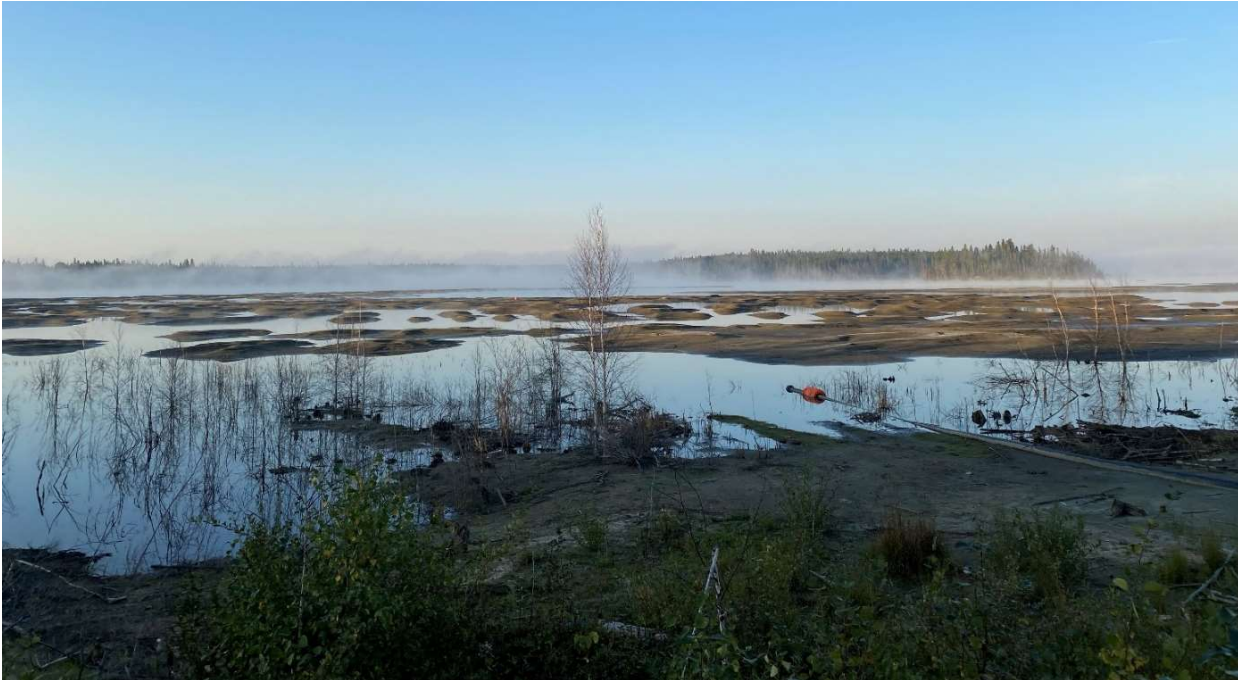
Large portions of the northern shoreline section of Anderson TIA have exposed tailings in the shallow areas, or immediately adjacent to the existing road that lead into the terrestrial shoreline environment. The aquatic shoreline has a shallow grade with little aquatic vegetation present, and no riparian vegetation present along the shoreline. The terrestrial shoreline and surrounding environment were cleared for the maintenance and expansion the road running along the north portion of Anderson TIA. Some large shrubs and small trees were left standing along road between the terrestrial shoreline and the existing treeline. The forest stand was composed mainly of trembling aspen and balsam poplar, with some black spruce throughout.

Figure 8 – Anderson TIA Shoreline Type 5 - View of Exposed Tailings from the Road

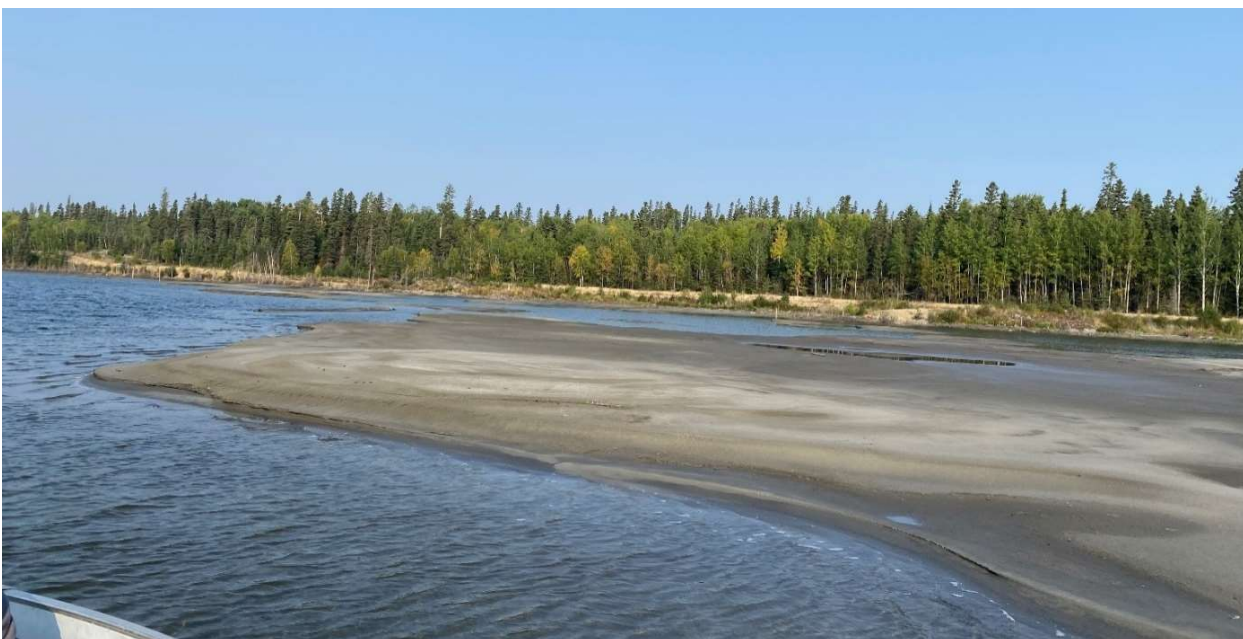
Figure 9 – Anderson TIA Shoreline Type 5 - View of Exposed Tailings and the Northern Shoreline Road

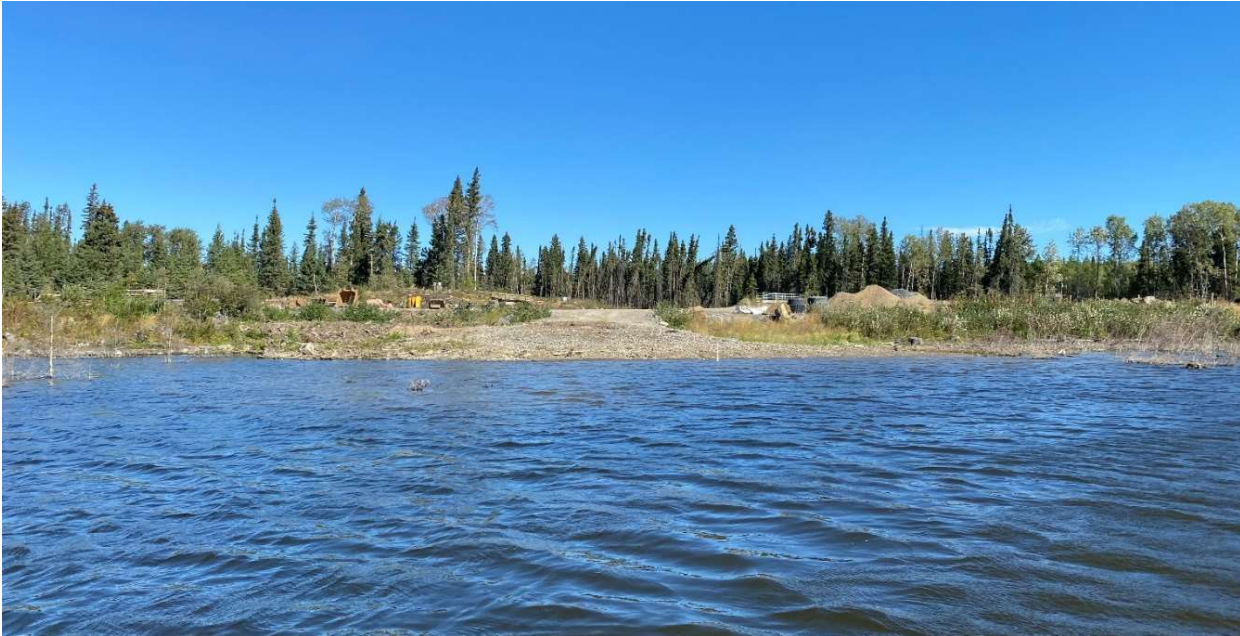
The aquatic shoreline has a shallow grade with little aquatic vegetation present, and no riparian vegetation present along the shoreline. Downed trees were observed throughout the aquatic shoreline as a result of previous clearing efforts. The terrestrial shoreline has been heavily cleared over the past several years to accommodate several roads, laydown areas, and the existing dam along the east portion of Anderson TIA. Sparsely vegetated areas with mature trees and brush are still present along the shoreline, however a large majority of the terrestrial shoreline environment has been altered. In the areas north and south of the existing dam of Anderson TIA, a mature forest stand of black spruce, balsam poplar, and trembling aspen exists past the cleared areas. Large portions of the ground near the Anderson TIA dam are covered in gravel or other forms of fill to accommodate the construction efforts.

Figure 10 – Anderson TIA Shoreline Type 6 - View of Cleared Storage Areas

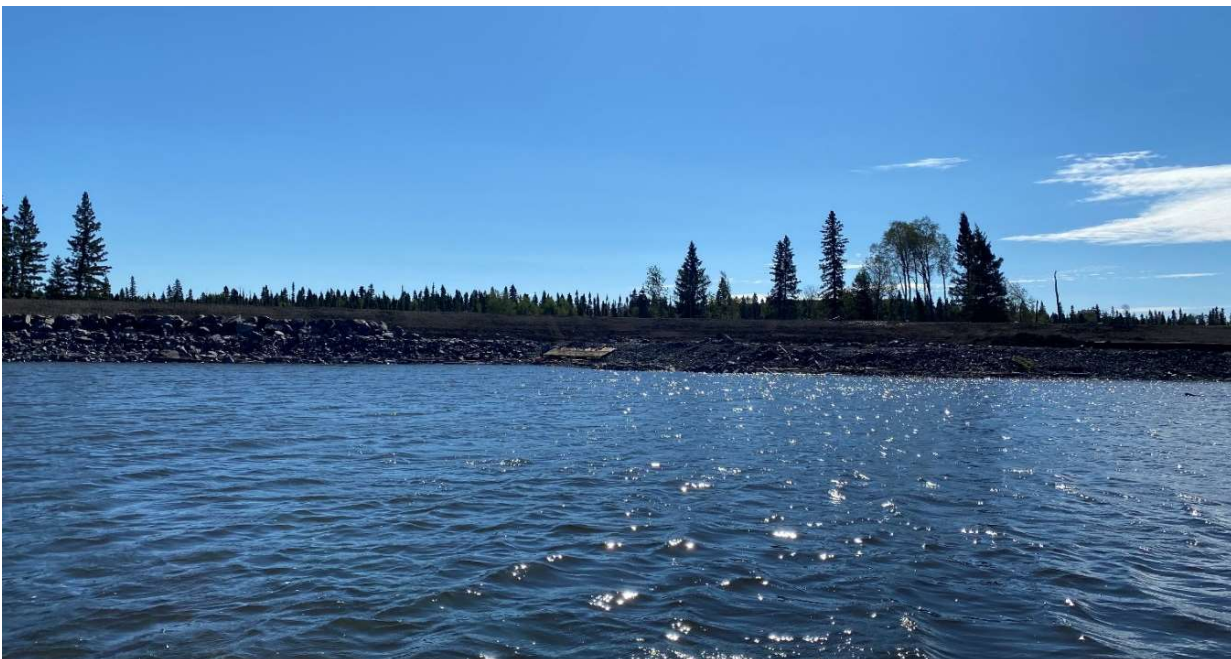
Figure 11 – Anderson TIA Shoreline Type 6 - View of the Existing Outflow Dam Structure
