# Notice of Alteration Form

**Subject: Notice of Alteration – Birds Hill Provincial Park Wastewater Treatment Lagoon**  
**Client ref.: File no. 166.10**

# BIRDS HILL PROVINCIAL PARK LAGOON DYKE ASSESSMENT REPORT

# BIRDS HILL PROVINCIAL PARK LAGOON DYKE REPAIR

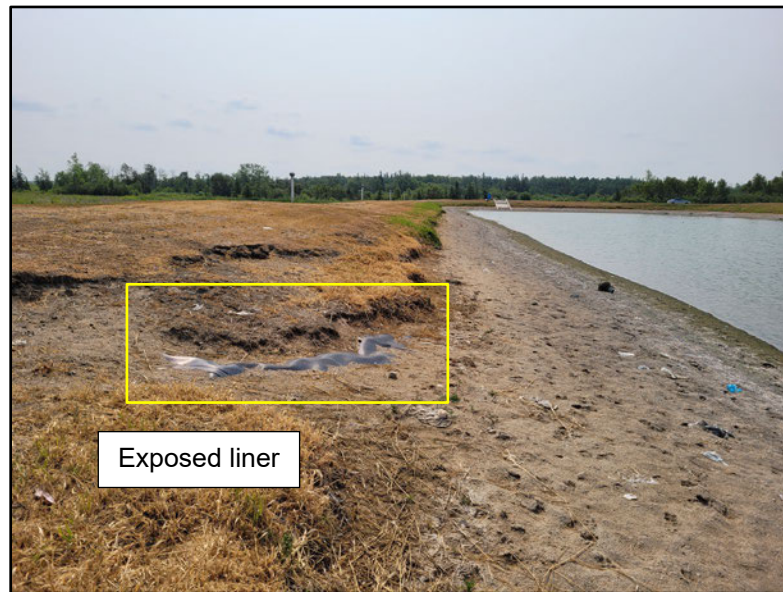
*Figure 1: Exposed liner on the east side of the primary cell dyke, looking south (July 13, 2021).*

The figures above also show how the sand cover has been eroded from the upper to lower area on the dyke slopes, giving the appearance of slumping.

WSP, on behalf of Parks and MWSB, is proposing to repair the lagoon dyke erosion and armour the dykes with geotextile and rip rap material to prevent future erosion. The following methodology is proposed for the lagoon dyke repair and rip rap armouring:

1. Begin the repair work by stripping the existing topsoil and vegetation of the interior slope of the lagoon dykes and stockpile for reuse.
2. Place the excavated and/or imported sand material on the dykes, verifying a 300 mm depth of sand cover on the liner.
3. Place non-woven geotextile and a 300 mm thick layer of 100 mm to 200 mm diameter rip rap. Rip rap will be placed from the toe of the dyke to an elevation approximately 1.8 m above the floor of the cell. This equates to a width of approximately 7.5 m, based on the as-constructed slopes of 4H:1V.
4. Place topsoil and seed areas affected by construction activity.

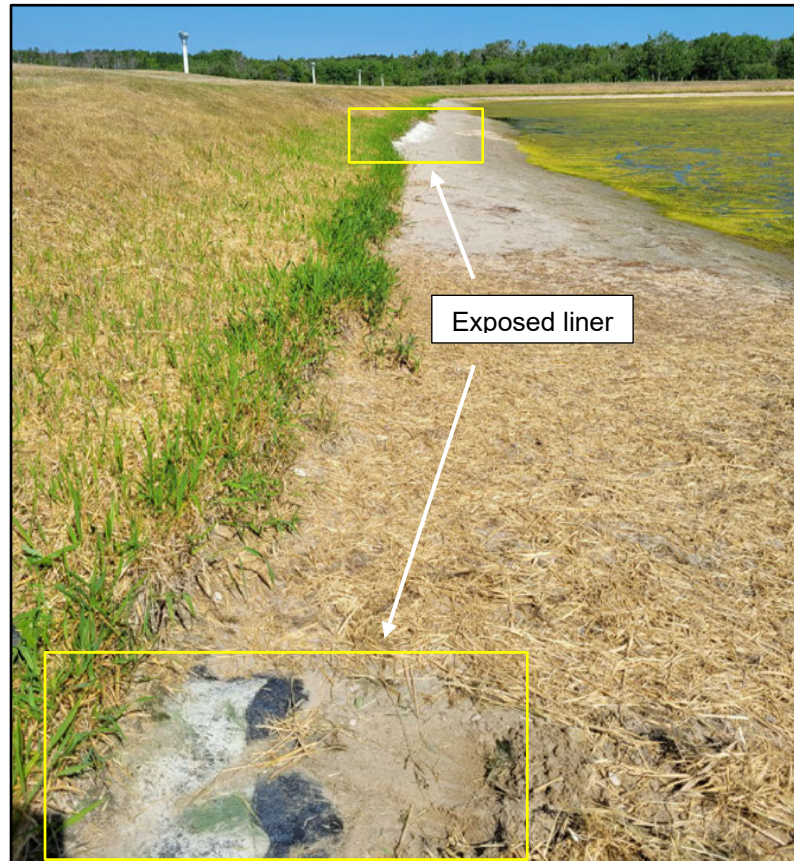
*Figure 2: Exposed liner on the west side of the secondary cell dyke, looking north (June 30, 2021).*

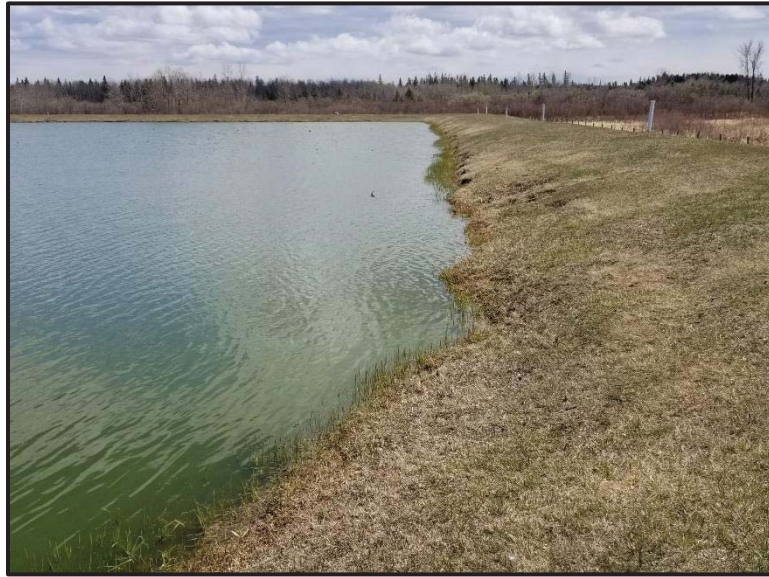
- Noticeable erosion of the sand cover on all the interior dykes of the secondary cell, in particular the south and east sides. The primary cell also had some erosion on its interior dykes, though not as substantial.

**Figure 1 - West secondary cell dyke, looking south (May 8, 2019)**

Due to erosion observed on the majority of the interior dyke slopes, coupled with the lack of any erosion protection (i.e. rip rap), WSP recommends that the both the primary and secondary cells dyke erosion be repaired. This can be completed by placing either imported sand cover material or recovered sand material deposited at the toe of the dyke and placing rip rap for erosion protection.

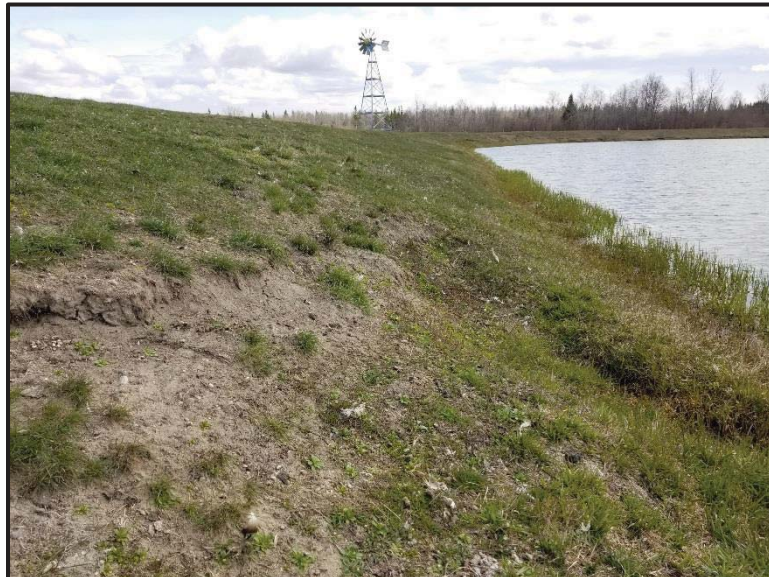
**Figure 2 - Primary intercell dyke, looking north (May 8, 2019)**

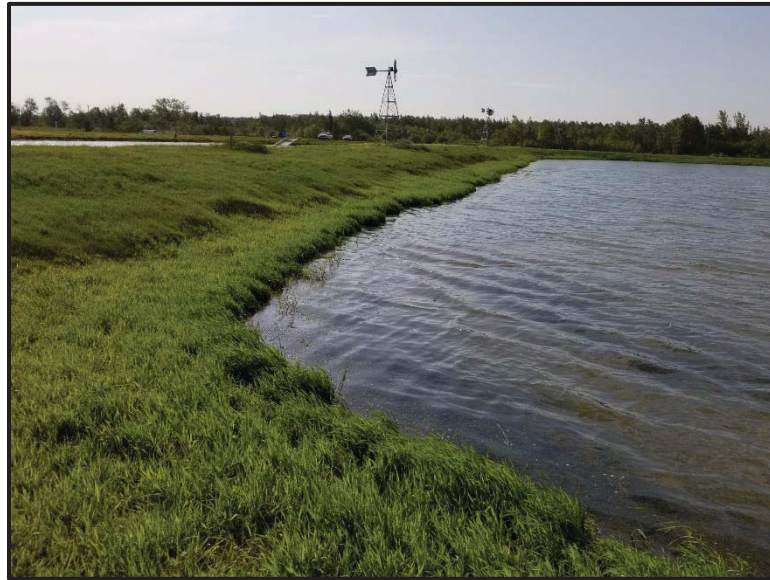
- The sand cover has been eroded from the upper area of the dyke slopes and has deposited on the lower area, giving the appearance of slumping.

**Figure 3 - Secondary intercell dyke, looking south (July 25, 2019)**

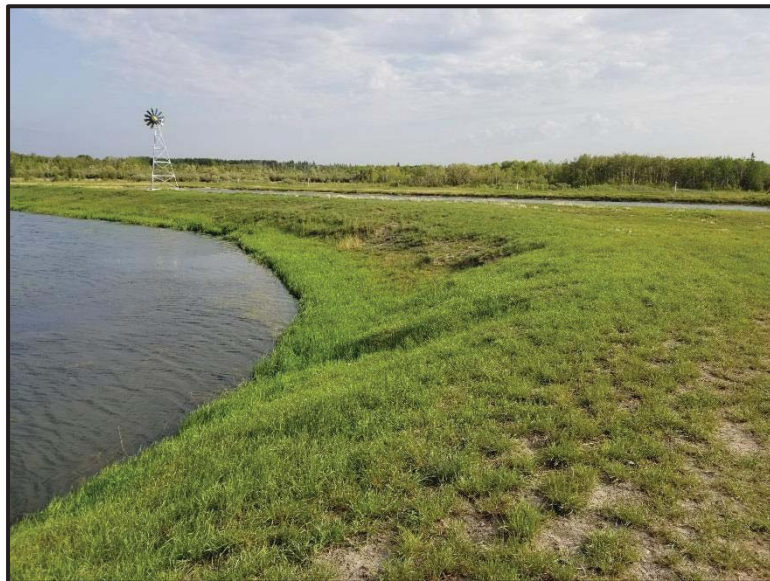
**Figure 4 - Secondary cell southeast corner, looking northeast (July 25, 2019)**

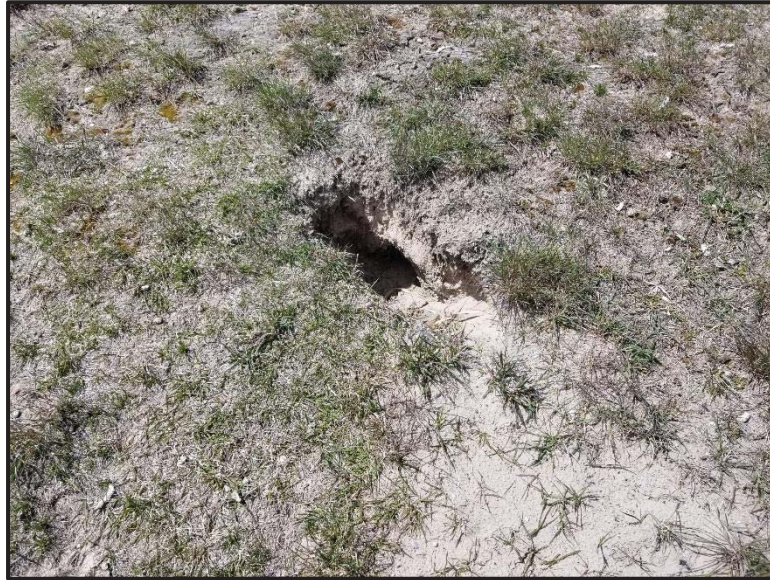
- Signs of burrowing animals within the sand cover, predominantly at the northwest corner of the secondary cell.

**Figure 5 - Burrowing animal hole, northwest corner of secondary cell (May 8, 2019)**

Regarding the issue of burrowing animals, it is recommended that Parks staff actively monitor and remove burrowing animals.

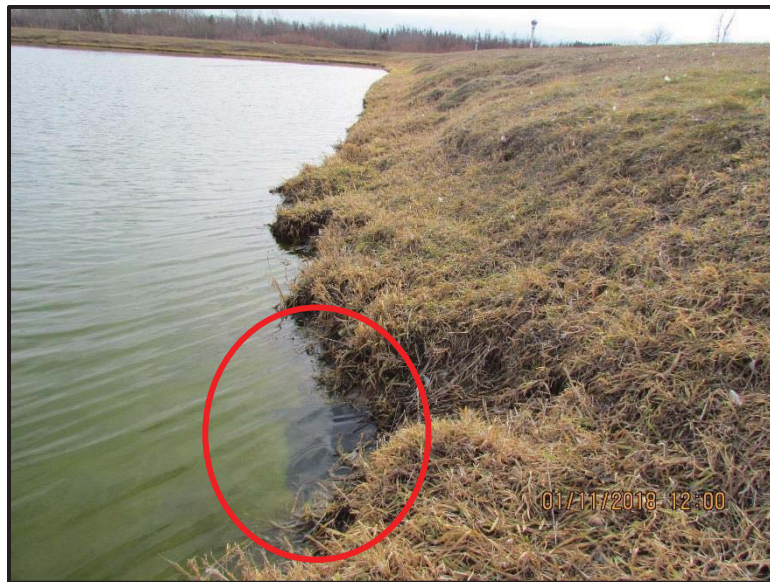
- No signs of exposed liner were observed by WSP during the site reviews, though exposed liner on the west secondary cell dyke was noted and photographed by Parks staff when the lagoon was at a lower operating level.

**Figure 6 - Exposed liner, west secondary cell berm looking south (Source: Parks)**

As discussed in Section 2.1, WSP did not encounter any exposed liner areas along the interior dyke slopes, though one exposed area was previously documented by Parks staff. This area may have been hidden due to higher liquid levels of the lagoon when the site reviews took place. Therefore, the condition of the exposed liner at this location could not be verified. Incidentally, there was no indication of any liner protrusions (i.e. bubbling) due to groundwater or gas build-up beneath the liner. HDPE type liners are a durable material that has good UV resistance, especially when compared to PVC type liners. While HDPE liners are susceptible to punctures and stress cracking, usually during the installation process, there is no indication that this is an issue at Birds Hill. A more thorough review of the entire liner system can only be accomplished if the lagoon is completely discharged exposing the floor of the cells. This should be completed prior to the repair of the dykes.
