RE: Canadian Tire Property  
18th Street & Aberdeen Avenue  
Brandon, Manitoba  
Our Project No. 454

RE: Environmental Site Assessment, Stage 2 to 4  
Report On Field Investigation & Lab Testing Results  
Commercial Development, 14th Street & Aberdeen Ave.  
Brandon, Manitoba Our Project No. 389

ENVIRONMENTAL SITE ASSESSMENT - STAGE 2 - 4  
FIELD INVESTIGATION & LABORATORY TESTING RESULTS  
PROPOSED COMMERCIAL DEVELOPMENT  
NORTH OF ABERDEEN AVENUE BETWEEN 14TH & 18TH STREETS  
BRANDON MANITOBA

June 18, 1990

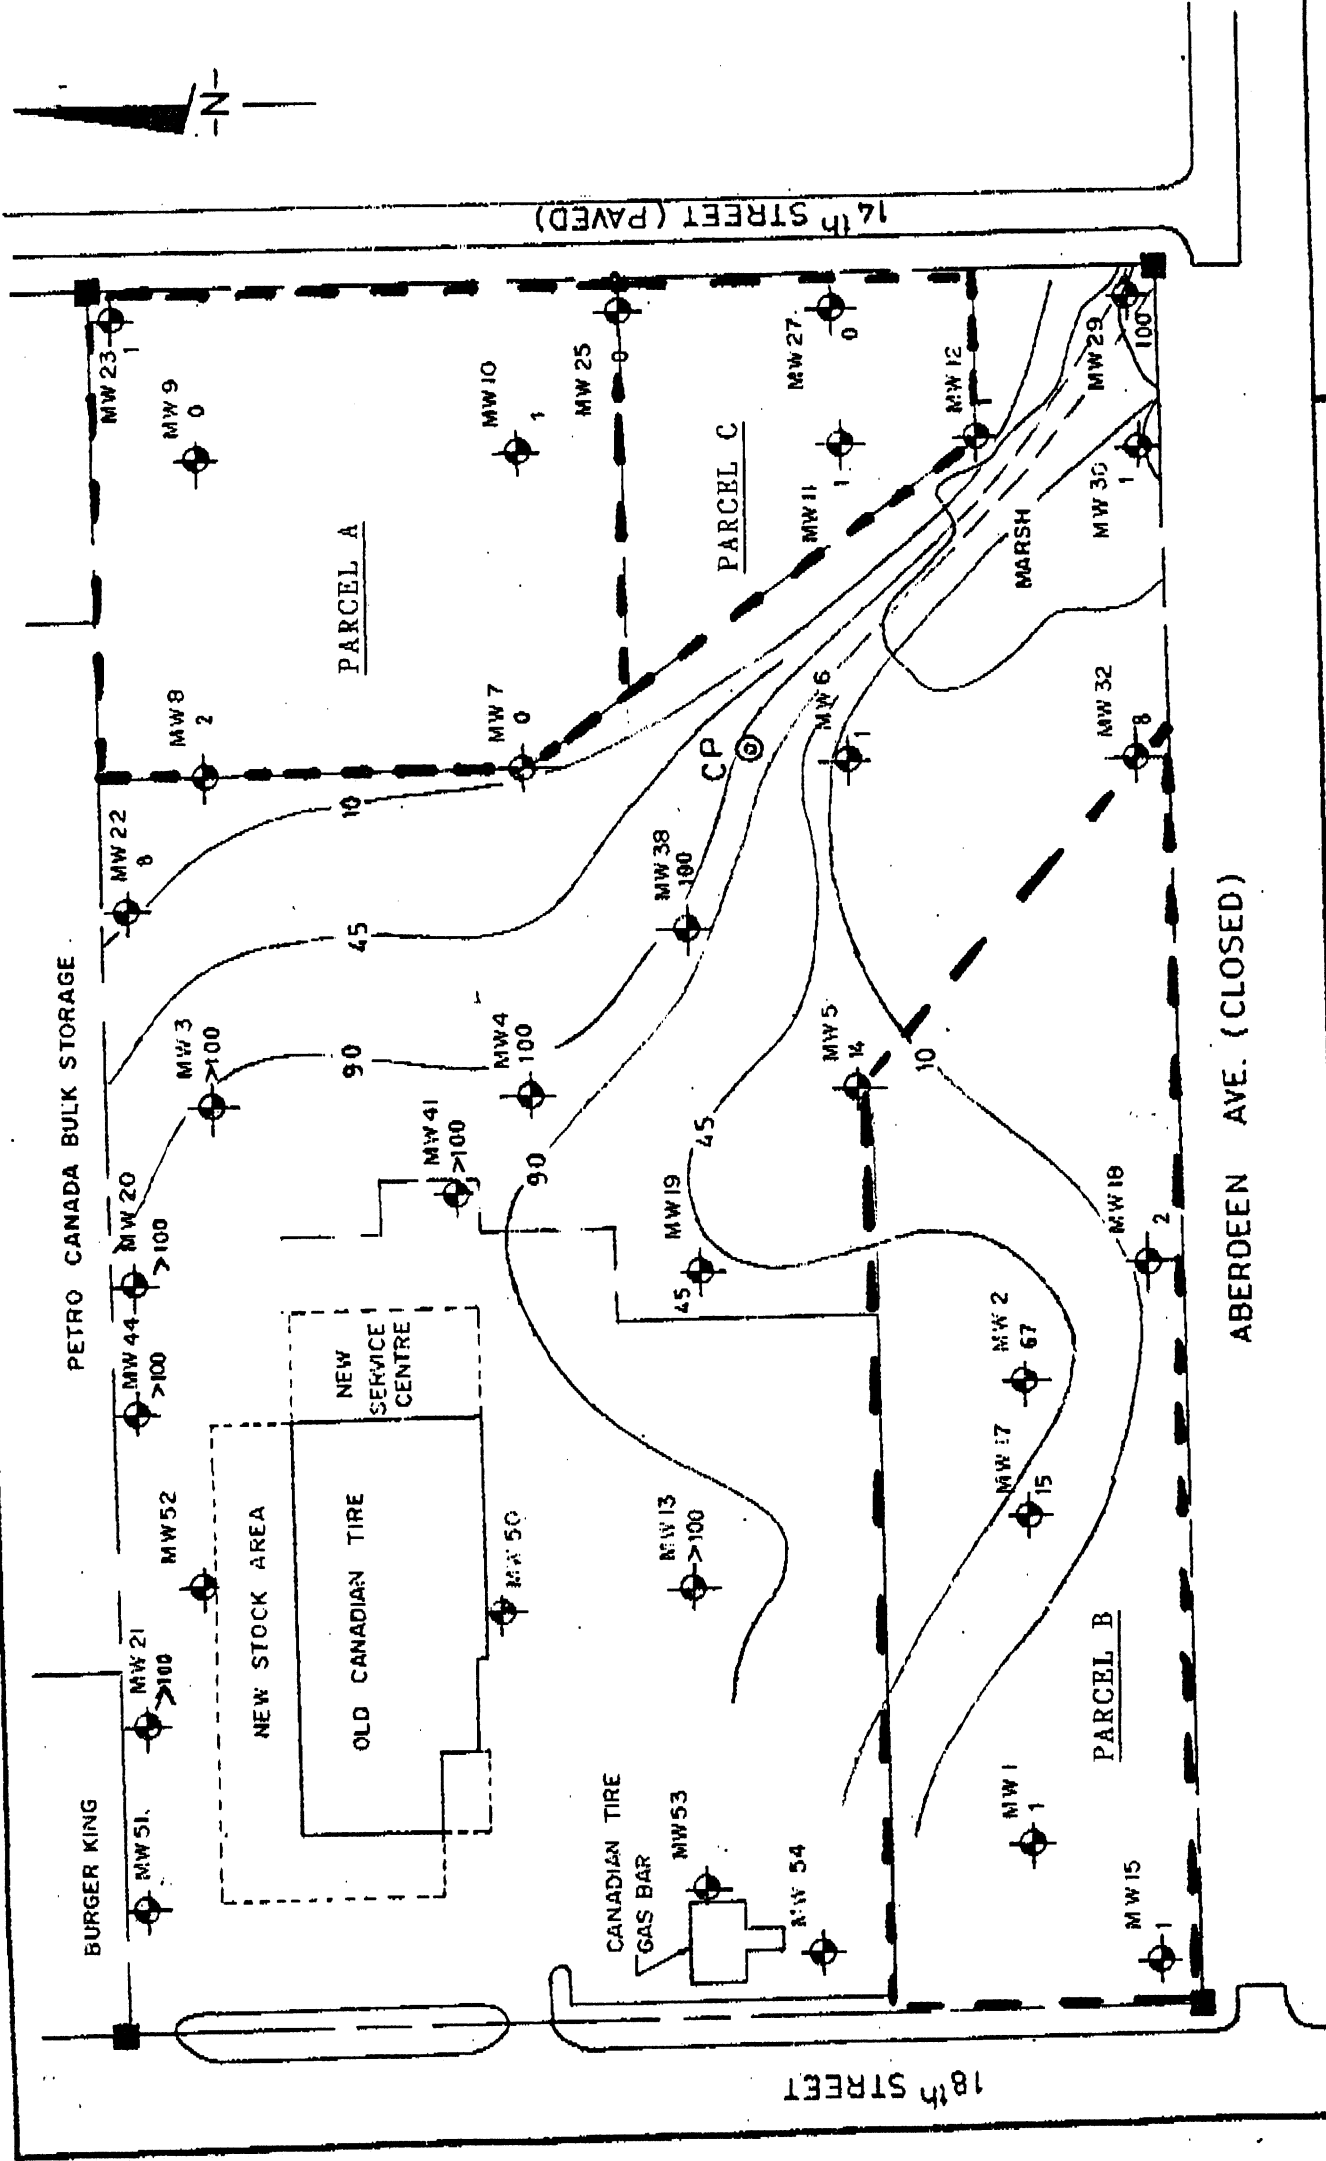
SCALE: 1"=120'	DATE: 22/05/90	MADE: RK	CHKD: WK	JOB: 389	PLATE: 1C
----------------	----------------	----------	----------	----------	-----------

You will note that 3 parcels of land (A, B & C shown on Plate 1C) have been identified by our firm as potentially suitable to commercial development at this site, and that a Stage 5 study has been recommended in our report. We expect that this study will be implemented, as soon as the present report is reviewed by the Canadian Tire Corporation Ltd. and after a brief meeting between yourself, the writer and the representatives of the Manitoba Environment Department. To ensure safety and health, the free phase gasoline and flammable vapours presently surrounding the CTC store in Brandon should be properly collected and disposed as soon as possible.

5.8 Three parcels of land (Plate 1C) have been identified by us within the CTC property, where there are less environmental impact and are considered suitable for commercial building development, subject to proper foundation design, site drainage, and environmental control such as soil vapour and pungent odour management.

FLAMMABLE SOIL VAPOR DISTRIBUTION  
% L.E.L. - JANUARY 19, 1990  
14TH ST. + ABERDEEN AVE., BRANDON

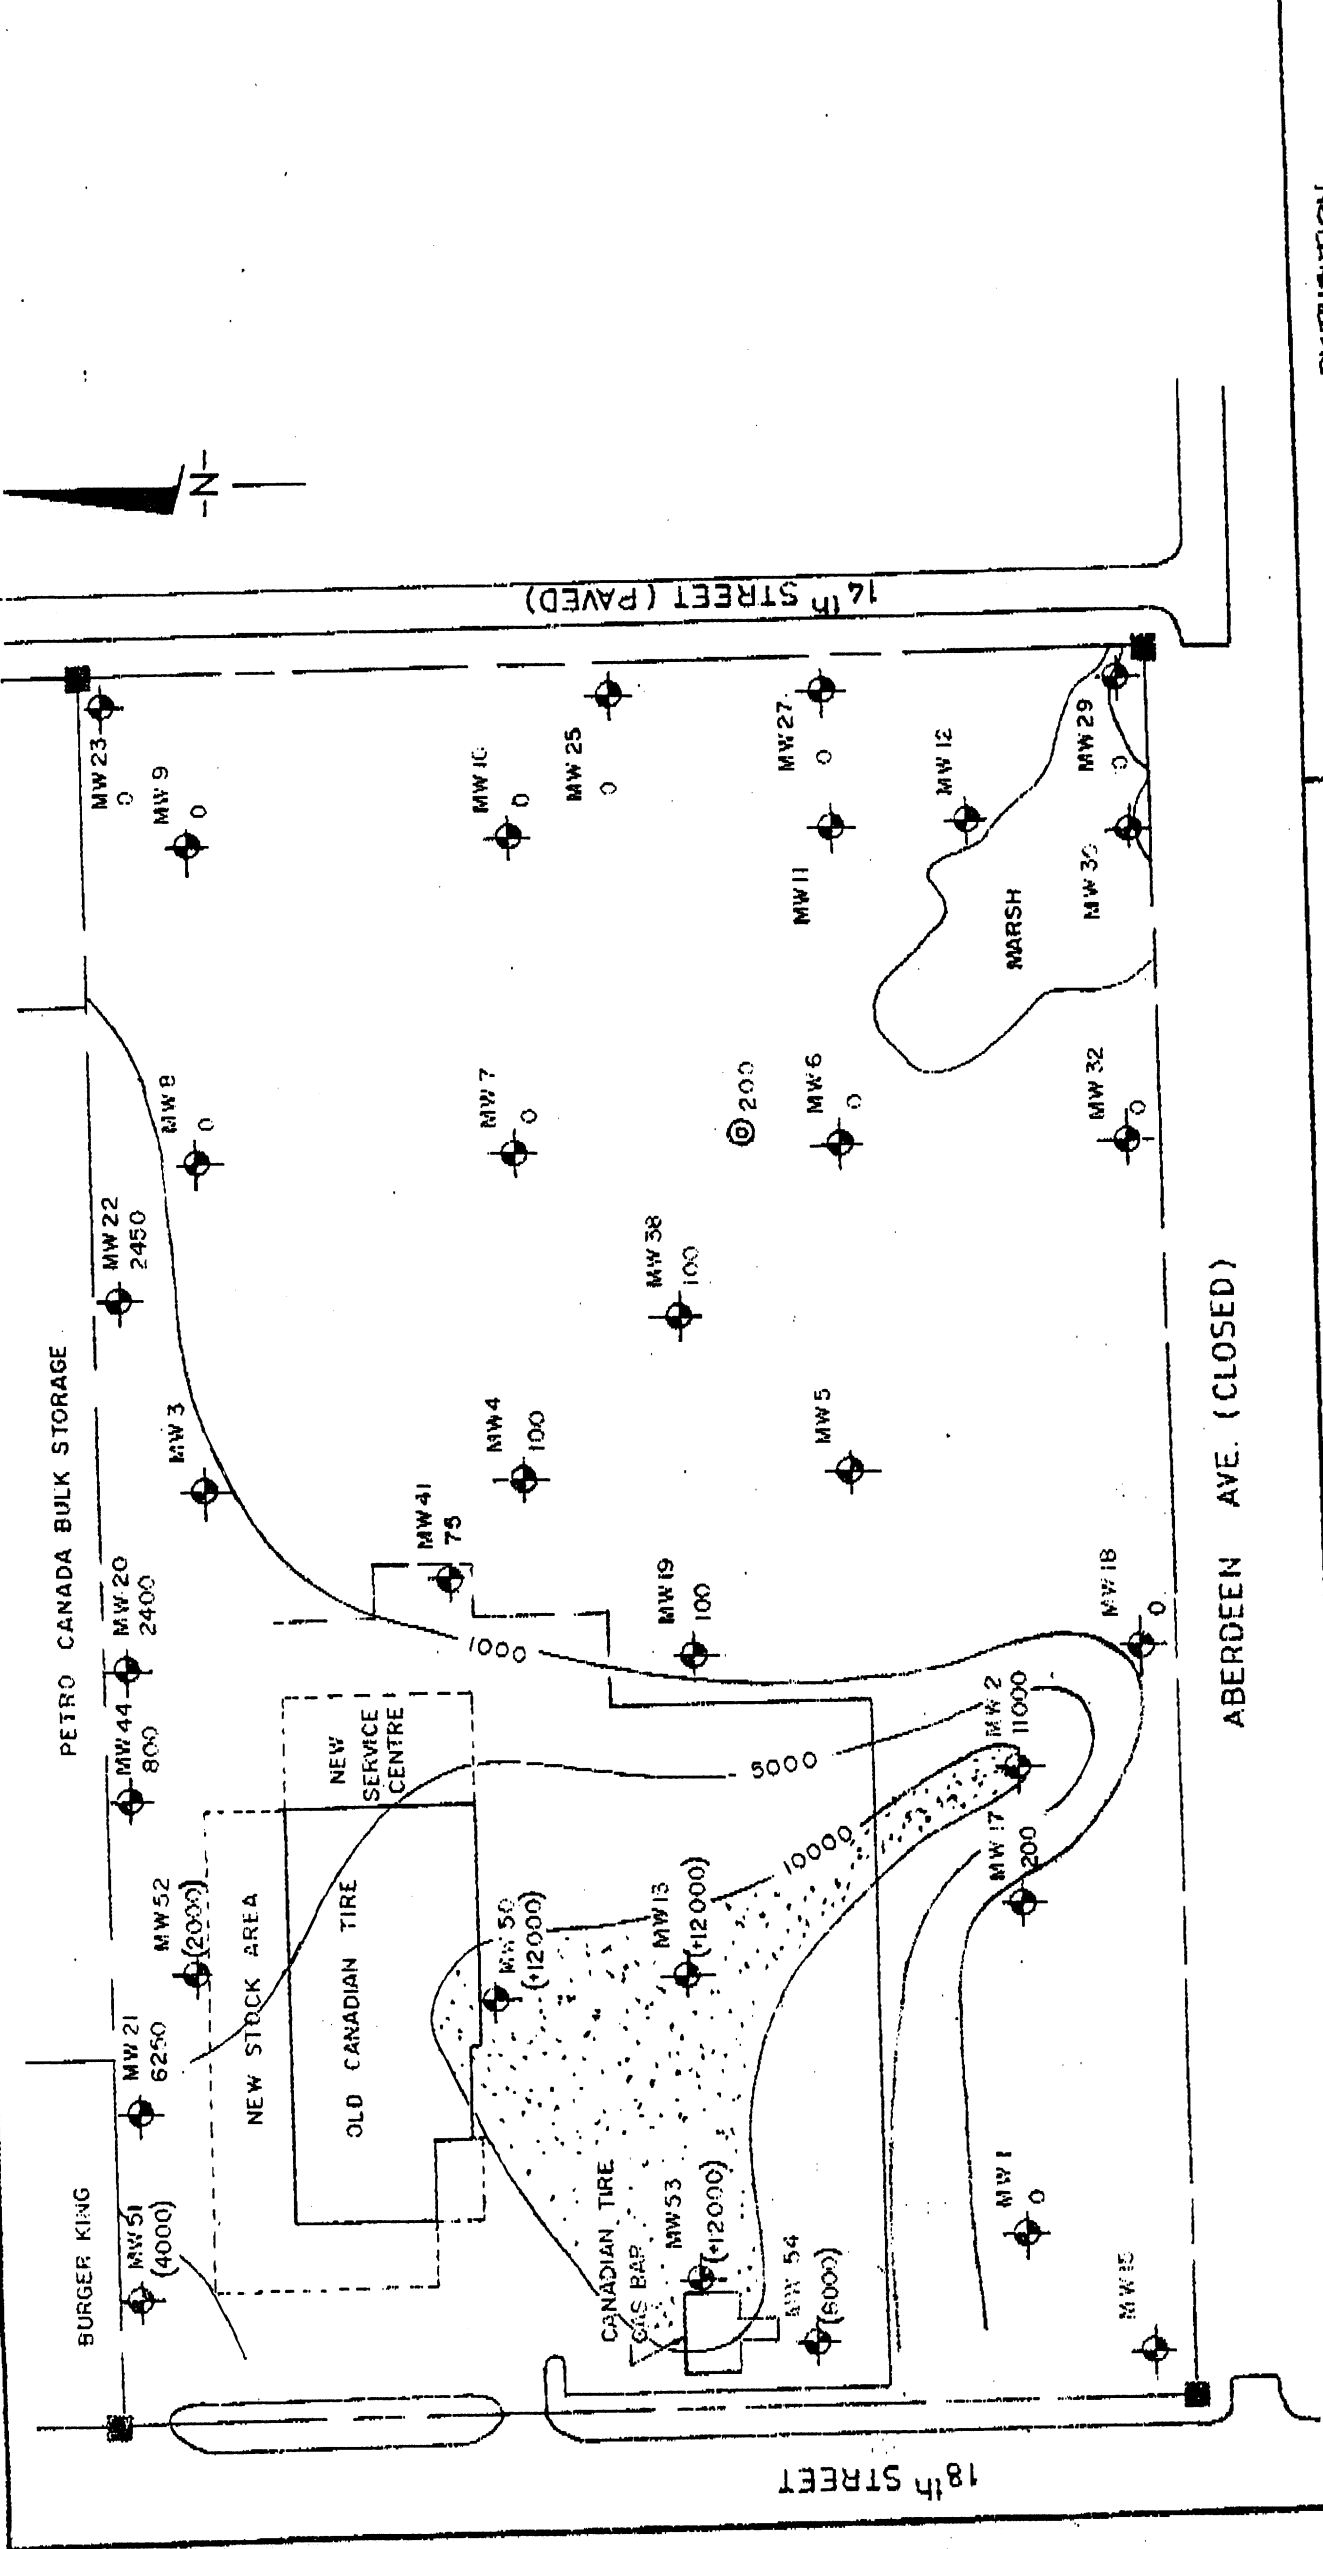
It should be noted that the flammable vapours presented on Plate 62 to 64 are related to gasoline. These flammable vapours had been qualitatively and quantitatively confirmed using the Gastec gasoline detection tubes and sampling pump. As shown on Plate 64, there is a distinct gasoline vapour plume well defined by MW 53, 50, 13 & 2. Plate 64 also shows that the gasoline vapours

In our opinion, Plate 64 (except the east portion of the 1000 ppm contour), 65 and 67 (except the easterly portion of the %LEL contours, east of MW 19, 41 & 3) are more representative of the distribution of flammable vapours (i.e. gasoline, methane, ethane, etc.) at this site. Please note that MW 3 is no longer useful for contaminant monitoring, as it had been damaged by the snow clearing crew for the CTC store since February 22, 1990.

© VAPOUR PIPE DONE BY OTHERS 100 - MAY 0/90 READING (PPM) (2000) - MAY 16/90 READING (PPM)		<b>Geokwan Engineering Ltd</b> CONSULTING GEOTECHNICAL ENGINEERS		GASOLINE VAPOUR DISTRIBUTION MAY 0 & MAY 16, 1990 14TH ST. & ABERDEEN AVE., BRANDON
SCALE: 1"=120'		DATE: 22/05/90		JOB: 389
		MADE: RK		CHKD: W K
				PLATE: 64

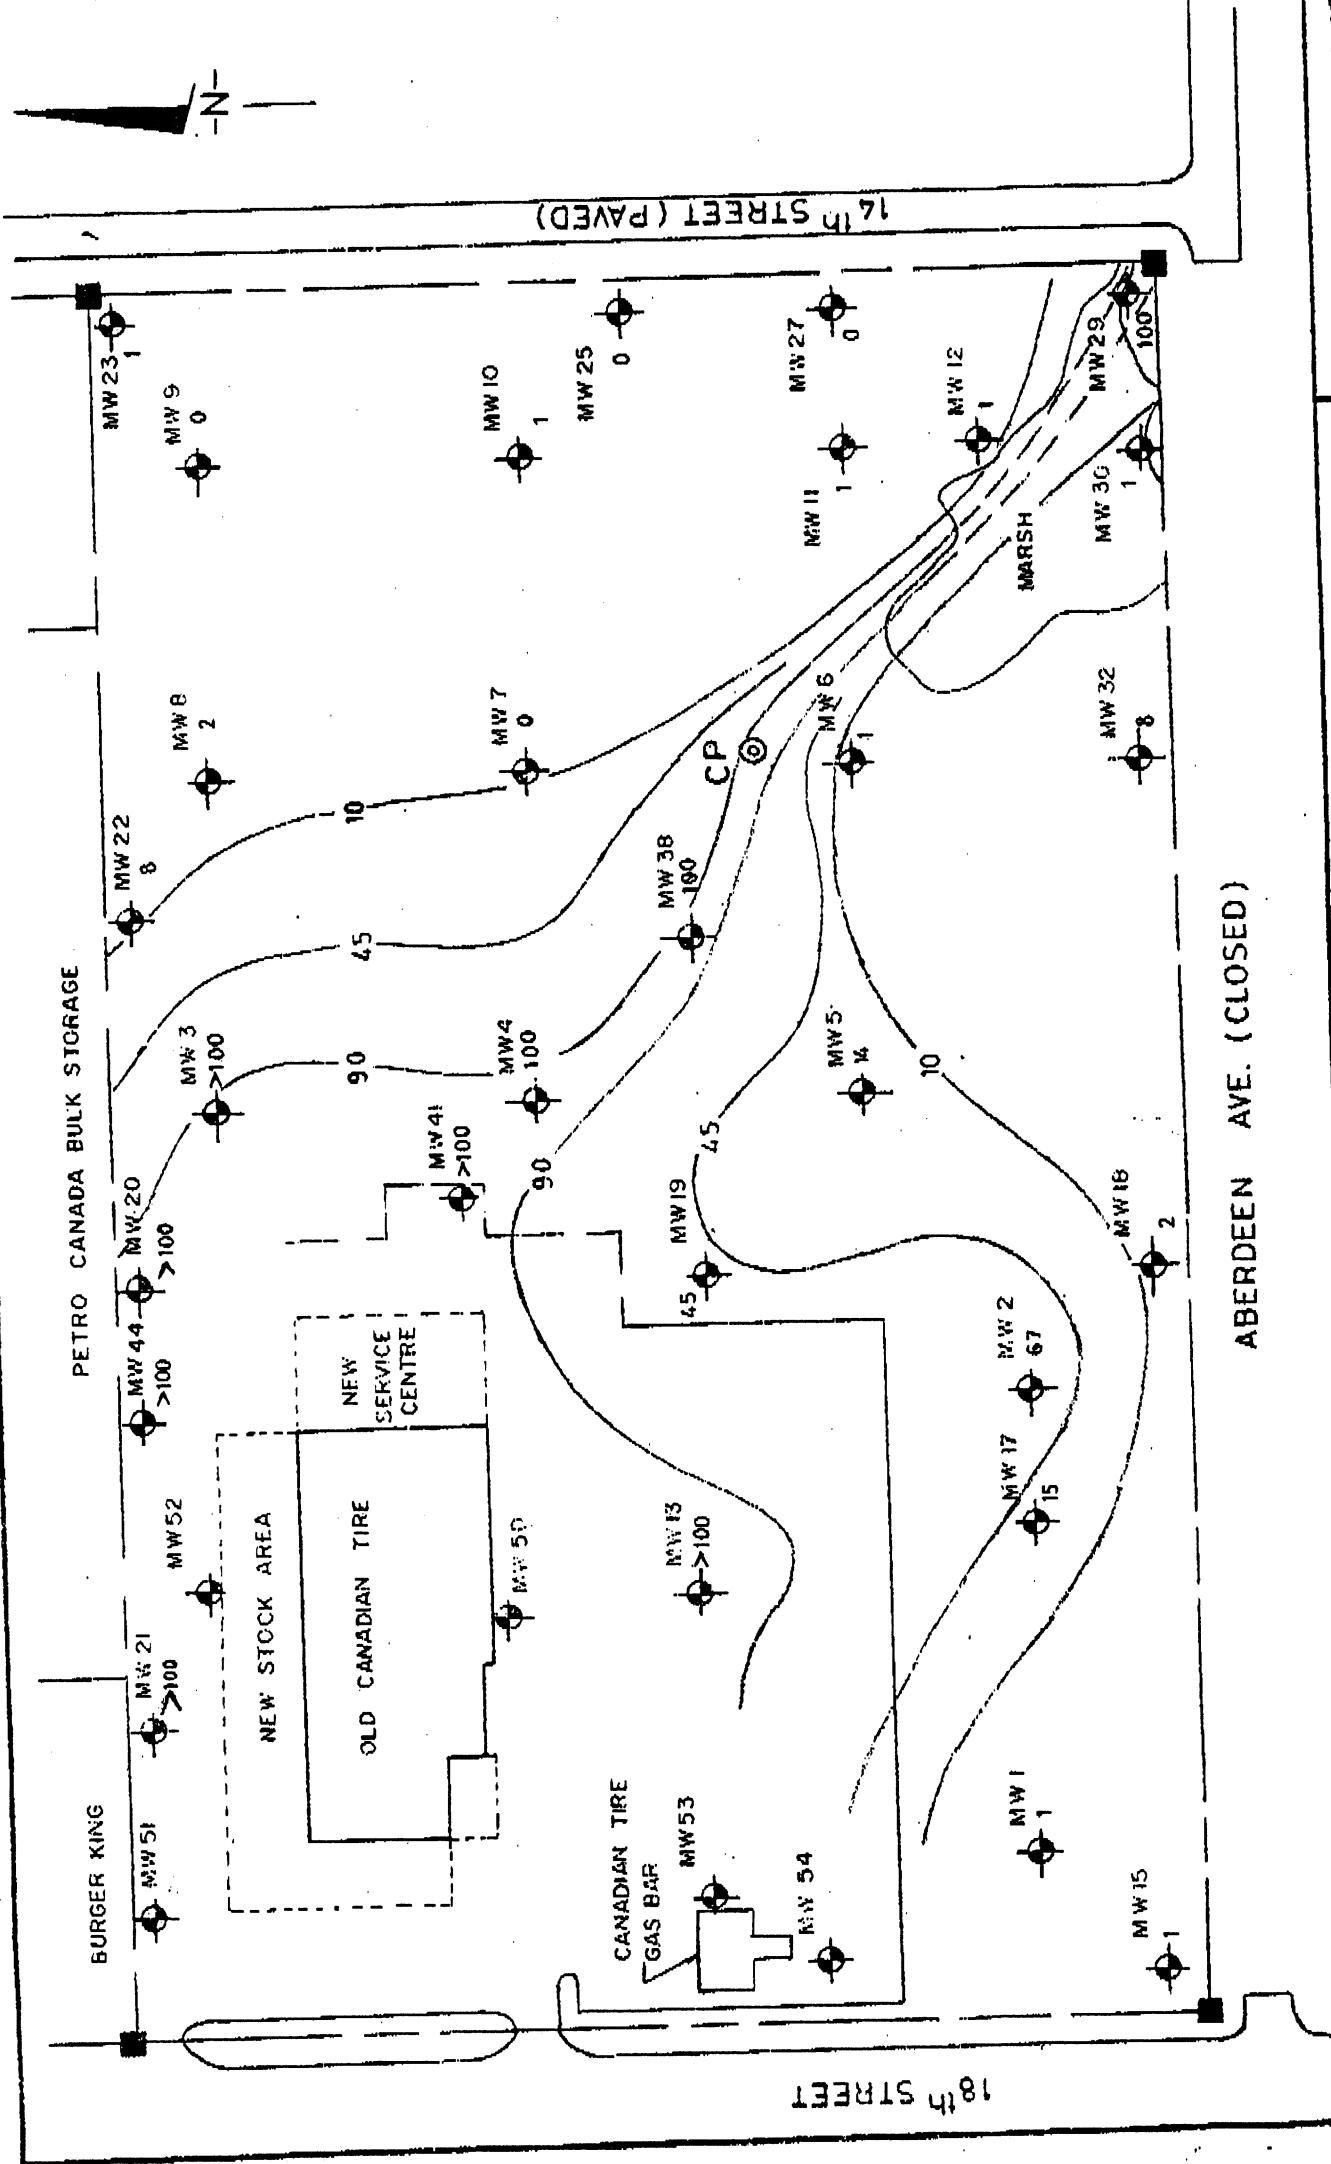
4.4d There is a distinct stream of hydrocarbon vapour (greater than 100% LEL) migrating across the Canadian Tire property in a northwest - southeast direction, towards the marsh (Plate 65). Apart from the monitoring wells noted in item 4.4c above, 100% LEL flammable soil vapours were detected at MW 38, the CP pipe, TH 39 & MW 29 (near the southeast corner of the property). These soil vapours are mainly methane gas (especially at MW 29), with nominal concentrations of gasoline vapour.

5.6 The very high concentrations of methane gas (100% LEL) present to the north and east of the Canadian Tire Store, including the fairly narrow vapour stream (Plate 65) through MW 41, MW 4, MW 38, the CP pipe and MW 29, are considered to have been caused by the long term degradation of hydrocarbons (especially gasoline). Recent environmental research has shown that under certain bacteria actions, petroleum hydrocarbons trapped in the soil pores can degrade into methane and carbon dioxide, with time. The occurrence of methane gas may also related to natural cause (i.e. decomposition of natural organic materials). However, the amount of organic materials identified in the monitoring wells, testholes and testpits are such that the very high concentrations of methane gas detected at this site are not associated with natural causes but petroleum hydrocarbons.

© VAPOUR PIPE DONE BY OTHERS  
>100 = FLAMMABLE SOIL VAPOUR  
CONCENTRATION MEASURED INSIDE  
THE MONITORING WELL GREATER  
THAN 100% L.E.L.
