# Geokwan Environmental Ltd

RE: Progress Report No. 4  
Asphalt Paving and Installation of Vapour Extraction System  
Canadian Tire Store, Brandon, Manitoba  
Our Project No.'s E238 & E239

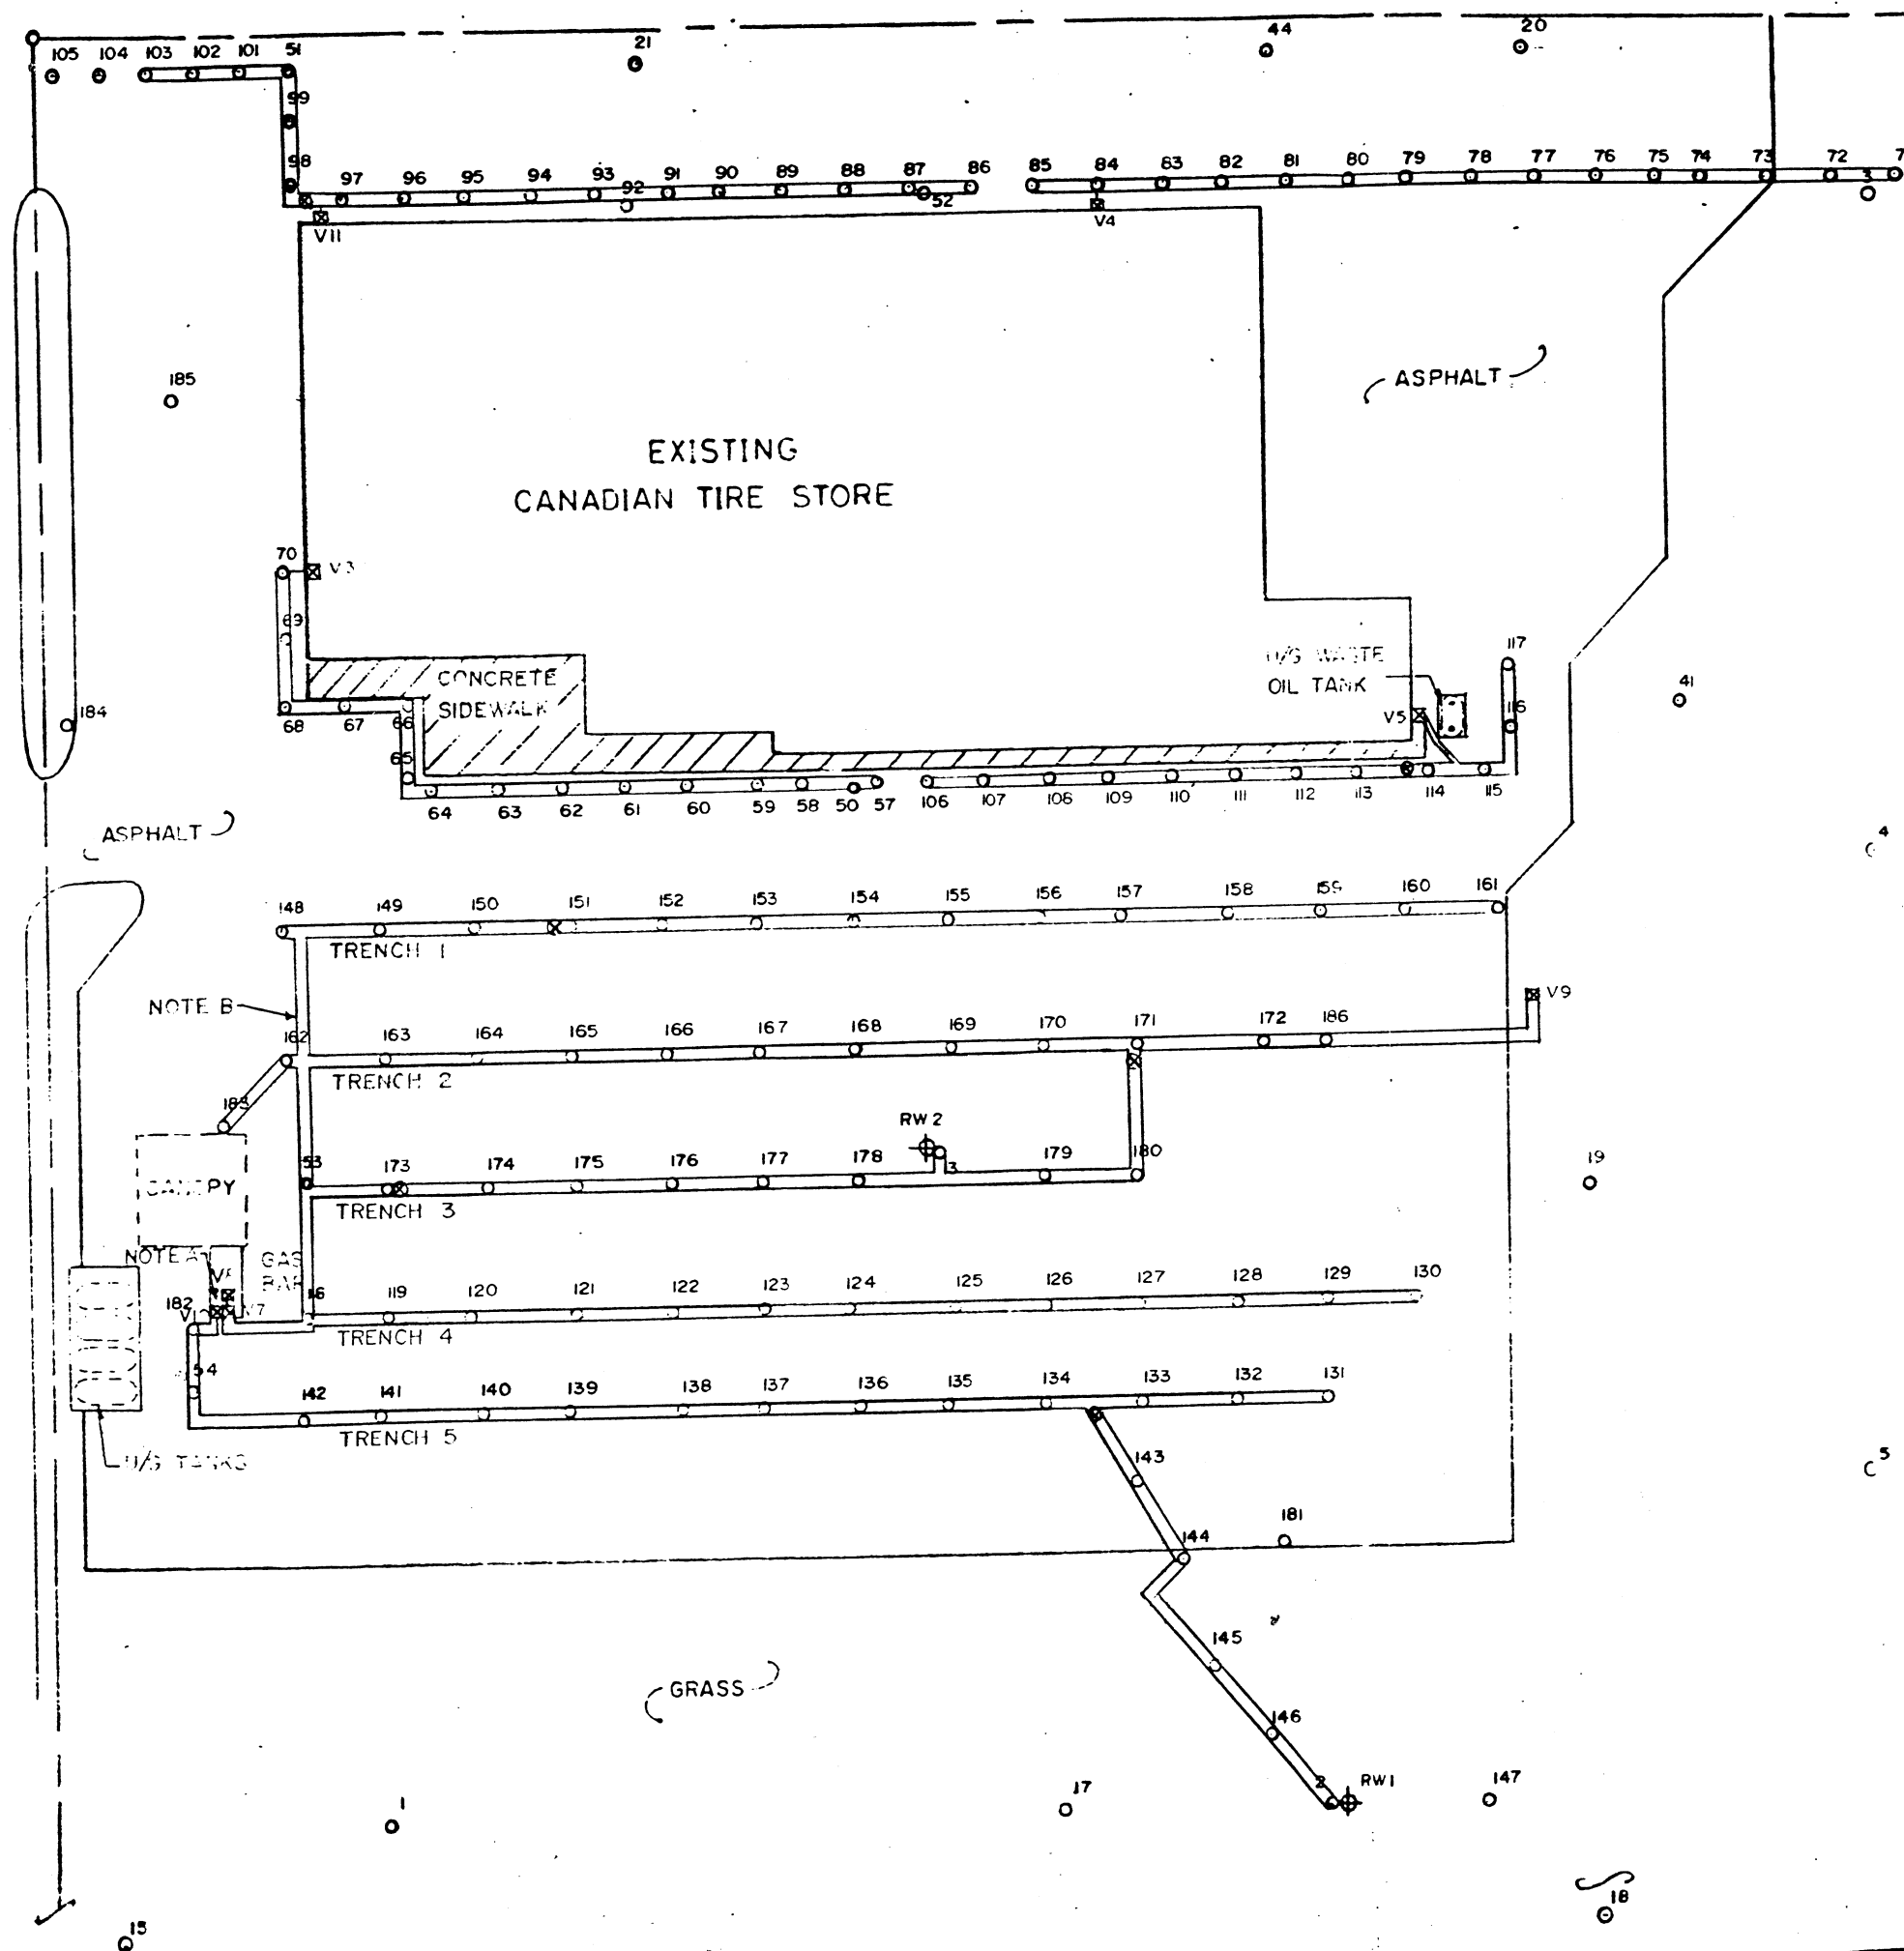
NOTE A - V10 MOVED FROM FORMER LOCATION TO TOP OF GAS BAR AS OUTLINED IN REPORT.  
NOTE B - NEW TRENCHES INSTALLED AS OUTLINED IN REPORT.
