O'CONNOR ASSOCIATES

January 3, 1989.

Re: Red River Esso

Selkirk, Manitoba

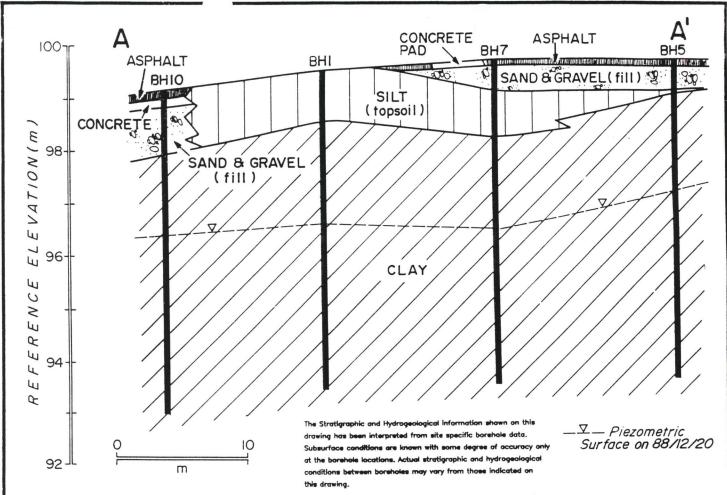
Stratigraphic Cross Section A - A'

The natural soil profile encountered in the boreholes consisted of silt topsoil overlying silty clay which extended below the 6.1 m depth of investigation. The clay unit was fractured, laminated and contained silt and sand lenses. Surficial asphalt and sand and gravel fill were noted in BH5, BH6, BH7, BH9, BH10 and BH11. A cross-section illustrating the stratigraphy is presented on Drawing No. 1.3.

Piezometric surface elevations measured in the boreholes on 88/12/20 suggest that the water table is in the clay unit 2.4 m to 4.0 m below the ground surface (Drawing No. 1.3). The groundwater in the tank backfill area appeared to be mounded and was 1.5 m to 2.2 m below grade. Based on preliminary monitoring, the principal direction of groundwater flow appears to be south and southeast toward the Red River (Drawing No. 1.4). The fluid levels in BH6 to BH11 may not have reached equilibrium with the groundwater regime as of 88/12/20.
