MENNONITE FARM BUILDINGS

An Architectural History Theme Study

Ed Ledohowski & David Butterfield
Historic Resources Branch

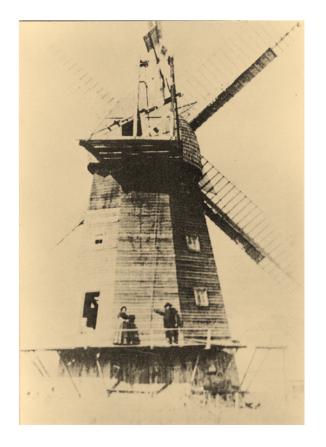
Figure 6
The Rein

The Reinland windmill, one of the early landmarks in the West Reserve. Constructed by Johann Bergman in 1878-79, it was used for grinding wheat and crushing feed until it was dismantled at the turn of the century. (Reinland, 1976: 53)

Within each village, lots were laid out so that the buildings of individual farm units were placed about sixty metres apart and about thirty metres from the street to provide ample space for trees, gardens, and fences. Building lots were also reserved, usually in the village centre, for schools and church buildings. Towards one end of the village, and in a few cases, along a short side street, were the smaller lots of the "Anwohner" or non-farmer section. Generally, the homes of young married couples - still without farmland - tradesmen (Like shoemakers, tanners, watch-repairmen, and the village herdsman's hut would all be located in this area. In later years this would also be the location of a general store/post office or blacksmith's shop. The opposite end of the village street was traditionally reserved for the village windmill, necessary for grinding flour and sawing lumber, although mills were actually built in only a few villages (Reinland and Reinfeld were two examples) (Figure 6).

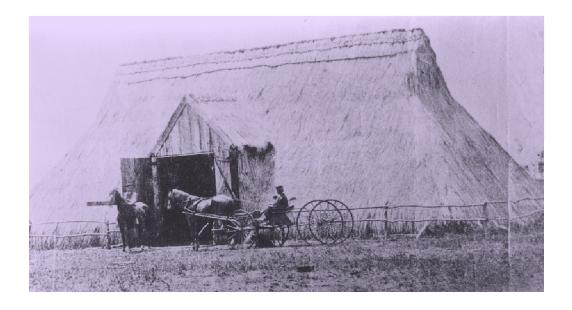
Figure 8
An early "Sarai". This type of shelter was an alternative building style to the "Semlin", but was not as warm and therefore not as common. (Provincial Archives Manitoba)

Occasionally a farmer chose to build the "Sarai", essentially a steeply pitched thatched roof which rested on the ground (Figure 8).

The gable-shaped structure was about eight meters square, five and a half meters high at the peak, and was supported by long poles. Shiplap was sometimes used to line the family portion, and in a few cases this area was lined with logs. The "Sarai" was not as common as the "Semlin" in the MSTW district for it had been used by the first settlers in the East Reserve in 1874 and had proved to be much colder than the "Semlin". A number of settlers used this type of structure as a temporary stable for the livestock however.

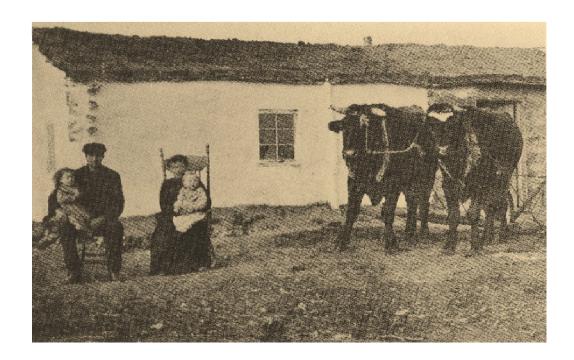
Figure 9

Most of the early Mennonites in the West Reserve obtained logs for constructing their early shelters from the Pembina Hills. A few followed the example set by the southern Ontario settlers living there and built themselves small, sod-roofed log cabins. (Reinland, 1976: 53).

Other Mennonite pioneers constructed simple, sod roofed log cabins often with attached stables (Figure 9).

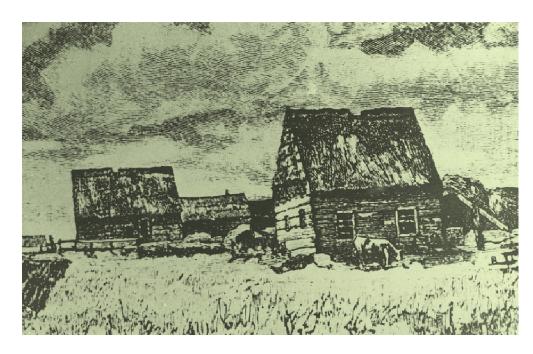
Figure 10
Early Mennonite homes in the West Reserve, as depicted by a newspaper artist, ca. 1878.
(Provincial Archives Manitoba)

The initial shelters constructed by the Mennonites were usually replaced within a few years by more secure structures. Although these structures usually followed the traditional house/barn design of the Russian colonies, there is still neither the time nor the materials available for the construction of large permanent buildings with carefully worked details. Many of these first house/barn units and especially the barn sections were small and hastily constructed (Figure 10).

The house and barn were joined end to end, in the traditional manner, to form a long, single structure. The building was, as a rule, set perpendicular to the village street. Both house and barn always faced either east or south regardless of the side of the street on which they were located.

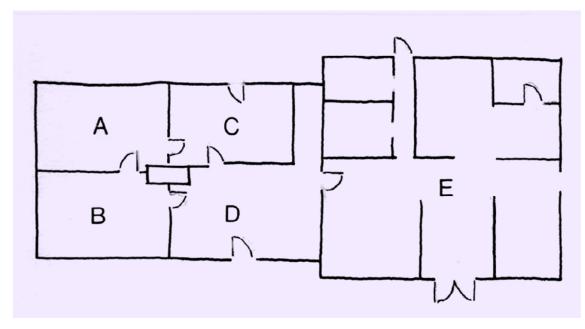
Figure 11
Floor plan an early Mennonite
house/barn: A – Tjleene Shtov; B
– Groote Shtov; C – Alt T'Hues;
D – Fae T'Hues; and E - Shtall.

The floor plan of these early homes usually consisted of four rooms: the "Groote Shtov" (large room), the "Tjleene Shtov" (small room), the "Fae T'Hues" and "Alt T'Hues" (front and back hall) (Figure 11).

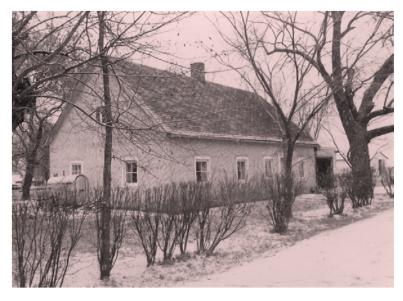
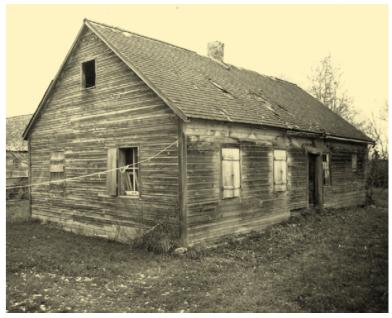
Figure 12

Peter Wiebe residence, Hochfeld, ca. 1876.

Fortunately, several early log structures still survive in the MSTW district, although they are rapidly deteriorating. As one would suspect from descriptions of pioneer Mennonite life, these log buildings seem to have been relatively crude and hastily built. One example, built around 1876 in the village of Hochfeld and still occupied, has logs that were sawn smooth on the inside but left round on the exterior side (Figure 12). In this example saddle notches were used at the corners. A rare example of post and fill construction still exists in the village of Osterwick (Figure 13).

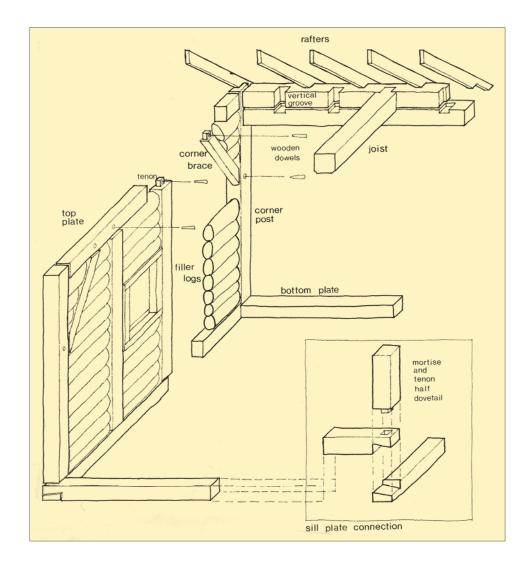
Figure 14
Theissen residence:
construction details.

With this method the logs were hewn square and the corner notches expertly cut allowing few spaces between the logs. This building also features a variety of carefully constructed joints which suggest that despite its early construction date it was well built and intended to last for some time (Figure 16).

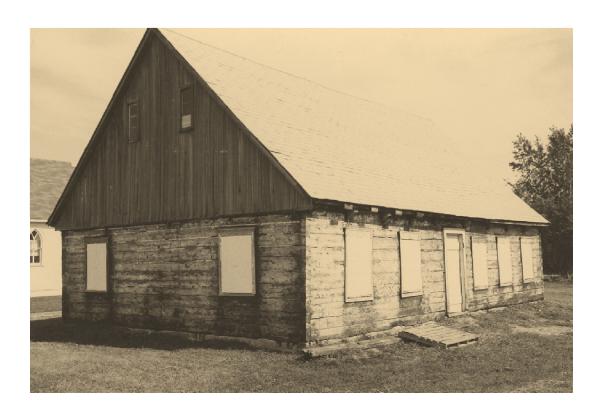
Figure 15

The majority of early log houses featured the dovetail method of log construction. This example, now a museum piece, is one of the few remaining good examples in the MSTW district.

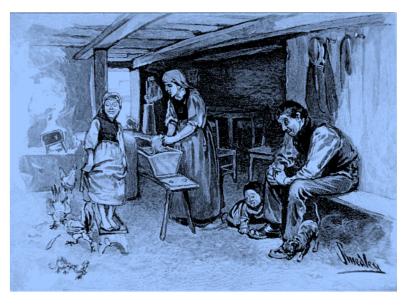
Figure 17
Interior scene of an early
Mennonite home, as depicted by
a newspaper artist. (Provincial
Archives Manitoba.)

Although basic construction methods varied, most of the early log homes were very similar in appearance. Walls were plastered inside and out with a mixture of clay and straw to which a layer of whitewash was applied, Harding the surface and giving it a more finished appearance. The thick plaster also served to insulate the building, keeping it warm during the winter and cool during the summer months. Roofs were constructed of grass thatch obtained from the edges of sloughs or creek banks. Initially, holes were simply left in the roof for smoke from the cook stove to escape, but before long tin stovepipes were introduced. Often the floors of early homes were of earth, hardened with sour milk and wood shavings. Cut lumber was used sparingly, usually for the ceiling, gable ends, doors, and occasionally for a floor. Since hinges, latches and furniture were normally homemade from logs, the only additional cost, besides lumber, was the cost of a few nails (Figure 17).

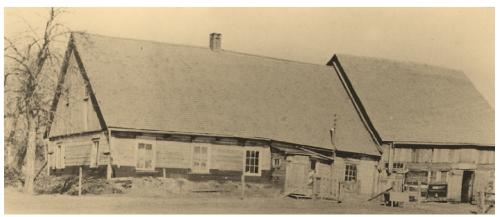
Figure 18
An early house/barn unit, ca.
1878. Note the small barn
section. (Winkler, 1982: 162.)

Barns were generally added a few years after the house was completed. The few head of stock kept during the early years were housed in the initial sod or thatch shelters until a more secure structure could be built. None of these small early barns still survive in the MSTW District; however, photographs suggest that many of these consisted simply of a small stable area with hay storage in the loft above (Figure 18).

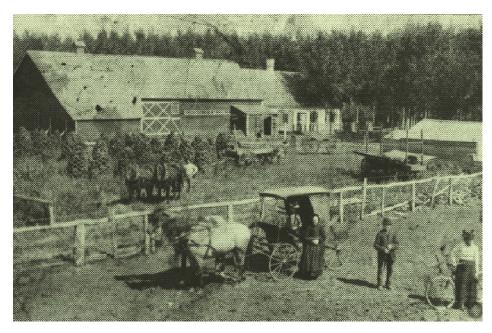
Figure 19 Isaac Wiens farmstead, Rosebach, 1895. (Winkler, 1982: 25).

Depending upon the care with which they were constructed, and the economic progress of the settler, most of the early house/barn units were replaced within ten years of their construction. The earlier structures were usually dismantled to make room for the new house at the front of the yard lot because this, by tradition, was where a Mennonite house was located. As the necessary time and resources were generally now available, the new house/barn units were large and carefully constructed with close attention given to many of the traditional elements such as floor plan and interior fixtures (Figure 19). Like the earlier units, the house and barn section were often constructed separately.

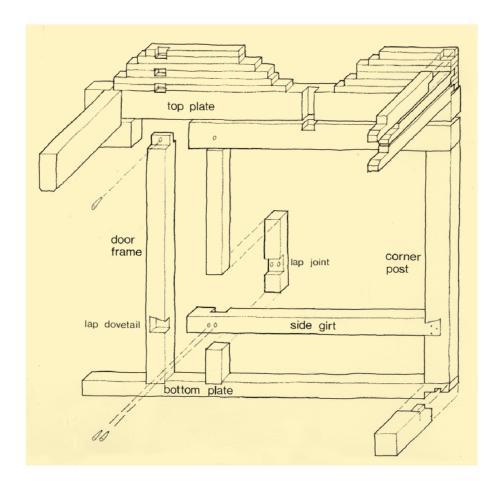
Figure 20

C. Unrau residence, Village of Chortitz: construction details.

While houses built during the 1880s were generally still of log construction, those built during the 1890s featured a light timber frame or sometimes a stacked-lumber system more commonly used in the construction of cribbed grain elevators (Figure 20 and 21).

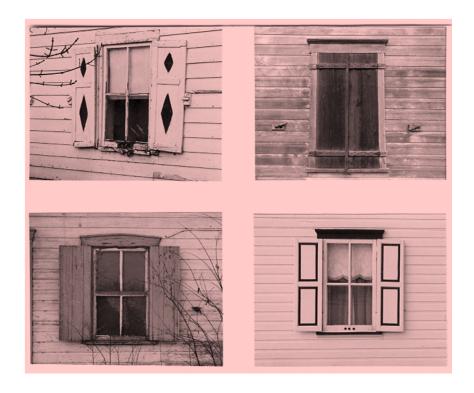
Figure 22
Mennonite houses constructed in the MSTW district, before the turn of the century, were characterized by exterior wooden shutters.

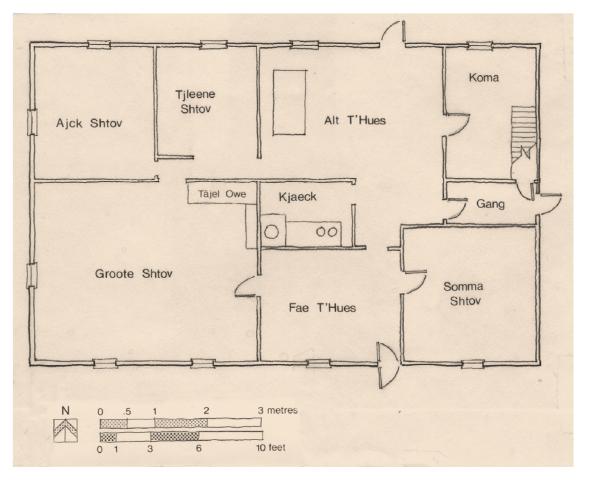
Figure 23
Typical floor plan of a traditional Mennonite house.

Wood frame construction was not generally used until after the turn of the century. During this period roofs sheathed with wooden shingles began to replace thatch and, as rapid run-off of rain was no longer critical, this was usually accompanied by a slight lowering of the roof line and slope. Horizontal wood siding, which eliminated the regular repairs necessary to maintain mud-coated walls, became increasingly common as did wooden storm shutters (Figure 22). During the winter months these were often kept closed, especially at night, to help retain the interior heat. These later houses usually featured a multi-roomed floor plan closely based on the traditional Russian model (Figure 23).

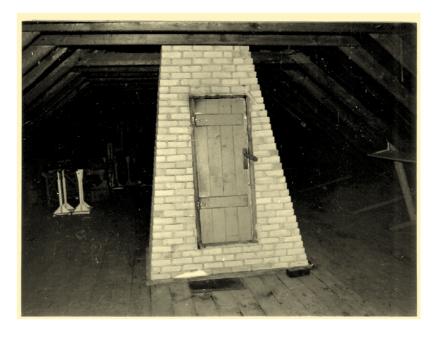
Figure 24

Many of the traditional Mennonite houses had smoke chambers built into the chimney above the kitchen area for curing meats.

Above the ceiling of the cooking room, in the attic, a large tapering chimney or "Rajka Koma" was often constructed. This chimney served a double purpose. It not only kept sparks from flying out too quickly and igniting the roof, (this was especially important when thatched roofs were common), but it also could be used as a smokehouse for curing meats. The chimney was usually about two metres square at the bottom. Access to it, for cleaning or inserting meat, was gained through a large metal door. None of the remaining house/barn units in the MSTW district still have either the central cooking room or the smoke chamber above it; the only known house with these features was previously located in the village of Chortitz, and it is now situated in the Mennonite Village Museum in Steinbach (Figure 24). The interior walls of the new homes were initially lined with shiplap, but in later years this was often covered with wainscott panelling and wall paper (Figure 25). The ceiling joists, which were invariably exposed, were usually cut square and the bottom corners bevelled (Figure 26).

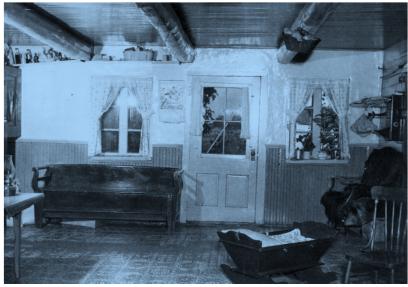
Figure 26

Former Heide residence, Village of Hochfeld: interior view showing exposed joists, wainscotting and doorways leading to (left to right) the pantry, the attic and the barn.

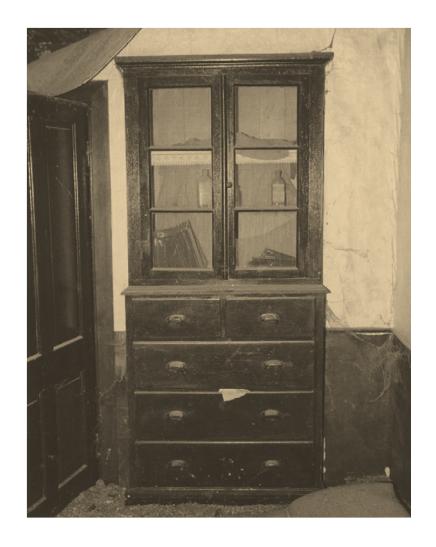
Figure 27

The "Glauss Shaup" was a standard interior fixture in most Mennonite homes.

Interior of one of the better presreved early Mennonite homes as photographed during the 1950s. (Provincial Archives Manitoba) This simple bevel was actually one of the few decorative features in the largely utilitarian design of the house. Another standard interior fixture was the "Glauss Shaup" or china cabinet built into the walls of the "Groote Shtov" next to the brick heater (Figure 27).

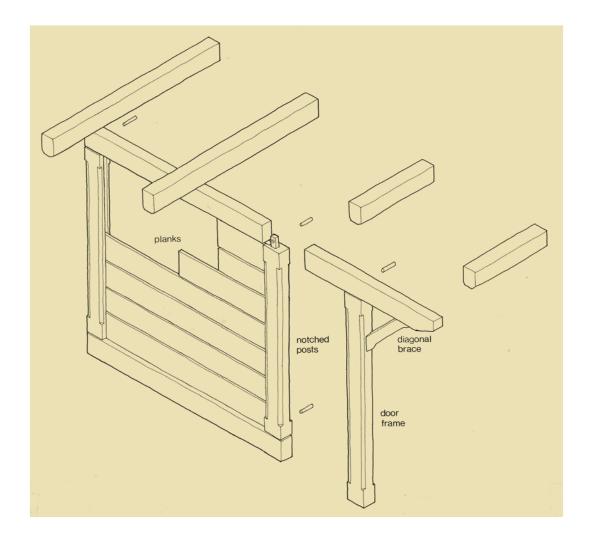
Figure 28

Peter Wiebe residence, Hochfeld: wall construction detail.

Finally, in the few homes where some of the original walls remain, such as the Wiebe house in Hochfeld, the wall separating the "Groote Shtov" from the "Ajck Shtov" features an interesting tongue and groove construction with the uprights possessing the same bevelled edges as the ceiling joists (Figure 28). The large brick heater or "Tajel Owe" located in the centre of the building, was an item of great importance and could be found in most of the dwellings constructed during this period. A portion of it extended into several of the rooms in the front half of the house, and as a result, it acted as an efficient central heating system, (Figure 29).

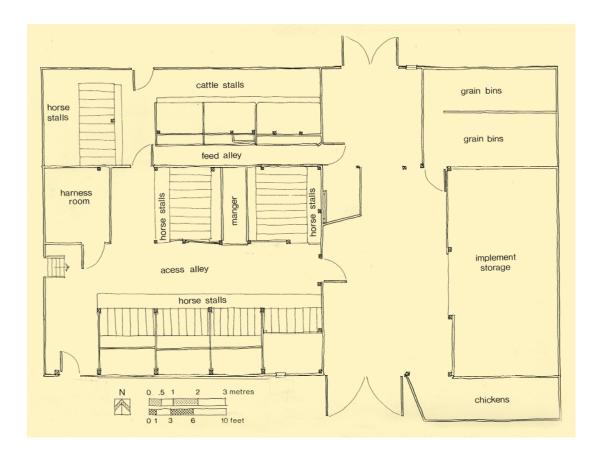
Figure 32
J.F. Ens barn, Village of
Reinland, ca. 1885: floor plan.
This structure is one of the few
well preserved Mennonite barns
in the planning district.

The stable area of the barn was always adjacent to the house. The interior arrangement, although varied, usually consisted of a central aisle with doors at both end and stalls along either side; cow stalls along one side and horse stalls along the other. Two additional doors were located along the front and rear walls near the dividing wall between the barn and house. Light for the stable was provided by a row of small windows along the length of the front of the barn just below ceiling level. Because sunlight entered the room from only one side, the stalls located along the opposite wall were often set sideways, so that the animals would not shade themselves while feeding. The majority of the stalls in the Mennonite barns were for horses, which were the main source of farm power until the 1930s. Cows were raised purely for domestic use and only a small number were kept at one time. Another common feature of the stable was a small storeroom such as the one located in the Ens barn in Reinland. This room was commonly used for storing harnesses, hand tools, and miscellaneous small items (Figure 33).

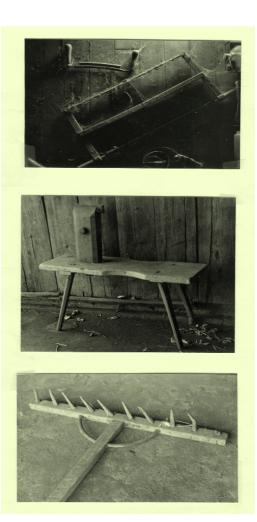
Figure 33
Early handmade tools: a bucksaw, a harness repair vice and a garden rake

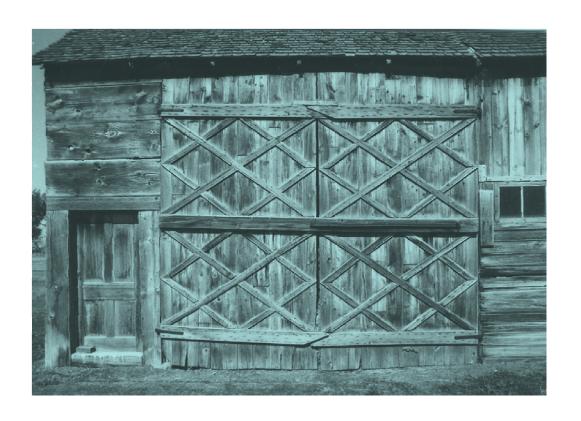
Figure 34

Typical "Sheen" doors. The criss-crossing pattern was typical of Mennonite barns in both Prussia and Russia and was found on virtually all traditional style barns in Manitoba.

Although present in many of the barns constructed in the MSTW district, the "Sheen" section soon took on a different function than originally intended. By the time the Mennonites who settled in Manitoba could afford to construct large traditional barns, steam-powered threshing machines were becoming available. As all threshing activities were now conducted outside, the "Sheen" was no longer required and was put to use as an extra storage area for hay and equipment. In the Ens barn, a cutter, wagon, and miscellaneous other items are still being stored in this area, as they were in years past (Figure 35).

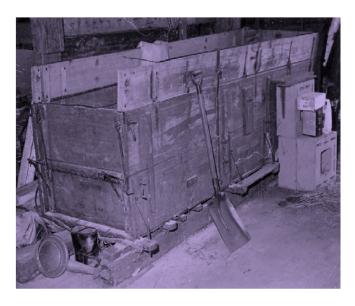
Figure 35
The "Sheen" area in many
Mennonite barns was used to
store items such as wagons and
cutters.

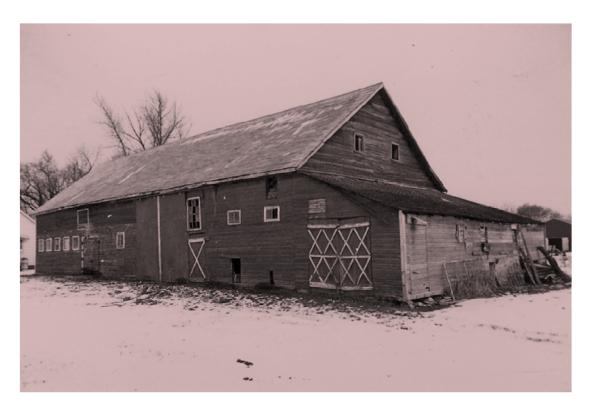
Figure 37
P.A. Rempel barn, Village of
Neuenburg. Although not part of
the traditional barn design, a rear
"Sheua" section was often added
to the barns in the MSTW district.

Another common feature of many of the Mennonite barns was the "Sheua". This was a large shed roofed section attached to the far end of the barn and used for machinery storage or as a fowling and calving area (Figure 37).

Apparently, this section was not commonly found on Mennonite barns in Russia, but, by the turn of the century it had become a standard feature of many Mennonite farmyards in the MSTW District.

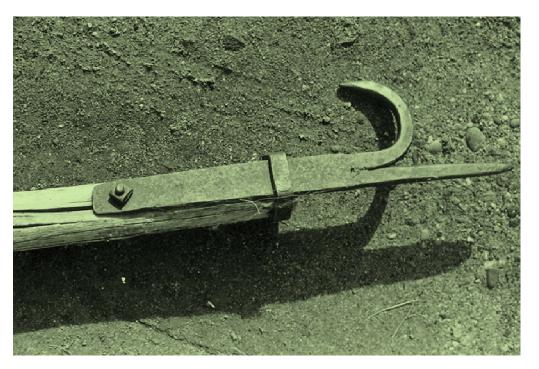
Figure 38
Detail of a hand-forged
"Booshoake" or fire hook. This
once common item was used for
pulling down burning buildings
and, thus, preventing fires from
spreading to neighbouring
structures.

A final, yet important, characteristic of most Mennonite barns was the "Braunt Lada", or fire ladder, and the "Booshoake", or fire-hook, both of which were used for removing bags of grain from a burning loft or for pulling down a burning wall or roof (Figure 38).

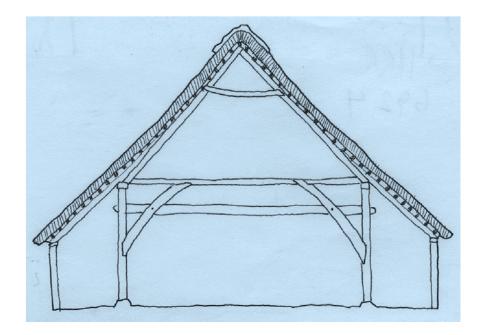
Section from a medieval Danish barn. During the seventeenth century Mennonites in the Polish and Prussian colonies adopted framing methods commonly used in Denmark and other northern European countries. This same

In addition to its exterior appearance, the traditional Mennonite barn was distinguished by its heavy post-and-beam interior framework. Although some of the mortise-and-tenon joinery was similar to that used in southern Ontario style barns, the design of the framework clearly reflects the northern European roots of Mennonite building techniques (Figure 39).

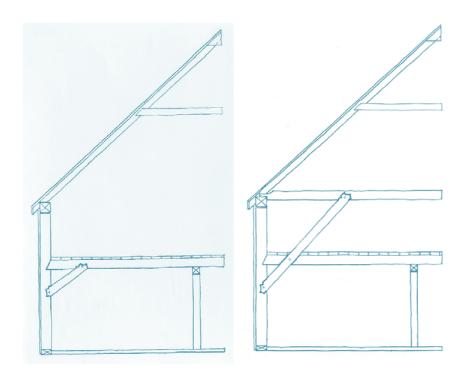
Figure 40
Standard bent design commonly found in the stable section of ost Mennonite barns.

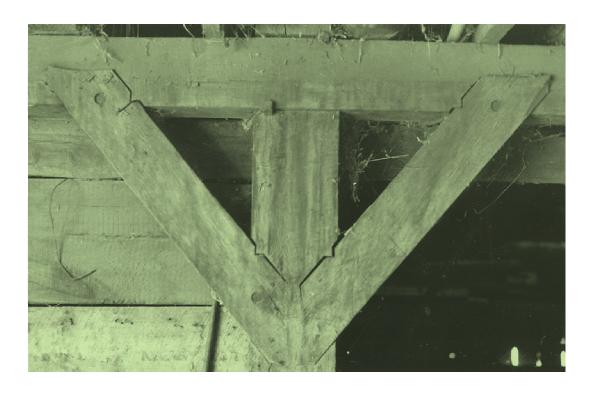
Figure 43
The sway braces in most Mennonite barns featured an unusual lap notch.

This type of notch, in Manitoba, appears to be exclusive to structures of Mennonite origin, and was no doubt transplanted from Europe as was the entire barn design. All the major joints were secured with wooden pegs. Like the more conventional mortise and tenon joints, the Mennonite lap joints were usually expertly cut and fitted. Examples were found where even a paper-clip could not be forced into the joint seam.

Standard mortise and tenon notches were used at all the perpendicular joints while an unusual type of formed lap-notch was used in all the diagonal joints (Figure 43).

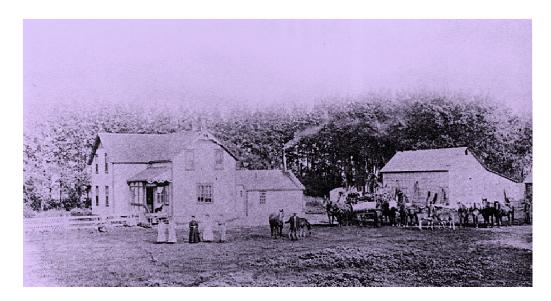
Figure 44

Jacob Loewen farmstead, eight kilometres north of Winkler, 1906. Most of the Mennonites who moved out of the villages to individual quarter section farms constructed houses and farm buildings of contemporary design. (Manitoba Mennonite Memories, 1974: 262)

Around the turn of the century, as the Mennonites in the MSTW district began to be assimilated into the mainstream of Canadian society, strict adherence to traditions began to wane. This was reflected not only culturally, as more Mennonites began accepting municipal government and public schools, but architecturally as well. The adoption of farm mechanization was especially disruptive. The "Raine" or strip field system proved to be unsuited to mechanization and, as residents began to move out to individual farmsteads, many villages began to break up. Moreover those Mennonites who did move onto farmsteads rarely chose to construct the customary house/barn units, but instead erected separated structures of contemporary design (Figure 44).

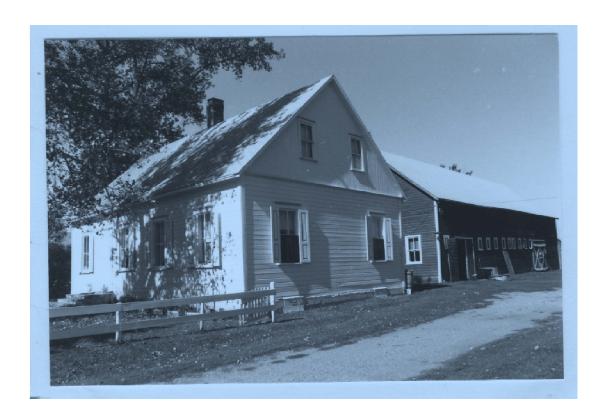
Figure 45

Jacob Peters residence, Village of Reinland. After the turn of the century many Mennonites broke with tradition and constructed houses which faced the village street.

The more conservative Mennonites who remained in the villages, tended to continue constructing attached units. While the general shape and exterior appearance of the house was usually retained, a number of modifications began to be introduced. One of the most notable was the re-orientation of new homes so that they now faced the village street resulting in a "T"-shaped plan (Figure 45).

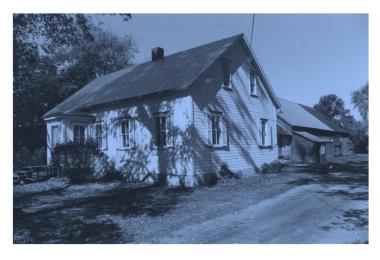
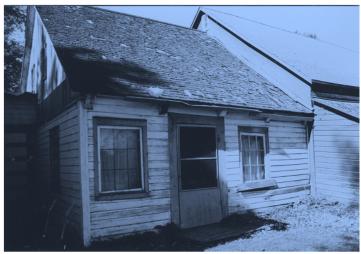
Figure 46

Henry Ens residence, Village of Reinland. On the left, the link in the context as a connection between the house and the barn. On the right, the link in more detail.

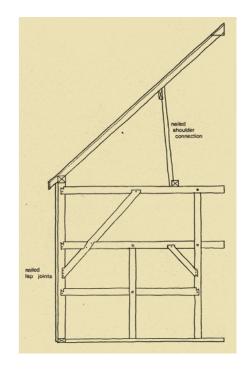
Figure 49
With the adoption of hay sling, shortly after the turn of the century, an open span type of rafter was required, which resulted in the modification or complete removal of the original barn rafters?

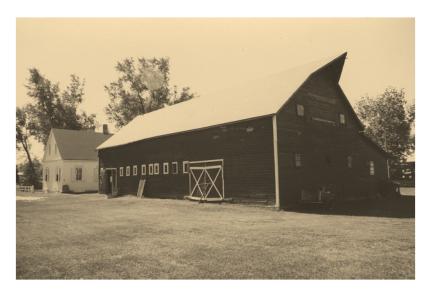
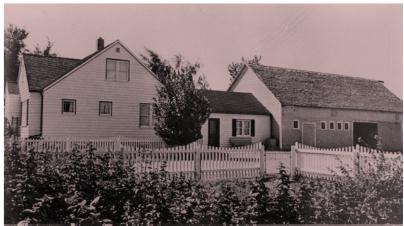
Figure 50

Jacob Peters barn, Village of Reinland, 1912. The protective peak extension over the sling tracking mechanism was an innovation.

In other cases, the entire roof was replaced with a more contemporary, gambrel shaped roof, which was self-supporting and had a high volume storage capacity (Figure 50).

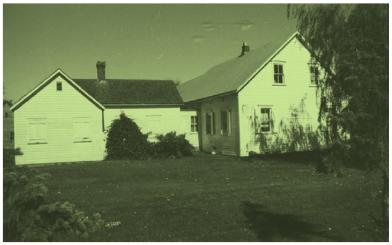
Figure 54

Fehr residence and summer kitchen, Village of Osterwick.

The planning and construction of these buildings was straightforward. Because space was only needed for a stove, table, and a cupboard or two, the majority of summer kitchens were simple one-room gabled structures. Since most of the summer kitchens were not added to the farmstead until the 1890s, they were usually of frame lumber construction. None of the remaining "Somma Kjaecken" in the MSTW district are known to be of log construction. One in the Village of Osterwick, however, has a high, steeply-pitched roof. This suggests that it may once have had a thatch cover in which case the walls, now covered by siding, could well be of log (Figure 54).

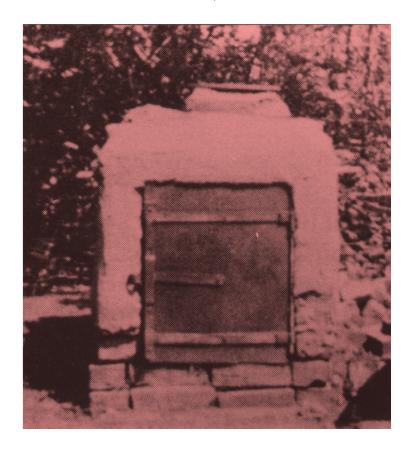
Figure 56
A typical Mennonite bake oven, in this case featuring a flat, rather than a vaulted top. (Blumenfeld: Where Land and People Meet, 1981)

The main brick oven in the house, by virtue of its design, gave off a great deal of heat. This was a welcome feature during the winter months, but it left the house uncomfortably hot during the summer when bread had to be baked. Therefore, as soon as the settlers became established, many of them constructed outdoor ovens commonly known as "Shtroo Hietens" (Figure 56). A common location was at the rear of the house, near the summer kitchen.

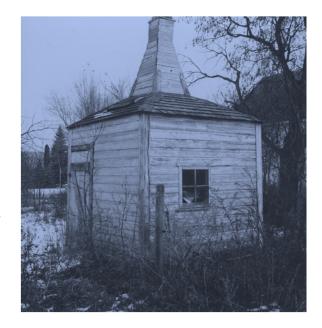
Figure 58
Wood frame smoke house
located on the P. Suderman
farmstead, Village of Neuenburg.

These attic smokers, however, had a limited capacity, were inconveniently located, and required a great deal of time and heat to properly cure the meat. Thus, larger families found it more convenient to construct separate smoke houses or "Rajka Koma" outdoors. Because one or two of these generally served the needs of the whole village, they were not as common as bake ovens. The smoke houses that were built were generally located on the rear side of the house, or towards the back of the yard near the granaries.

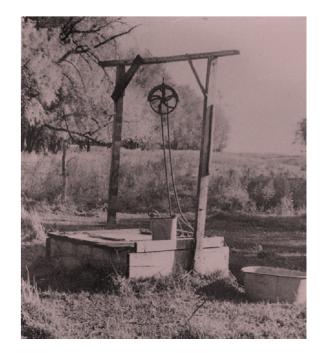
Figure 60
Crib-wells continued to be used after the turn of the century, often with the aid of a rope and pulley.
(Winkler, 1982: 161)

Around the turn of the century, many Mennonite families had new wells drilled and cast-iron hand pumps installed. A few of these later wells were connected to windmill-powered units for labour free operation. Hand pumps and crib wells were in general use until the early 1950s, when modern electric plumbing was installed in most of the homes. Although rarely used, a few of the early hand pumps can still be found in some of the villages.

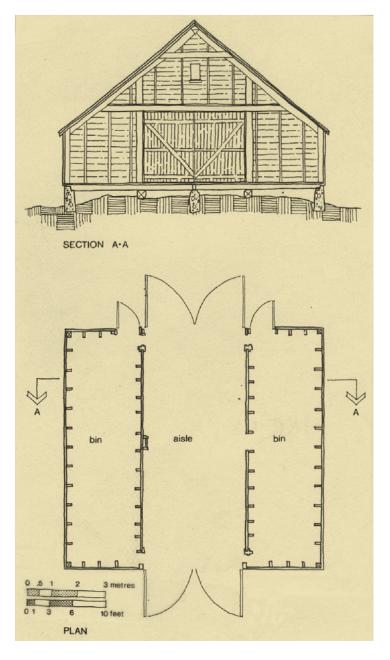
Figure 62Zacharias granary: section and plans.

The planning of these granaries was similar to that in granaries found in the English areas of MSTW. Both featured a central drive-through alleyway with two open-walled bins on either side. A team and wagon would be driven into the structure and bagged or loose grain transferred directly into or out of the bins. Many of the Mennonite granaries had a smaller door on each side of the main doors for easier access to the bins. The large area under the gable peak was often utilized for small equipment storage. Also many of the granaries had moveable wall sections which were placed across the alleyway and this space was then used as an extra grain storage area.

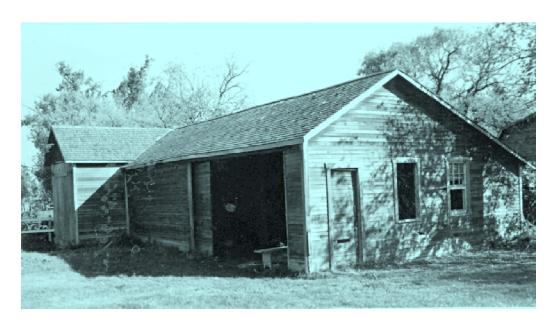
Figure 65

Ens machine shed, Village of Reinland.

Machine sheds constructed in the MSTW district were usually simple in design and construction and were not unlike the machine sheds constructed in many other parts of the province during this period. The nature of the equipment stored largely determined the design of the building. A shed in Reinland, for example, once housed a threshing machine. This can be determined by the high roof and large doors at the far end of the structure (Figure 65).

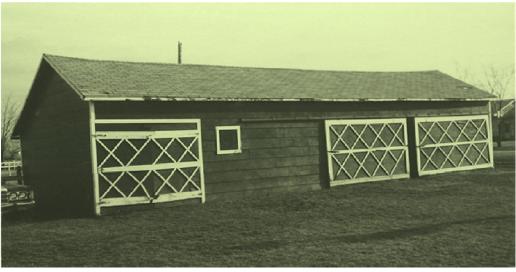
Figure 66

E. Wahl machine shed, Village of Friedensruh.

Many of the Mennonite machine sheds featured distinctive doors like those found on barns and granaries (Figure 66).

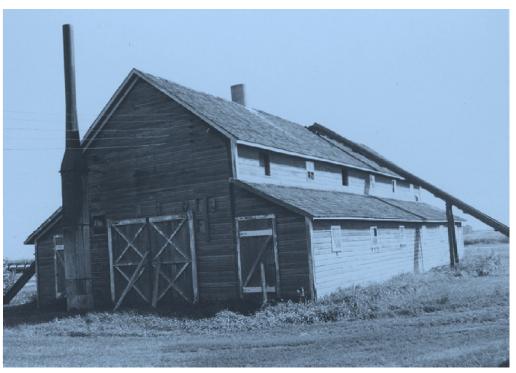
Figure 68

A.A. Kroeker corn dryer, constructed in 1937.

When it was first introduced during the 1930s, corn was simply used for livestock fodder, but in 1937, a few of the more progressive Mennonite farmers began to grow seed corn. At the time this required the construction of a building in which to dry and de-cob the corn. Three of these facilities were constructed in the MSTW district. The first was built by A.A. Kroeker, a few kilometres south of Winkler in 1937; the other, near Haskett, was constructed by G.G. Elias two years later (Figure 68 and 69).

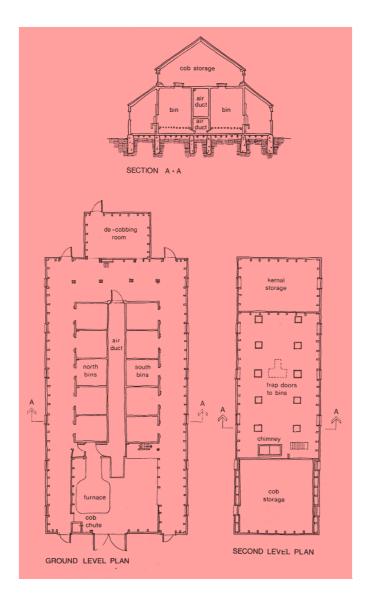
Figure 70
Elias corn dryer: plans and section.

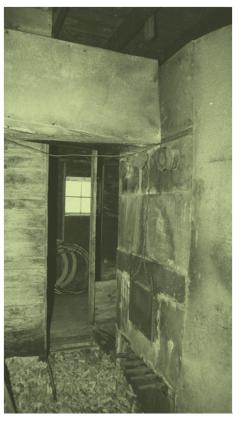
Figure 71

Elias corn dryer: second storey detail showing the distribution box and bin hatches.

In each case the corn was augured from ground level to a distribution unit at the top of the structure. Here it was directed into the various bins located along either side of a central duct system (Figure 71).

The various mechanical functions in these corn dryers were driven by a complex, integrated system of belt and chain drives and powered by a single stationary engine.
