UKRAINIAN FARM BUILDINGS

An Architectural History Theme Study

**Ed Ledohowski &
David Butterfield**
Historic Resources Branch

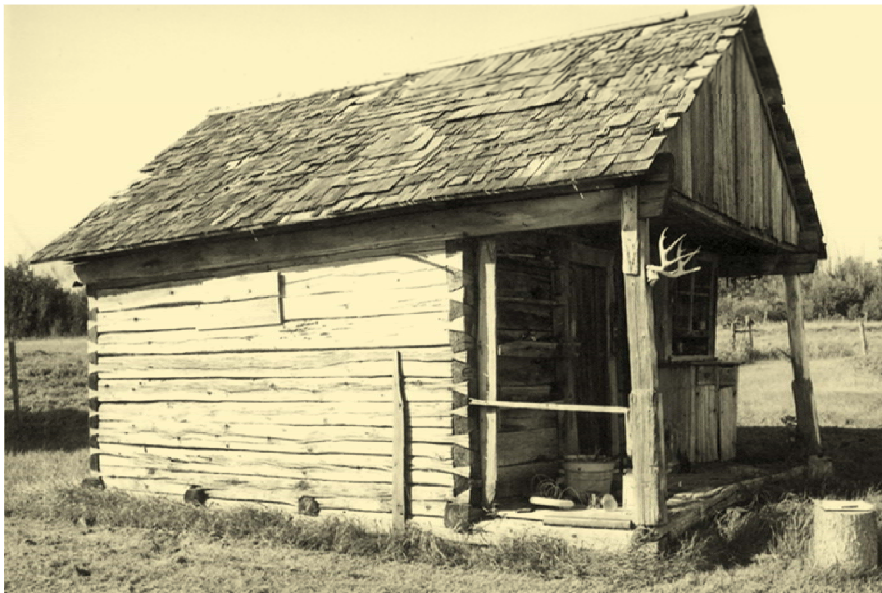
Lemecha *komora*, ca. 1920.

A *komora*, or tool shed, was a standard component of early Ukrainians farmyards, used to store harnesses, hand tools, small equipment and other items, and often featured a distinctive gable front projection.

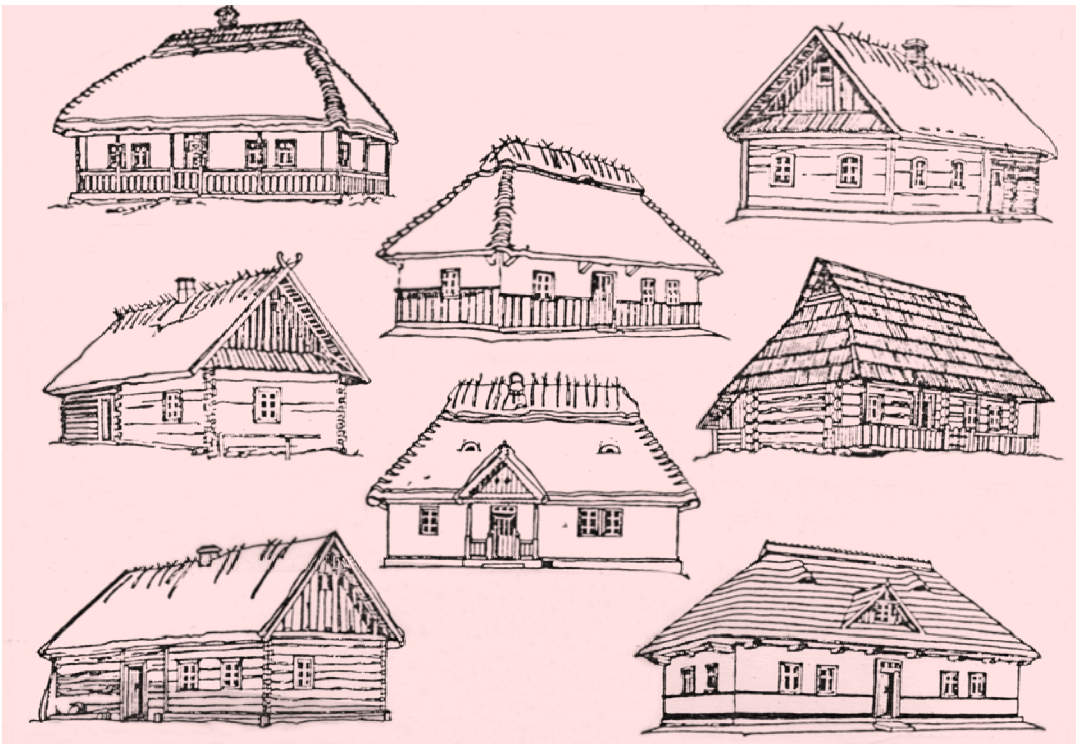
Figure 1
Examples of folk houses in districts of
the western Ukraine at the close of the
nineteenth century (V.P. Samojlovych,
Ukrains' ke Narodne. Kiev: Navakova
Dumka, 1972)

The peasants, operating within a very restricted economy, constructed their homes with a minimum of materials, which included timber, mud plaster and grass. These items were common to all Ukrainian folk dwellings, and appeared in varying proportions depending upon their availability. Although distinctive regional characteristics had developed in response to local economic, environmental and social factors, most of the traditional folk housing followed a relatively basic form (Figure 1).

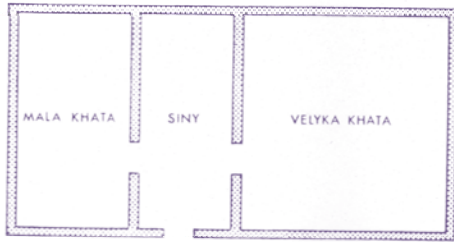
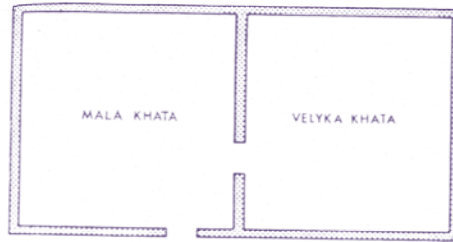
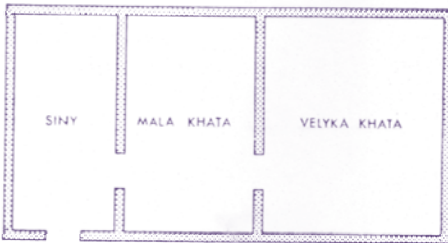
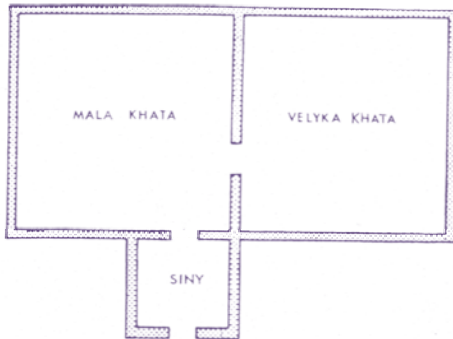
BUKOVYNIAN

GALICIAN

Figure 3
Typical plans of houses built by
Ukrainian settlers from the Bukovynian
and Galician districts.

This basic house type saw two distinct regional variations in the Ukrainian provinces of Bukovyna and Galicia, where most of the Ukrainian immigrants to Manitoba originated (Figure 2). The Bukovynians built houses which were generally larger and more ornate than the Galicians (Figure 3).

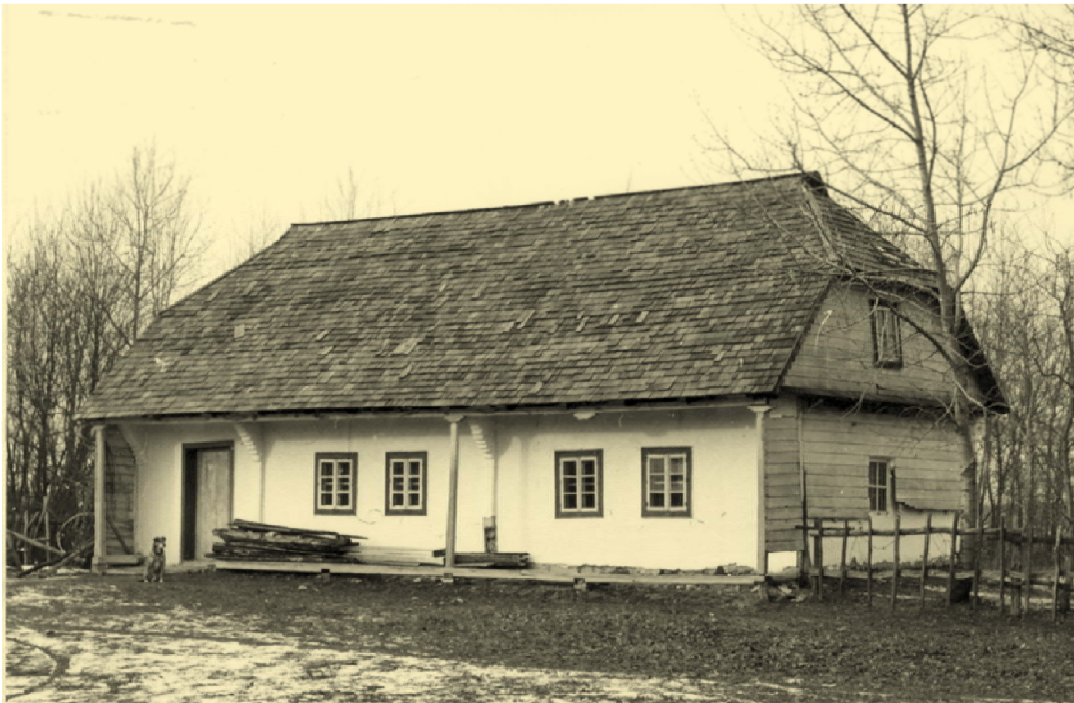
Figure 4

An early house built by Ukrainian settlers from Bukovyna. This example stands near Vita, in southeastern Manitoba. (Provincial Archives Manitoba)

These were usually three-roomed structures with a centrally located doorway (often sheltered with a gable-roofed porch extension) which opened onto a small entrance hall of "siny" (Figure 4).

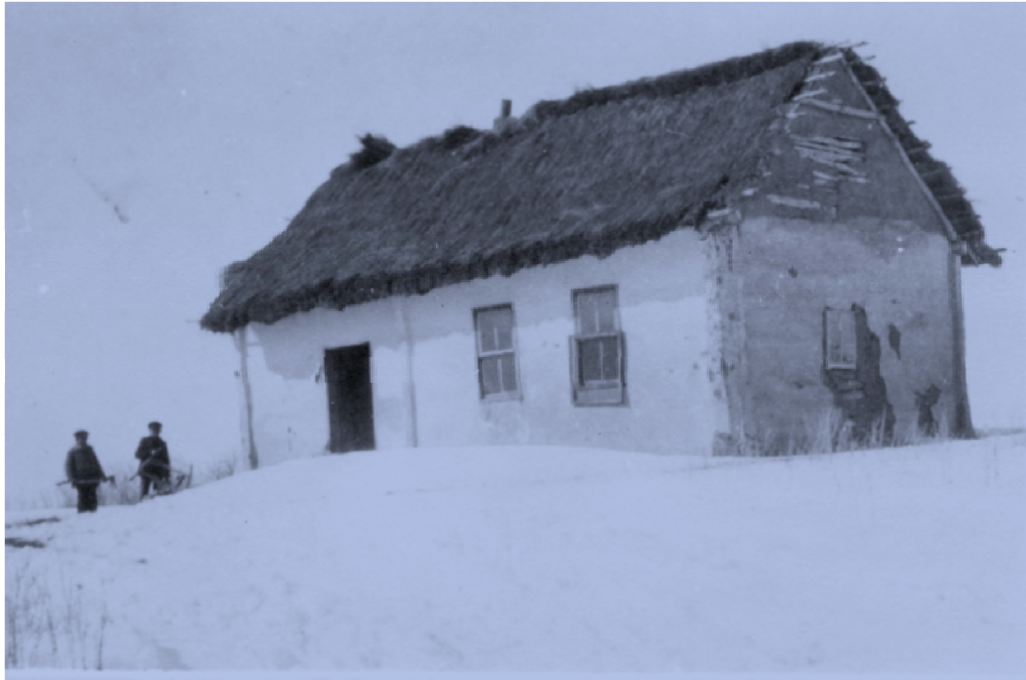
Figure 5
An abandoned early Galician house type, near Gimli (Provincial Archives Manitoba)

The Galician style, on the other hand, displayed the influence of the more sober and familiar styles of northwestern Europe (Figure 5). Most Galician houses had only two rooms and a simple gable or hipped-gable roof. Rarely did they have the same prominent overhang, and in consequence eave brackets were less common, and were always less pronounced. The buildings with gable roofs frequently had a distinctive pent extension on each gable end at the eave level to protect the plaster from rainwater damage (Figure 6).

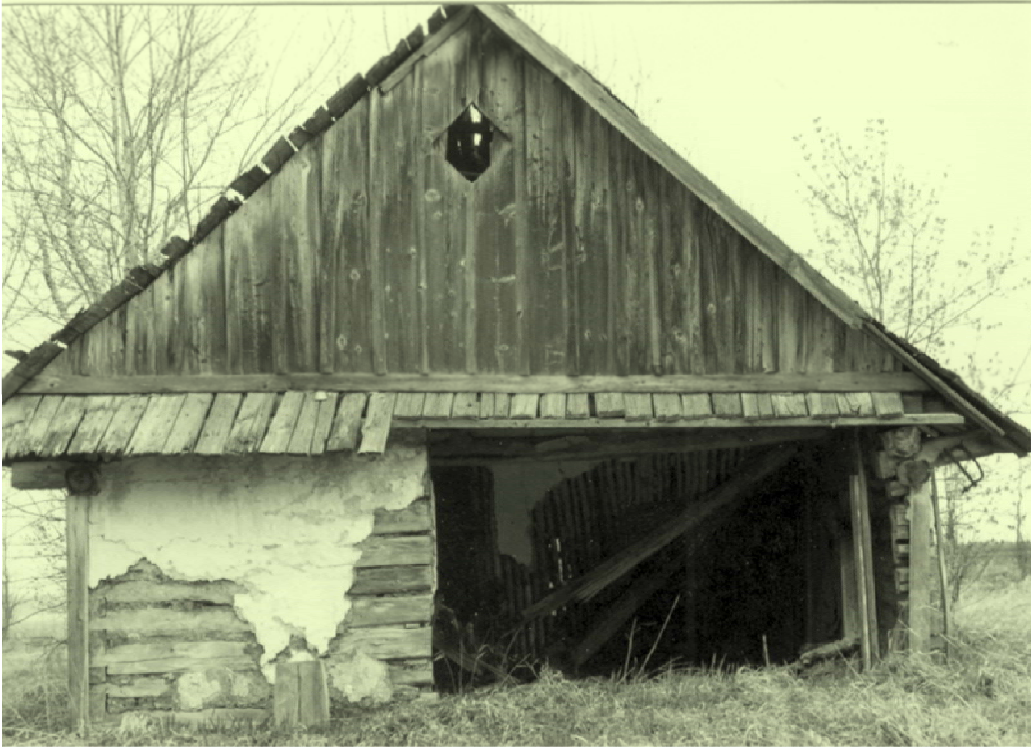
Figure 6

A former Ukrainian folk house near Ledwyn, Manitoba. The vertical weather boards and prominent pent extension on the gable ends were a common feature on early Galician homes.

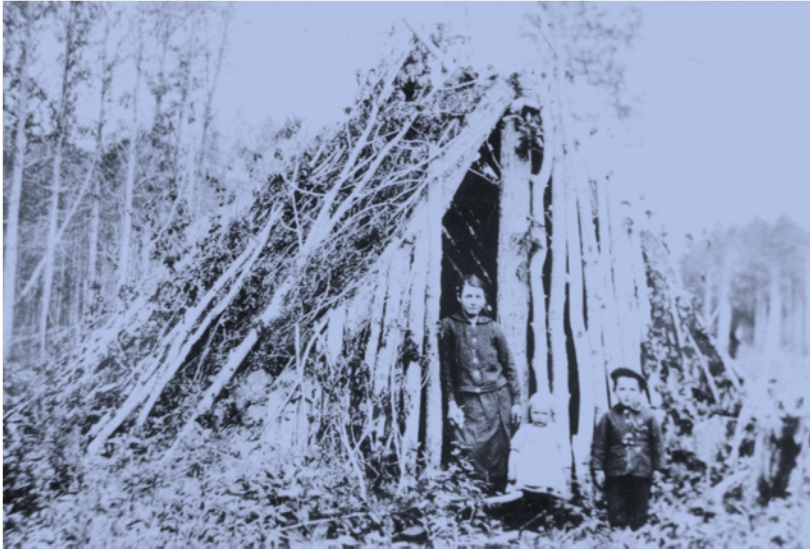
Figure 7

A typical temporary shelter constructed by Ukrainian settlers. This example was photographed in northern Alberta in 1912. (Public Archives Canada)

The initial shelters built by the settlers who arrived early in the year were of a temporary nature and were typically occupied for only a month while a more substantial structure was built. Such shelters, known as budahs, were usually crude one-room huts, simple lean-tos or teepees built of small trees and branches (Figure 7).

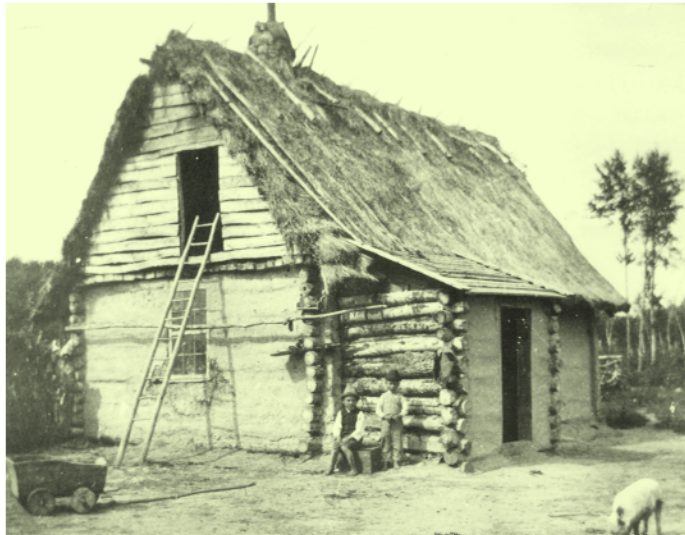
Figure 8

An early Ukrainian home near Gimli, ca. 1905. Unpeeled poplar logs, saddle-notch corner joints, the crudely thatched roof with gable ends of roughly cut planks, and the unfinished plaster coating on the walls are characteristics typical of many early Ukrainian homes. (Provincial Archives Manitoba)

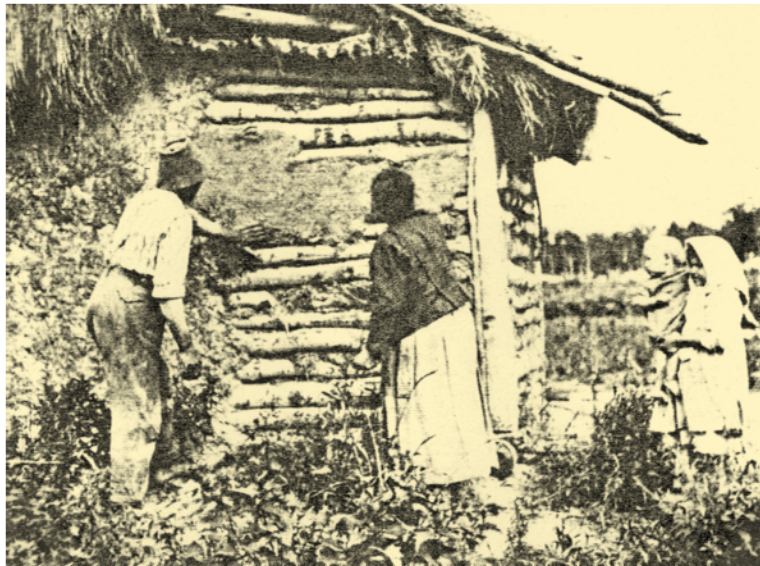
Figure 9

Ukrainian settlers applying mud plaster to an early structure of post and fill construction. Usually applied to both the inner and outer walls, the coating sealed and insulated the buildings and also provided for a smooth, finished appearance. (Provincial Archives Manitoba)

Ceilings were made from round or split trees and plastered. In many cases, the floor was hard-packed ground and plastered over. The rafters were fastened with oak pegs and well-braced. Door and window frames were made from split logs. Thin willow sticks were nailed diagonally across the outside and inside walls to hold the plaster better. While the men were getting the log grass from the meadow for thatching the roof, the women were preparing clay for plastering. They dug a small pit and with their bare feet they kneaded the mixture into plaster. This they applied with their bare hands to the outside and inside walls and the ceiling. (Figure 9)

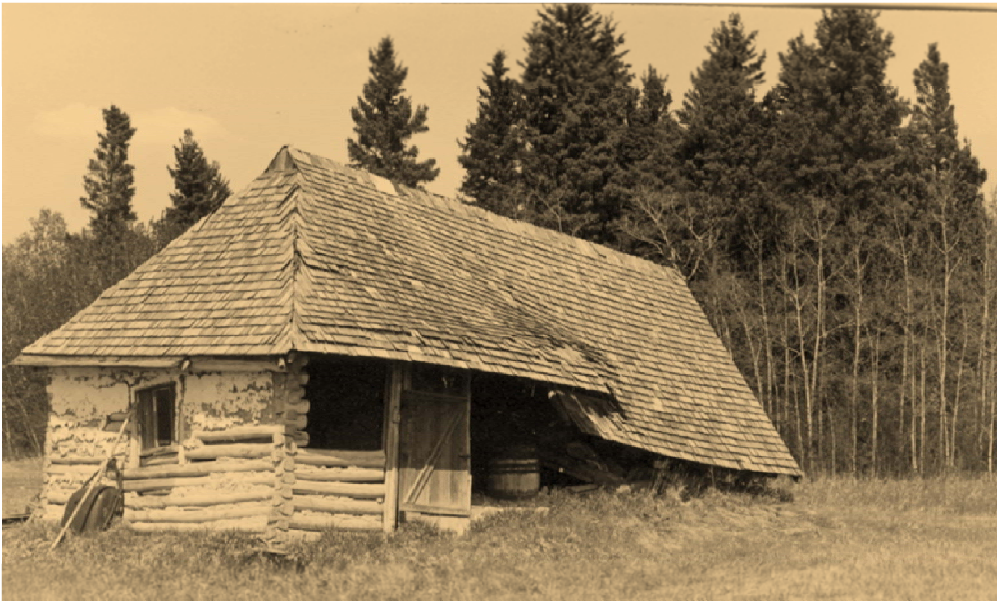
Figure 10

The former Lawrence Babiak residence, NE 1-18-3E, 1900. This structure, last occupied in 1948, is possibly the oldest remaining Ukrainian house in the planning district. Although the materials are sound, part of the roof has collapsed as a result of the removal of portions of the east and south walls for use as firewood.

In the planning district, only a few of these early homes still exist, and most are in very poor physical condition. In addition, most have had major alterations made to them to facilitate alternate uses over the years. The addition of extra doors or windows made the buildings useful as poultry coops while machinery storage sheds could be created with the complete removal of portions of the walls and ceiling. One fairly good example is located at NE 1-18-3E, at the extreme southern edge of the planning district (Figure 10).

A single storey Galician house, the structure is oriented east-west and has a doorway on the south side. The larger of the two rooms is on the east and the smaller is on the west. The doorway and the chimney are located in the small room, the mala khata.

The walls of this house are constructed of thin logs, peeled but left in the round. The dovetailed notches in the corners are somewhat crudely cut, resulting in loose fitting walls with relatively large spaces between many of the logs. These spaces were filled with wood scraps before the traditional mud plaster was applied. The door and window frames are made of shaped logs, rather than the cut lumber frames commonly found in later homes. A number of interesting connections were used in the construction of this house (Figure 11).

As was sometimes the case with Ukrainian structures built of logs left in the round, diagonal lathing was not nailed to the walls to provide purchase for the mud plaster. The natural undulations of the round logs were sufficient to hold the plaster. The plaster in the Babiak house was given a blue colour finish on the interior and the usual brilliant white lime finish on the exterior.

One of the more interesting aspects of this house is the unusual gable roof shape, which is hipped at one end. Although the original thatch roof has been replaced with wooden shingles, the rafters and roof shape are apparently original. Only one other roof of this type was encountered in the planning district, on a small shed several kilometres north of the Babiak house. Another log structure, possessing several Bukovynian characteristics, is located in the extreme southwest corner of the R.M. of Bifrost (Figure 12).

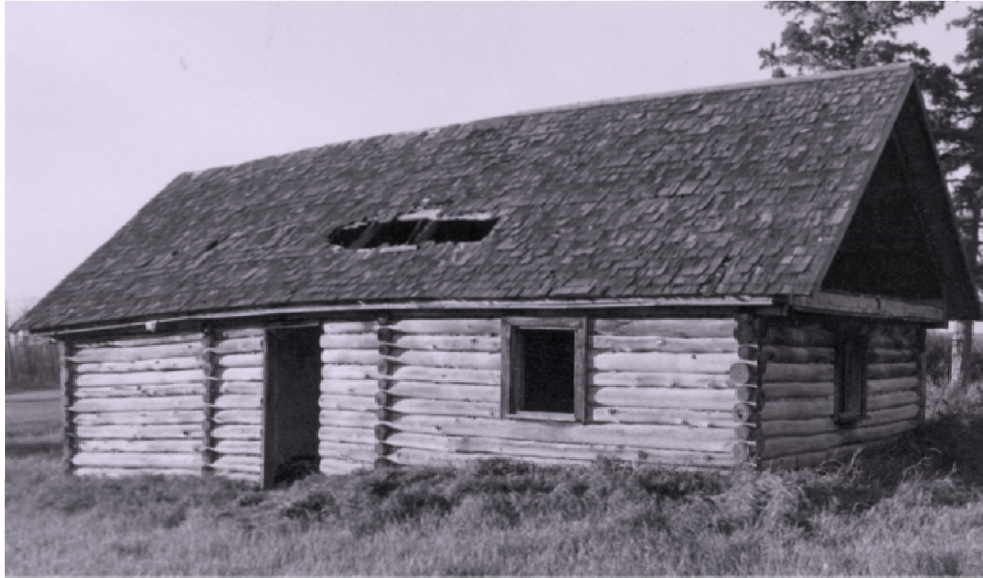
Figure 12

The former A. Leszczyński residence, SE 5-22-1E, ca. 1910. This structure had undoubtedly been abandoned for many years. All the windows, the door, chimney, and the lumber from one of the gable ends has been removed, but it is still in good physical condition.

The three-room plan with centrally located doorway and chimney are characteristically Bukvynian as is the prominent eave projection on all sides of the structure. Although constructed of thin unsquared logs with saddle-notched corners (both early features) the building exhibits a great deal of care in its construction and was certainly not hastily built. The straight, uniformly thick logs were carefully selected and the corner notches were expertly cut allowing few spaces between the logs.

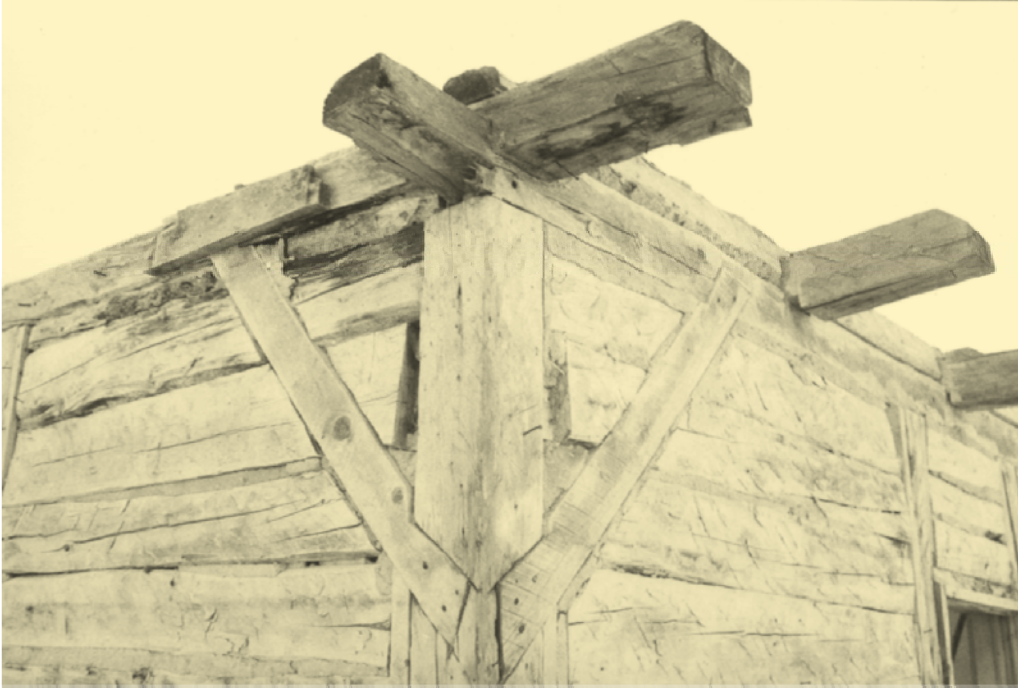
Figure 18

The corner bracing and the top plate-beam connections used in German post and fill construction encouraged some interesting detail work.

During the settlement of the Eastern Interlake area several rural districts were homesteaded by German-speaking immigrants whose language became dominant in the districts of Felsendorf, Haas, Berlo and Rosenburg. By 1915, largely due to poor soils, many of these settlers left the area to return to Europe or resettled in Saskatchewan. The few who did remain, especially in the Berlo district, built structures that are distinctively German. Like many Ukrainian buildings in surrounding areas the typical German house was a single storey gabled structure with a rectangular two or three room plan. Unlike the Ukrainian residences, the German houses had a north-south orientation with the entrance on the west side. The use of post and fill construction, rather than horizontal log construction, also distinguishes the typical German house (Figure 18).

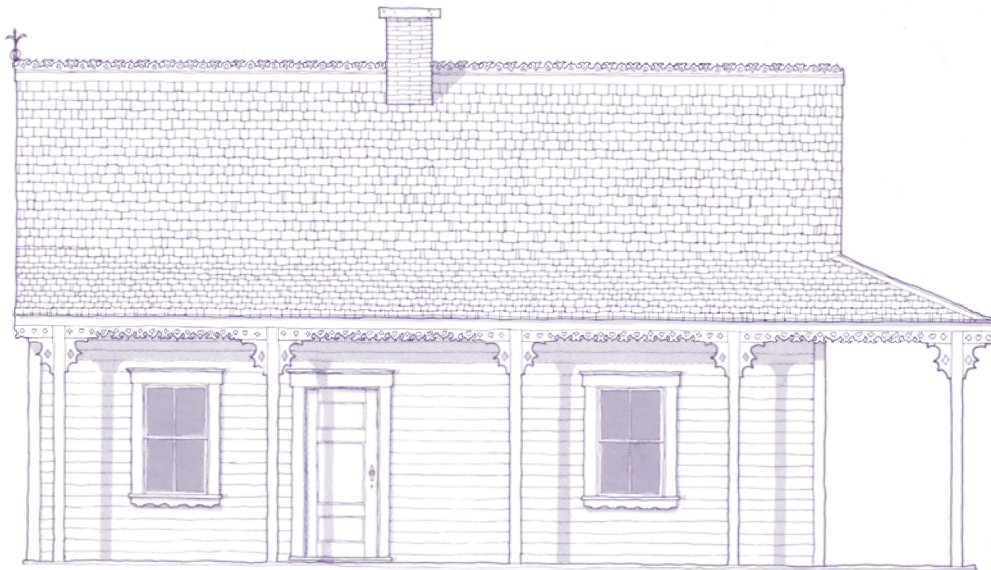
Figure 19

The roof cresting, window and door mouldings and the intricate verandah detailing were typical elements on the German houses in the Eastern Interlake.

Finally, a prominent flared eave projection along the west and south faces formed a large verandah that was usually supported by rectangular posts. Subsequently these houses were often sheathed with wood siding, extended with a lean-to addition and upper storey bedroom and embellished with decorative mouldings (Figure 19).

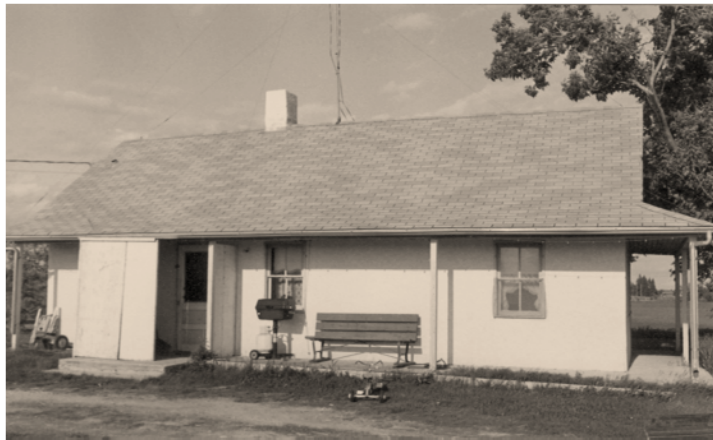
Figure 20

Gottfried house, SE 27-20-3E, ca. 1910. The eave projection and the north south orientation with a western entrance are evident here.

Only three log houses and three log farm buildings remain in the Berlo area. The Gottfried house, at SE 27-20-3E is the best German house remaining, even though it has been altered with a new roof, a stucco finish and the removal of most decorative elements (Figure 20).

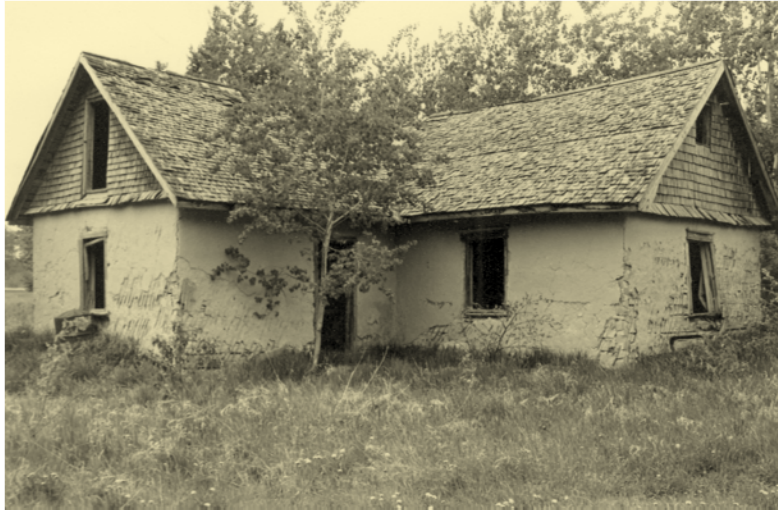
Figure 21

Polish house, SE 27-19-3E, ca. 1915. The logs used to construct this house in the Gimli area were joined with dovetail notches. Purchase laths were nailed to the walls and a thick mud plaster coating was applied.

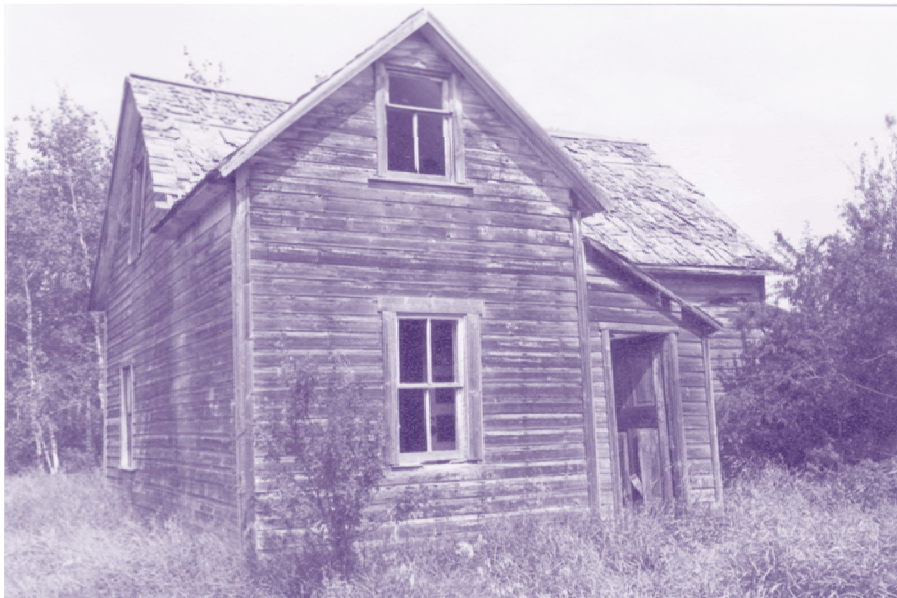
Figure 22

Barylski residence, SE 4-25-2E, ca. 1920.

In the Jaroslaw district, where there were more Polish settlers, a distinctive house was common at one time. These 1 1/2 storey gabled structures in the planning district were often covered on both sides of the wall with a thin mud plaster coating. Both of these kinds of houses, like the Ukrainian and German houses, were often enlarged and improved. A second storey was sometimes added, the whole structure was typically sheathed with wooden siding and a verandah frequently graced the entrance (Figure 22).

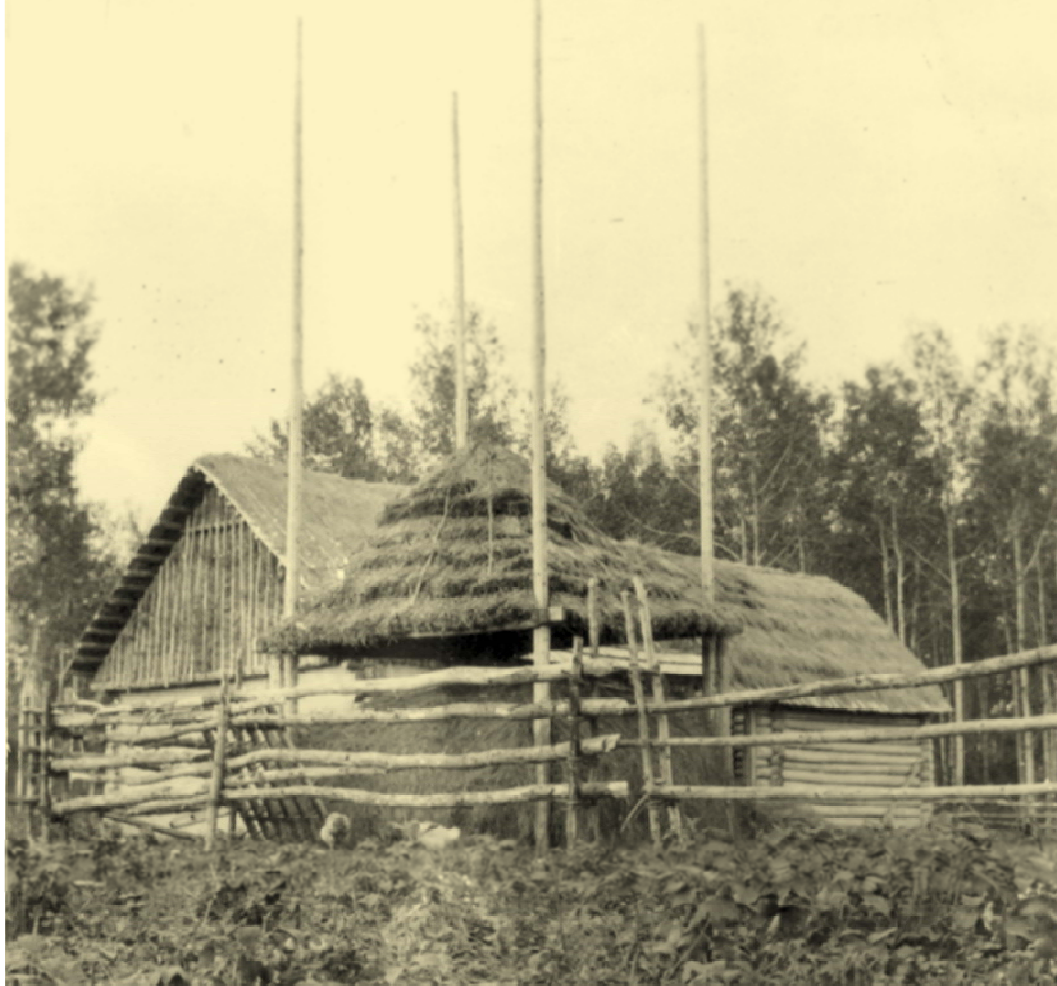
Figure 23
Early log barn in the Foley area. Feed hay was stored under the thatch-roofed structure in the foreground. (Provincial Archives Manitoba)

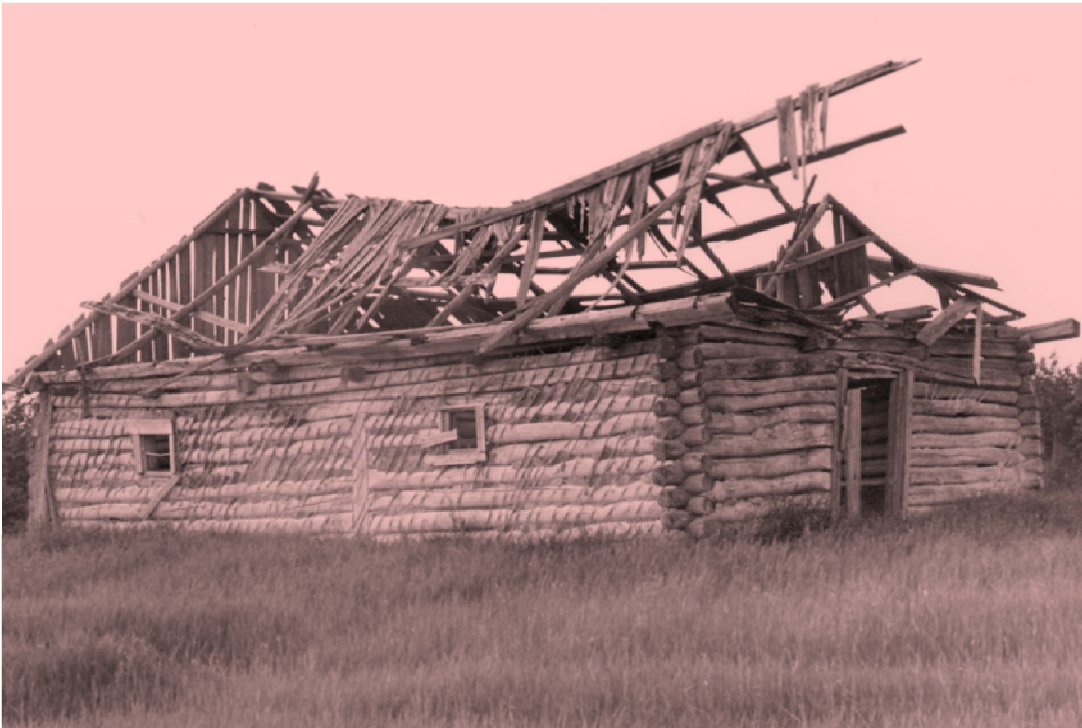
Figure 24
Moga barn, NE 16-21-3E, ca. 1915.

The walls are constructed of 200 mm (7") diameter logs, peeled but left in the round, joined at the corners by saddle-notches and laid on a foundation of loose boulders. The grooved saddle-notch made on the bottom of the logs directs rain water away from the joints and helps prevent rot. Like many of the early structures in which animals were kept, this barn has remnants of a mud plaster coating which sealed and insulated the building, on the exterior walls. The use of diagonal willow purchase laths suggests that this plaster coating was quite thick. The loft floor, constructed of unpeeled rails, was also covered with a layer of mud. Despite its simple construction the building exhibits good craftsmanship (Figure 25). Several interesting connections were used including a tongue and groove sidewall joint and a mortise and tenon peg joint on the interior supporting posts. Although very little remains of its roof, the walls of this structure are still quite sound.

Very few of these early barns still exist in the planning district, and those remaining are in poor condition. One in the Berlo area is a fairly good example (Figure 24).

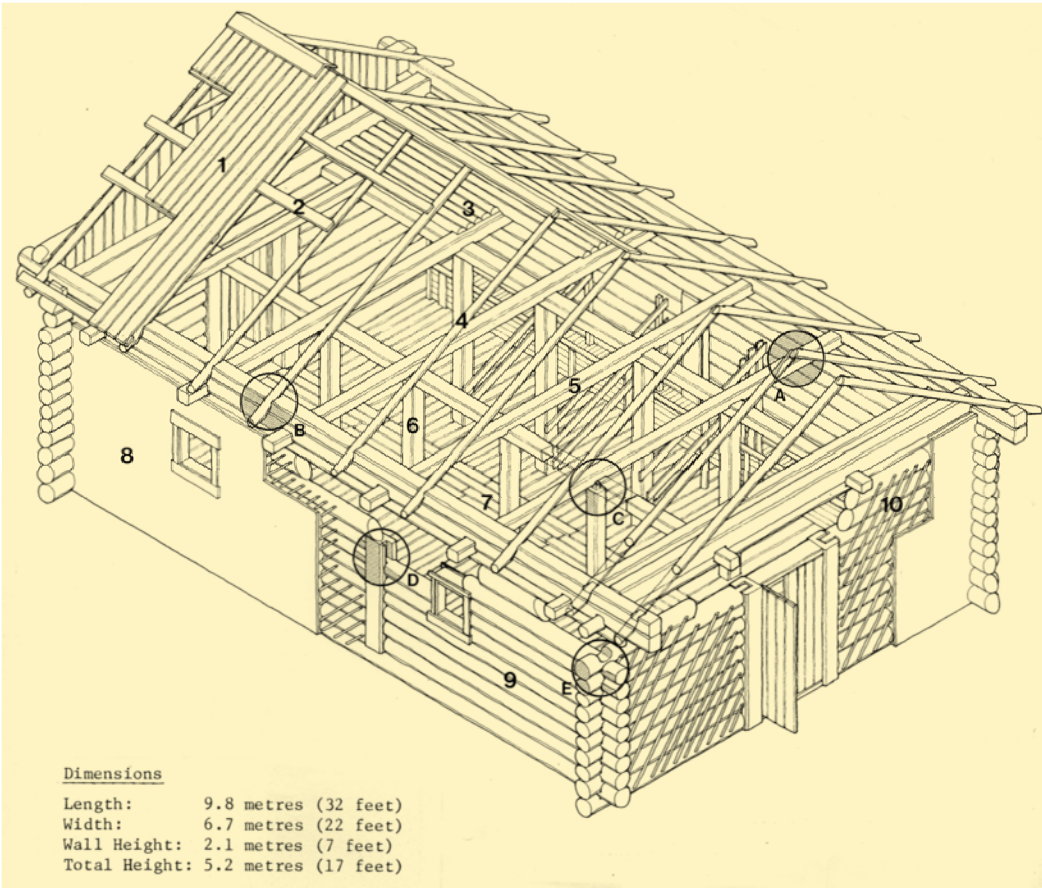
Length: 9.8 metres (32 feet)
 Width: 6.7 metres (22 feet)
 Wall Height: 2.1 metres (7 feet)
 Total Height: 5.2 metres (17 feet)

Figure 25
 Moga barn: construction details.

- A) Rafter lap-joint at apex; nailed
- B) Rafter seat notched into top plate; nailed
- C) Posts form mortise and tenon peg-joints at girders
- D) Guide posts (and framing at openings) use tongue and groove joint
- E) Corner joint: saddle-notch

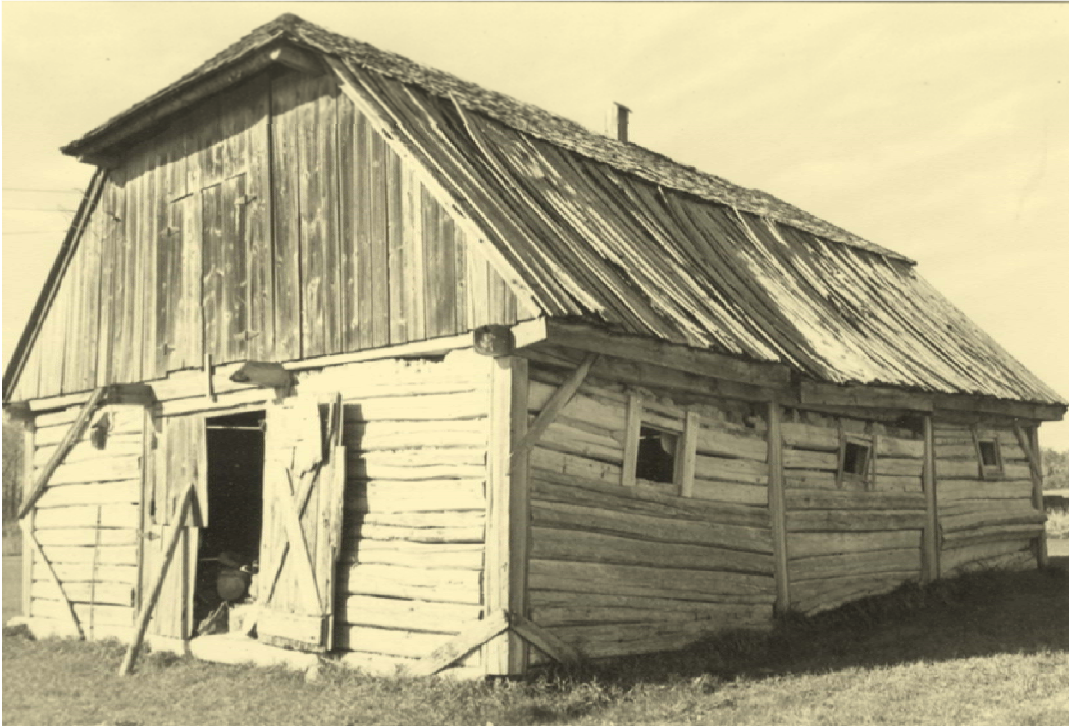
The gable end hips and lower roof eaves project out over half a metre, protecting the plaster coated walls from rainwash. The eave soffits were left open to improve loft ventilation and prevent spoilage of the stored hay. Large lock notches were used at the corners of the sill and plate logs to help keep the walls square as the building settled, a problem inherent with this type of construction. Diagonal sway braces attached to the top of each corner provided added protection. The vertical channels, into which the log ends were fitted, were formed by nailing two wooden strips to the sides of the supporting posts rather than cutting a groove along the length of the post. This was an easier way of creating a channel and was quite common in Ukrainian built post and fill structures.

Figure 27
Rostkowski barn, SW 4-22-1E, ca.
1925.

Only two examples of the latter were found in the areas of Ukrainian settlement. The Rostkowski barn in the Framnes area is an interesting example (Figure 27).

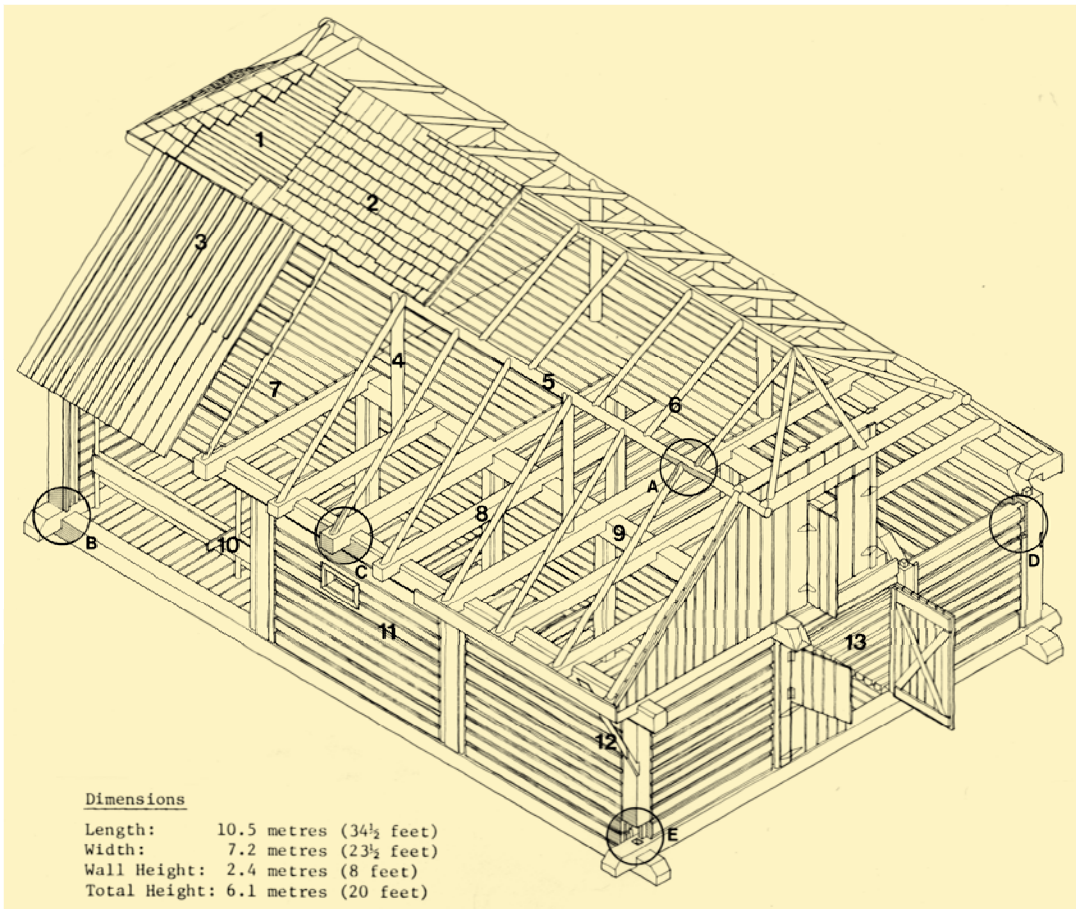
Figure 28
 Rostkowski barn: construction details.

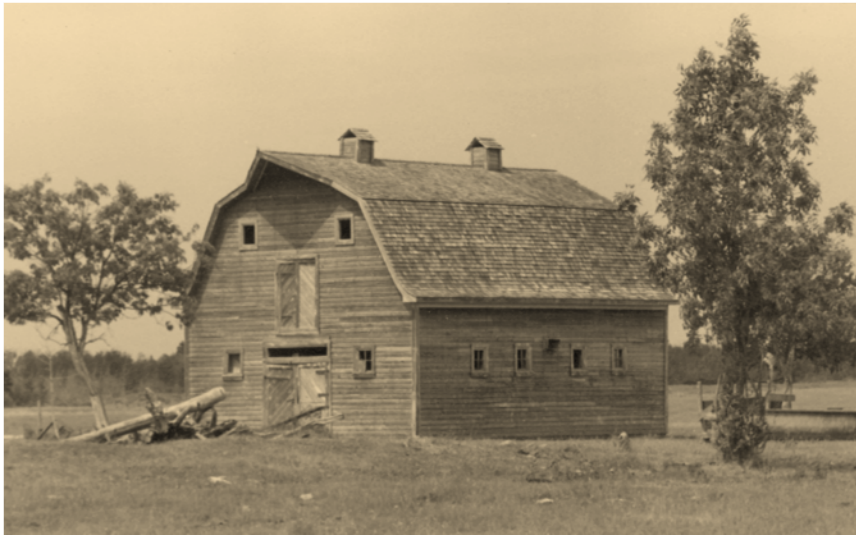
Figure 32
Farm barn, SE 33-21-3E.

During the post war period, few of the farm buildings constructed by Ukrainians in the Eastern Interlake displayed any traditional elements. They were all frame lumber structures of contemporary design similar to those being built in any other area of the province (Figure 32).

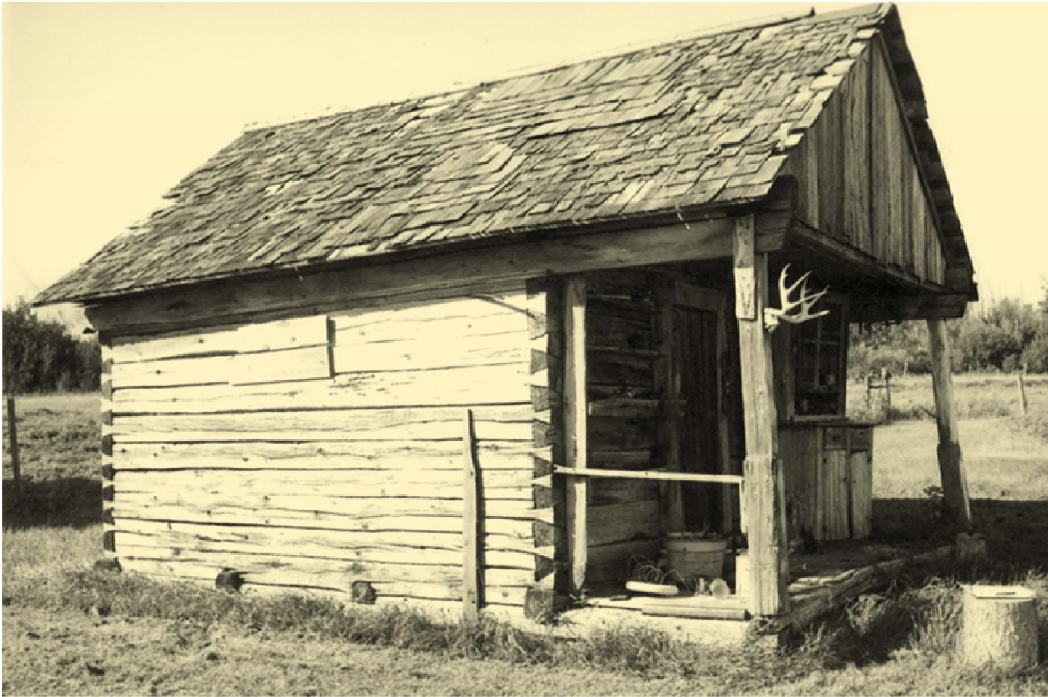
Figure 38
Lemecha komora, SW 23-21-3E, ca.
1920.

Another standard component of early Ukrainians farmyards was the "komora" or tool shed, which was used to store harnesses, hand tools, small equipment and other items. Like the granaries and chicken coops, the tool sheds were small, single-storeyed, one-roomed log structures usually with wooden floors and in some cases, prominent gable front projections (Figure 38).

This projection, accessed from the interior, not only provided additional storage space but sheltered an exterior work area as well. On the Lemecha komora, posts support the overhang, which has a raised wooden platform below. Its expert construction features a variety of carefully cut and fitted connections (Figure 39). One example, at NE 16-21-3E, had a shed-roofed front projection that is now enclosed (Figure 40).

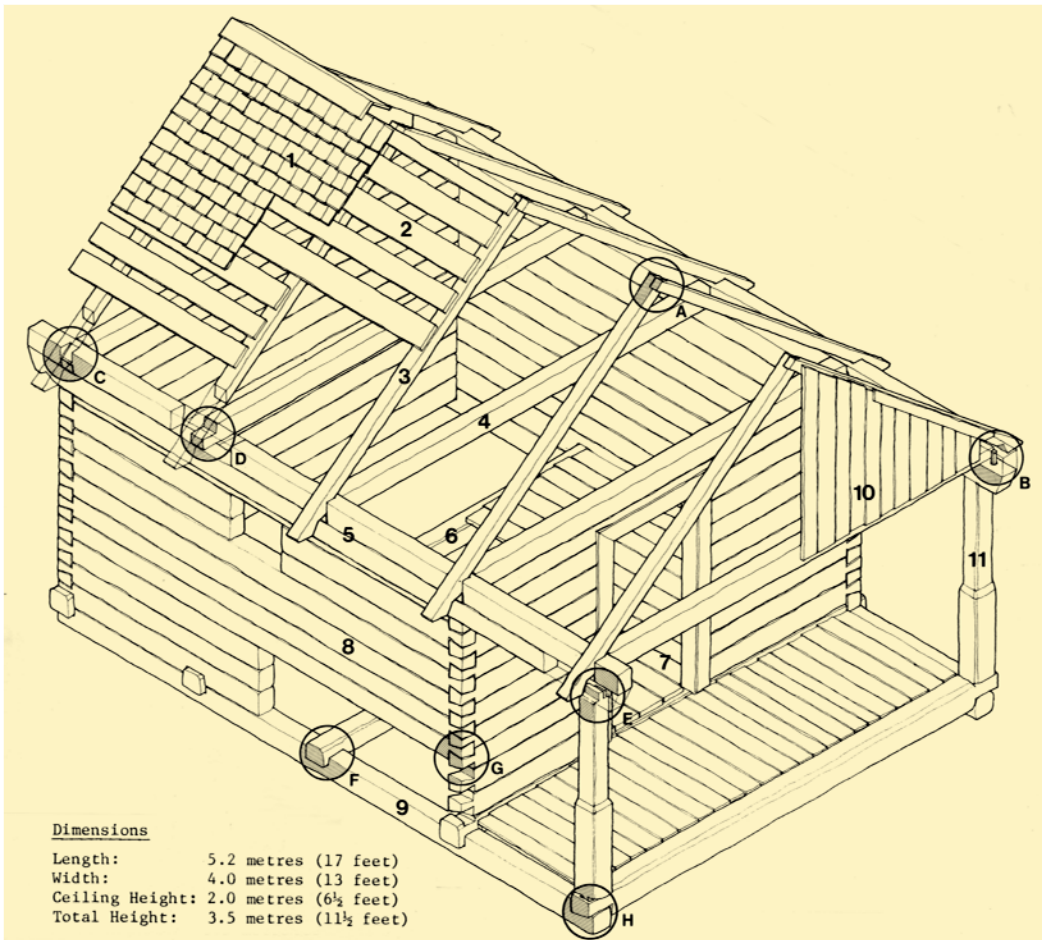
Figure 39

Lemecha komora: construction details.

- A) Rafter lap-joint at apex
- B) Top plates pinned together with 35 mm (1½") diameter wooden dowels
- C) Rafter seat notched into top plate; nailed
- D) Ceiling joist lap-joint at wall (top plate)
- E) Column forms mortise and tenon joint at sill and plate
- F) Floor joist and sill beam form lock joint
- G) Corner joint: dovetail
- H) Sill beam corner: half-dovetail
