## Appendix 1: Bedrock Quarries in the Capital Region Study Area

**NAME:** BORLAND QUARRY SOUTH

### Borland Quarry South

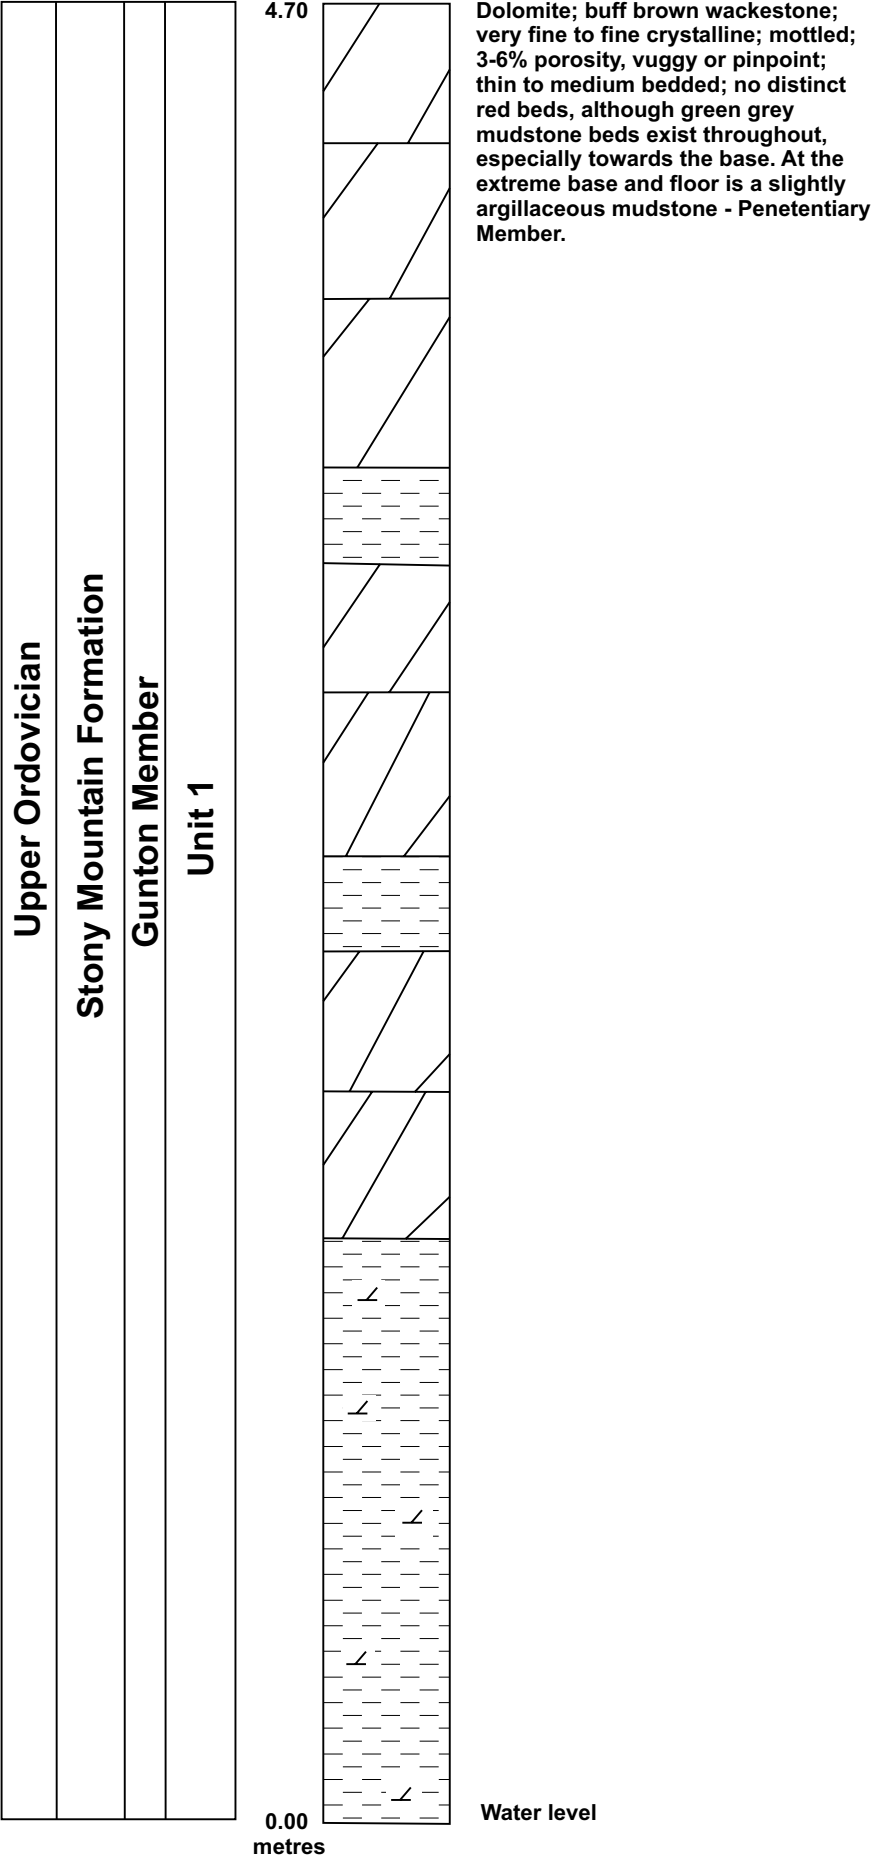
Borland Quarry South

GUNTON MEMBER (4.7 m): dolomite; buff brown wackestone; very fine to fine crystalline; mottled; 3-6% porosity - vuggy and pinpoint; thin to medium bedded; no distinct red beds, although green grey mudstone beds exist throughout, especially towards the base. At the extreme base and floor is a good, slightly argillaceous mudstone - Penitentiary Member. The Gunton Member appears more argillaceous than in other quarries

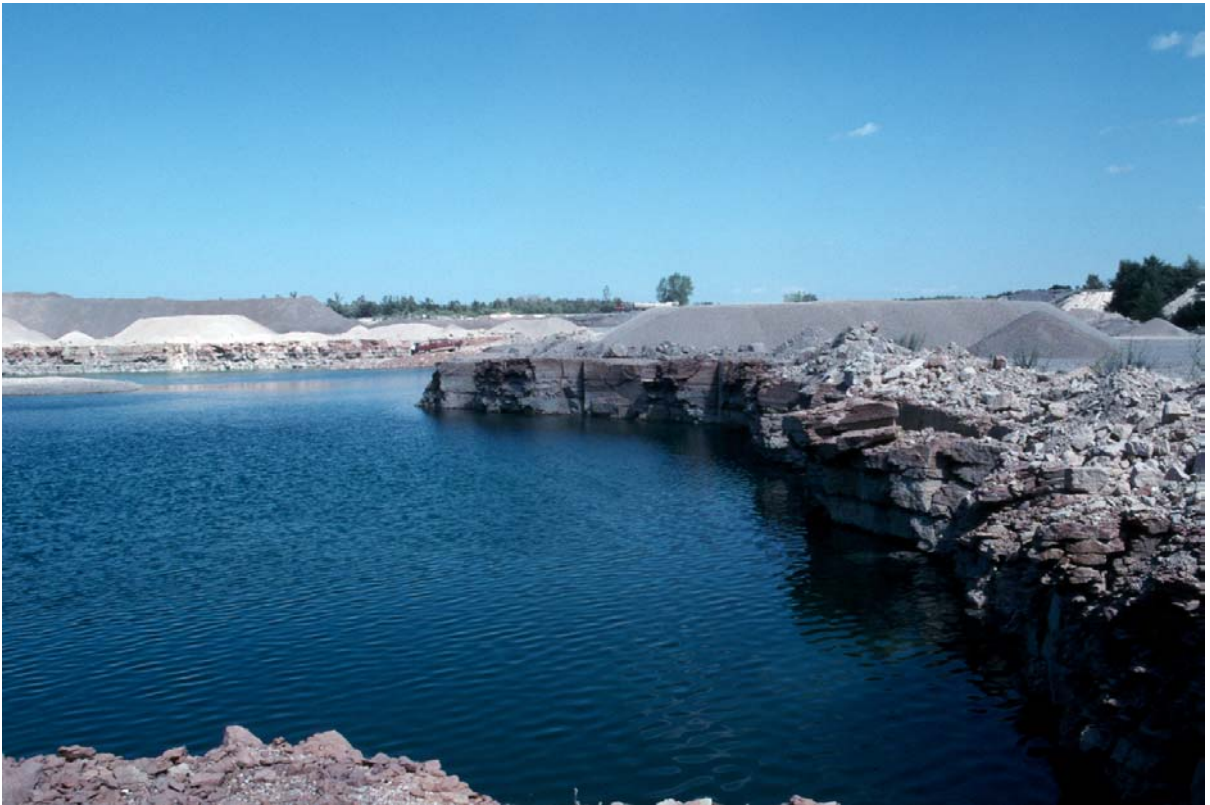
BA South 01 - 1995-07-12, B.A. Quarry South, Penitentiary and Gunton members of the Stony Mountain Formation. Photo of sump pit.

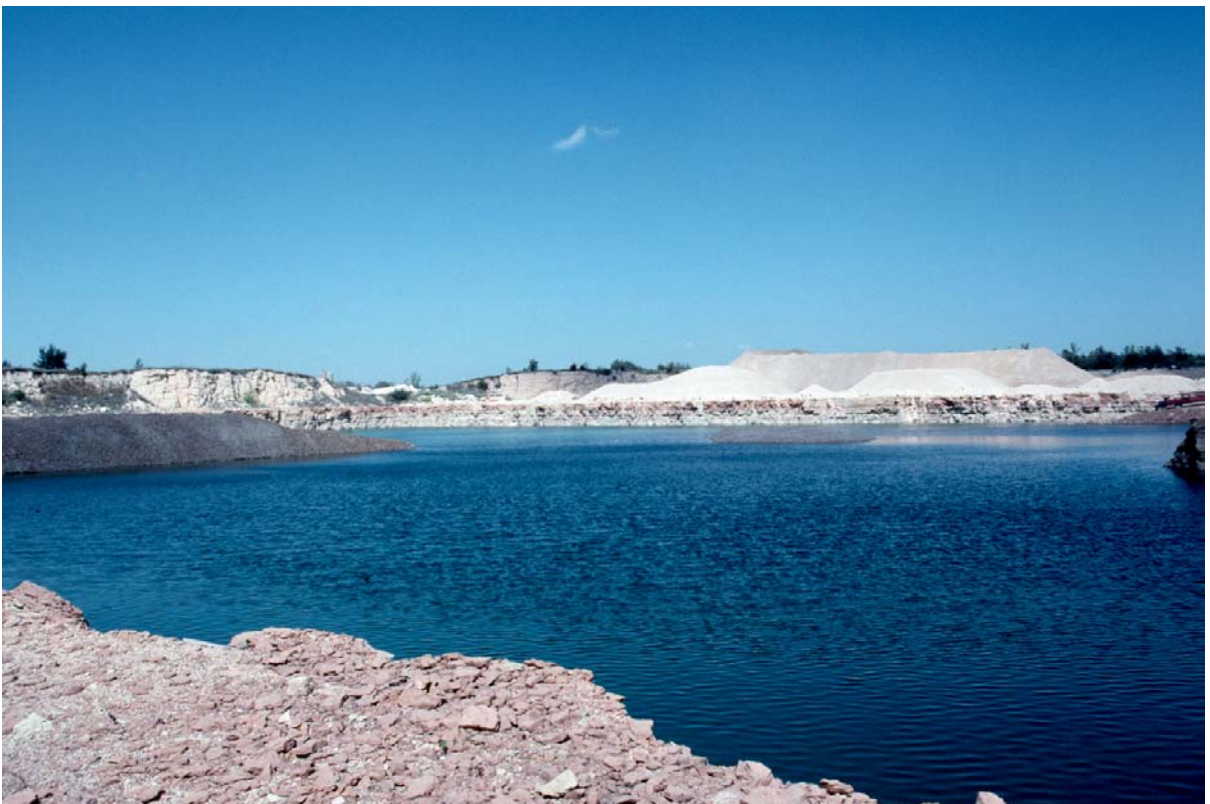
BA South 02 - 1995-07-12, B.A. Quarry South, Penitentiary and Gunton members of the Stony Mountain Formation. Photo of sump pit.

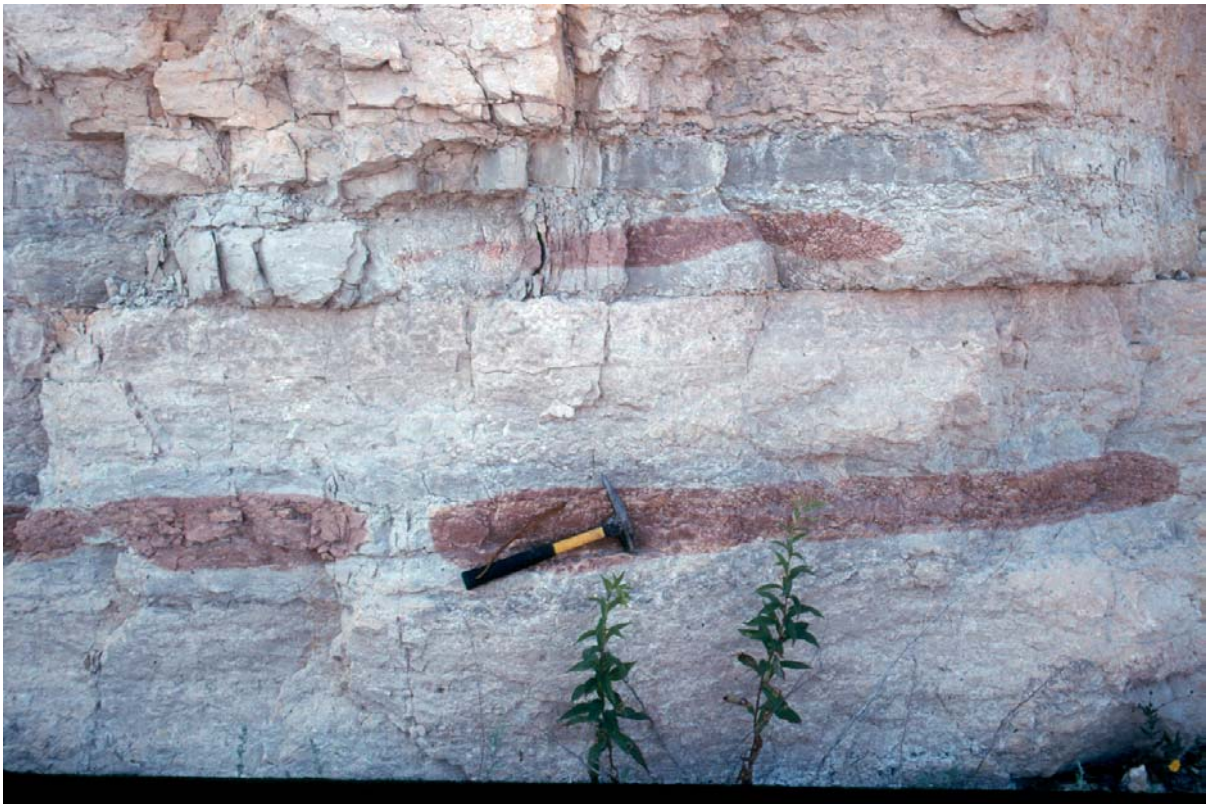
BA South 03 - 1995-07-12, B.A. Quarry South, Penitentiary and Gunton members of the Stony Mountain Formation. Transitional contact between red, mottled dolomitic mudstone and buff wackestone.

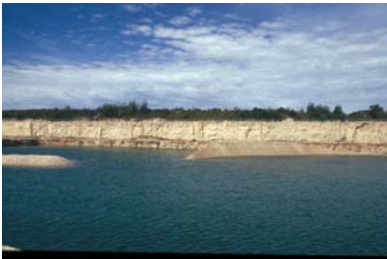
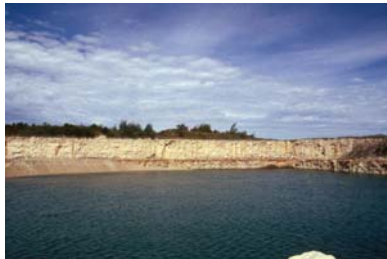
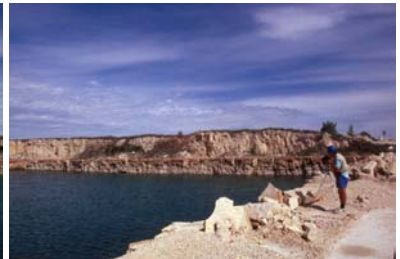
BA South 06-08 - 1995-07-12, Quarry South, Gunton Member of the Stony Mountain Formation. Photo of two benches and sump pit, view from southwest to northwest.

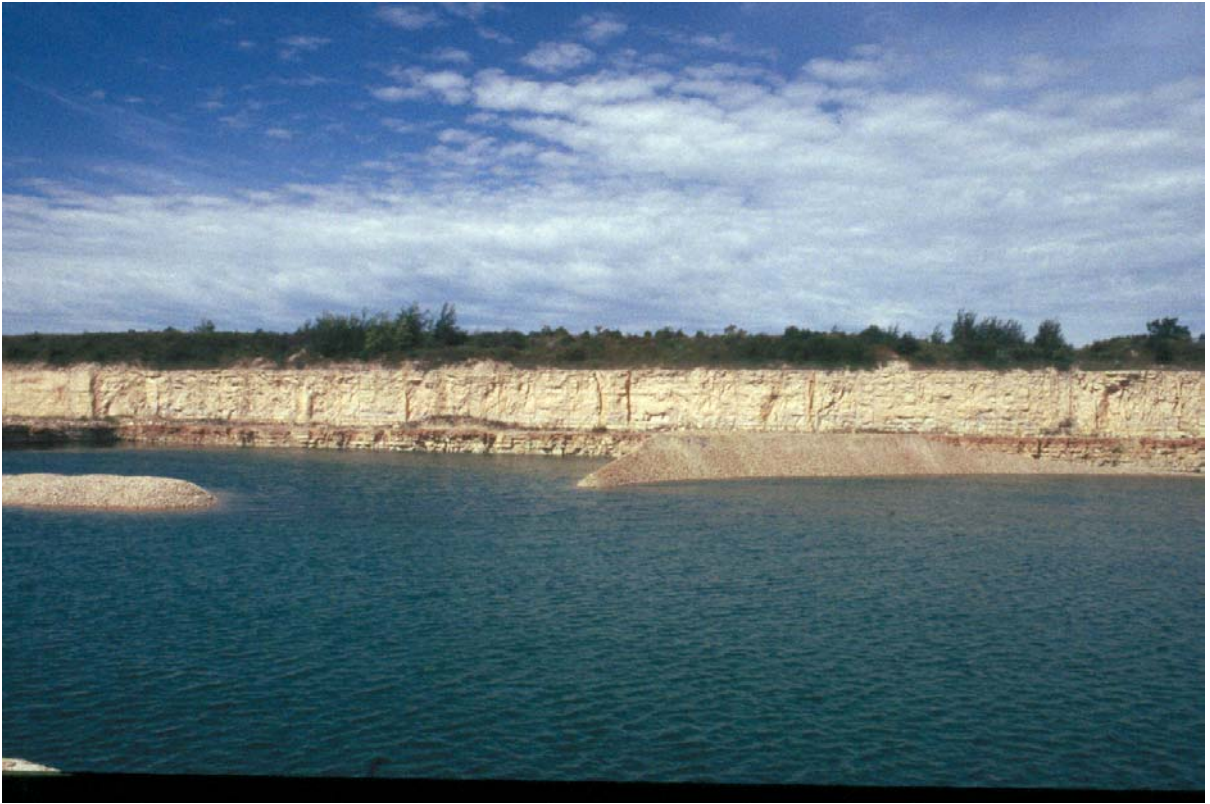
BA South 06 - 1995-07-12, Quarry South, Gunton Member of the Stony Mountain Formation.  
Photo of two benches and sump pit. View towards the southwest.

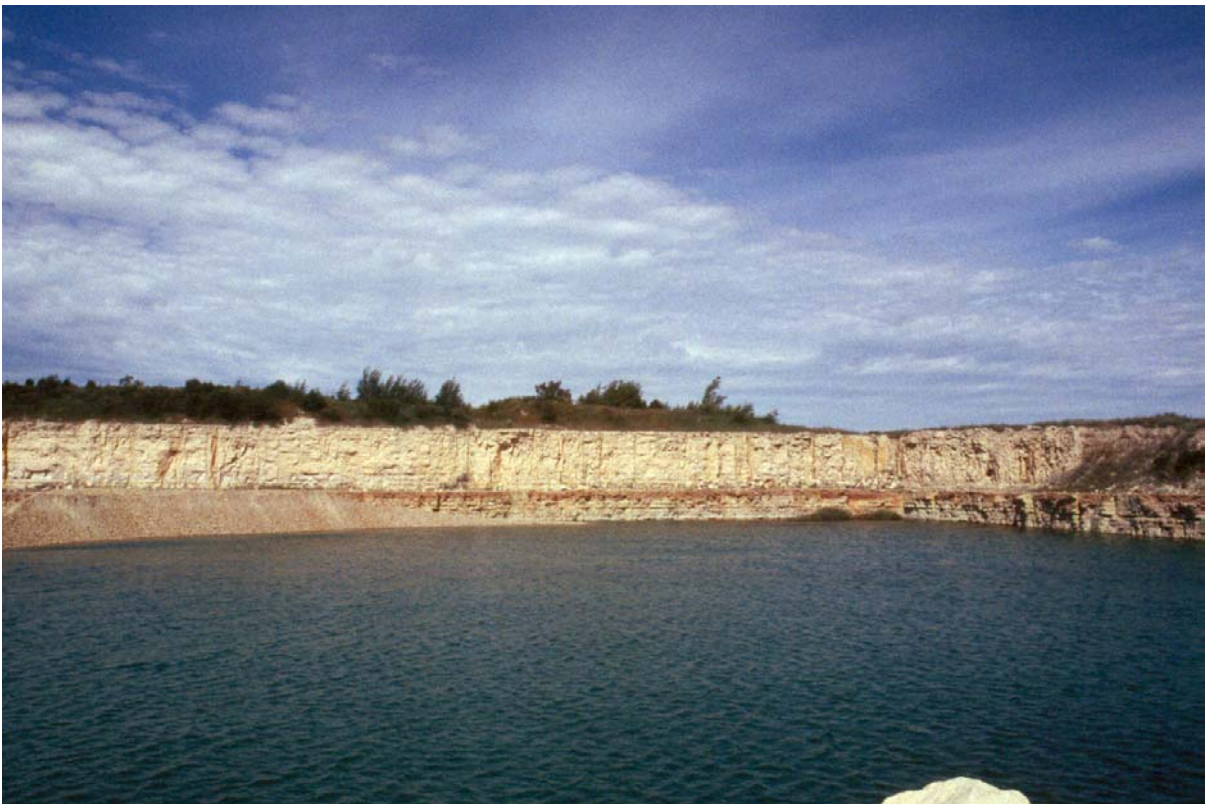
BA South 07 - 1995-07-12, Quarry South, Gunton Member of the Stony Mountain Formation.  
Photo of two benches and sump pit, view towards the west.

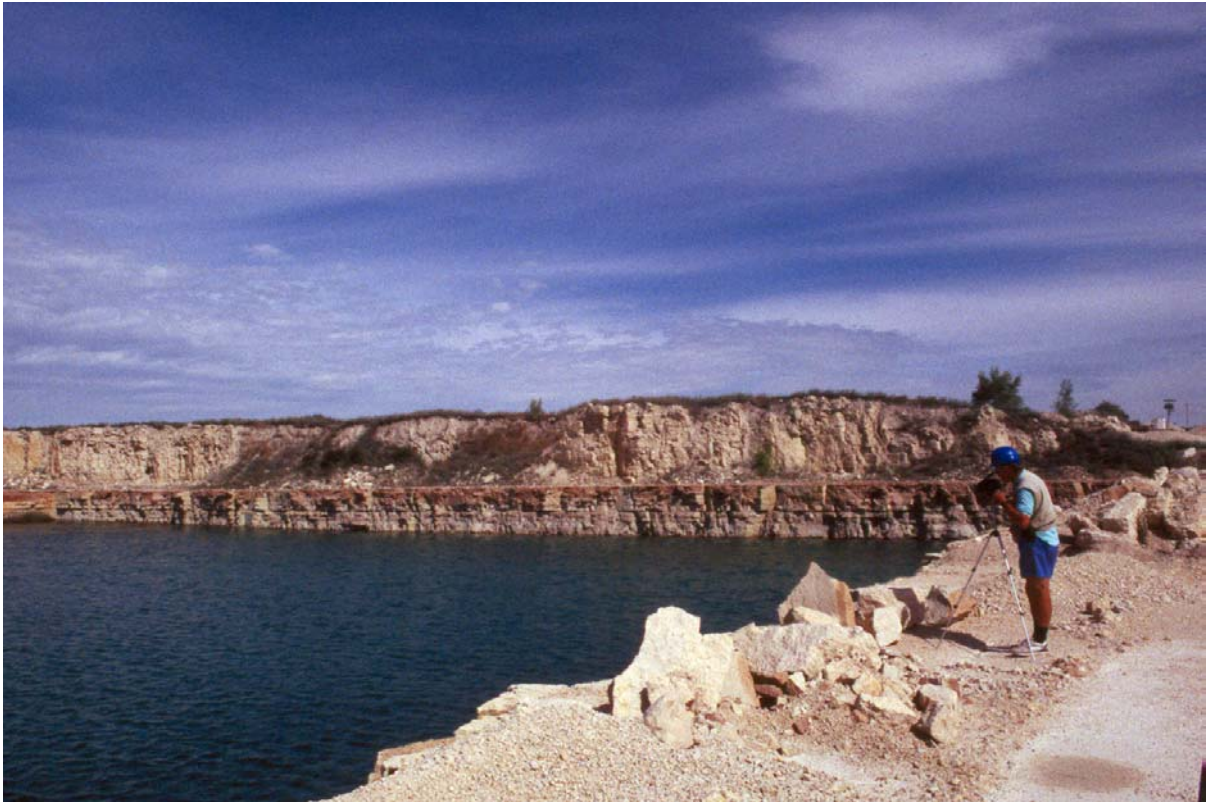
BA South 08 - 1995-07-12, Quarry South, Gunton Member of the Stony Mountain Formation.  
Photo of two benches and sump pit. View towards the northwest.

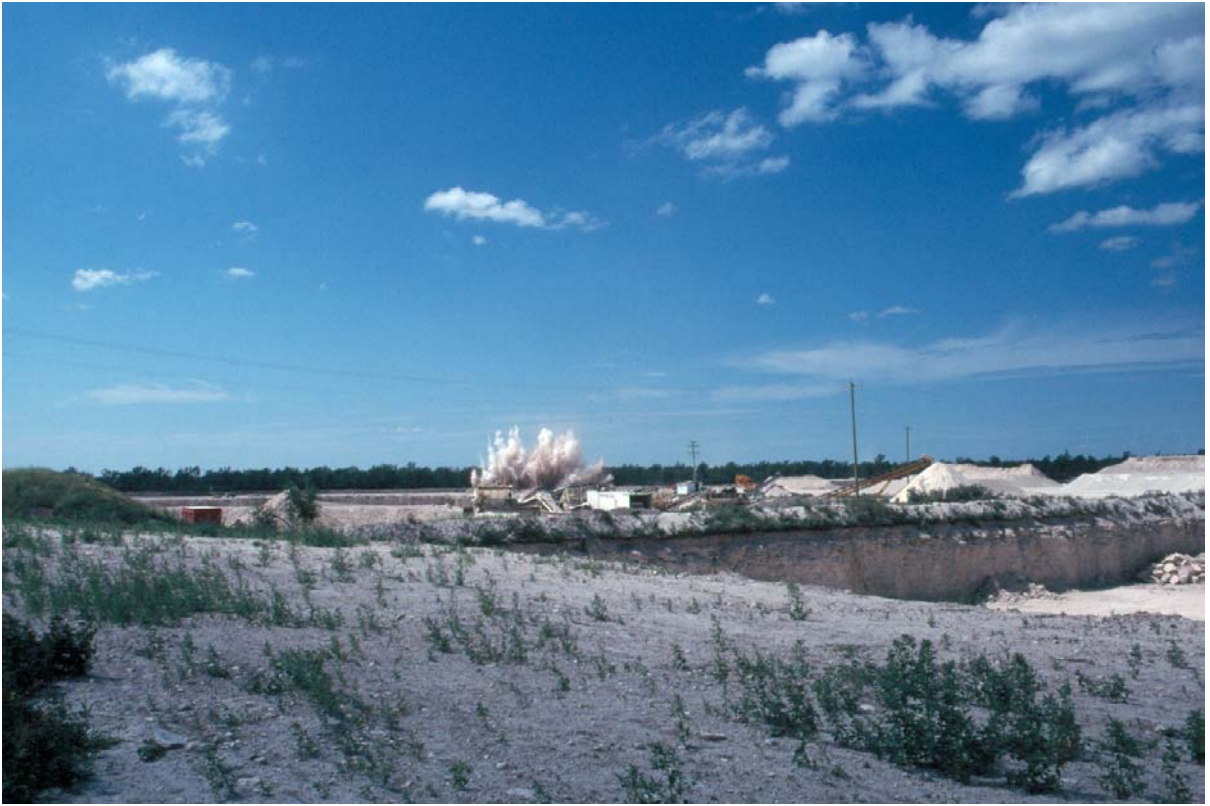
B.A. North 01 - 1995-07-13, B.A. Quarry North. Gunton Member of the Stony Mountain Formation. Blasting of bedrock.

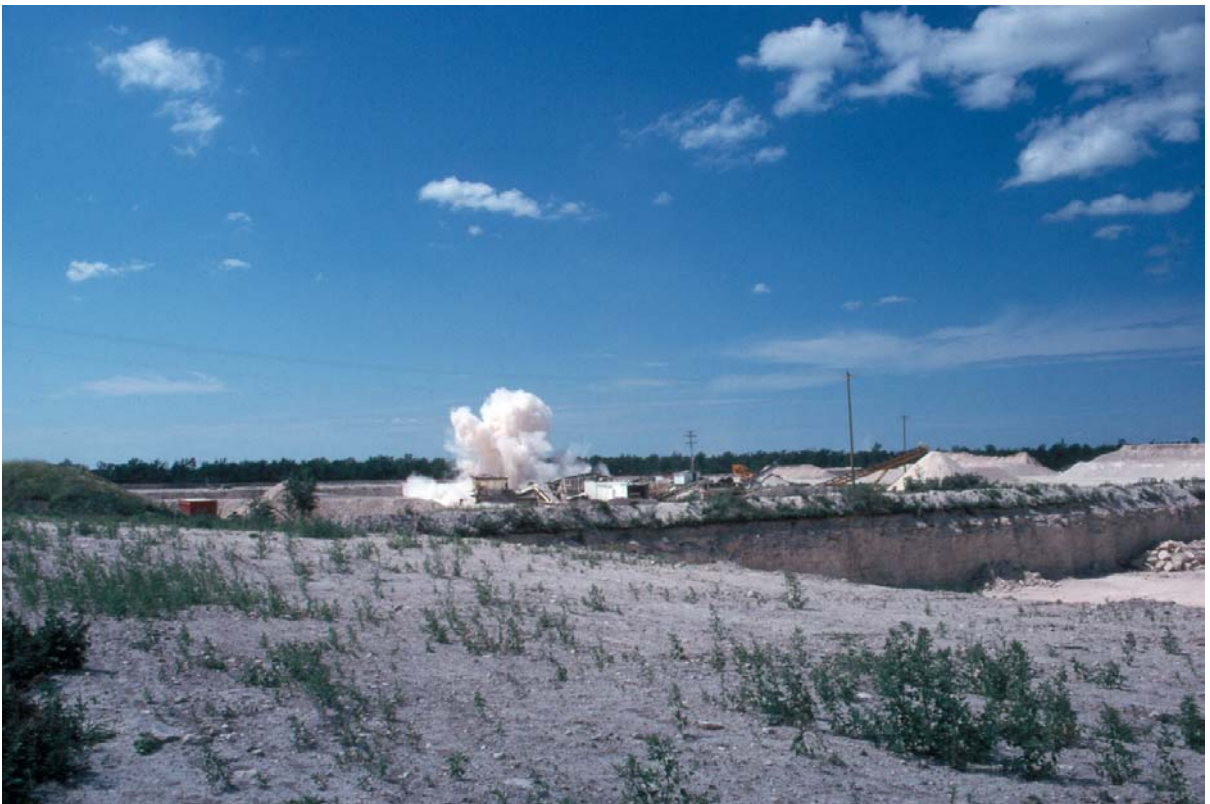
B.A. North 02 - 1995-07-13, B.A. Quarry North. Gunton Member of the Stony Mountain Formation. Blasting of bedrock.

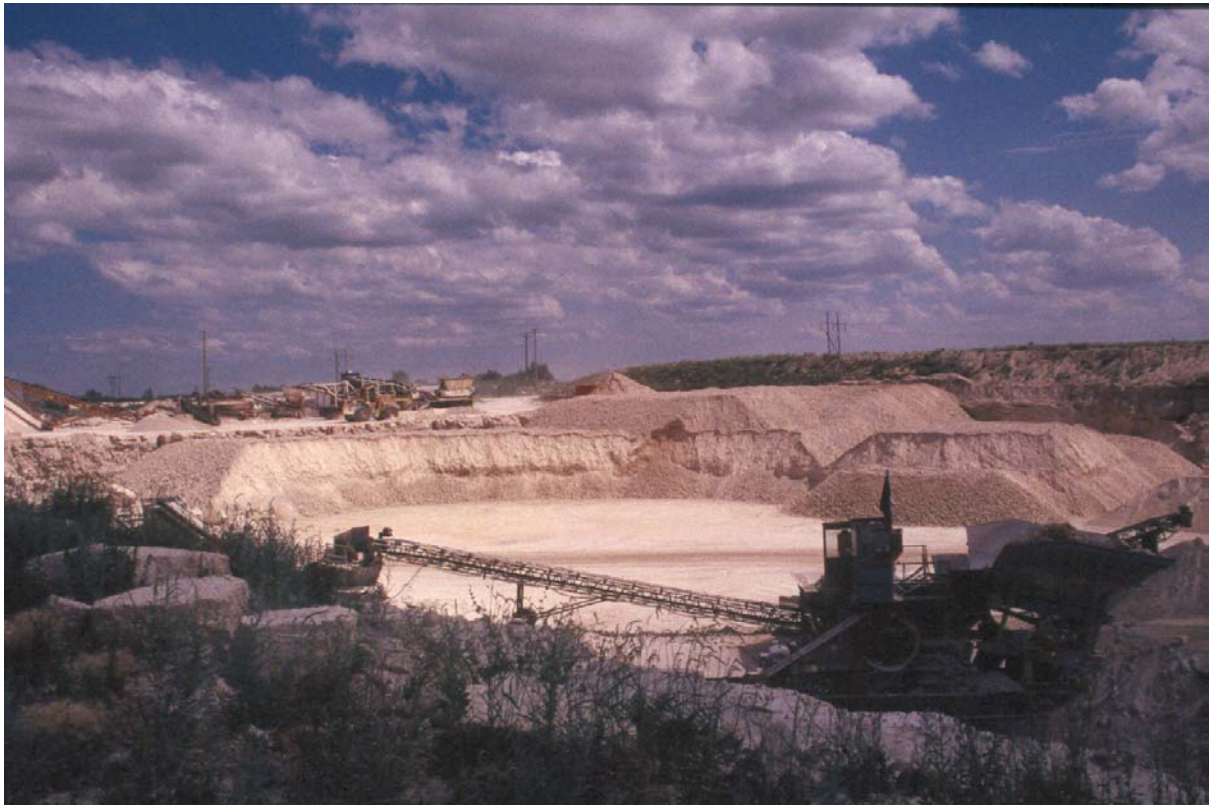
BA North 04 - 1995-07-13, B.A. Quarry North. Gunton Member of the Stony Mountain Formation. View towards the northwest.

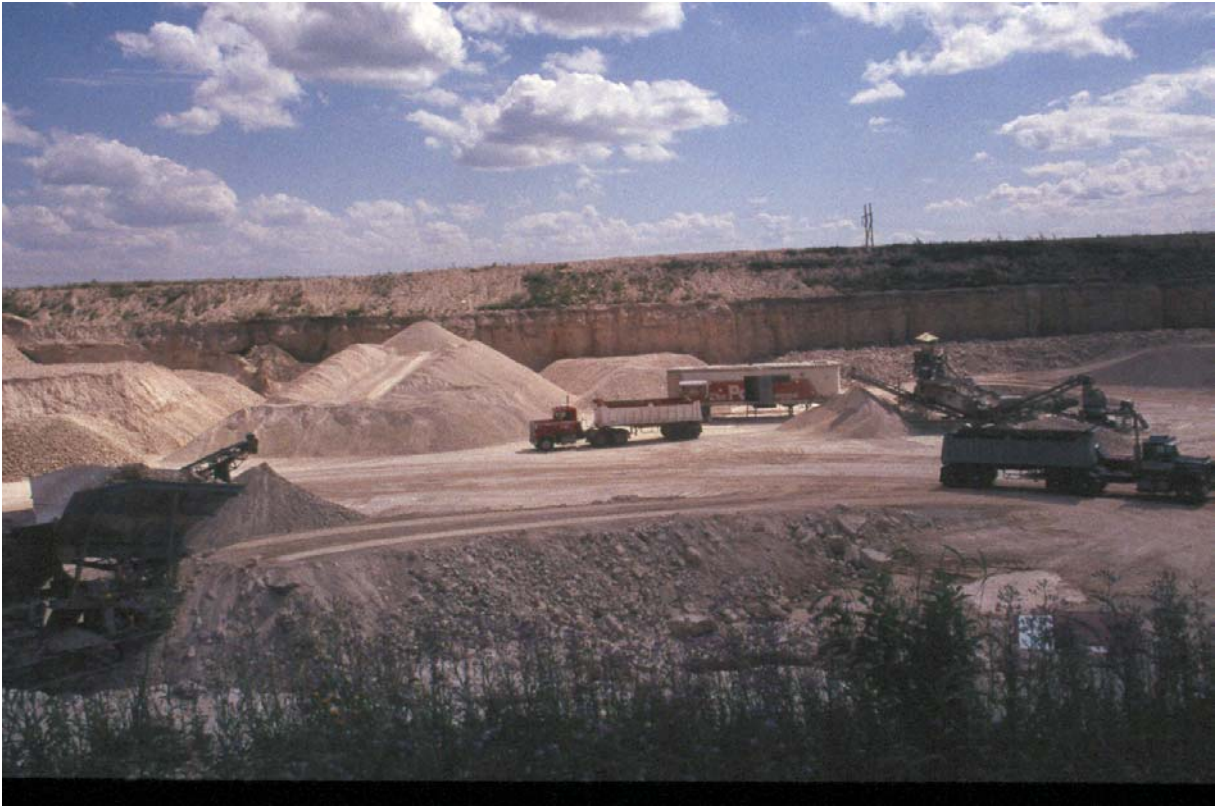
BA North 05 - 1995-07-13, B.A. Quarry North. Gunton Member of the Stony Mountain Formation. View towards the north.

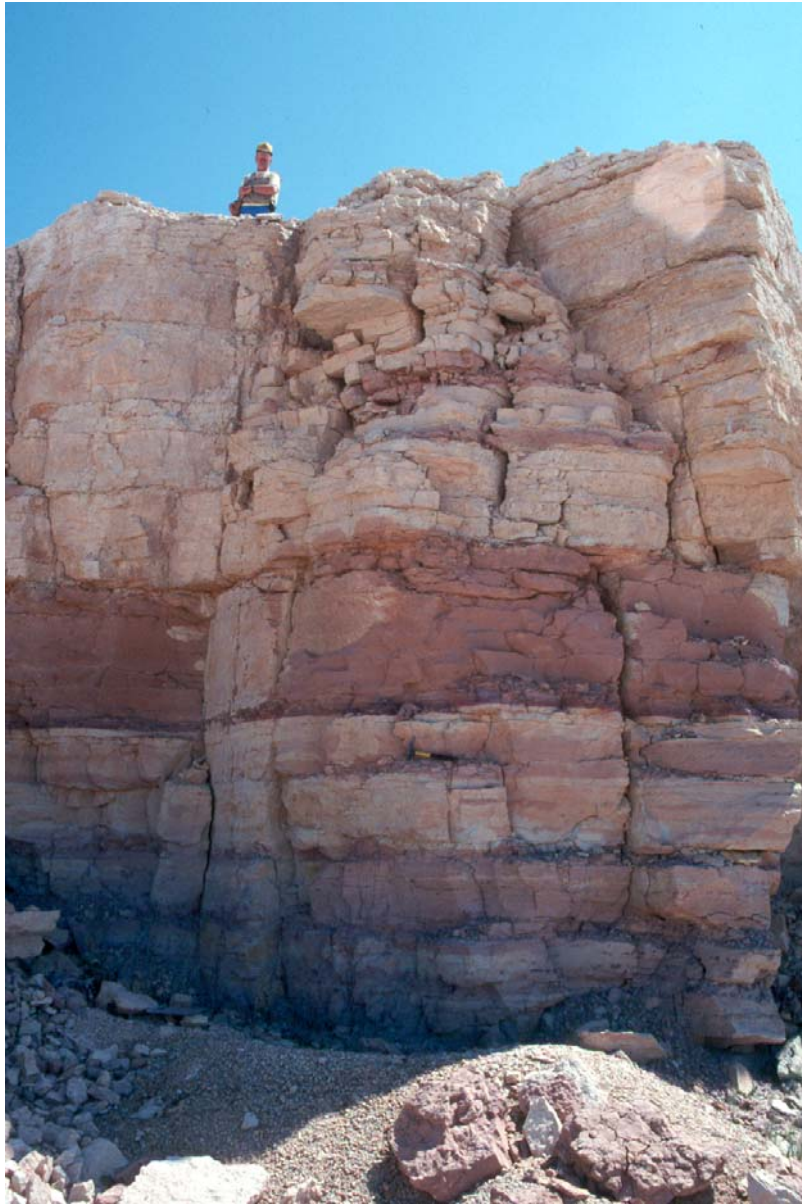
Mulder 05 - 1995-07-13, Gunton Member of the Red River Formation. JDB for scale.

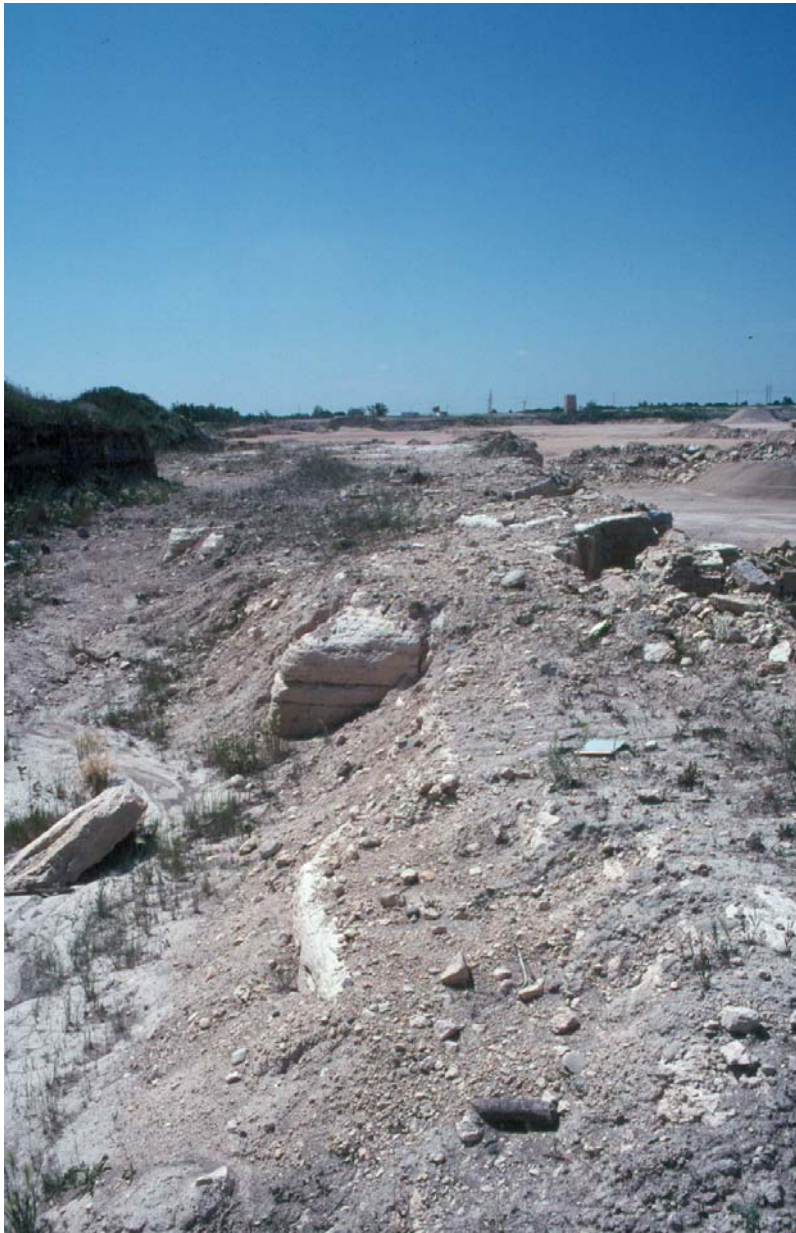
Mulder 07 - 1995-07-13, Gunton Member of the Red River Formation. Erosional edge of Gunton Escarpment, looking south. Quarry is to the west.

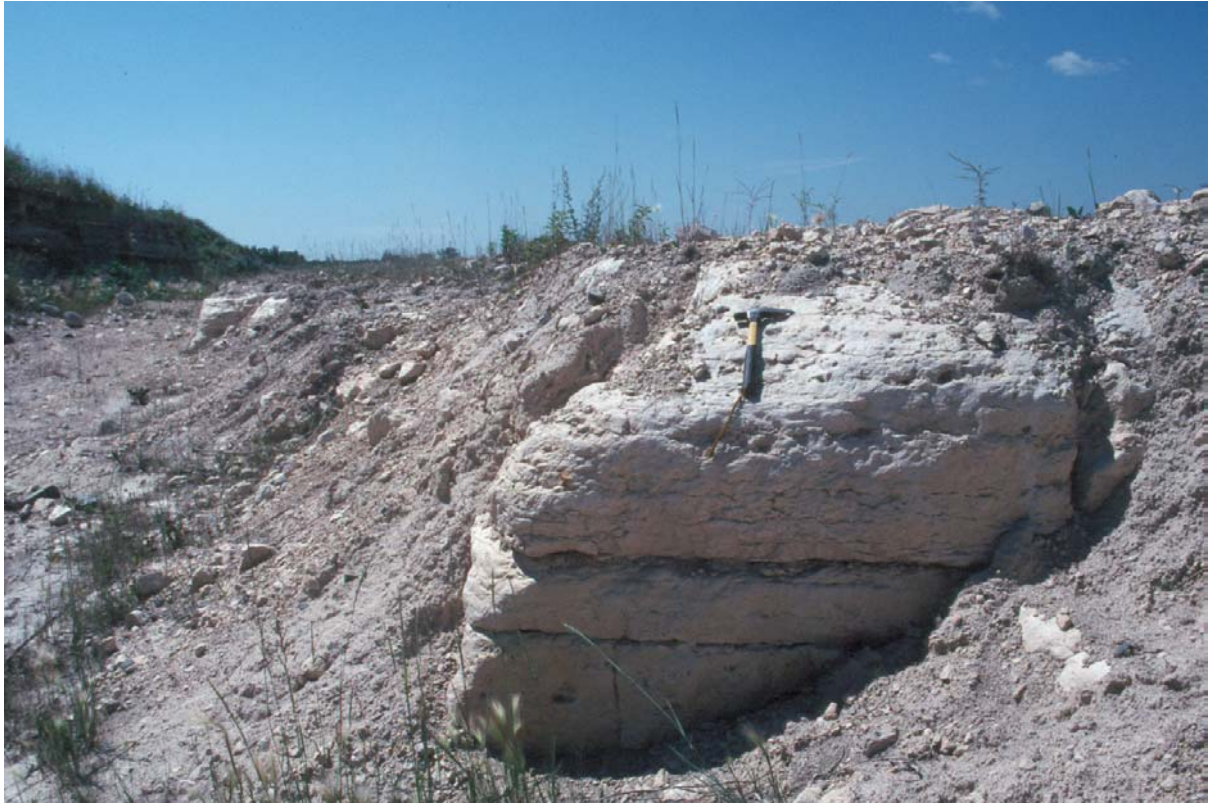
Mulder 08 - 1995-07-13, Gunton Member of the Red River Formation. Erosional edge of Gunton Escarpment, looking west. Quarry is to the west, behind escarpment.

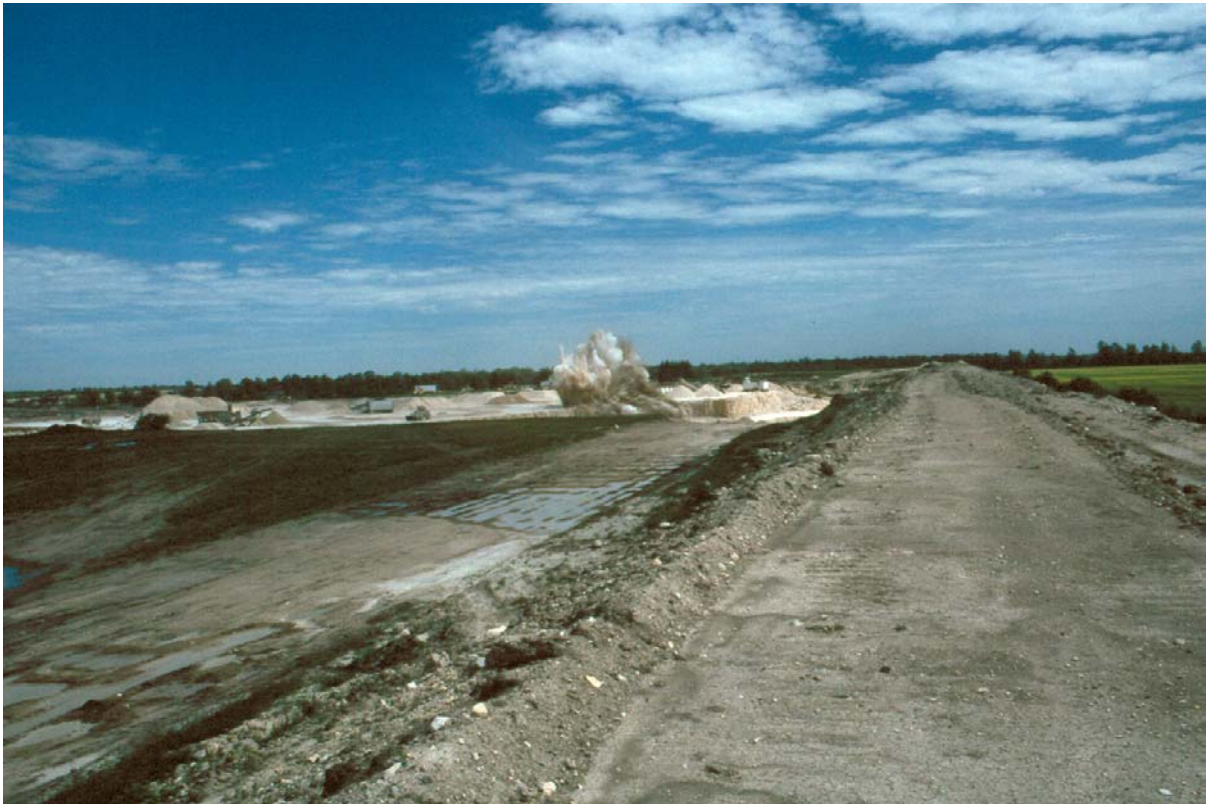
Mulder 88-3 - 1995-05-12, Gunton Member of the Stony Mountain Formation. View towards the east, from the south berm. Stripped off area in foreground, quarries in background with blast in background.

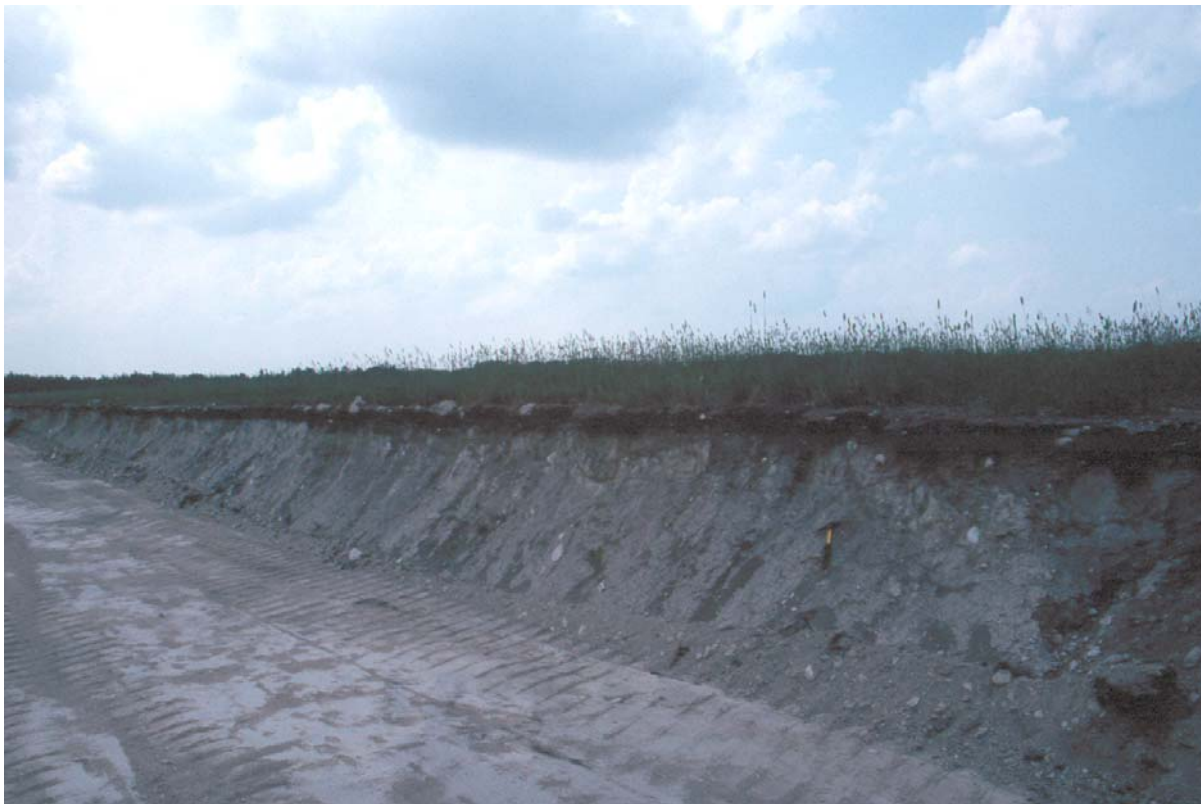
Bison 01 - 1995-06-27, 2 m overburden above bedrock pavement, looking southwest. Gunton Member of the Stony Mountain Formation.

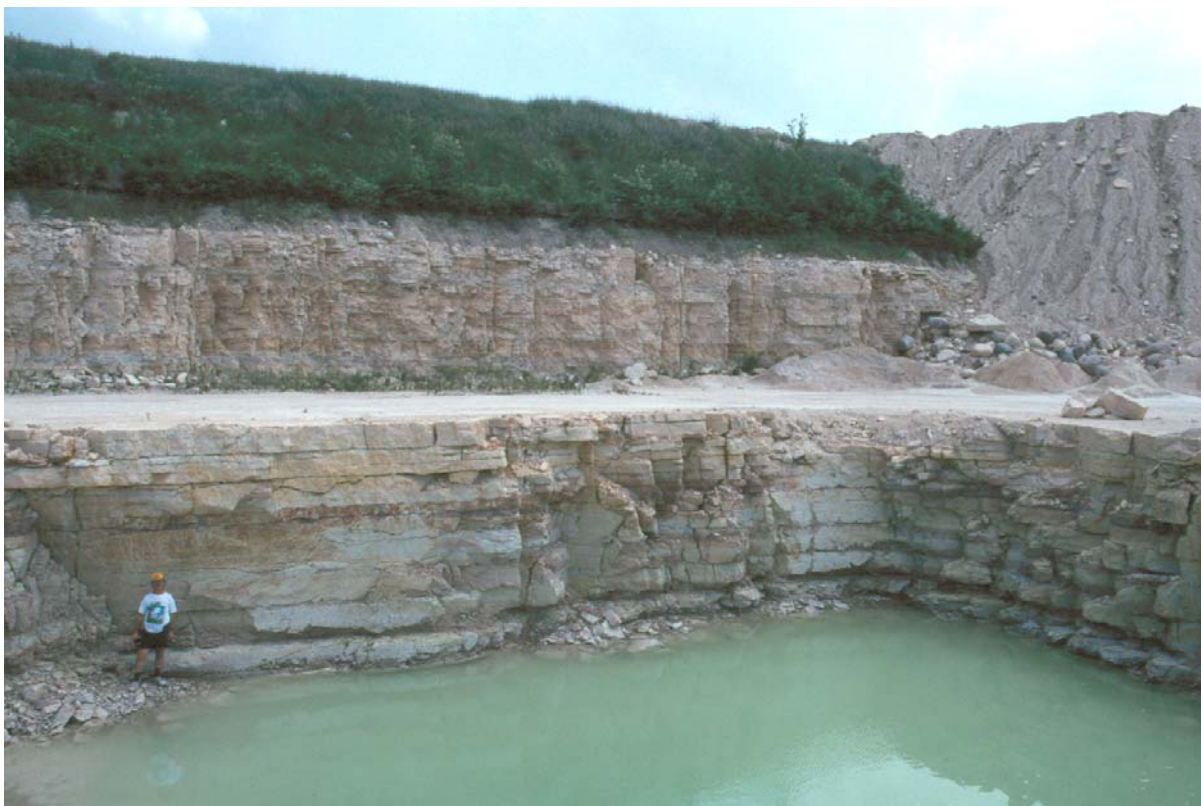
Bison 02 - 1995-06-27, Gunton Member overlying Penitentiary Member of the Stony Mountain Formation. JDB for scale.

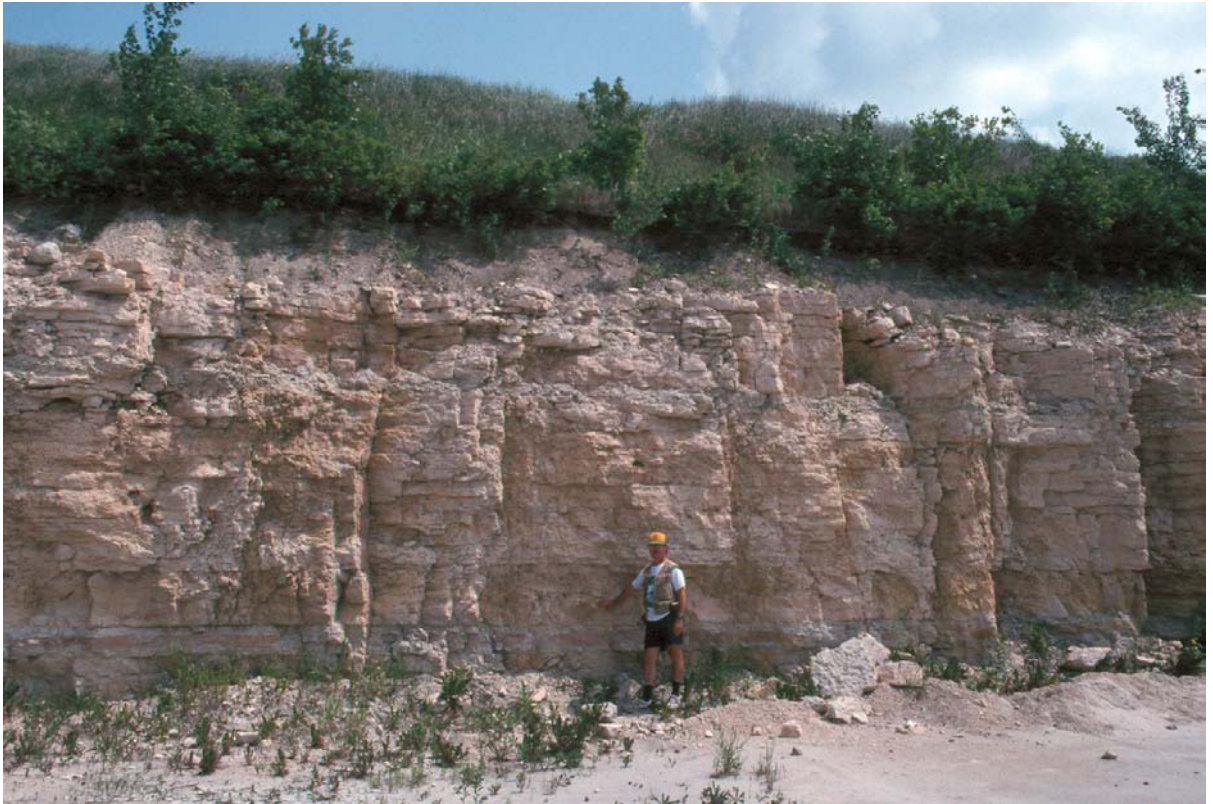
Bison 03 - 1995-06-27, Gunton Member of the Stony Mountain Formation. JDB standing on first bench, top of Penitentiary Member.

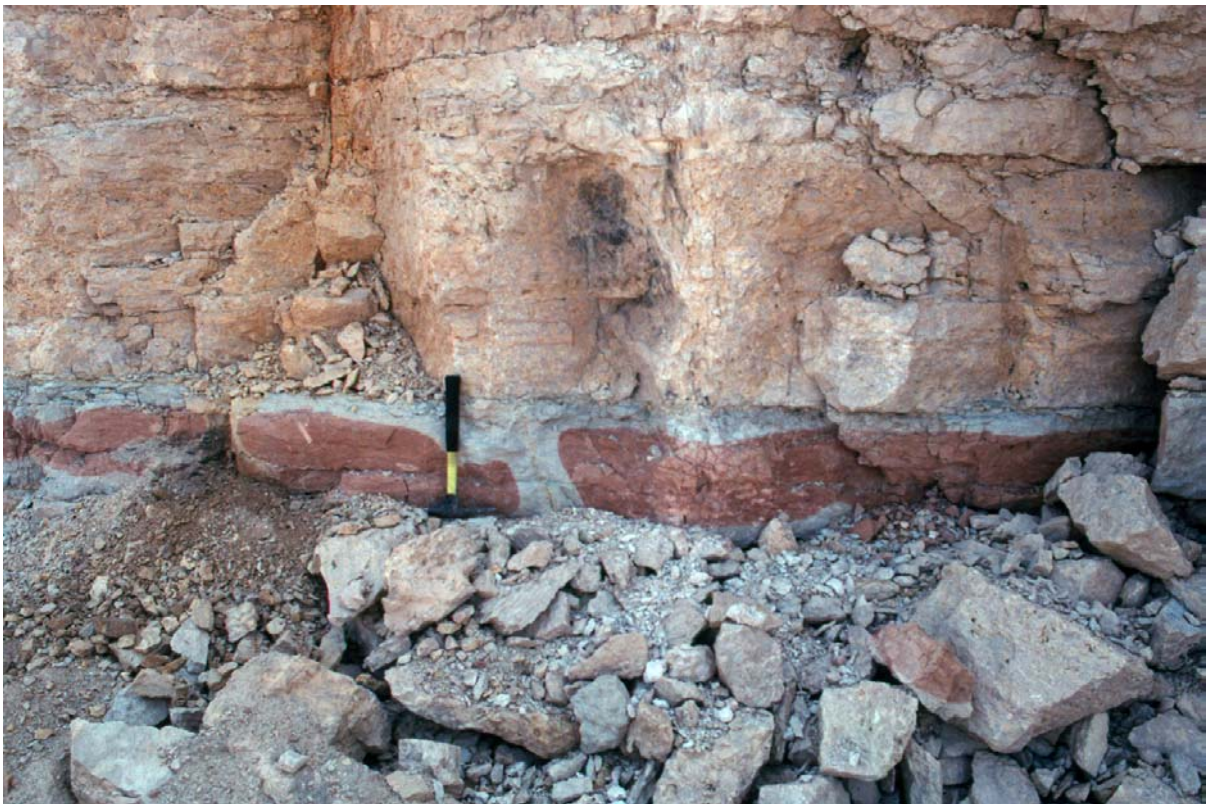
Bison 04 - 1995-06-27, Contact of Gunton Member overlying Penitentiary Member of the Stony Mountain Formation. Hammer just below contact.

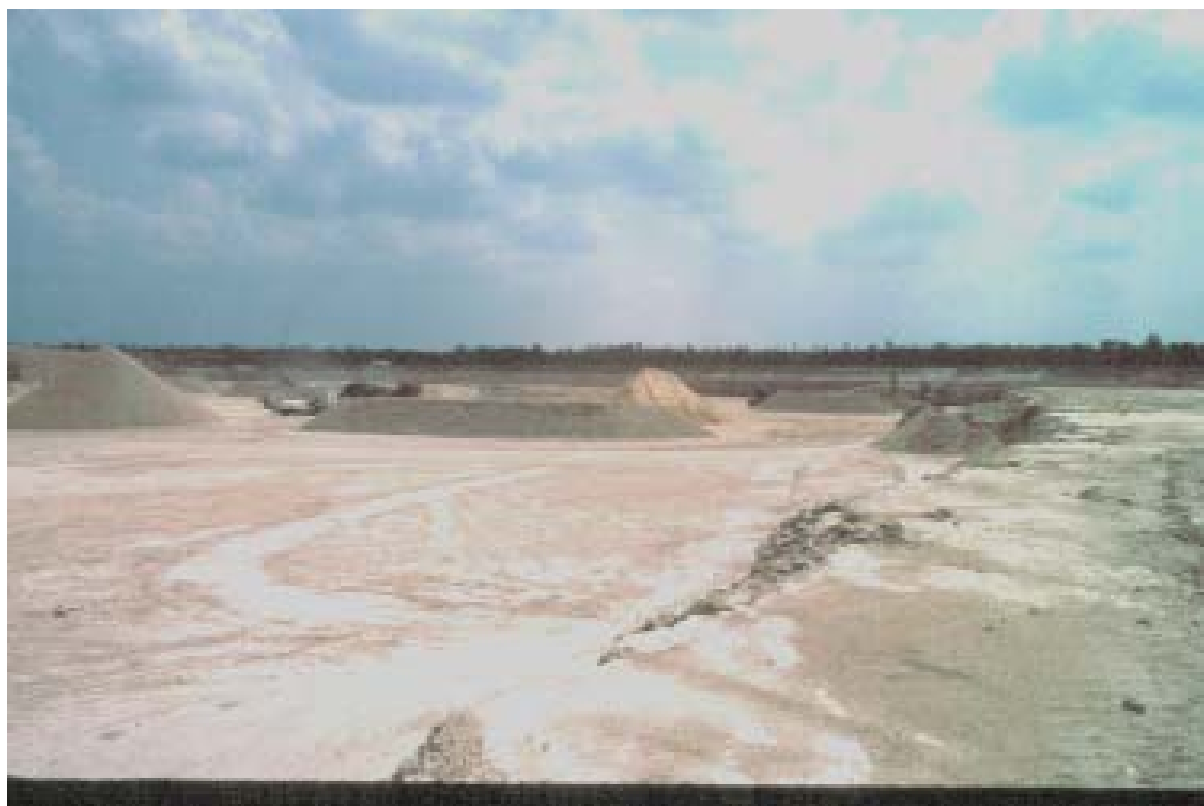
Bison 06 - 1995-06-27, Bison Quarry. Gunton Member of the Stony Mountain Formation. View looking southwest.

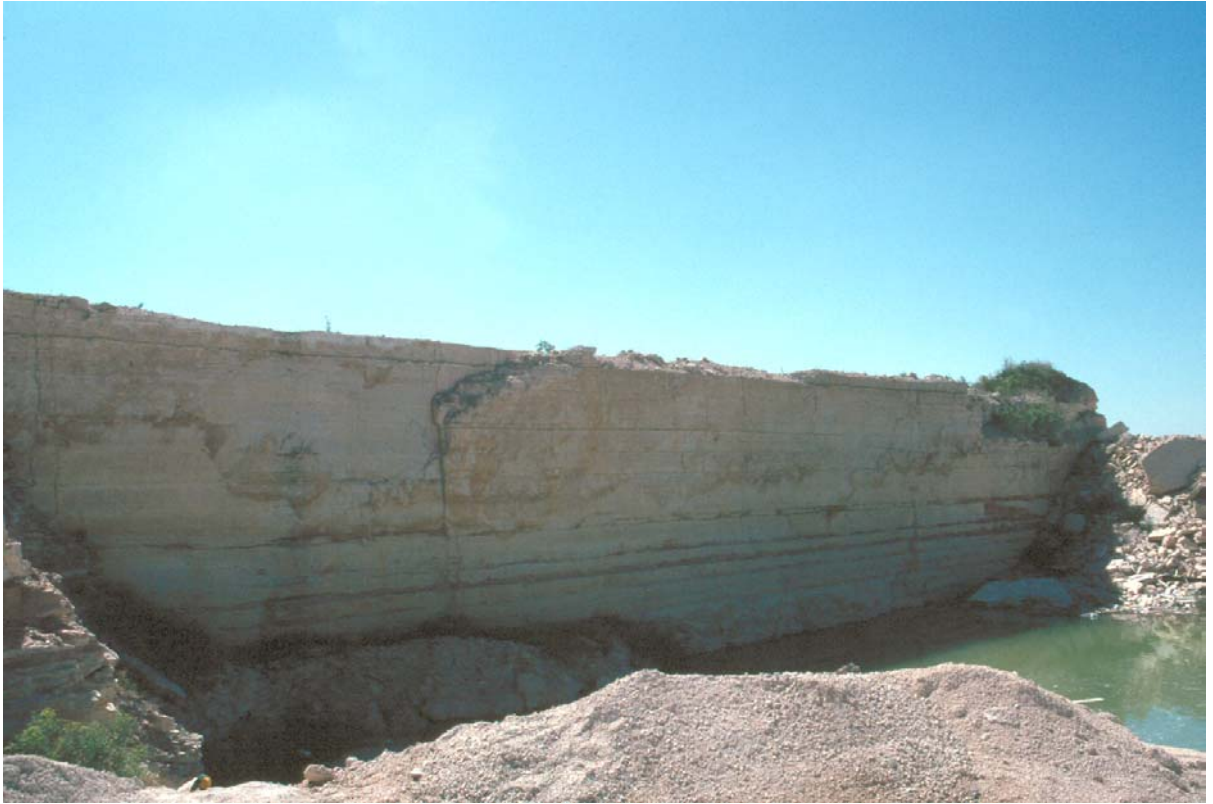
Standard 01 - 1995-07-12, Gunton Member overlying the Penitentiary Member of the Stony Mountain Formation. East wall of quarry near the northeast end.

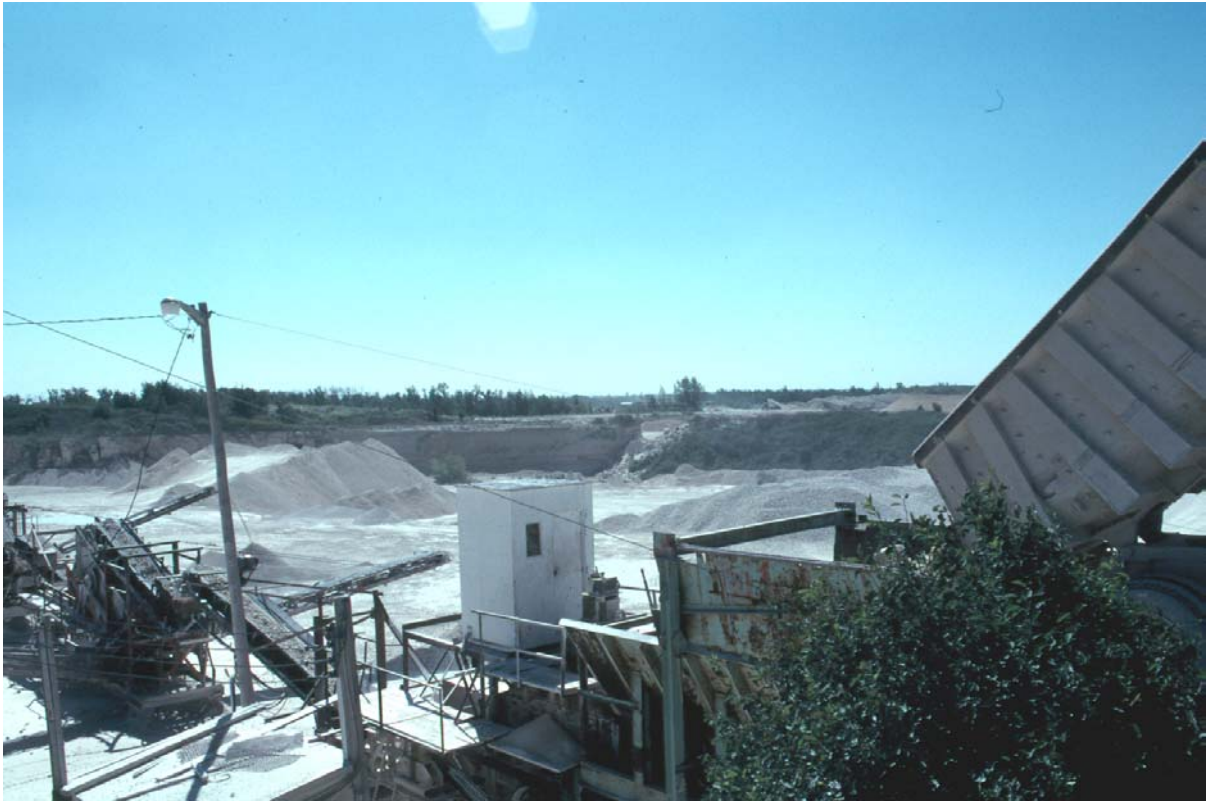
Standard 02 - 1995-07-12, Crusher and sorter at Standard Quarry South.
