## Appendix 1: Bedrock Quarries in the Capital Region Study Area

**NAME:** BORLAND QUARRY SOUTH

### Borland Quarry South

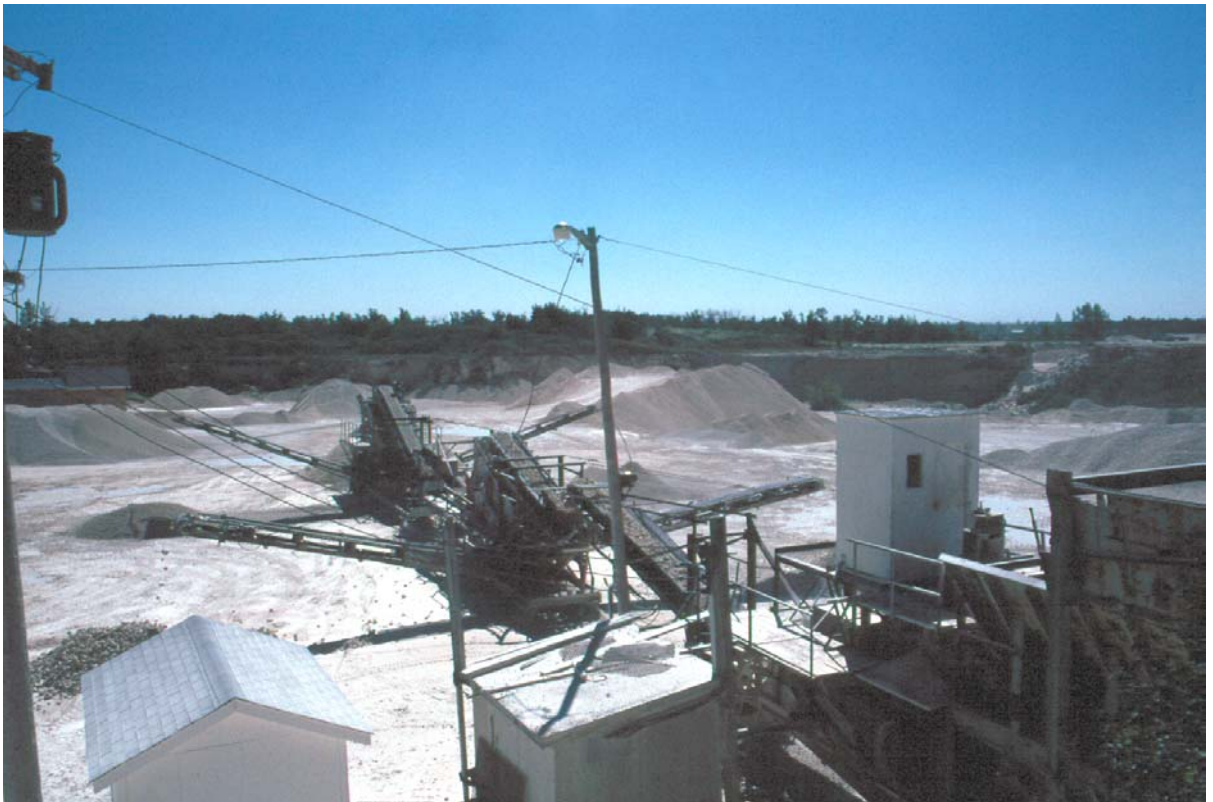
Standard 03 - 1995-07-12, Crusher and sorter at Standard Quarry South.

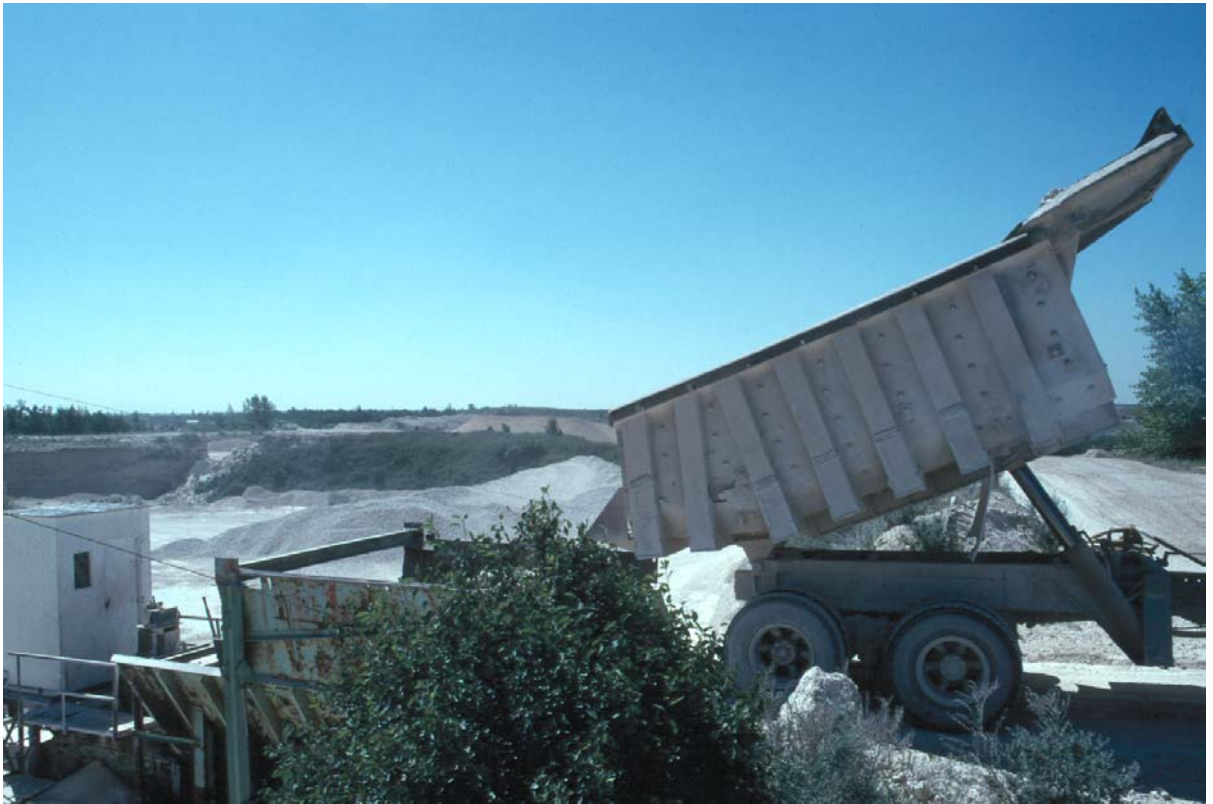
Standard 04 - 1995-07-12, Crusher and sorter at Standard Quarry South.

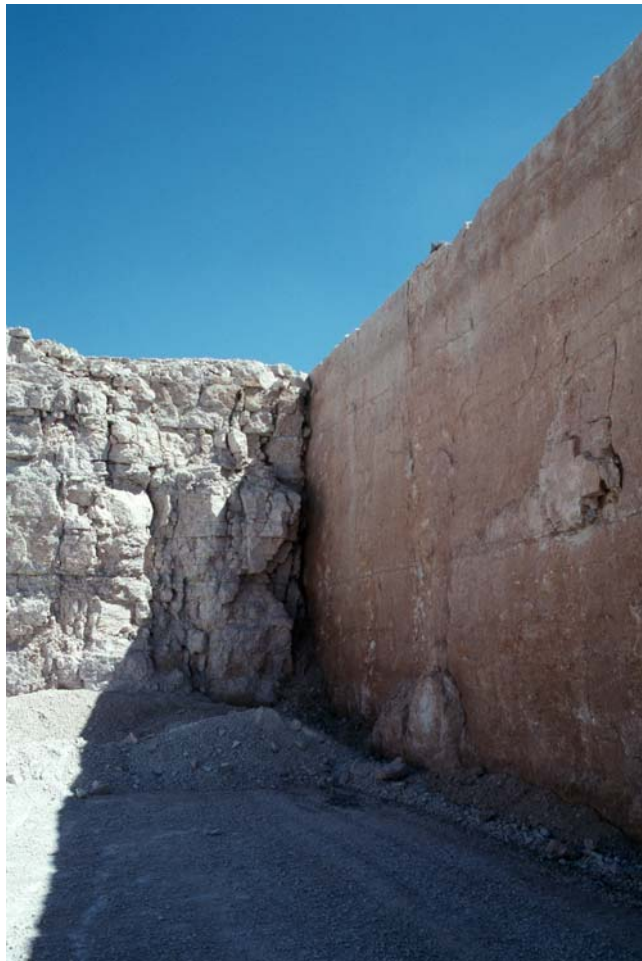
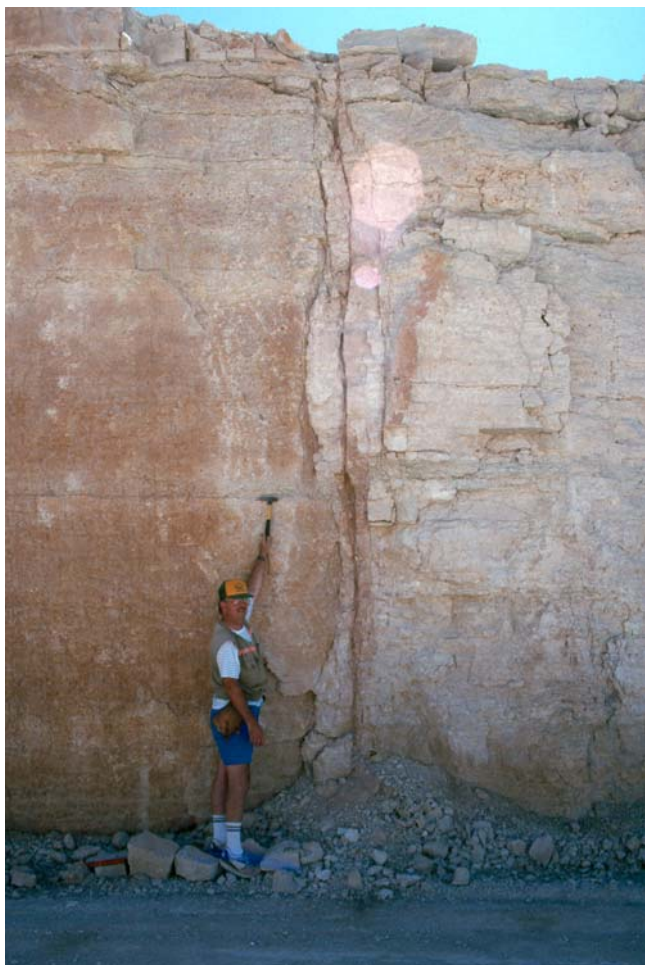
Standard 05 and 06 - 1995-07-12, Gunton Member of the Stony Mountain Formation. At south end of the quarry, view towards the north and northeast. Smooth fracture surface on east wall. JDB for scale.

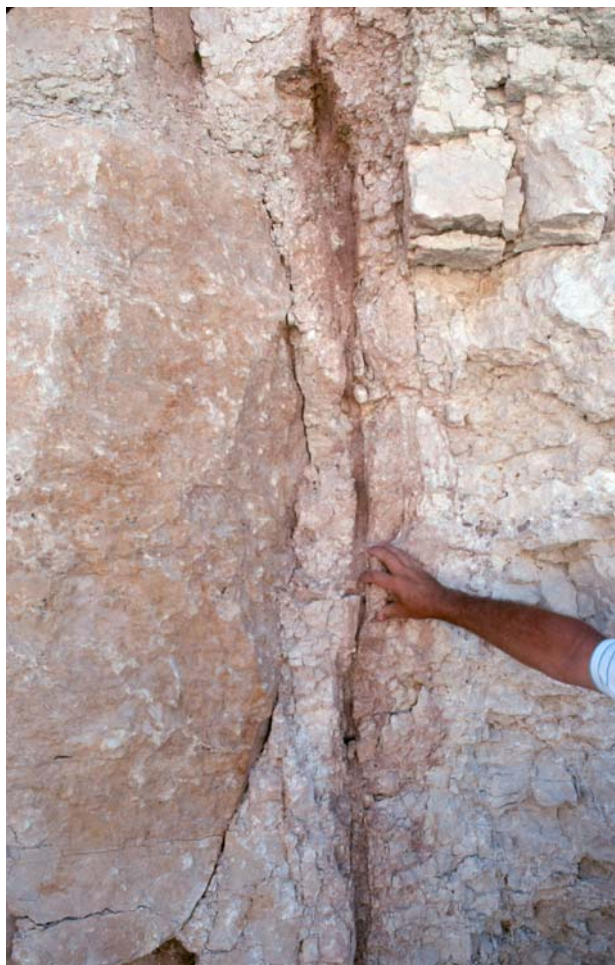
Standard 08 and 09 - 1995-07-12, Gunton Member of the Stony Mountain Formation. At south end of the quarry. East wall with smooth fracture surface. Horizontal joint at hammer head contains blue-green clay that may have been infilled from vertical joint to right (shown filled with red oxidized clay in close-up). JDB for scale.

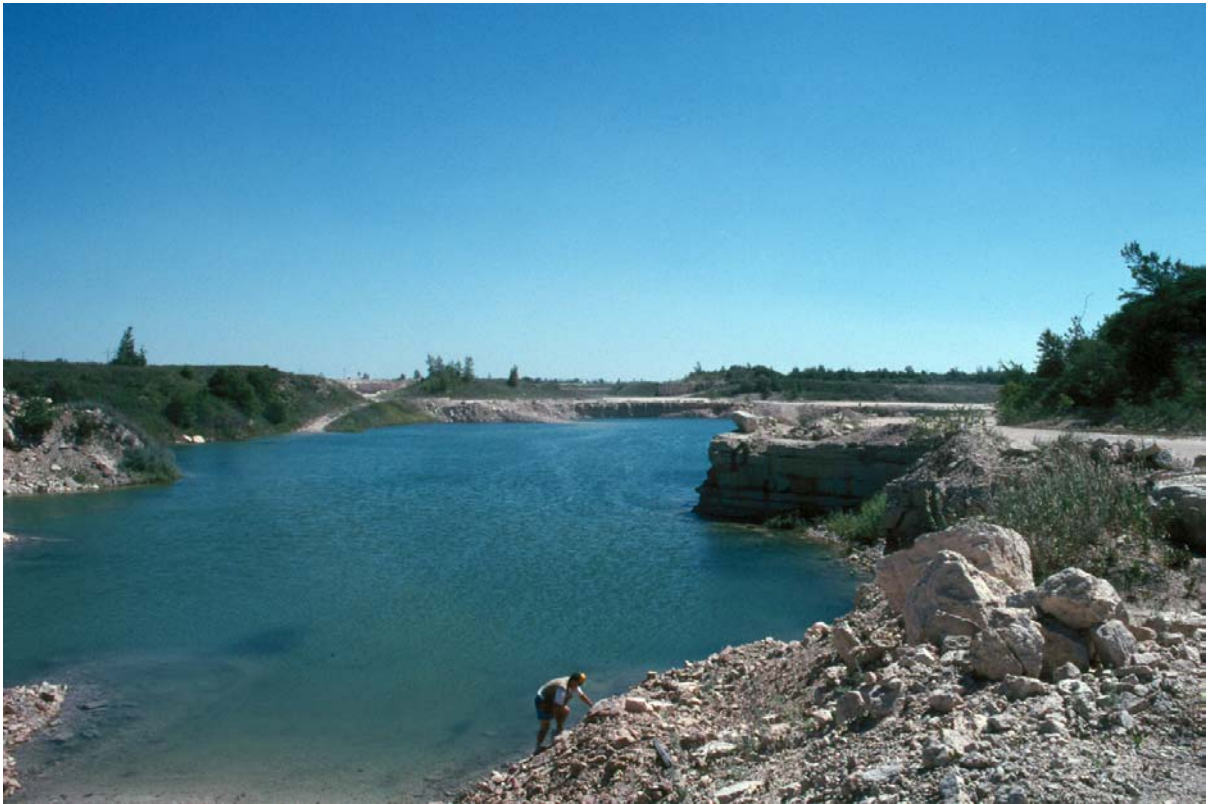
Standard 10 - 1995-07-12, Penitentiary Member of the Stony Mountain Formation in pit at the northwest corner of quarry. View towards the west. JDB for scale

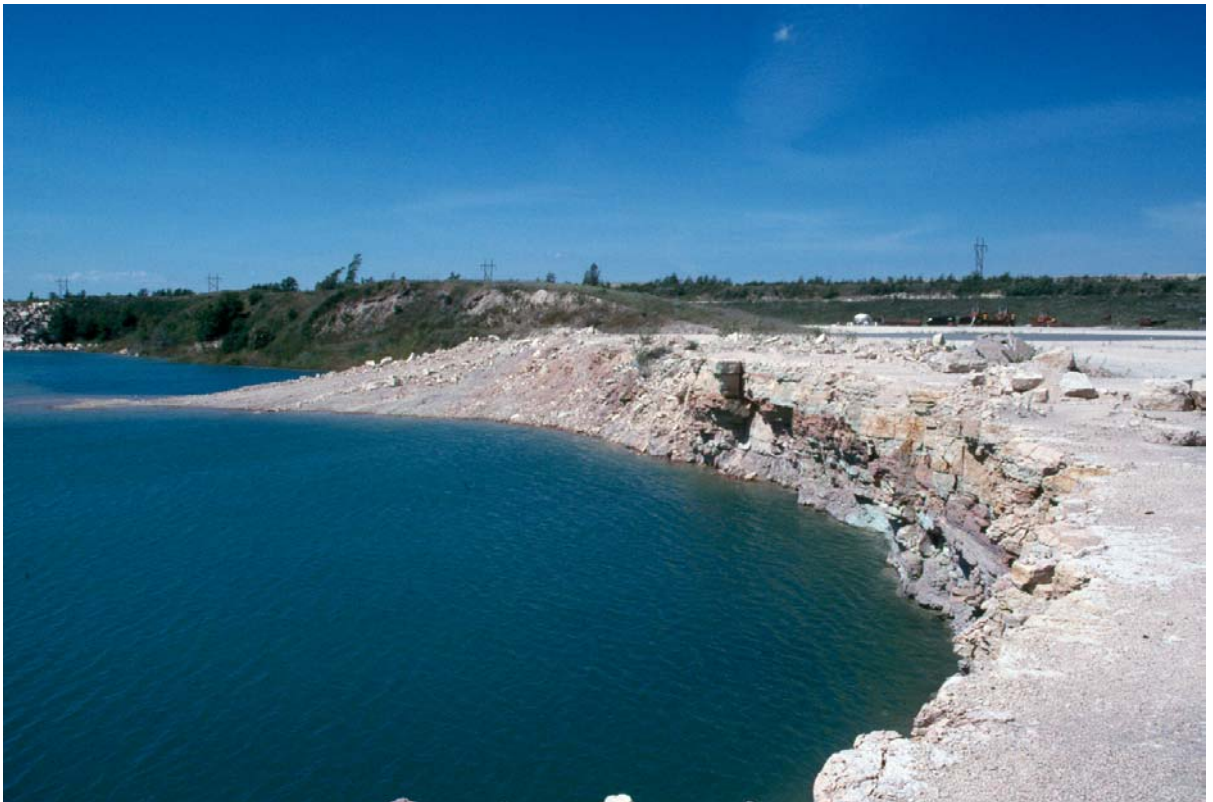
Standard 11 - 1995-07-12, Penitentiary Member of the Stony Mountain Formation in pit at the northwest corner of quarry. View towards the east.

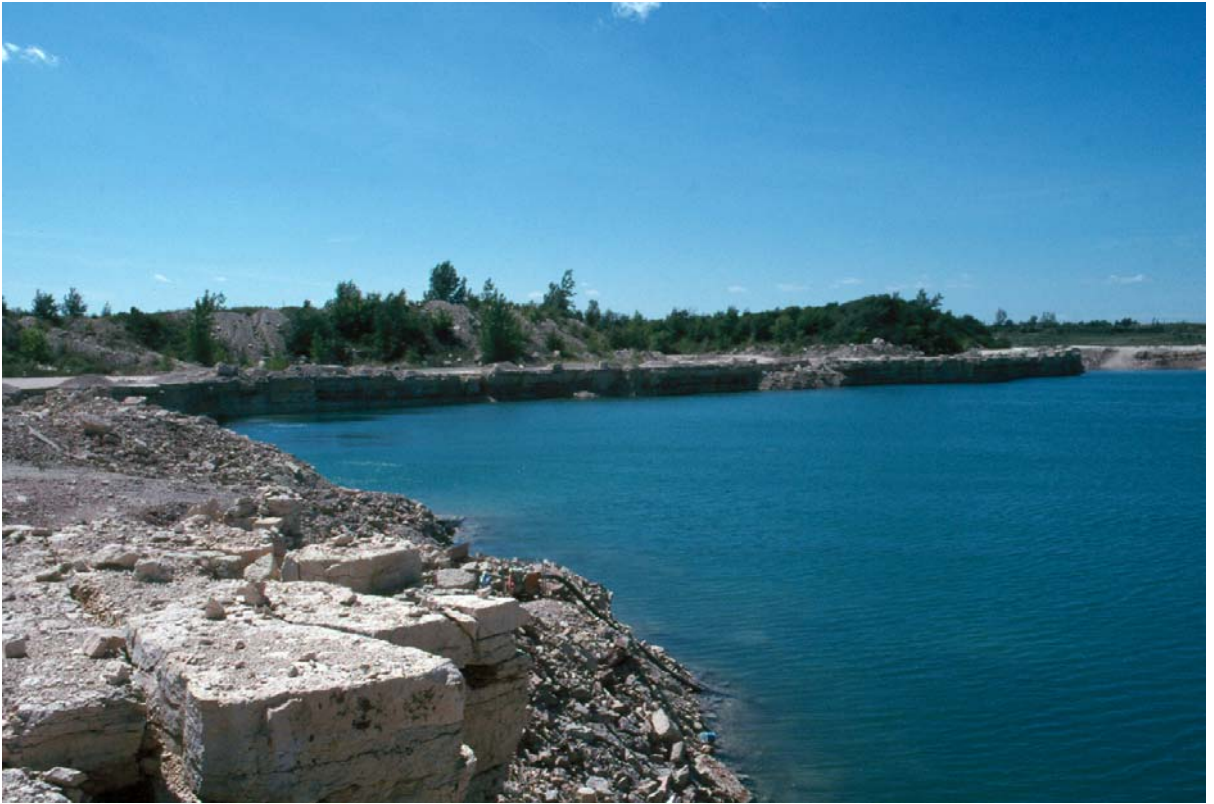
Standard 12 - 1995-07-12, Penitentiary Member of the Stony Mountain Formation in pit at the northwest corner of quarry. View towards the north.

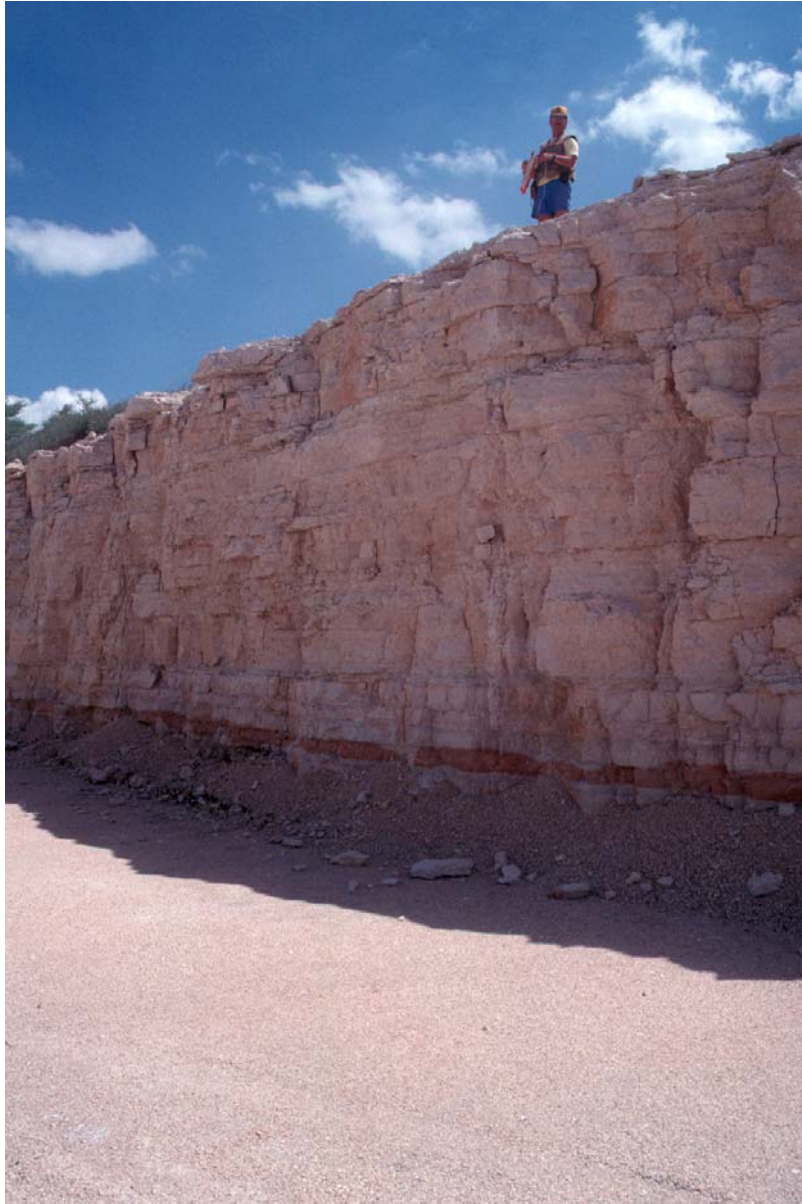
Standard North 01 – 1995-05-13, Gunton Member overlying the Penitentiary Member of the Stony Mountain Formation. View towards the southeast. JDB for scale.

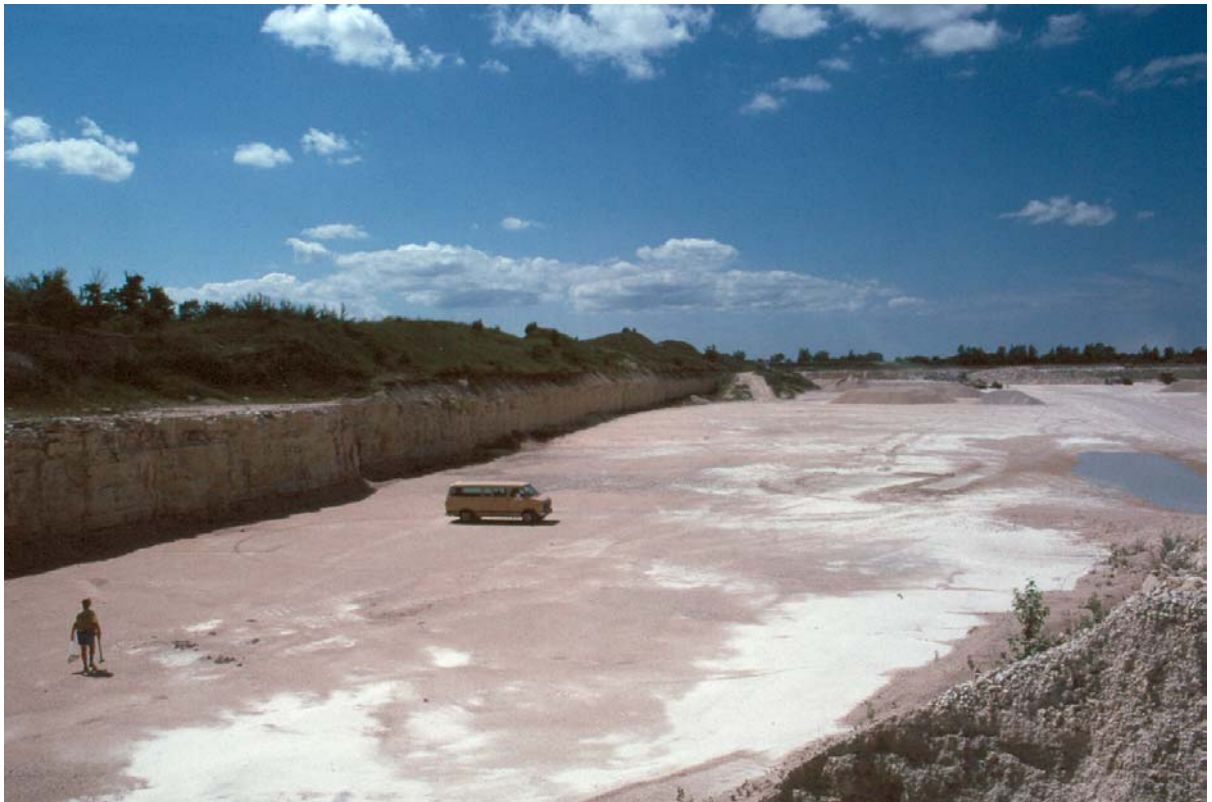
Standard North 02 – 1995-05-13, Gunton Member overlying the Penitentiary Member of the Stony Mountain Formation. View towards the southwest. JDB and van for scale.

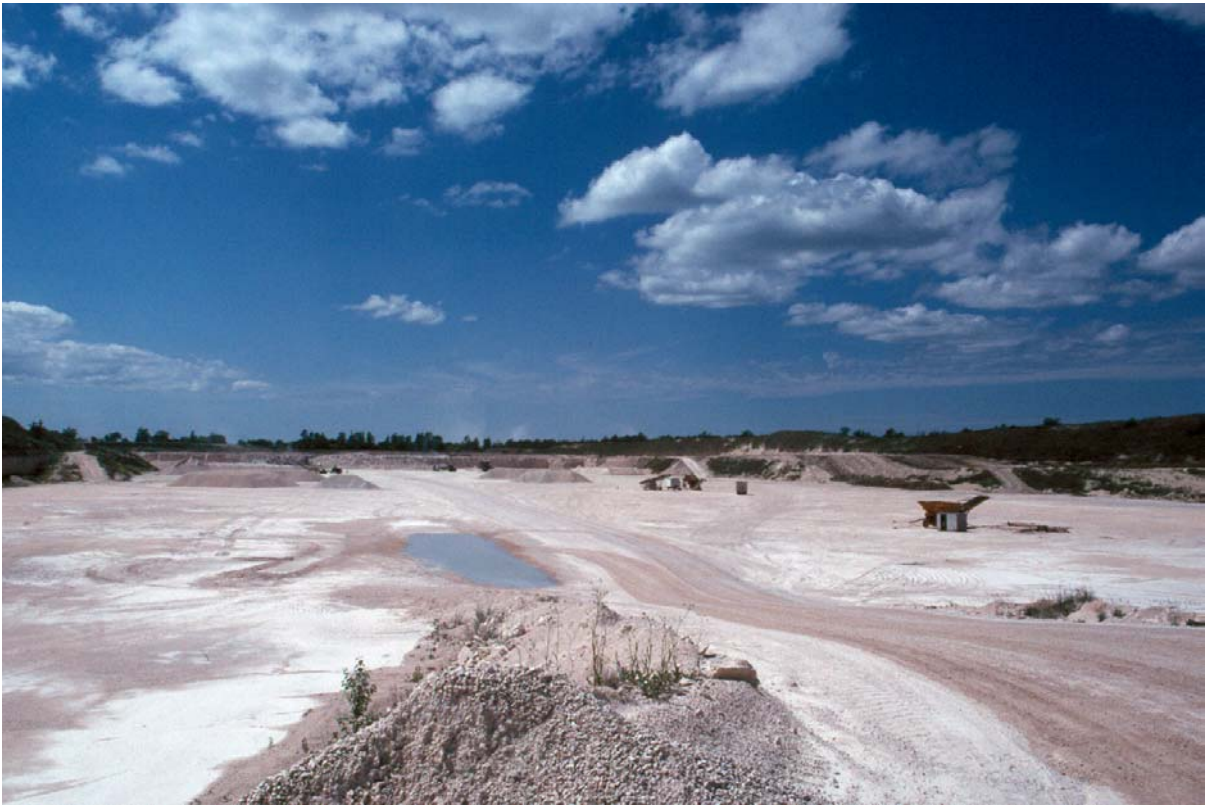
Standard North 03 – 1995-05-13, Gunton Member overlying the Penitentiary Member of the Stony Mountain Formation. View towards the west.

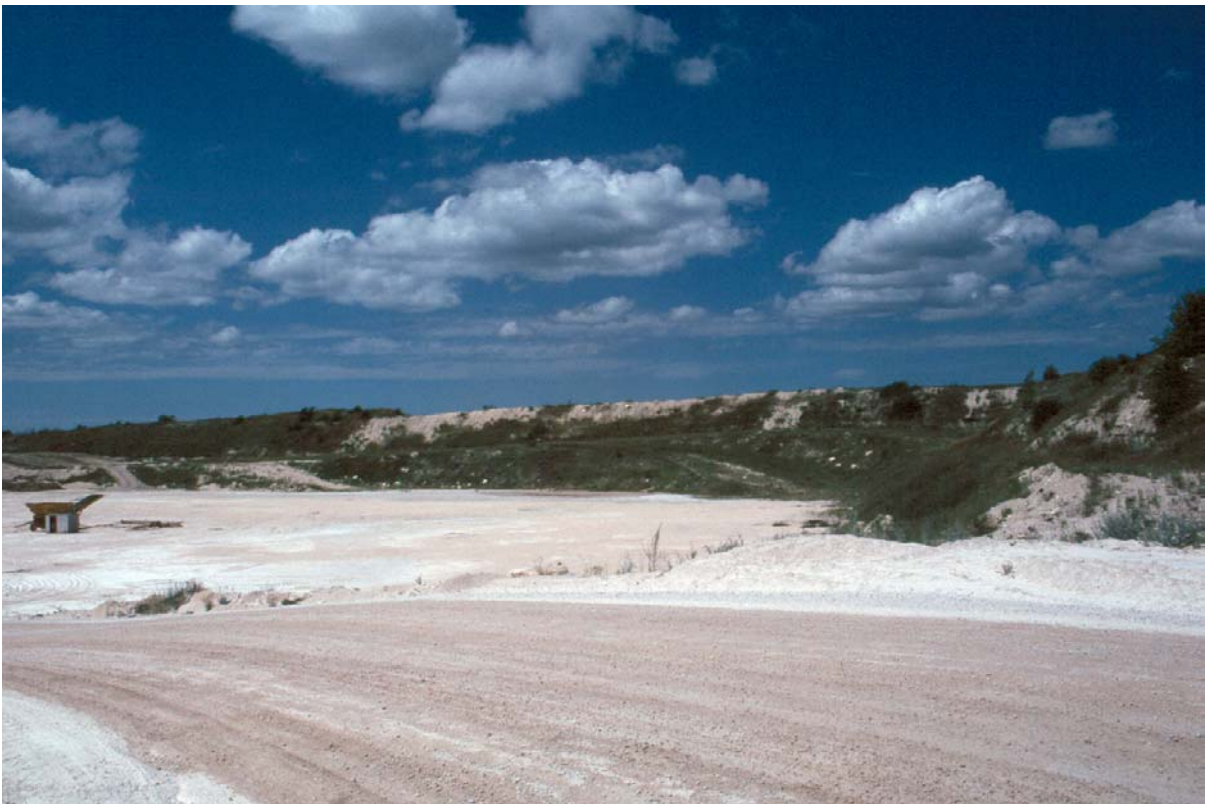
Standard North 04 – 1995-05-13, Gunton Member overlying the Penitentiary Member of the Stony Mountain Formation. View towards the northwest.

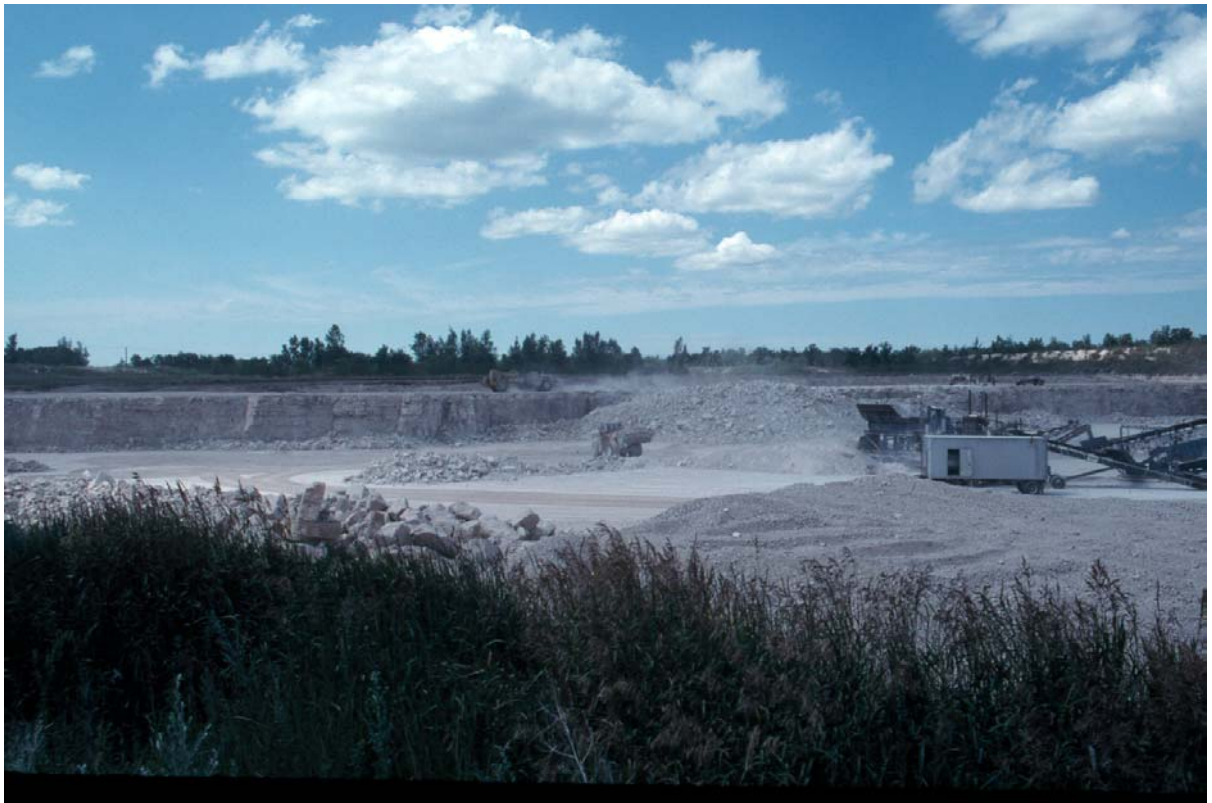
Standard North 05 – 1995-05-13, Gunton Member overlying the Penitentiary Member of the Stony Mountain Formation. View towards the southeast from the north wall.

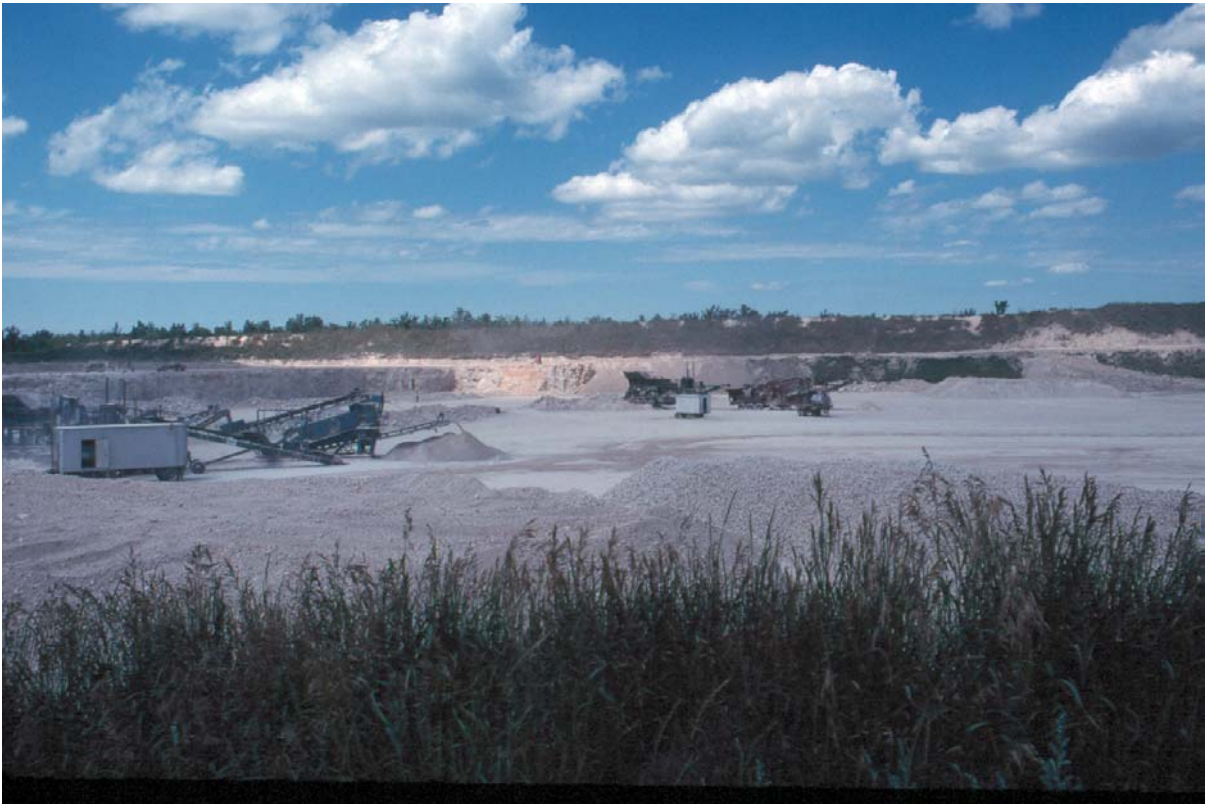
Standard North 06 – 1995-05-13, Gunton Member overlying the Penitentiary Member of the Stony Mountain Formation. View towards the south from the north wall.

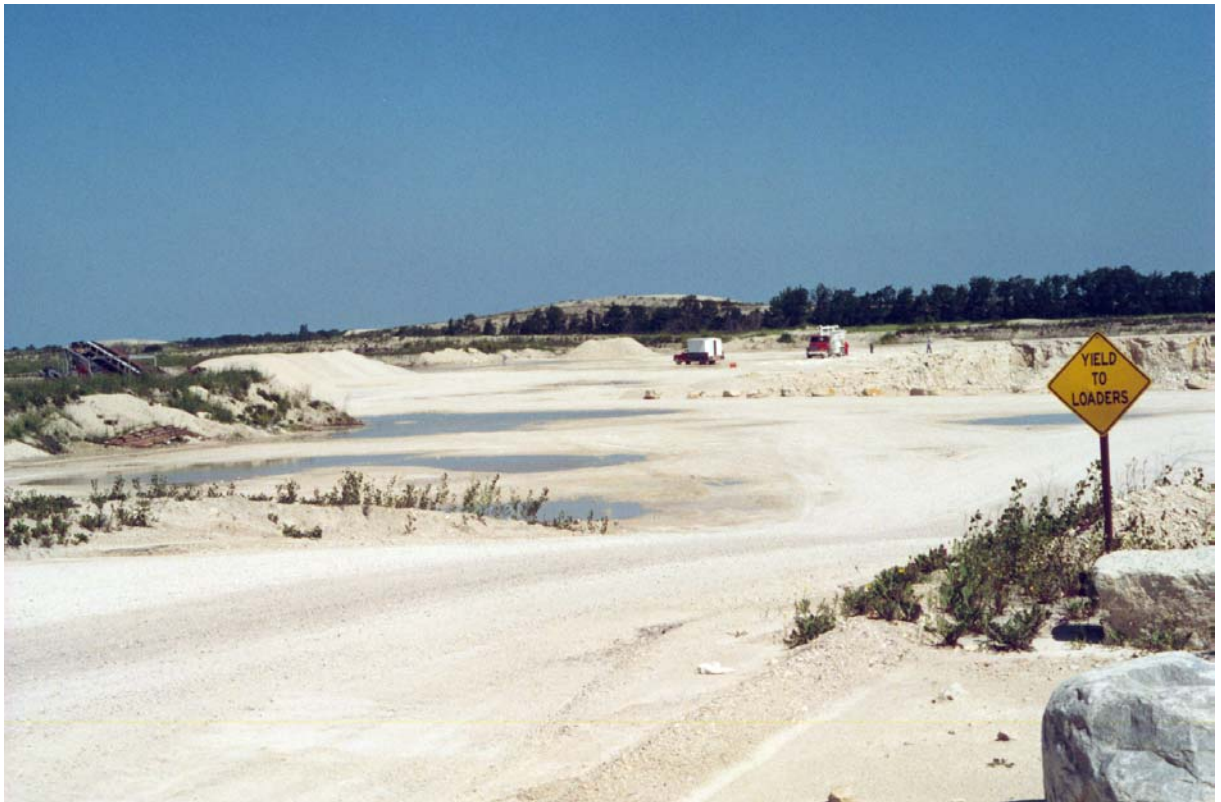
Standard 13 – 2000-07-13, Gunton Member of the Stony Mountain Formation. View towards the north.

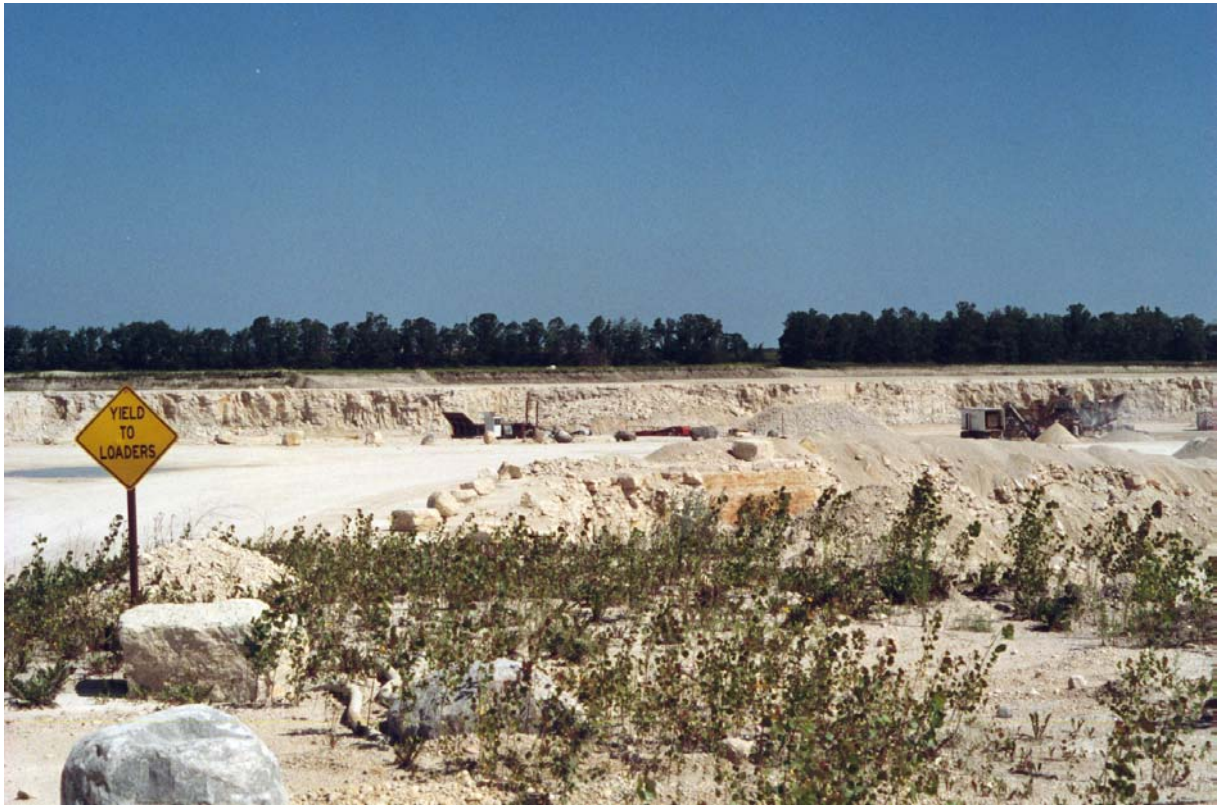
Standard 14 – 2000-07-13, Gunton Member of the Stony Mountain Formation. View towards the northeast.

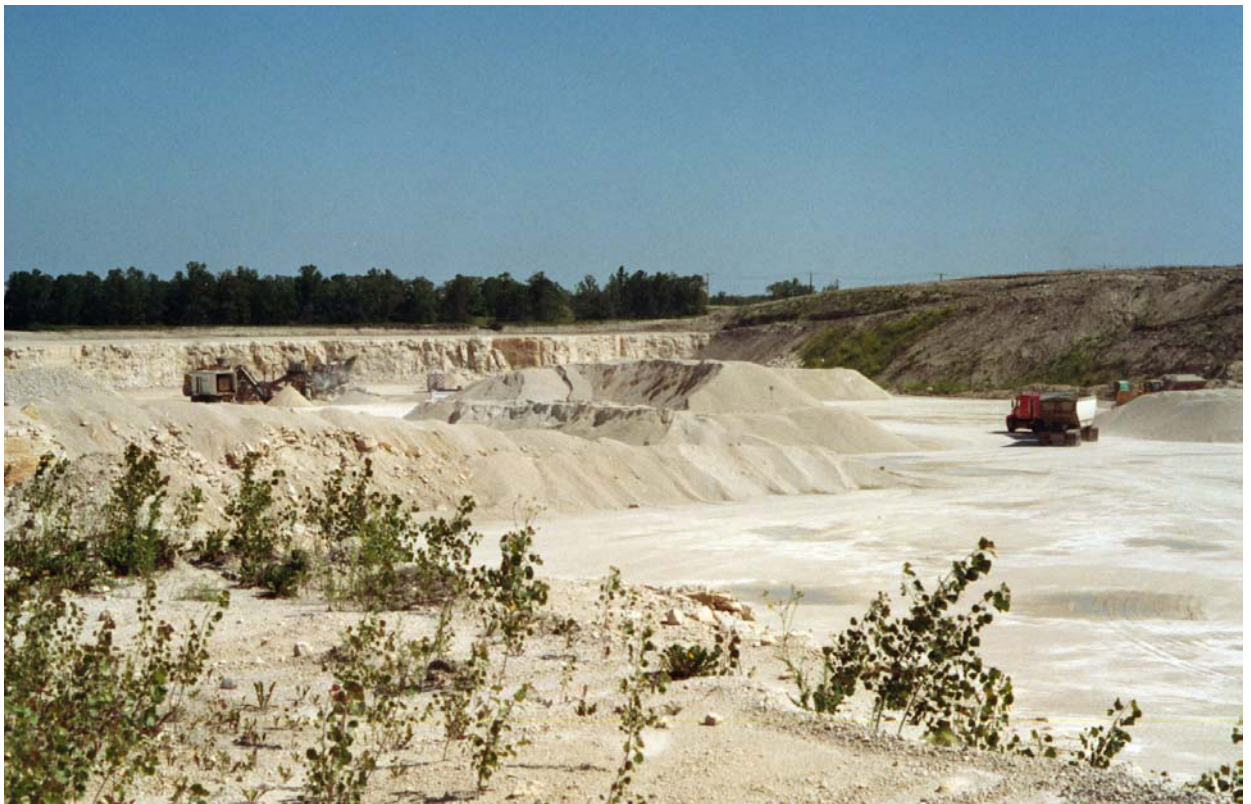
Standard 15 – 2000-07-13, Gunton Member of the Stony Mountain Formation. View towards the east.

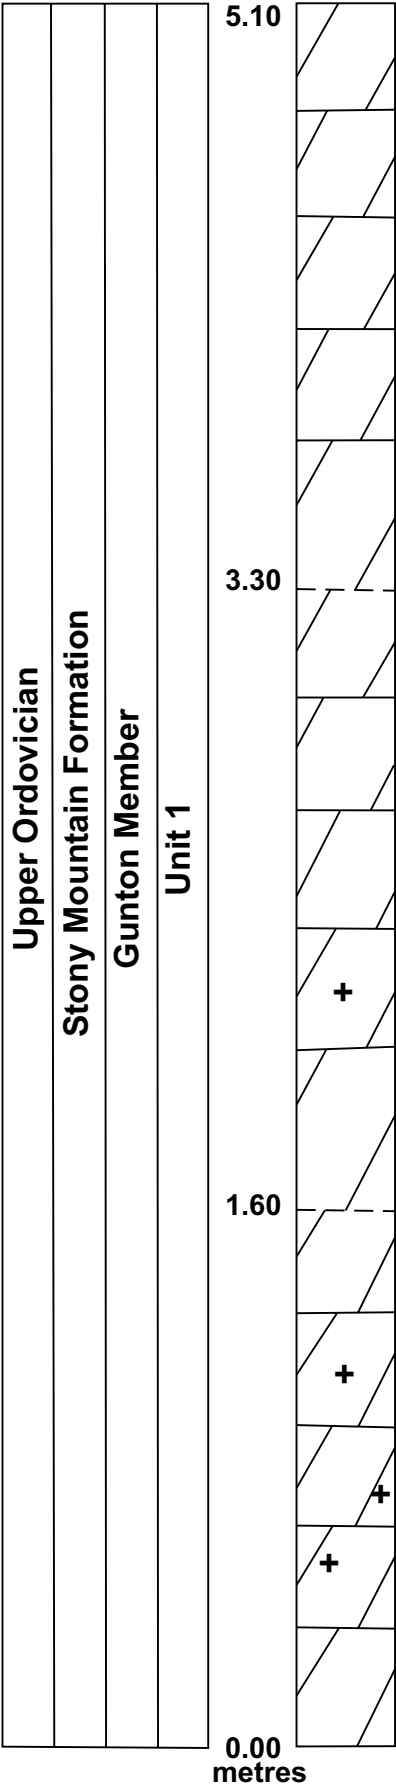
Gillies Quarry

Dolomite;buff brown (weathered and fresh); wackestone; slightly mottled; medium to thick bedded; fine - medium crystalline; 5-10% porosity - vuggy (very well developed); blocky fractures; possible salt clasts (<1cm)

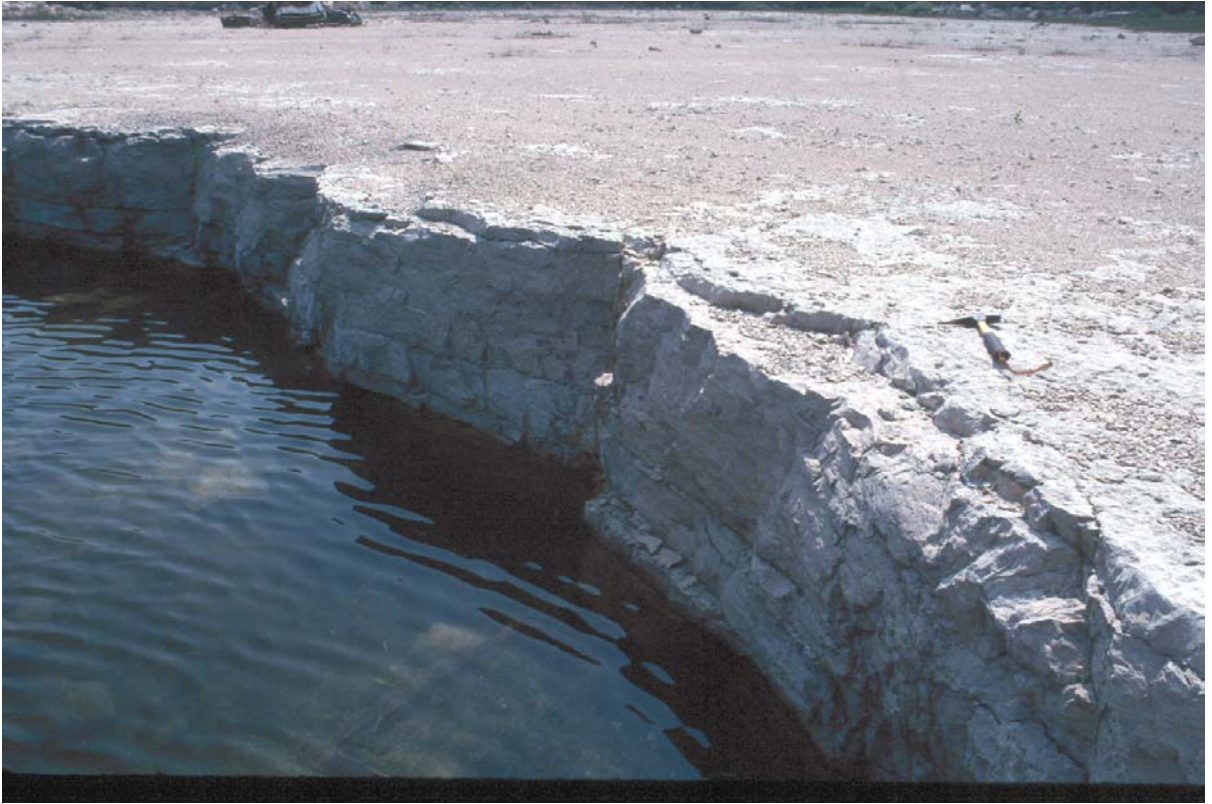
Gillies 01 – 1995-07-28, Penitentiary Member of the Stony Mountain Formation. Water filled. View towards the southeast.

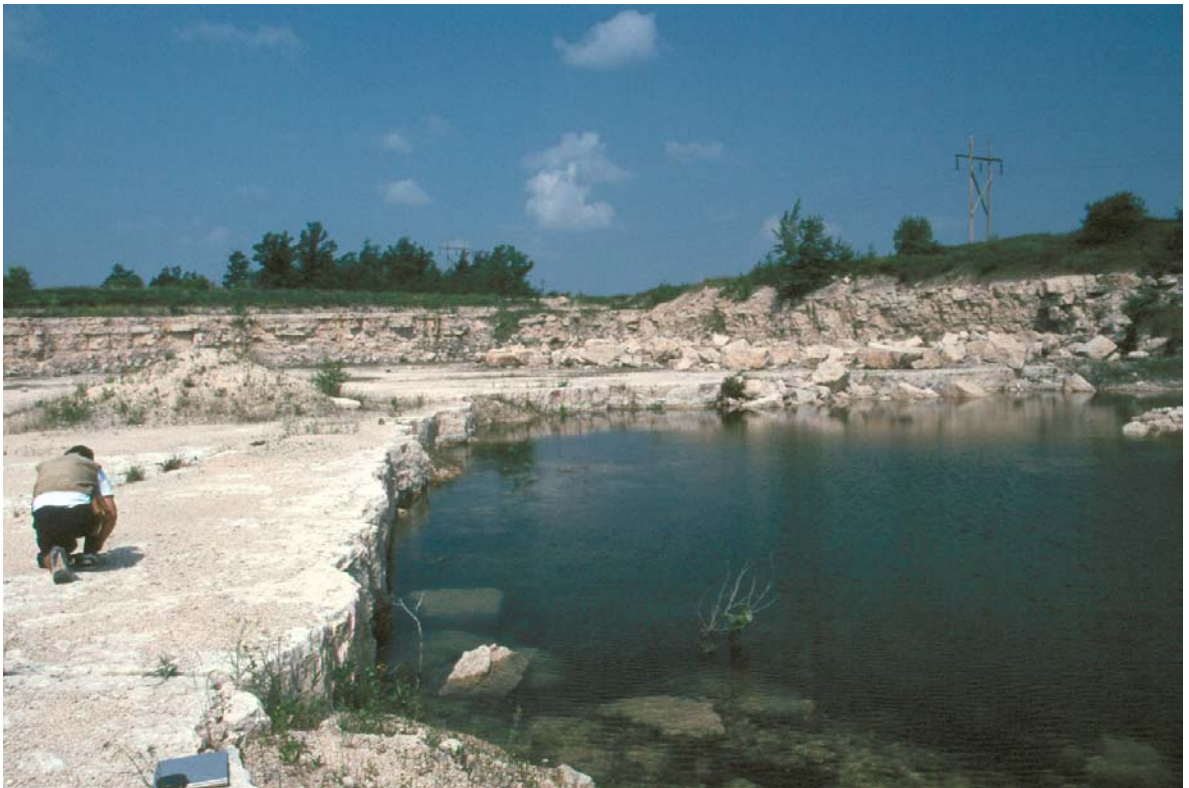
Gillies 02 – 1995-07-28, Gillies Pit in the Penitentiary Member of the Stony Mountain Formation. Water filled. Bench is top of Penitentiary Member, in background is the Gunton Member. View towards the northwest.

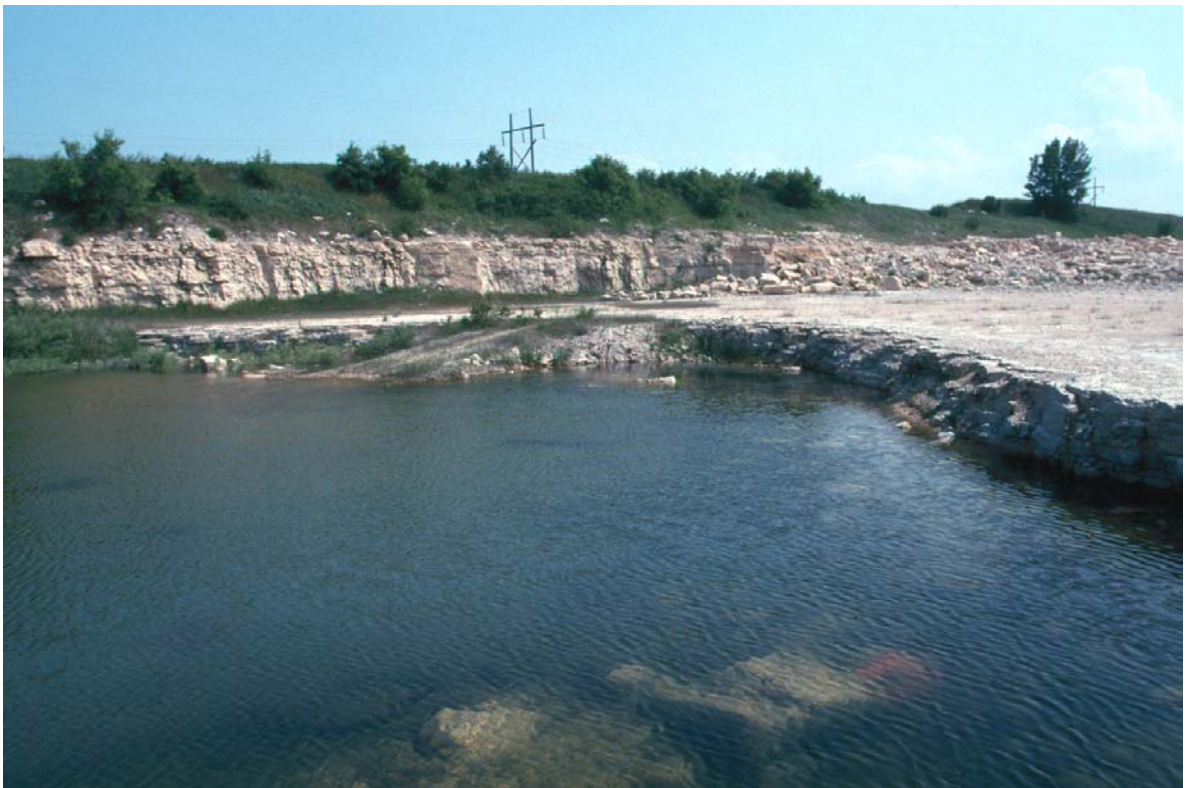
Gillies 03 – 1995-07-28, Gillies Pit in the Penitentiary Member of the Stony Mountain Formation. Water filled. Bench is top of Penitentiary Member, in background is the Gunton Member. View towards the north.

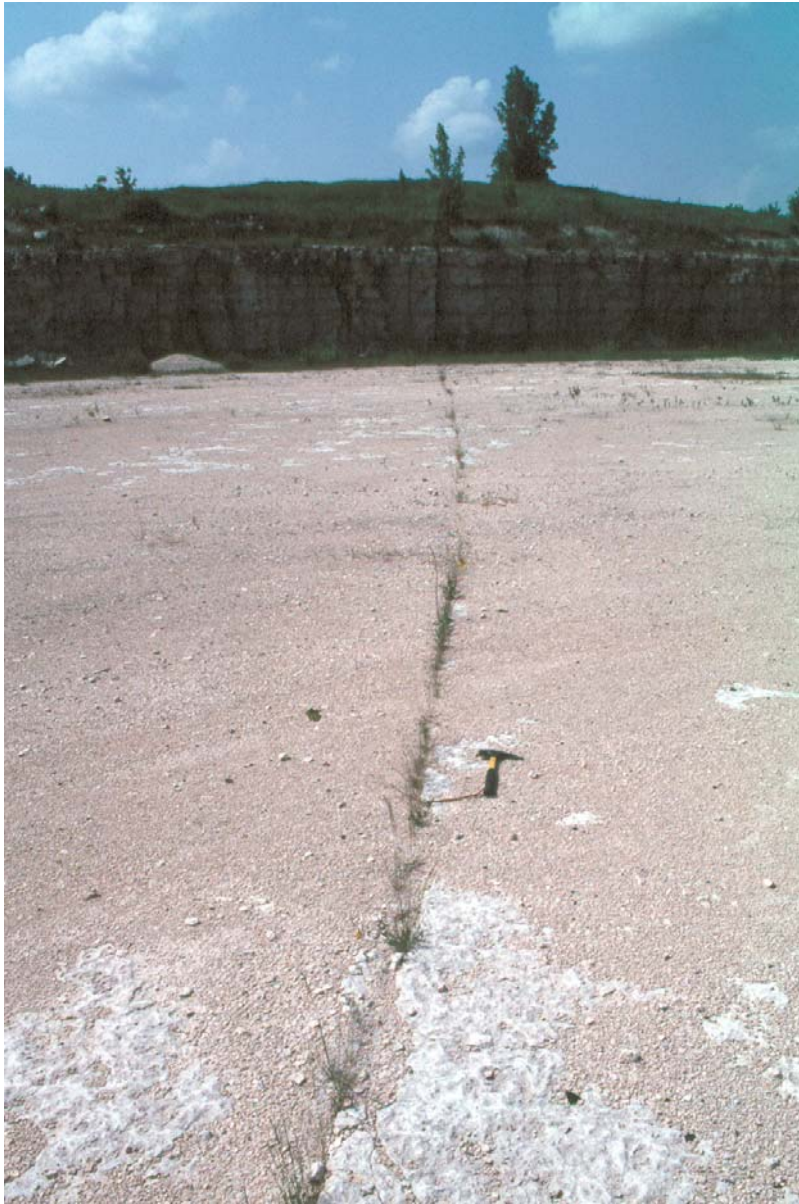
Gillies 04 – 1995-07-28, Major fracture in the Gunton Member of the Stony Mountain Formation. View towards the north.

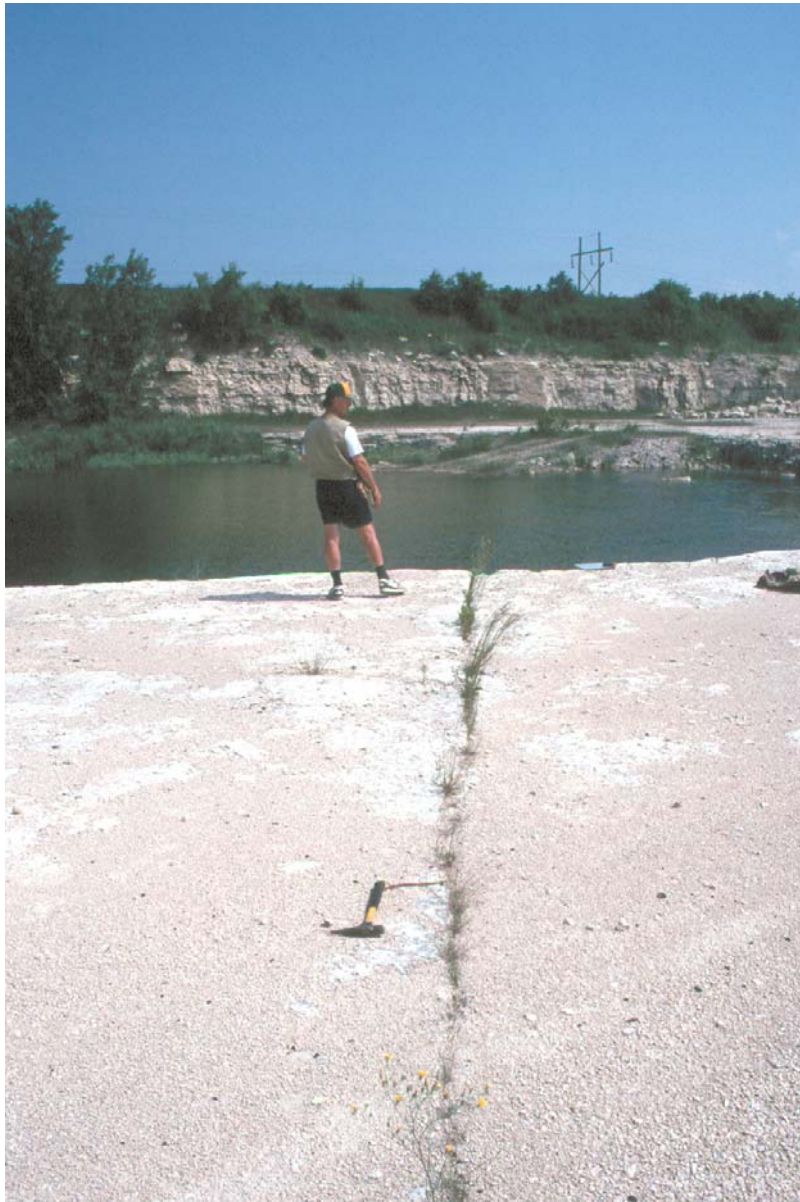
Gillies 05 – 1995-07-28, Major fracture in the Gunton Member of the Stony Mountain Formation. View towards the north. Water filled pit is in the Penitentiary Member. JDB for scale.

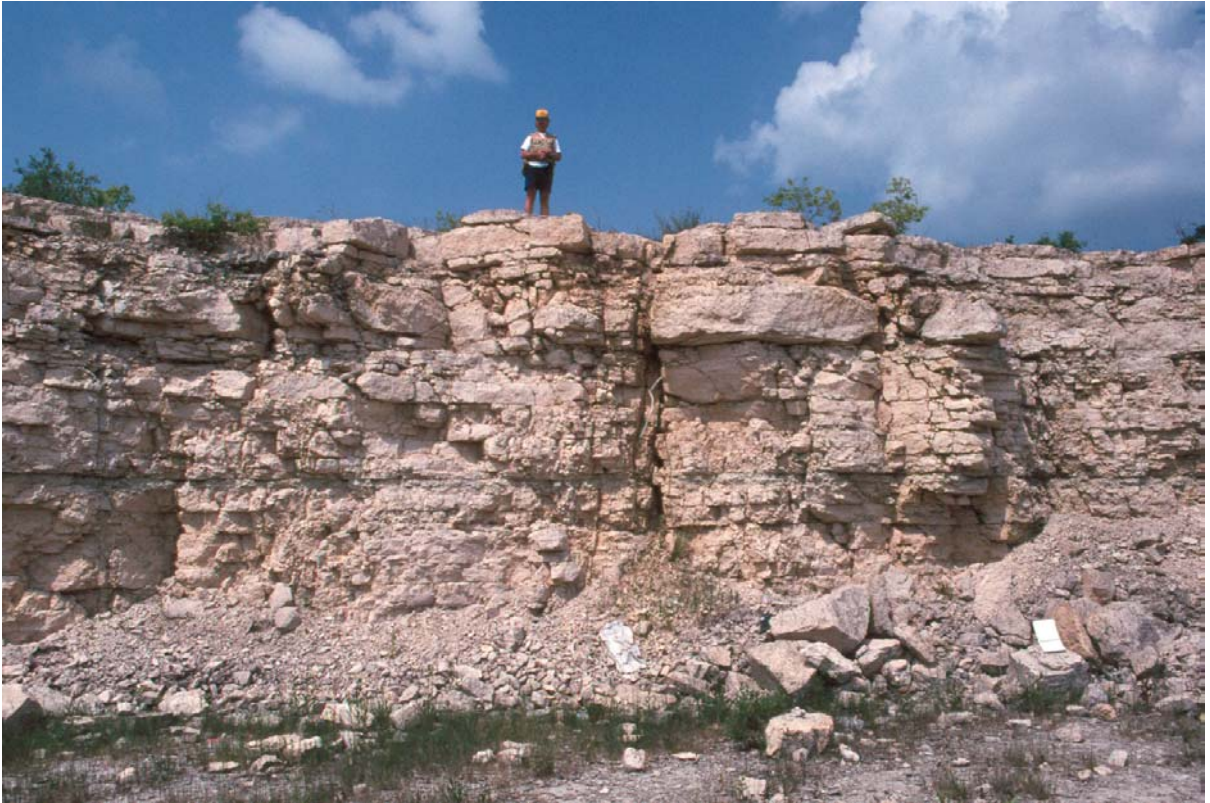
Gillies 06 – 1995-07-28, Guntion Member of the Stony Mountain Formation. West wall of Gillies Quarry. JDB for scale.
