## Appendix 1: Bedrock Quarries in the Capital Region Study Area

**NAME:** BORLAND QUARRY SOUTH

### Borland Quarry South

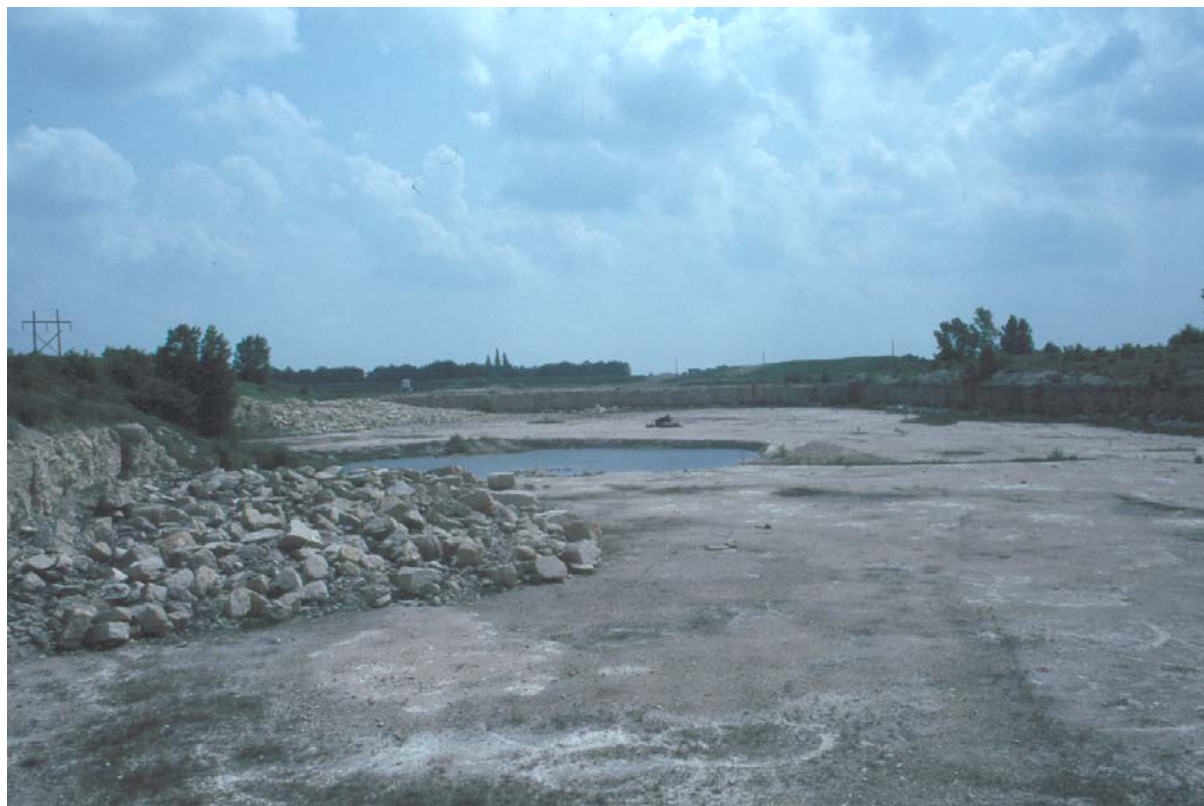
Gillies 09 – 1995-07-28, Gunton Member of the Stony Mountain Formation. View towards the east.

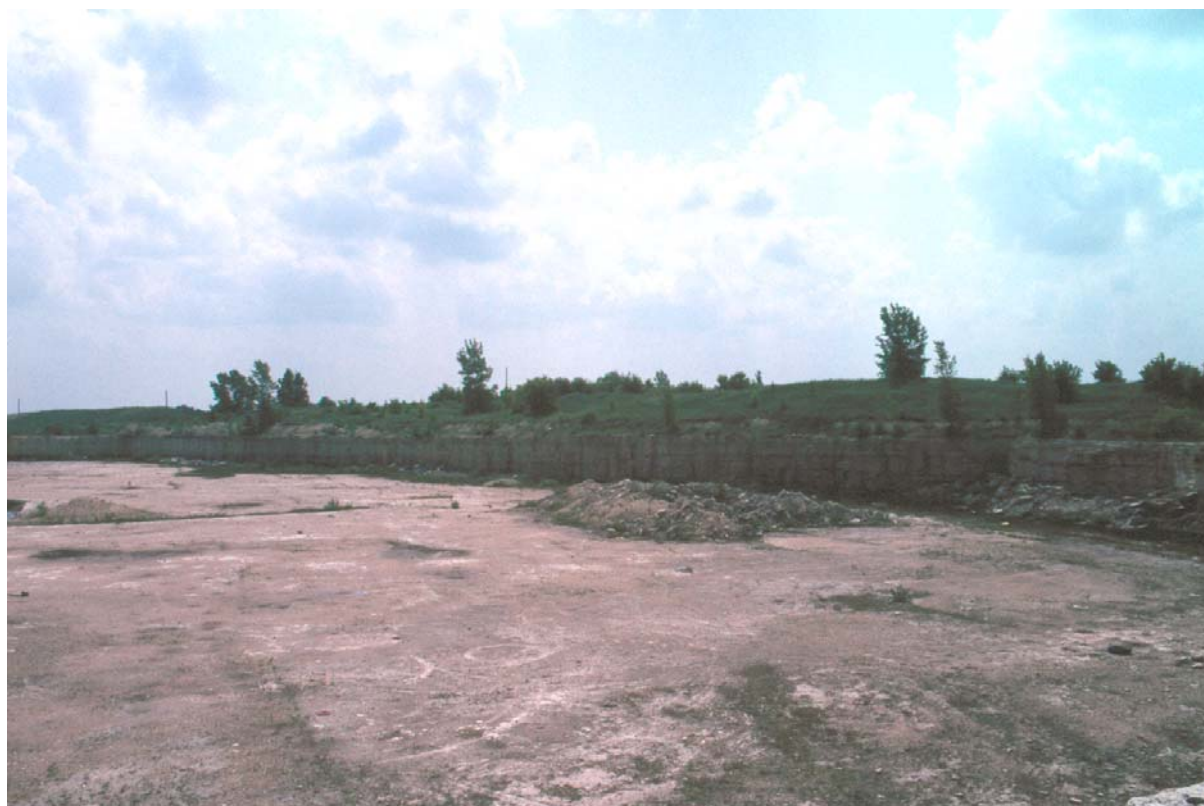
Gillies 08 – 1995-07-28, Gunton Member of the Stony Mountain Formation. View towards the southeast.

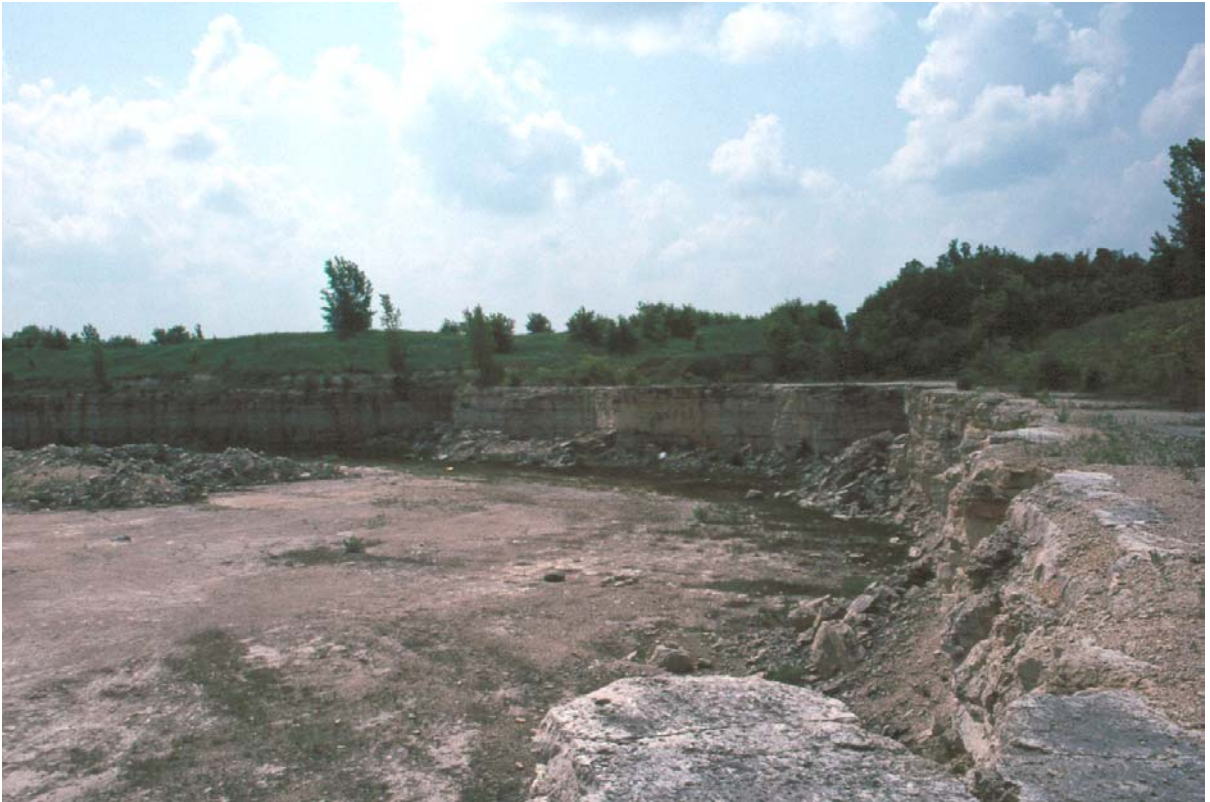
Gillies 09 – 1995-07-28, Gunton Member of the Stony Mountain Formation. View towards the south.

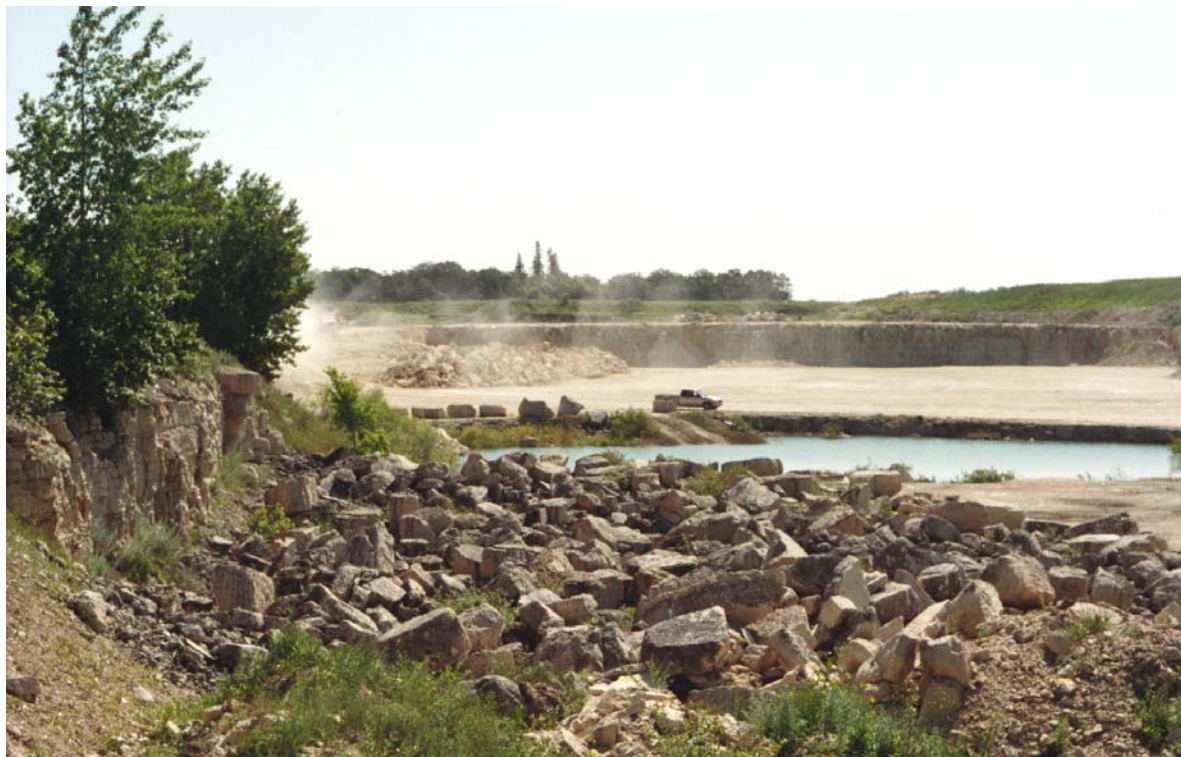
Gillies 11 – 199?-00-00, Gunton Member of the Stony Mountain Formation. View towards the east.

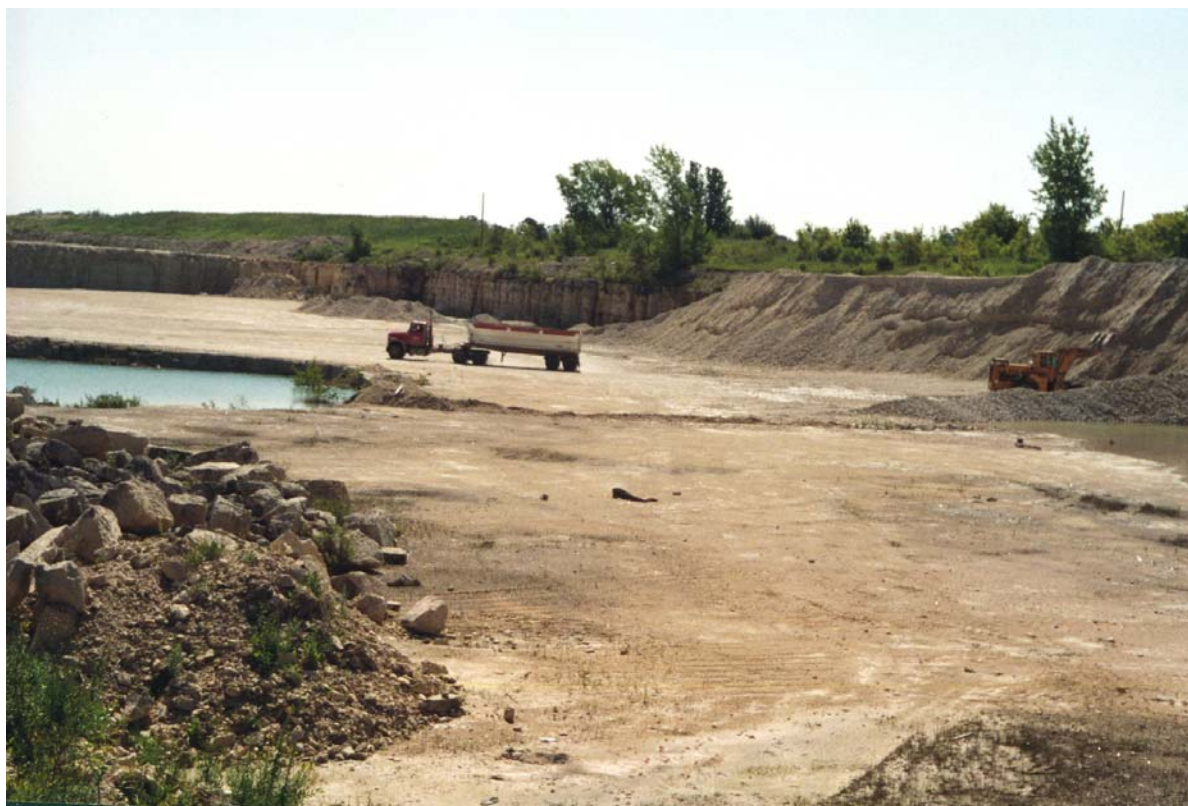
Gillies 10 – 199?-00-00, Gunton Member of the Stony Mountain Formation. View towards the southeast.

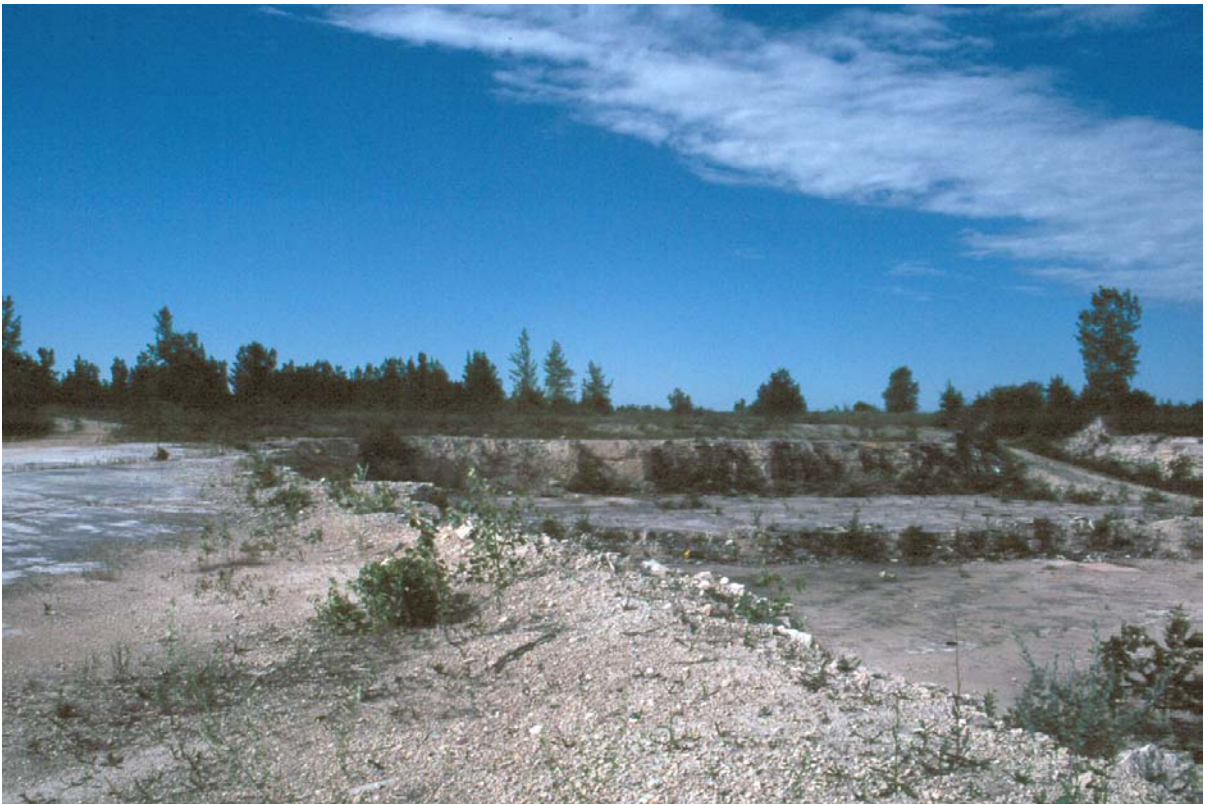
Whiterock 04 – 1995-05-13, Gunton Member of the Stony Mountain Formation. View towards the southwest.

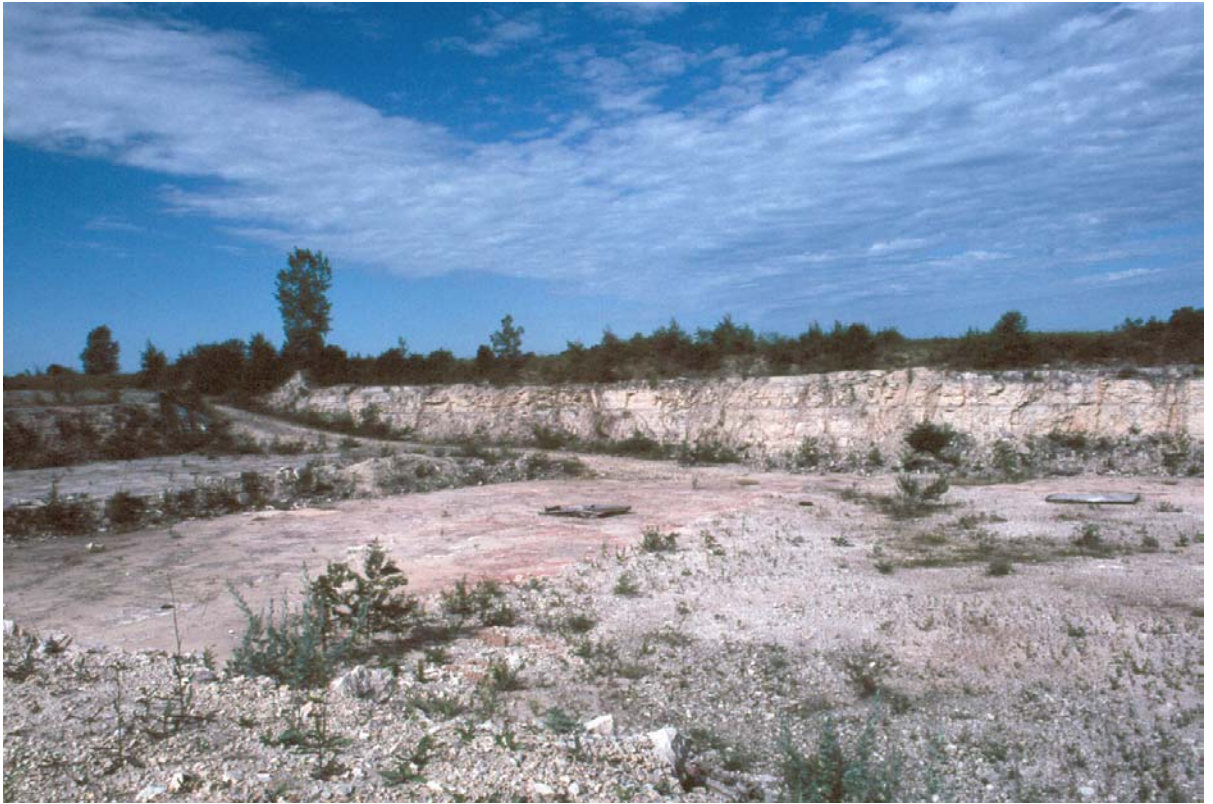
Whiterock 03 – 1995-05-13, Gunton Member of the Stony Mountain Formation. View towards the west-southwest.

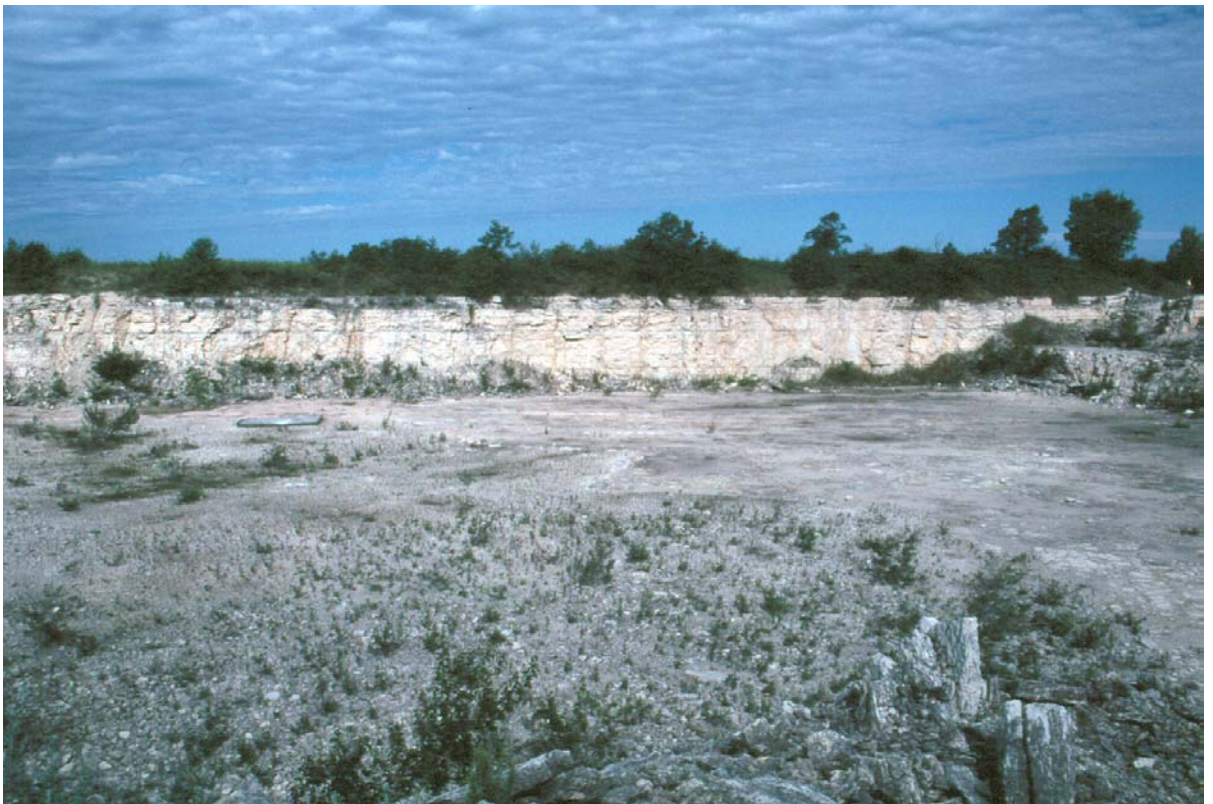
Whiterock 02 – 1995-05-13, Gunton Member of the Stony Mountain Formation. View towards the west-northwest.

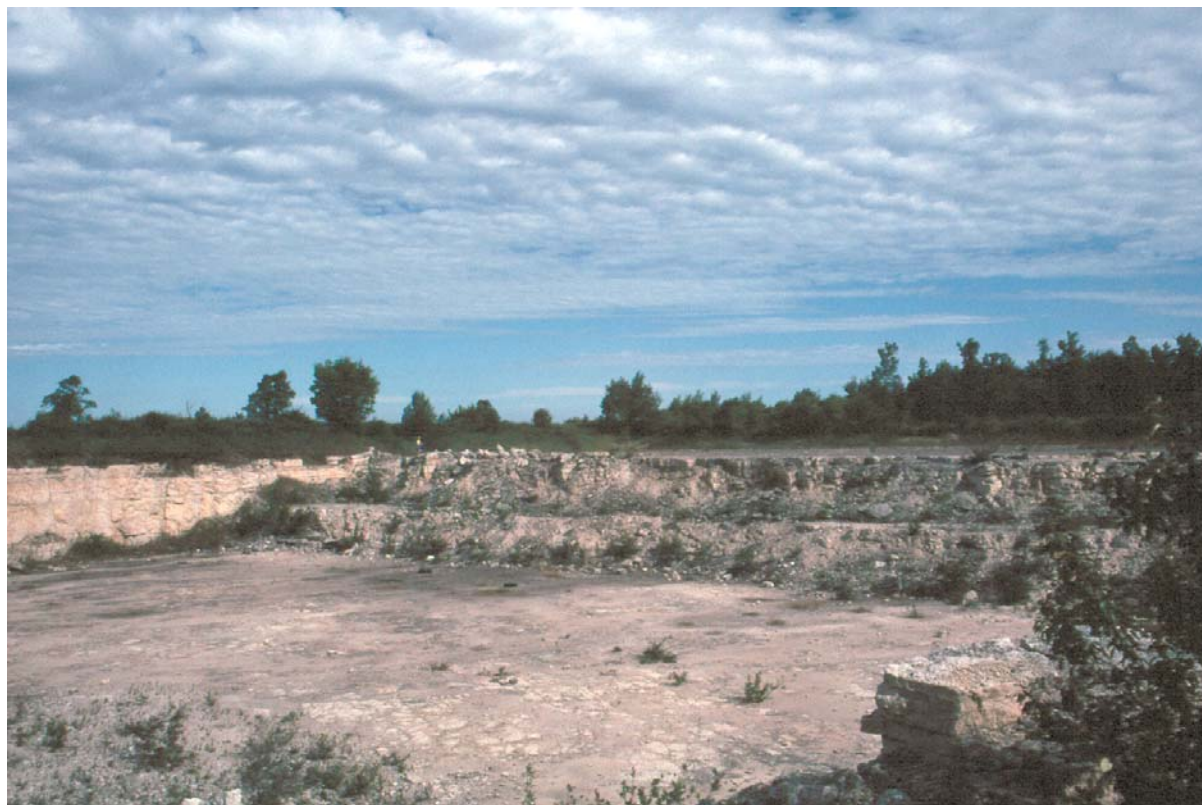
Whiterock 01 – 1995-05-13, Gunton Member of the Stony Mountain Formation. View towards the northwest.

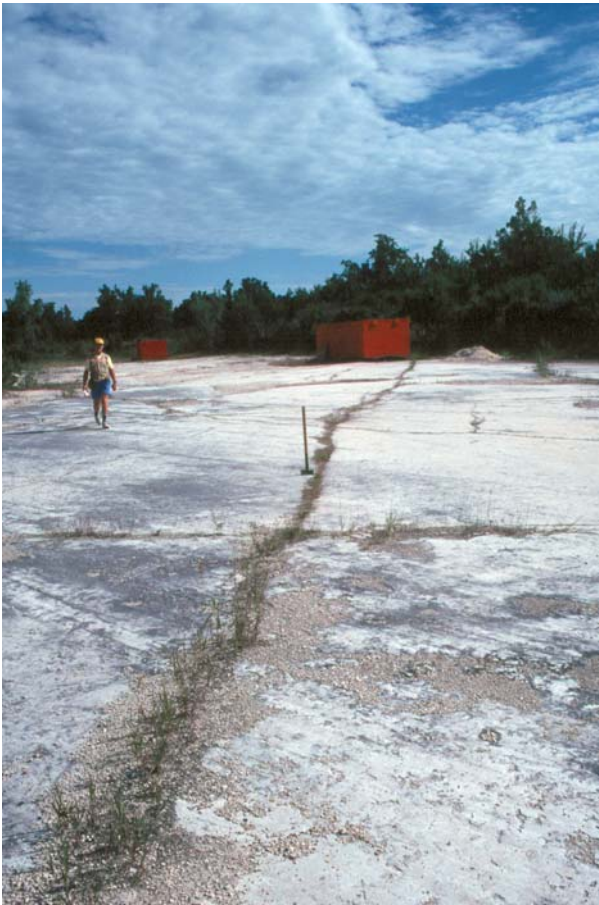
Whiterock 05 and 06 – 1995-05-13, Gunton Member of the Stony Mountain Formation. Major fracture on stripped off pavement, view towards the northeast. JDB for scale. Displaced minor fractures off major fracture shown in middle of right photo. View towards the east.

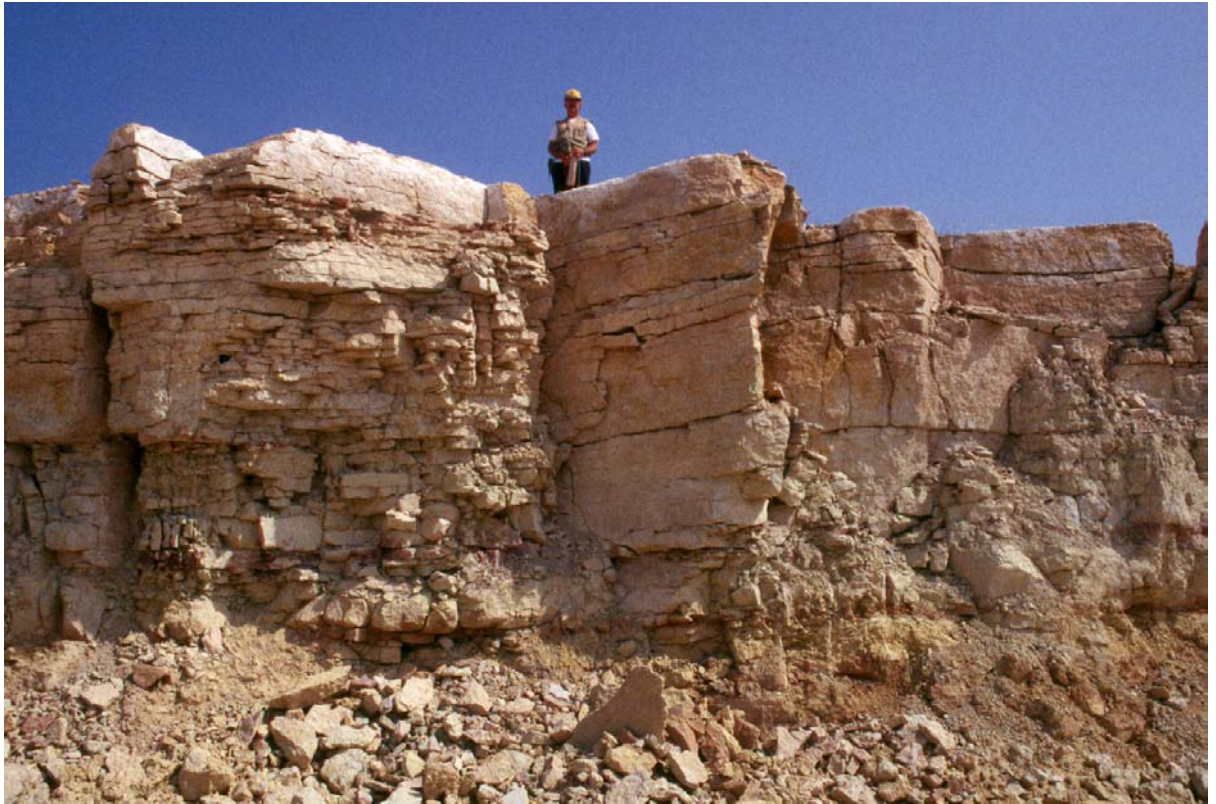
Mariash 01 -1995-07-18, Mariash Quarry. Gunton Member overlying Penitentiary Member (Stony Mountain Formation). View is looking north.

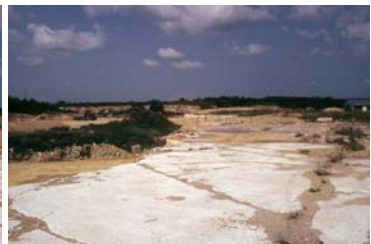
Mariash 03

Mariash 02 to 04 - 1995-07-18, Mariash Quarry. Gunton Member (Stony Mountain Formation) pavement with fractures. View is looking southeast, south and southwest.

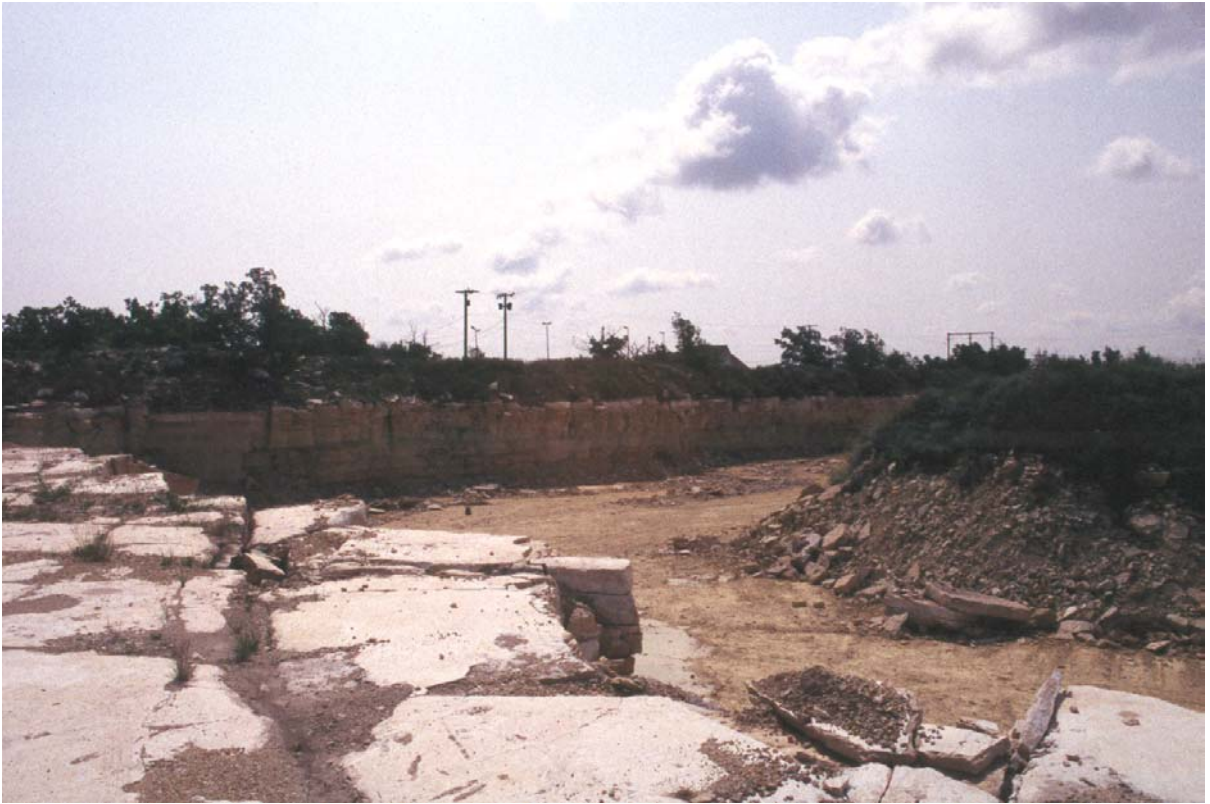
Mariash 04 - 1995-07-18, Mariash Quarry. Gunton Member (Stony Mountain Formation) pavement with fractures. View is looking southeast.

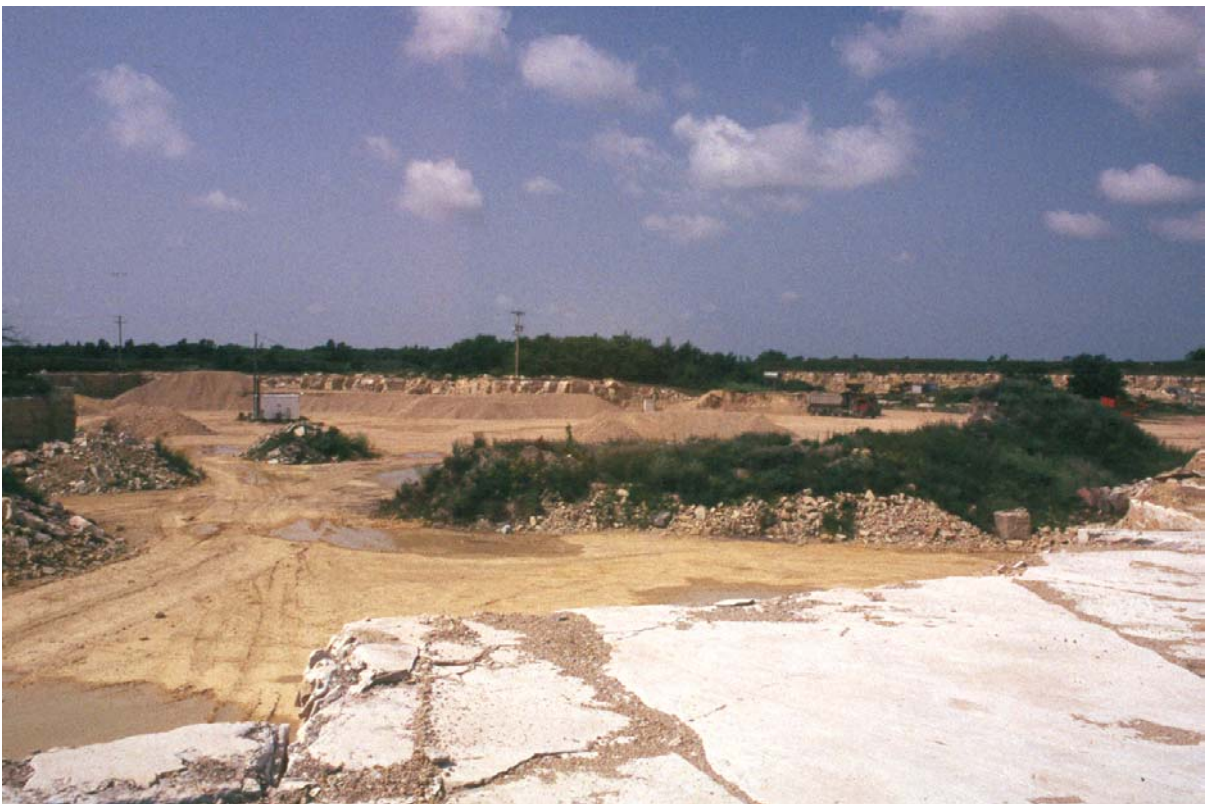
Mariash 03 - 1995-07-18, Mariash Quarry. Gunton Member (Stony Mountain Formation) pavement with fractures. View is looking south.

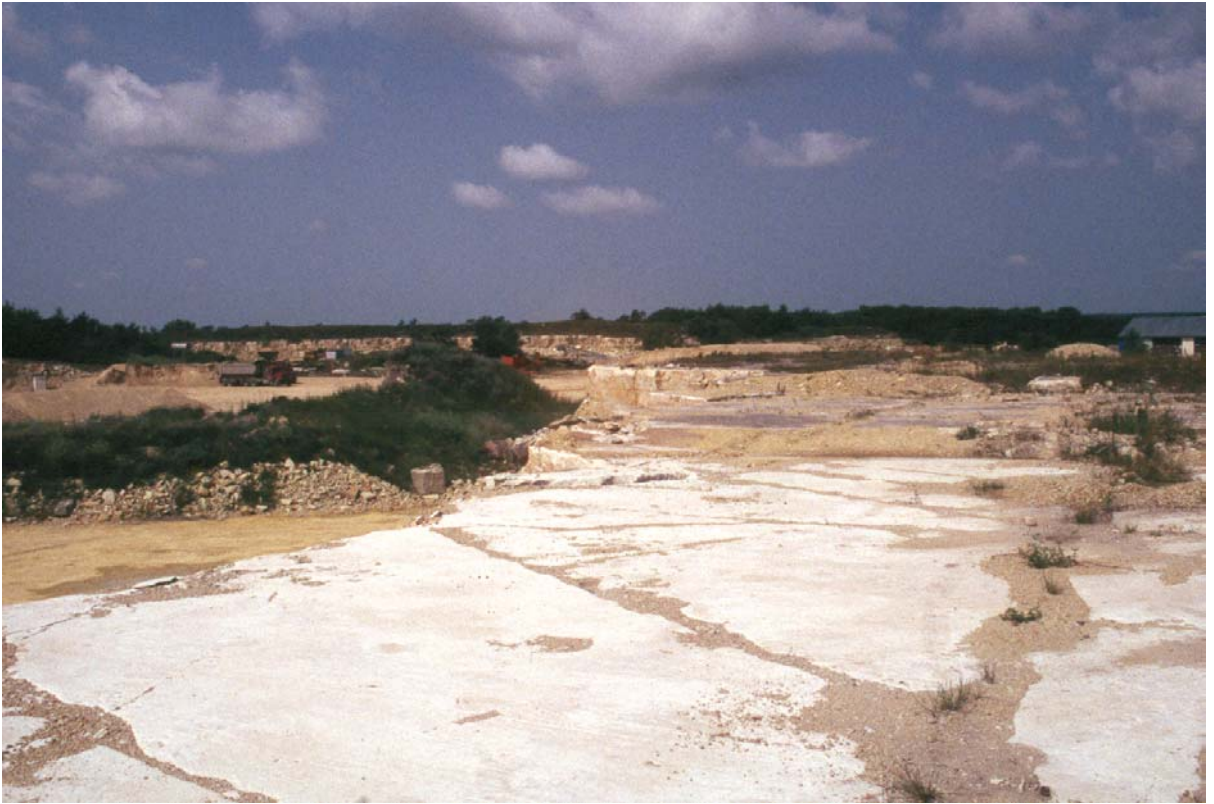
Mariash 02 - 1995-07-18, Mariash Quarry. Gunton Member (Stony Mountain Formation) pavement with fractures. View is looking southwest.

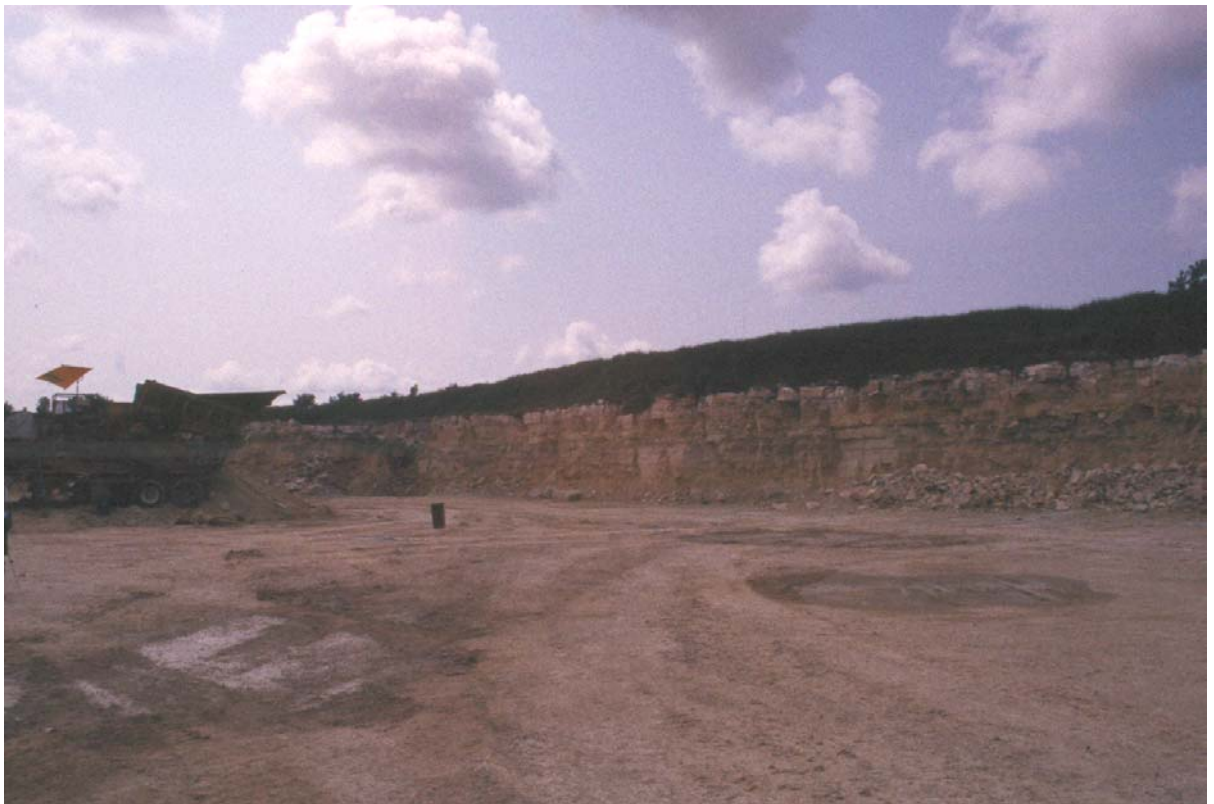
Mariash 05 - 1995-07-18, Mariash Quarry. South wall looking southeast. Ski hill lift on left at top of section.

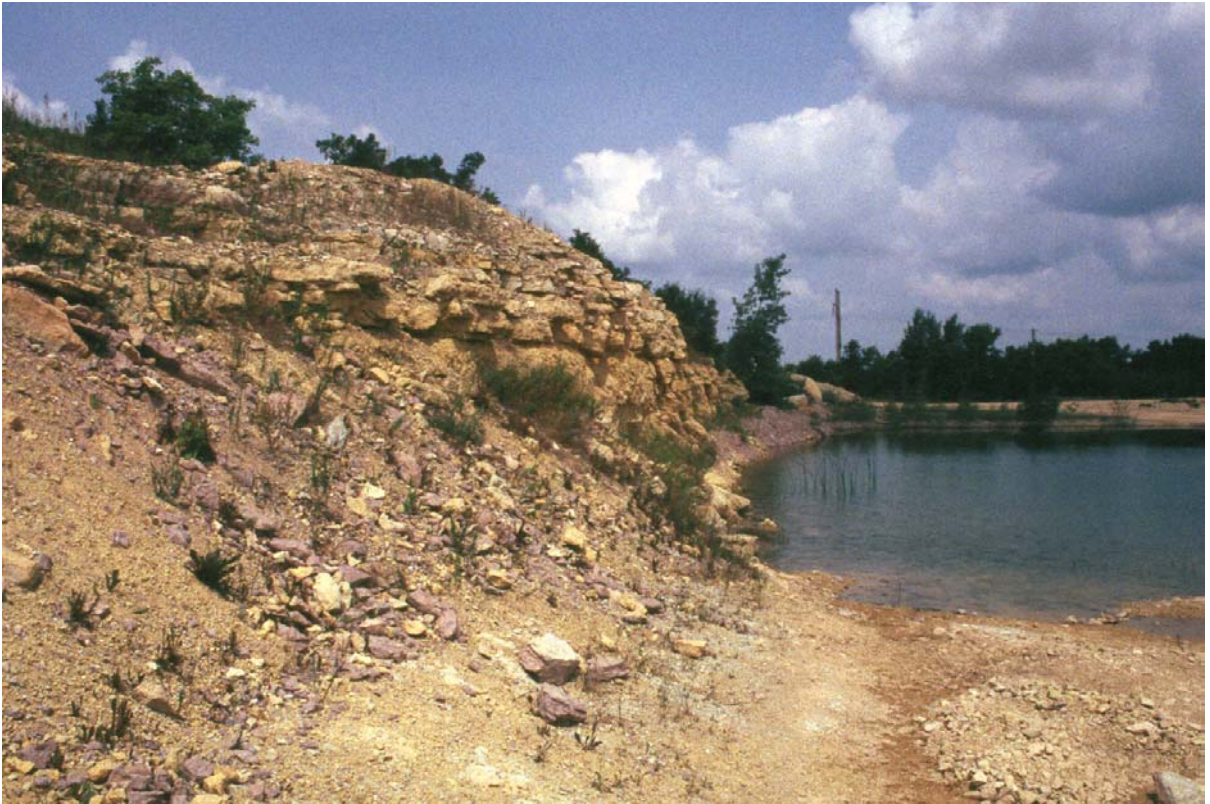
Mariash 06 - 1995-07-18, Mariash Quarry. West wall looking north. Thin Gunton Member at top, underlain by Penitentiary Member. Fragments of Gunn Member at base of section. Water-filled pond has Gunn Member bottom (Stony Mountain Formation).

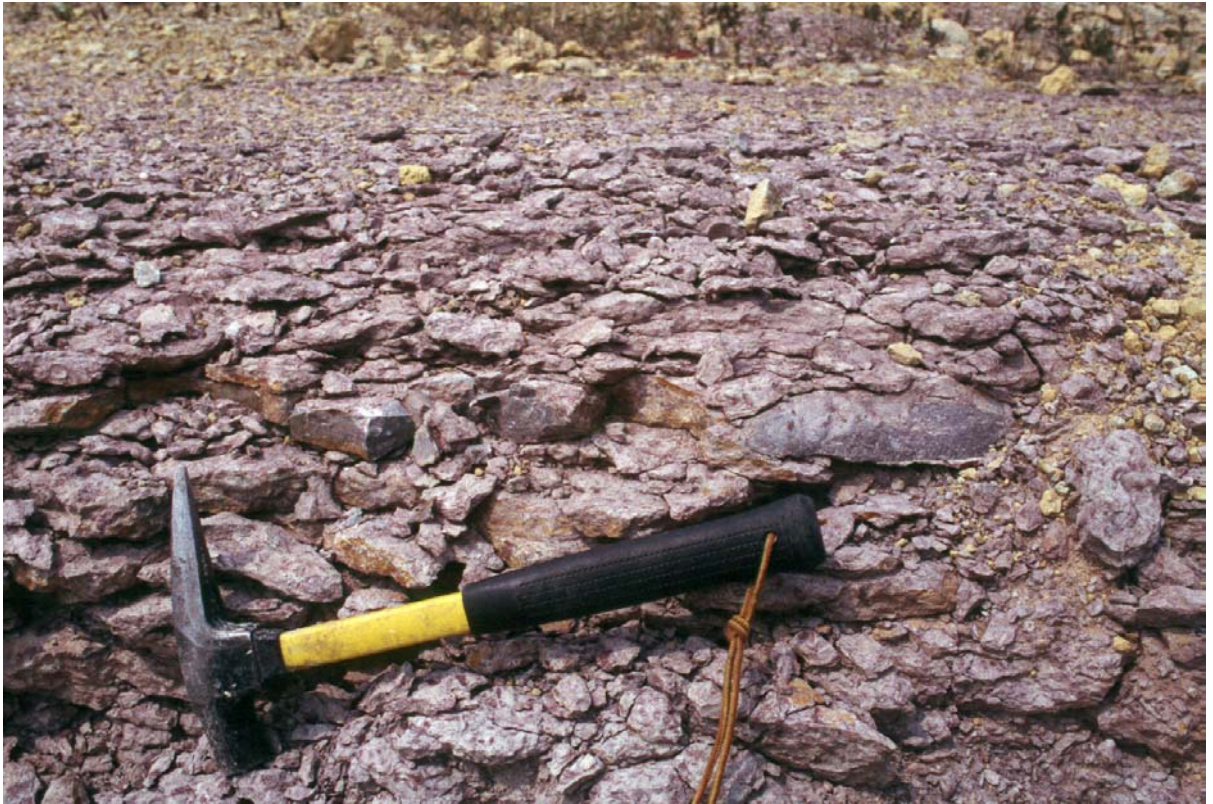
Winnipeg N 01 - 1995-07-18, Stony Mountain West Quarry. Close-up of Gunn Member (Stony Mountain Formation), upper surface. View looking north.

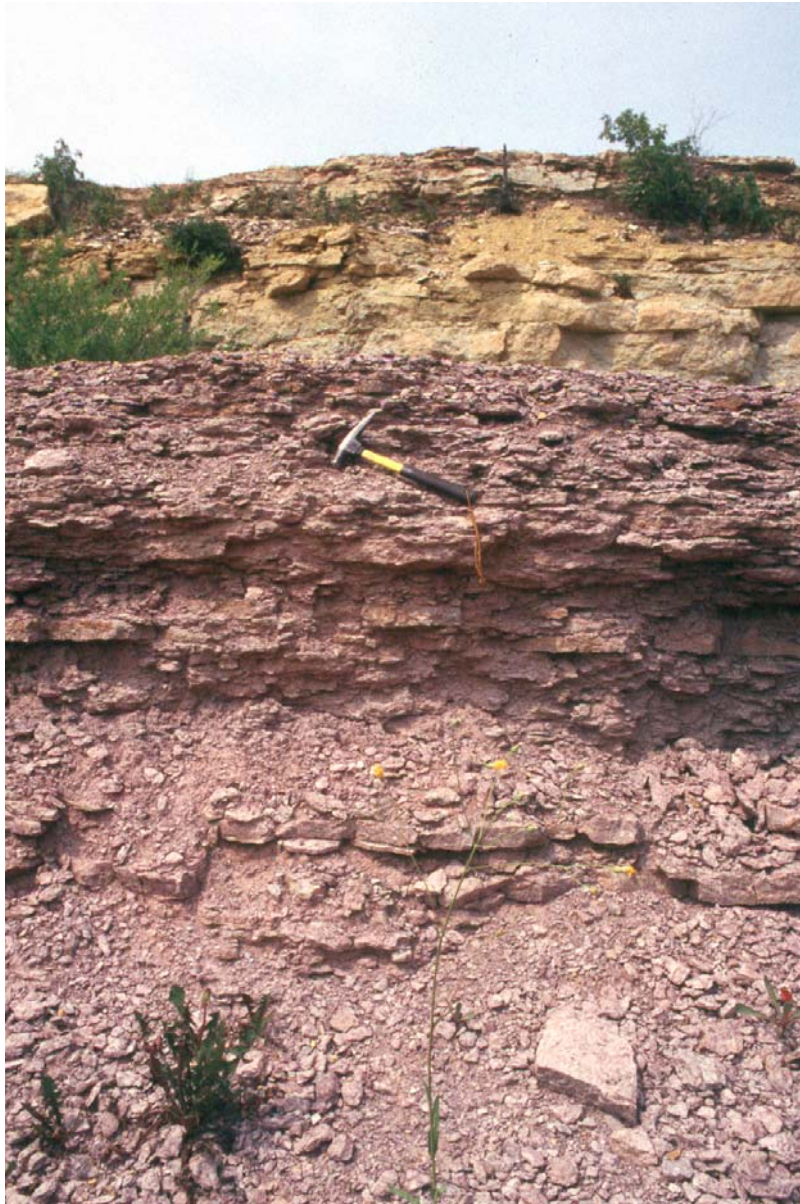
Winnipeg W 01 - 1995-07-18, Stony Mountain West Quarry. Gunn pit with Gunn Member in foreground and Penitentiary Member (Stony Mountain Formation) in background. View looking north.

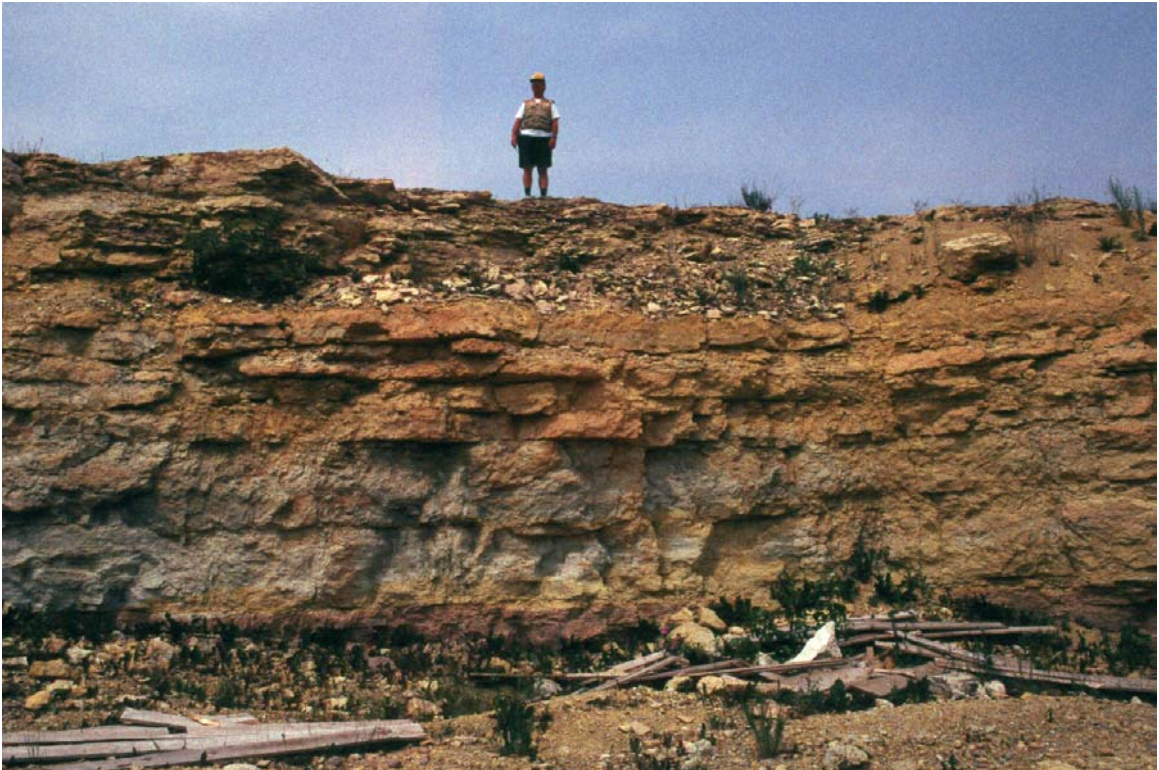
Winnipeg W 02 - 1995-07-18, Stony Mountain West Quarry. Penitentiary Member overlain by Gunton Member (Stony Mountain Formation). View looking north.

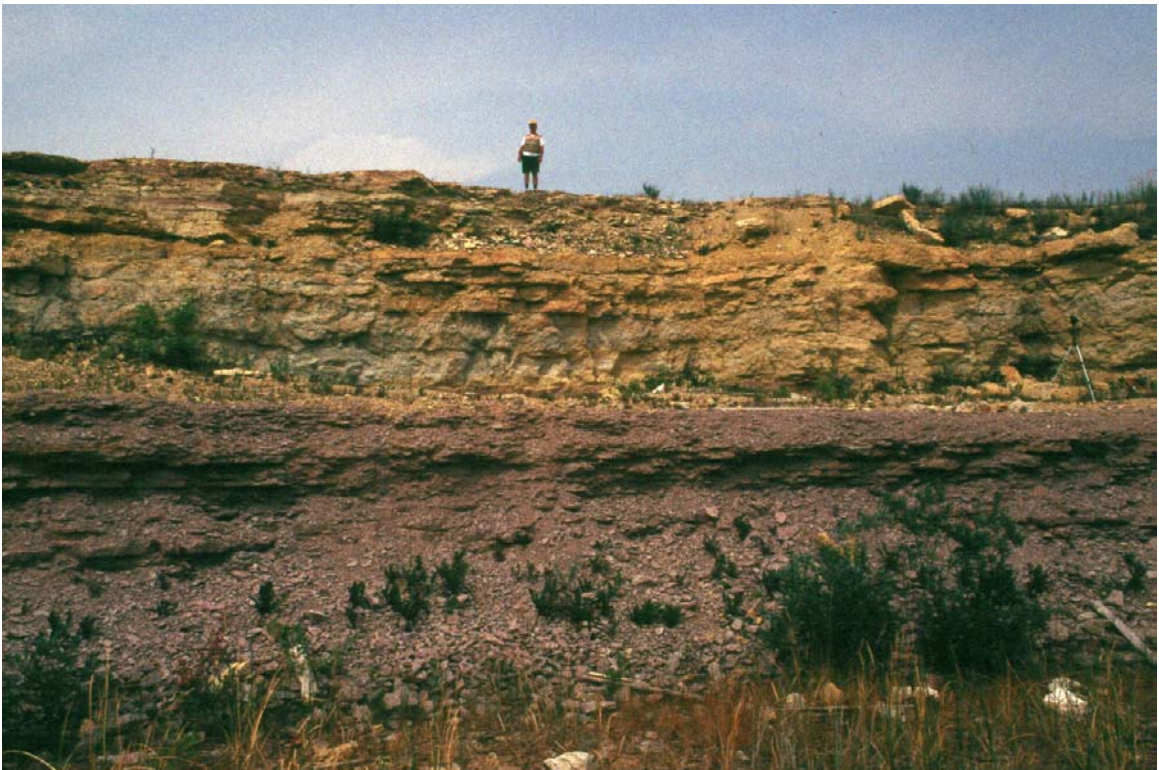
Winnipeg W 03 - 1995-07-18, Stony Mountain West Quarry. Gunn pit with Gunn Member in foreground and Penitentiary Member, overlain by Gunton Member in background (Stony Mountain Formation). View looking north.

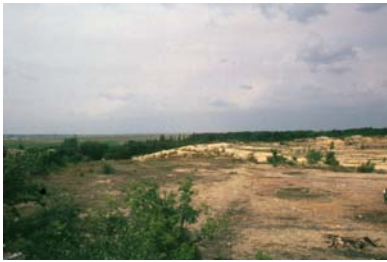
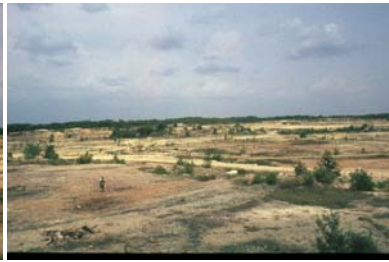
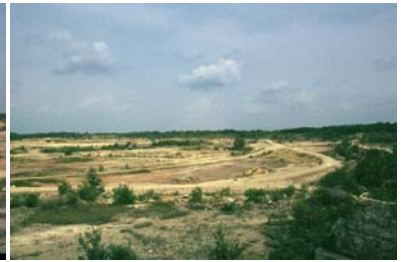
Winnipeg W 04 to 06 - 1995-07-18, Stony Mountain West Quarry. Northwest corner of quarry with remnants of Gunton Member (Stony Mountain Formation) caprock. View looking north, northeast and east. Prairie lowlands at far left.

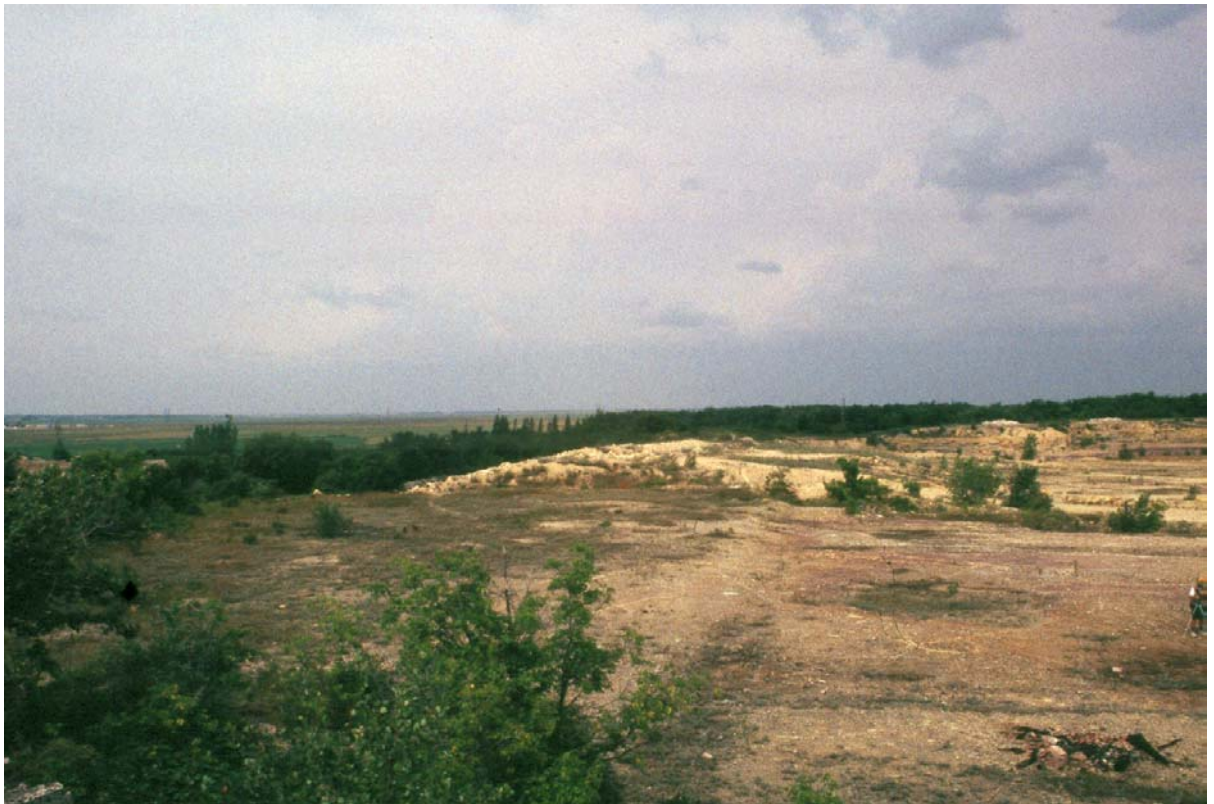
Winnipeg W 04 - 1995-07-18, Stony Mountain West Quarry. Northwest corner of quarry with remnants of Gunton Member (Stony Mountain Formation) caprock. View looking north. Prairie lowlands at far left.

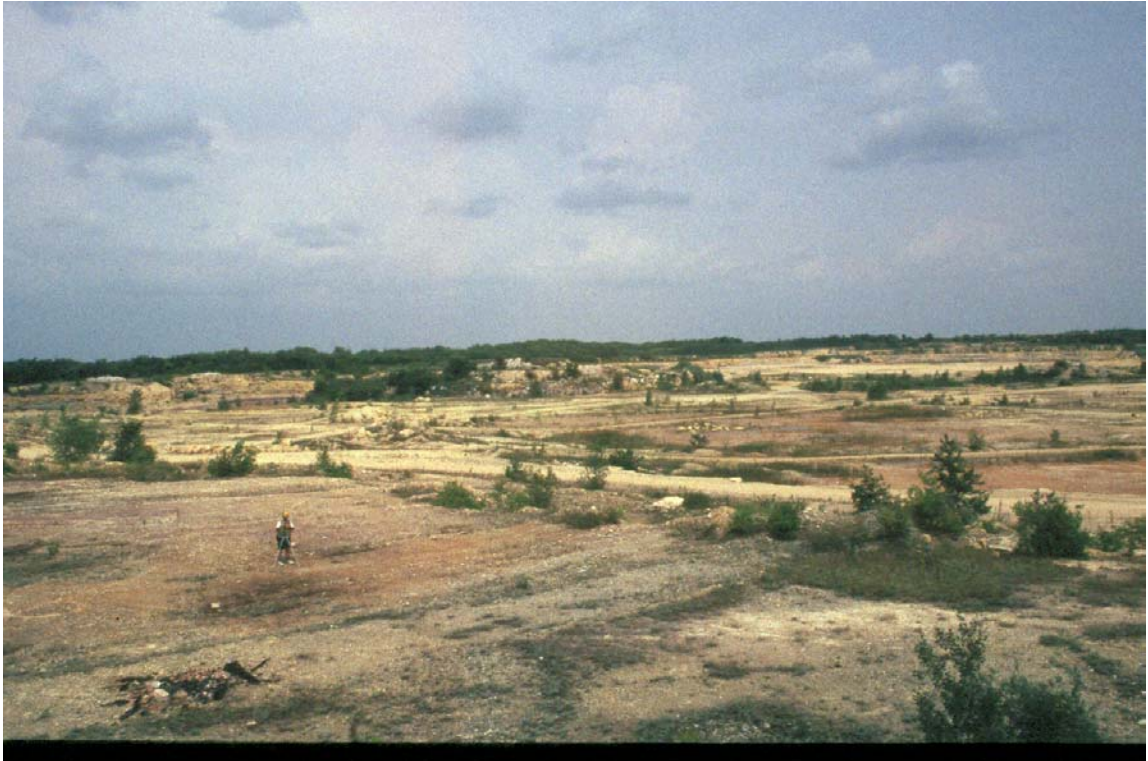
Winnipeg W 05 - 1995-07-18, Stony Mountain West Quarry. Northwest corner of quarry with remnants of Gunton Member (Stony Mountain Formation) caprock. View looking northeast.

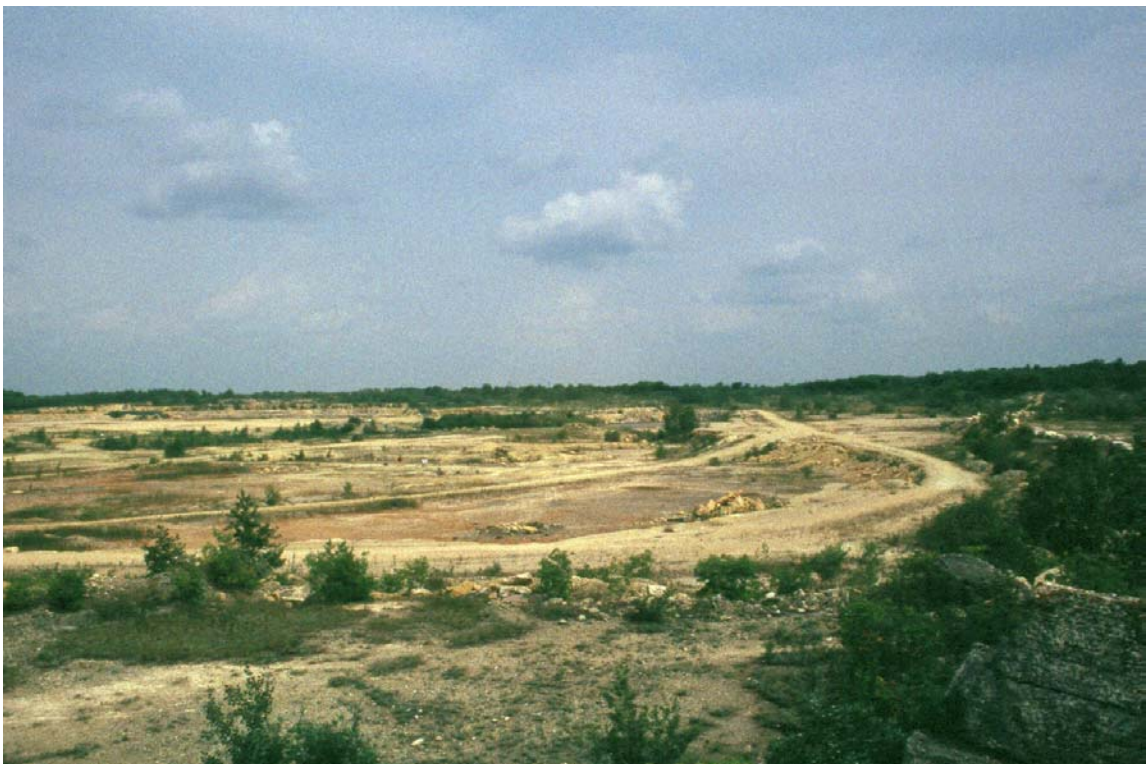
Winnipeg W 06 - 1995-07-18, Stony Mountain West Quarry. Northwest corner of quarry with remnants of Gunton Member (Stony Mountain Formation) caprock. View looking east.
