## Appendix 1: Bedrock Quarries in the Capital Region Study Area

**NAME:** BORLAND QUARRY SOUTH

### Borland Quarry South

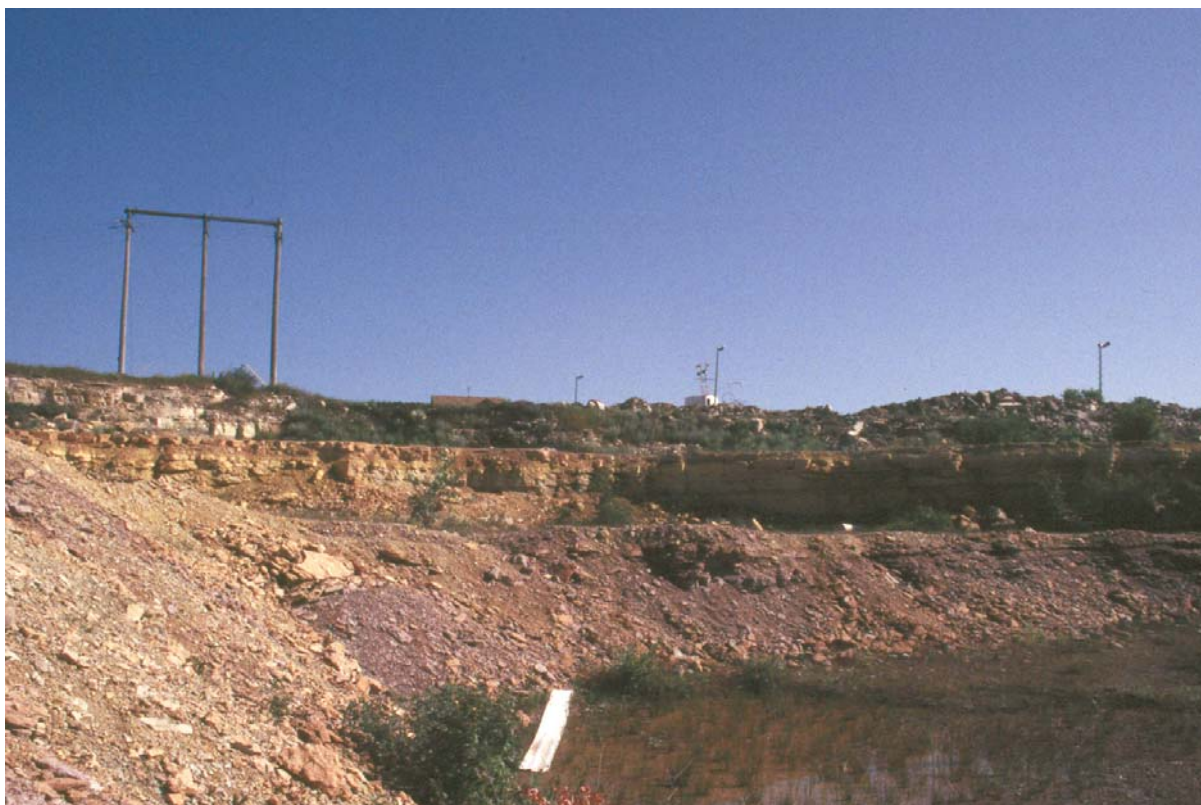
Winnipeg E 01 - 1995-07-20, Former City of Winnipeg Stony Mountain East Quarry showing Gunn Member in red at base, Penitentiary Member in orange to greenish-buff in middle, and Gunton Member in light beige at top of section, below hydro poles. All of the Stony Mountain Formation. View is towards the north. Ski hill lift on horizon at east side.

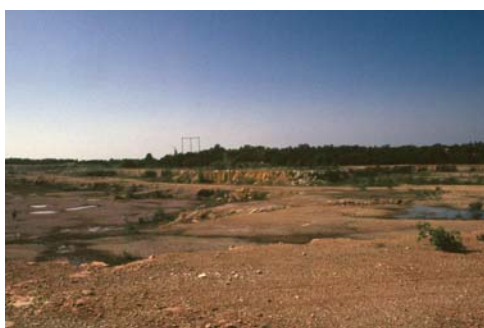
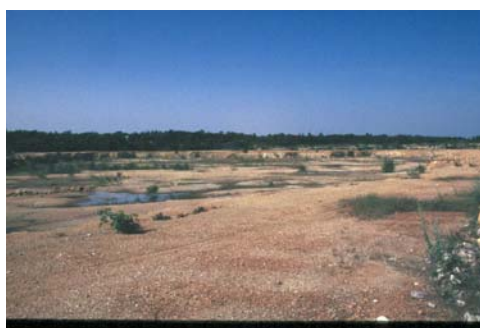
Winnipeg E 02 and 03 - 1995-07-20, Former City of Winnipeg Stony Mountain East Quarry showing Penitentiary Member in orange to greenish-buff at base, and Gunton Member in light beige at top of section. All of the Stony Mountain Formation. View is towards the east and southeast.

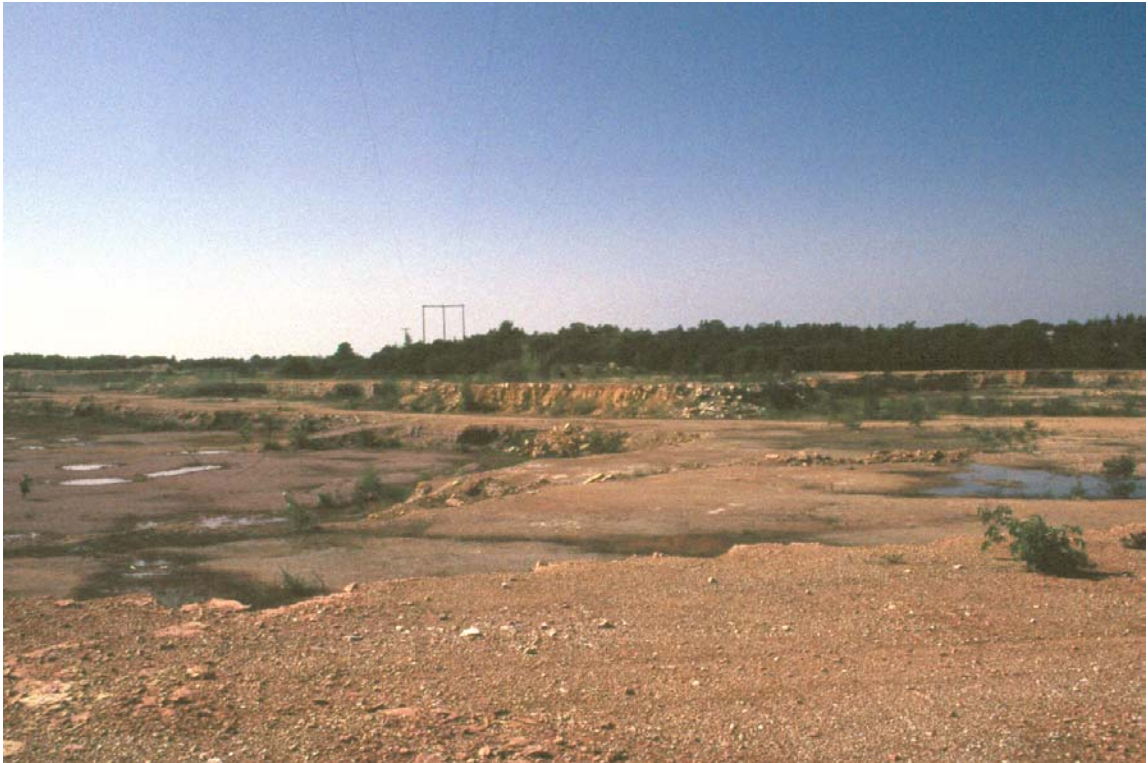
Winnipeg E 03 - 1995-07-20, Former City of Winnipeg Stony Mountain East Quarry showing Penitentiary Member in orange to greenish-buff at base, and Gunton Member in light beige at top of section. All of the Stony Mountain Formation. View is to towards the east.

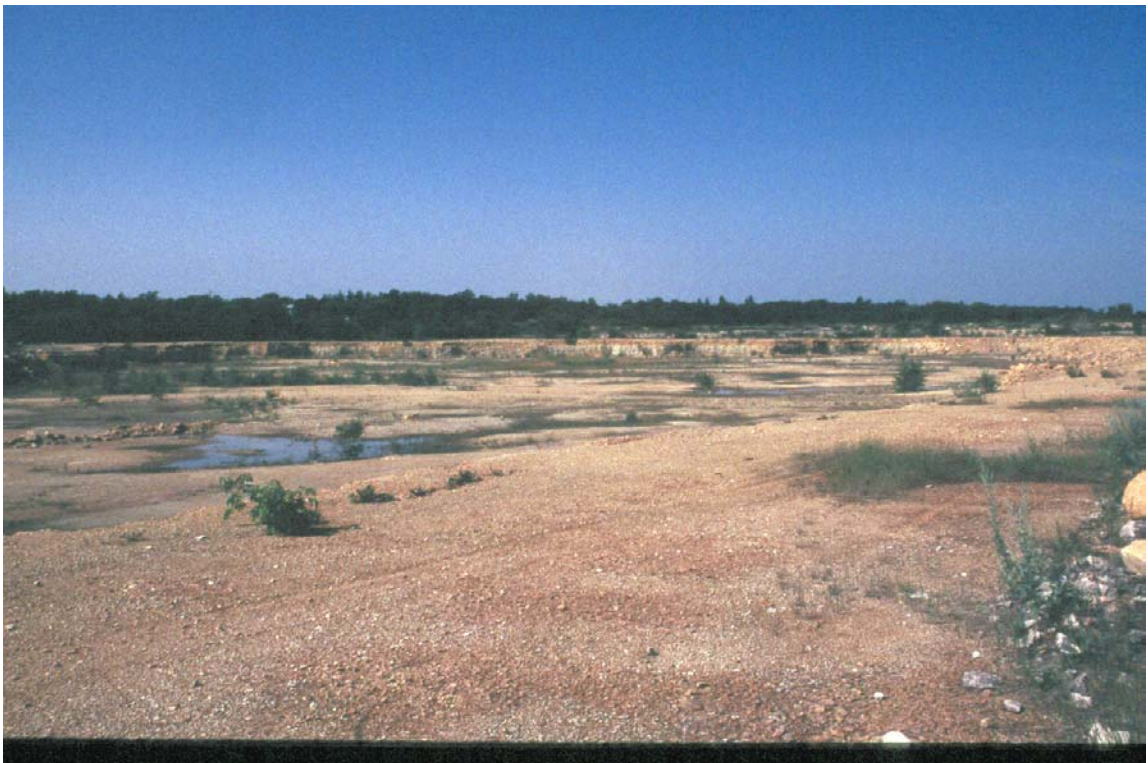
Winnipeg E 02 - 1995-07-20, Former City of Winnipeg Stony Mountain East Quarry showing Penitentiary Member in orange to greenish-buff at base, and Gunton Member in light beige at top of section. All of the Stony Mountain Formation. View is towards the southeast.

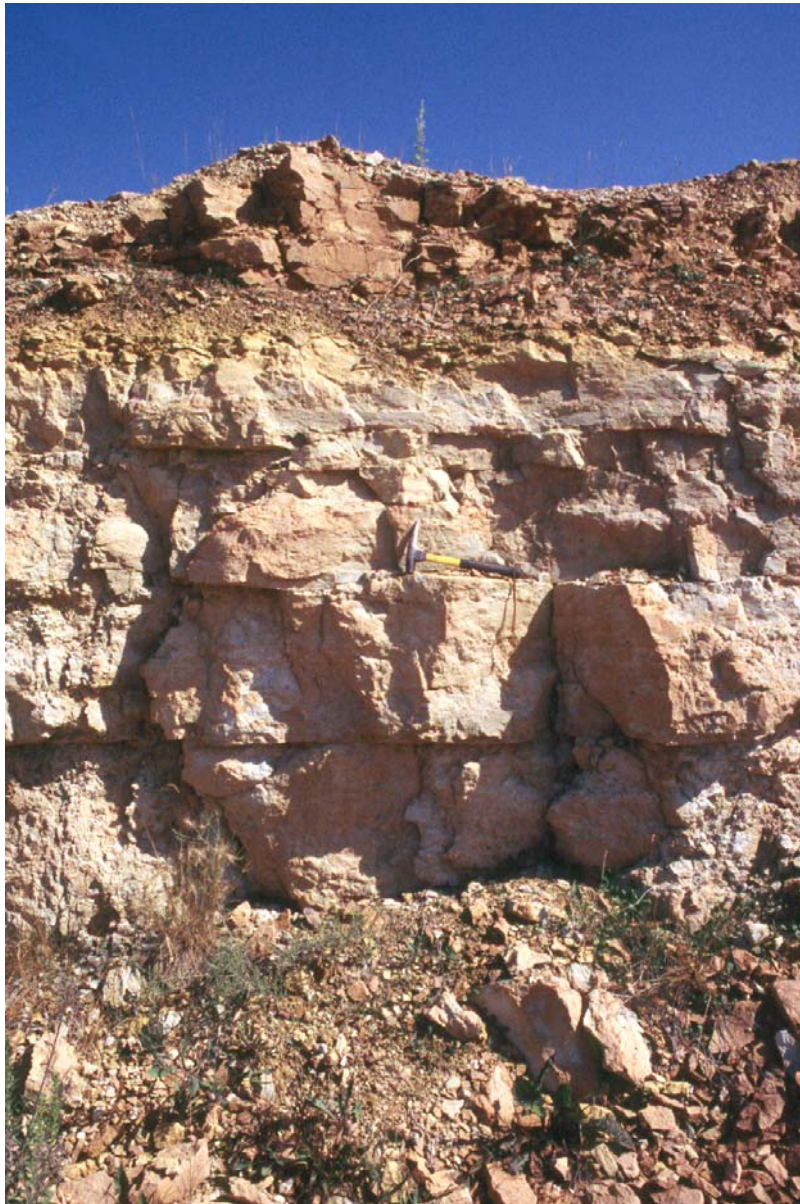
Winnipeg E 05 - 1995-07-20, Former City of Winnipeg Stony Mountain East Quarry.  
Penitentiary Member (Stony Mountain Formation), close-up. View is towards the north.

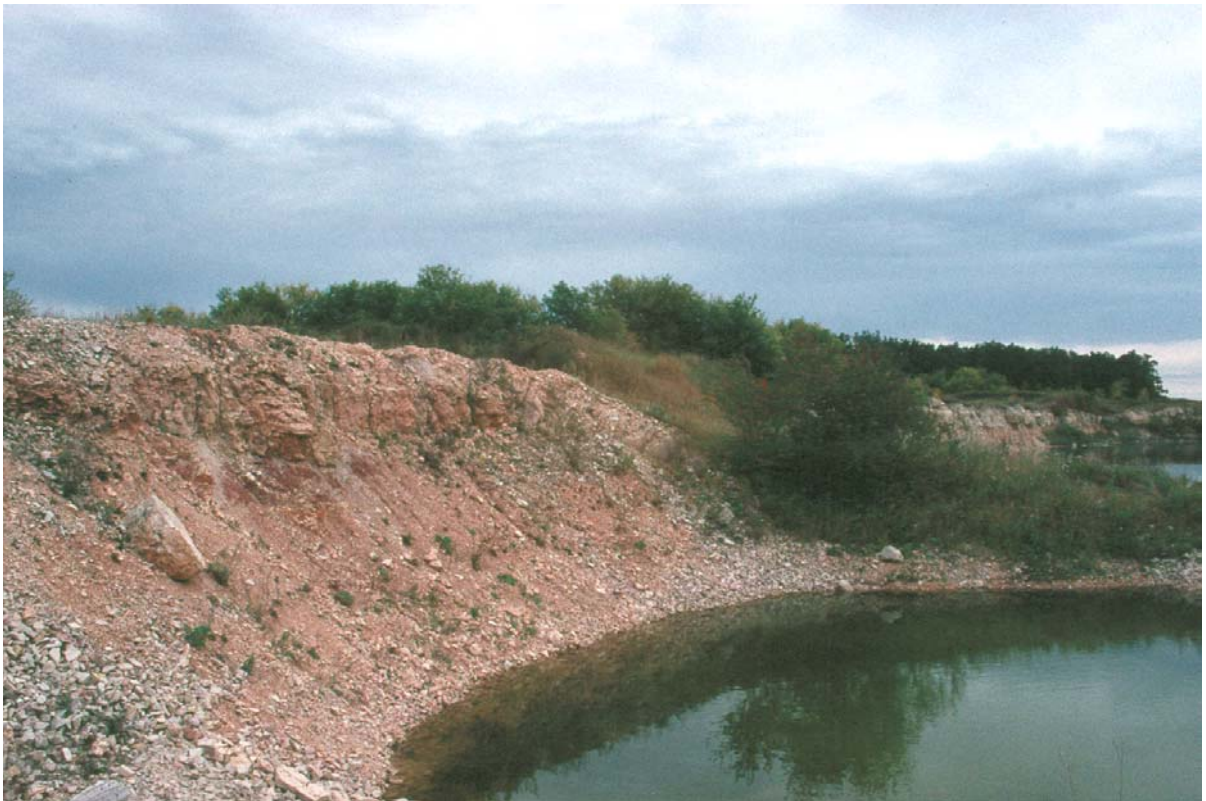
Mowatt 01 – 1996-05-30, Fort Garry Member of the Red River Formation. View towards the southeast, from the east wall.

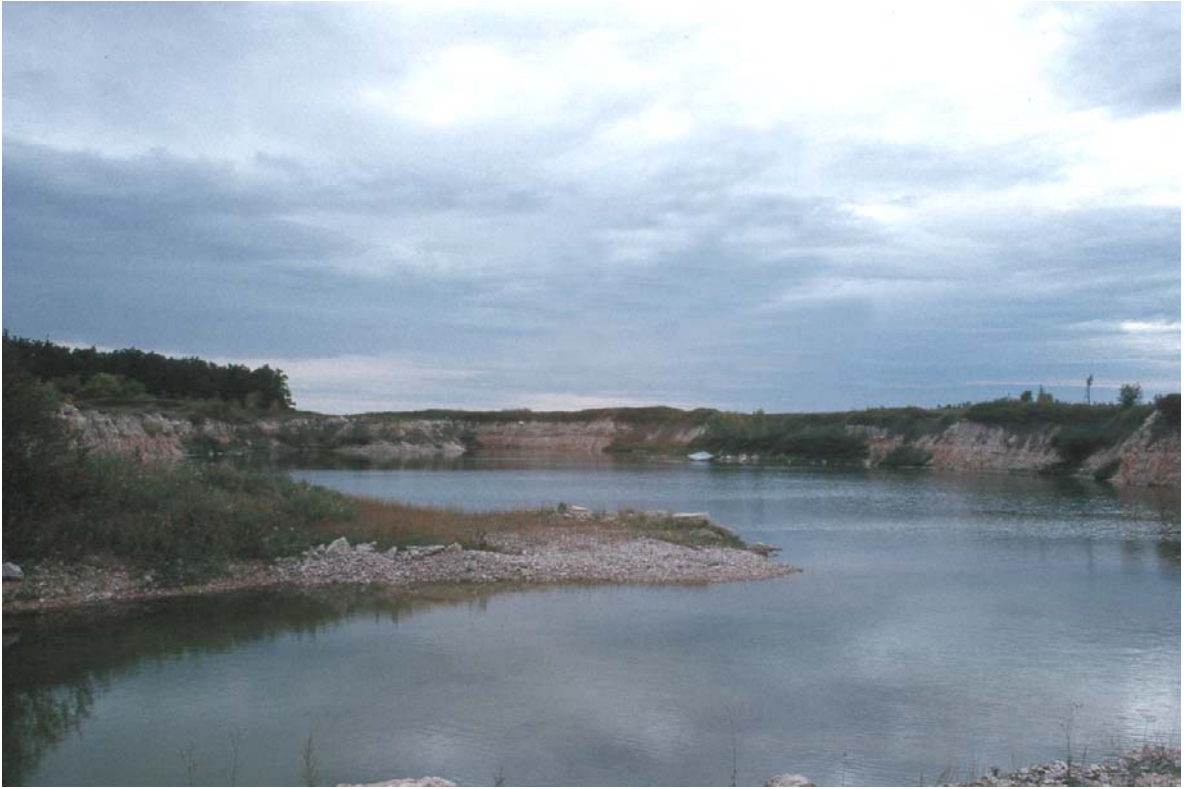
Mowatt 02 – 1996-05-30, Fort Garry Member of the Red River Formation. View towards the south, from the east wall.

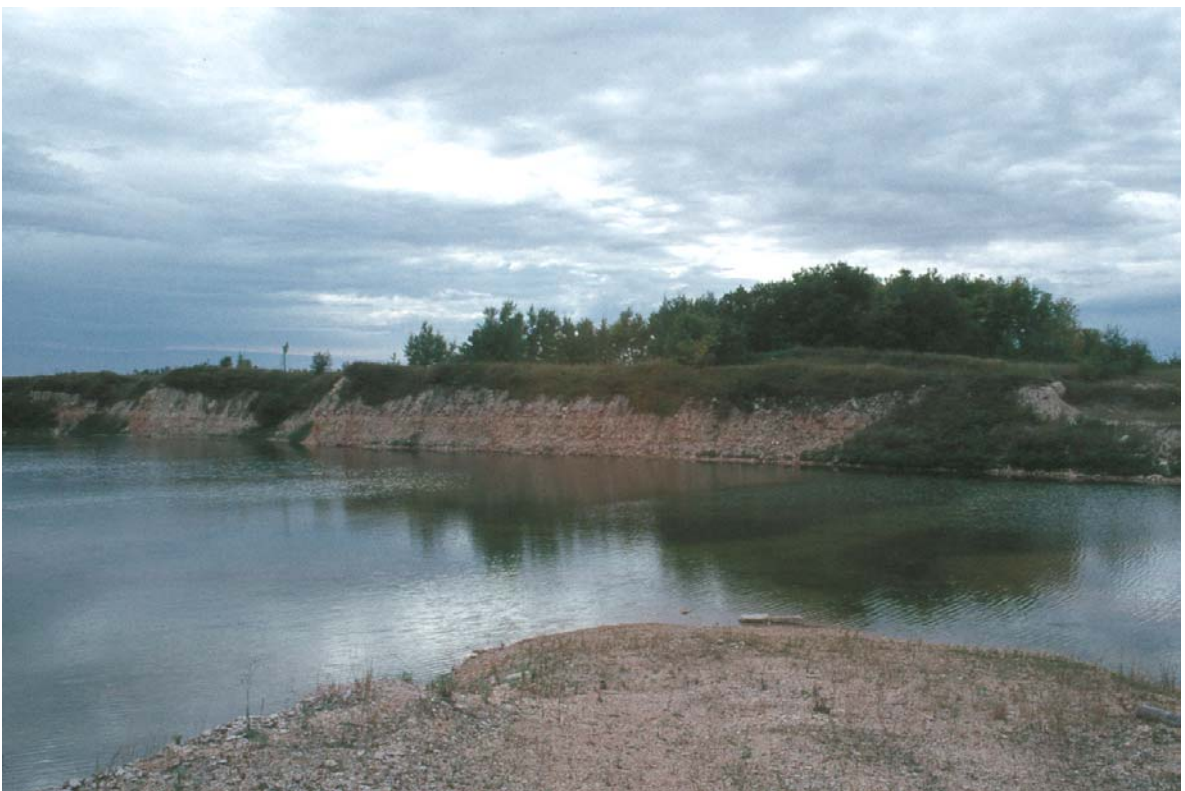
Mowatt 03 – 1996-05-30, Fort Garry Member of the Red River Formation. View towards the southwest, from the east wall.

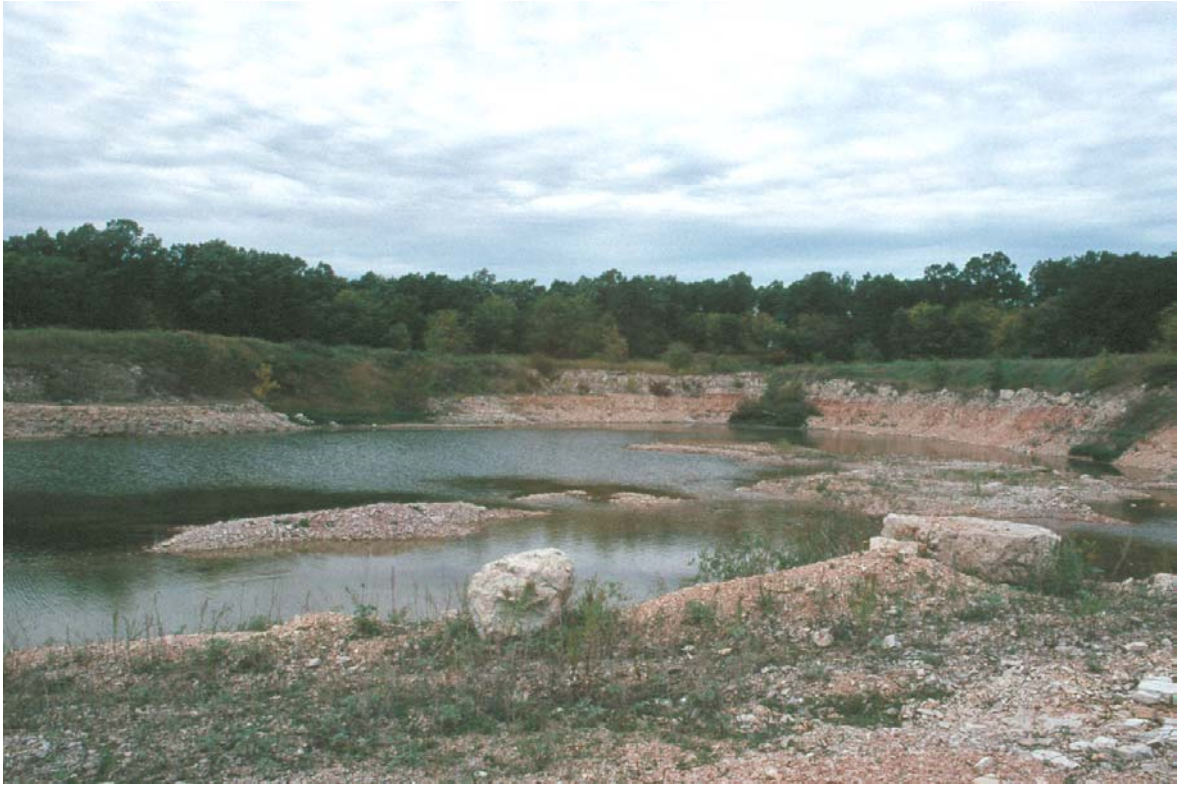
Mowatt 04 – 1996-05-30, Fort Garry Member of the Red River Formation. View to the northwest, from the east wall.

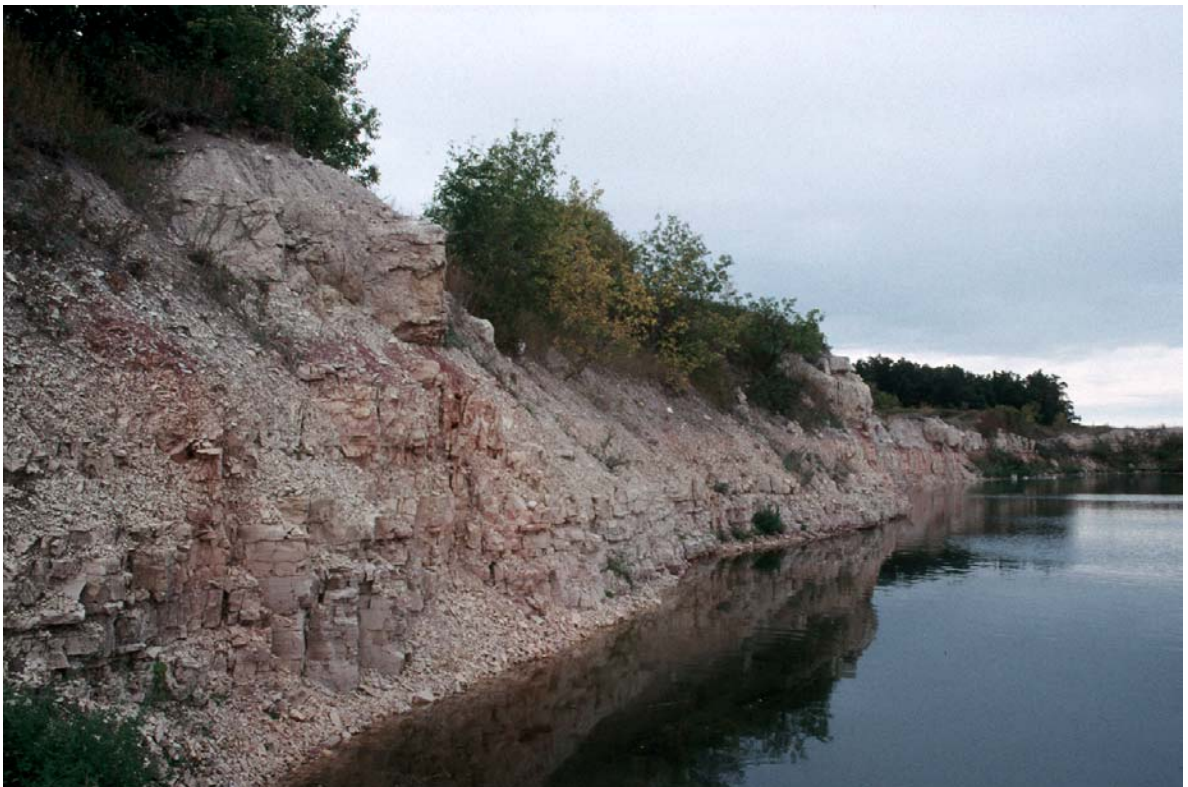
Mowatt 05 – 1996-05-30, Fort Garry Member of the Red River Formation. From the west wall looking north.

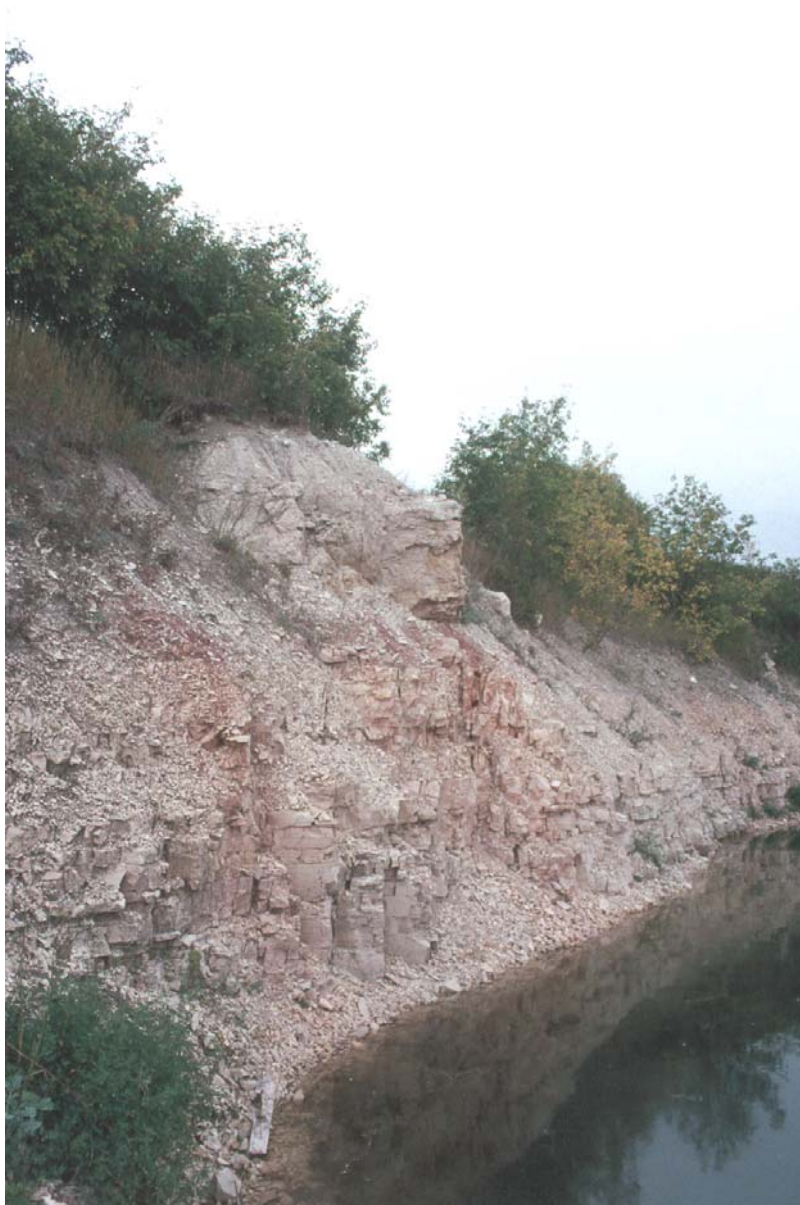
Mowatt 06 – 1996-05-30, Fort Garry Member of the Red River Formation. From the west wall looking north.

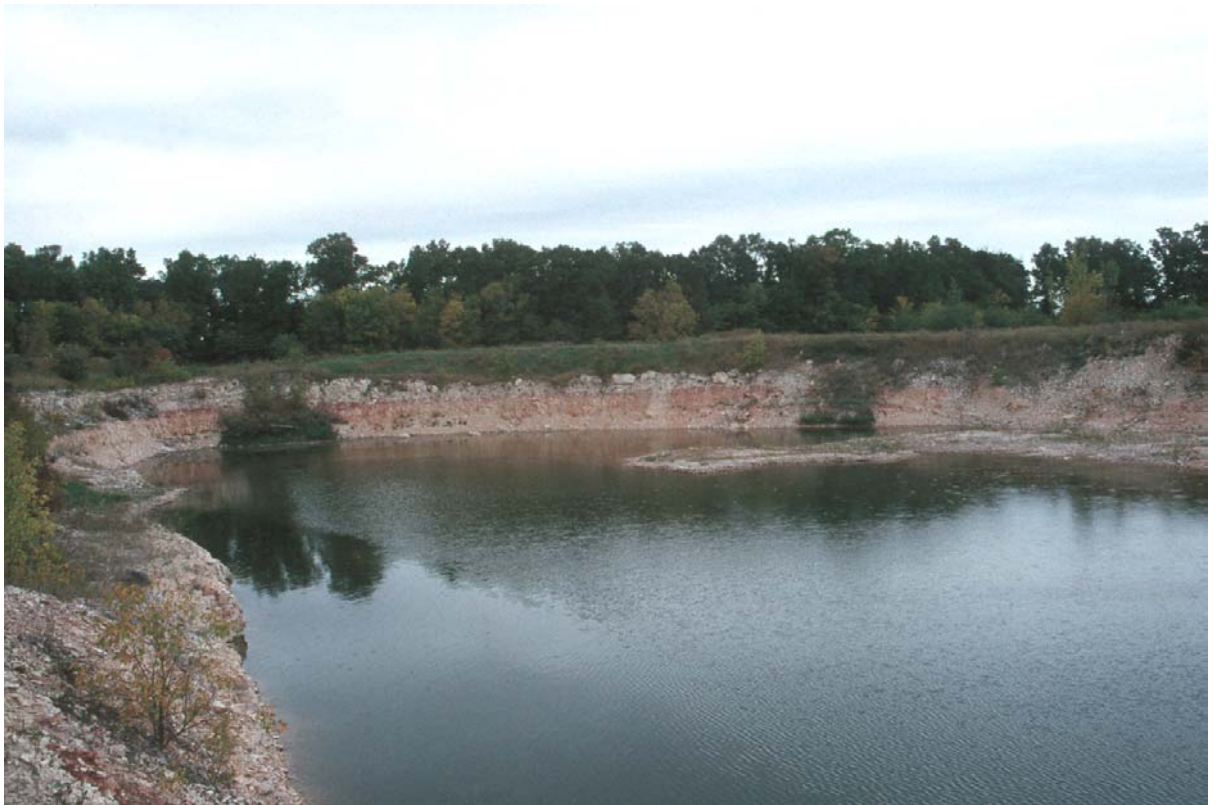
Mowatt 07 – 1996-05-30, Fort Garry Member of the Red River Formation. View towards the north, from the west wall.

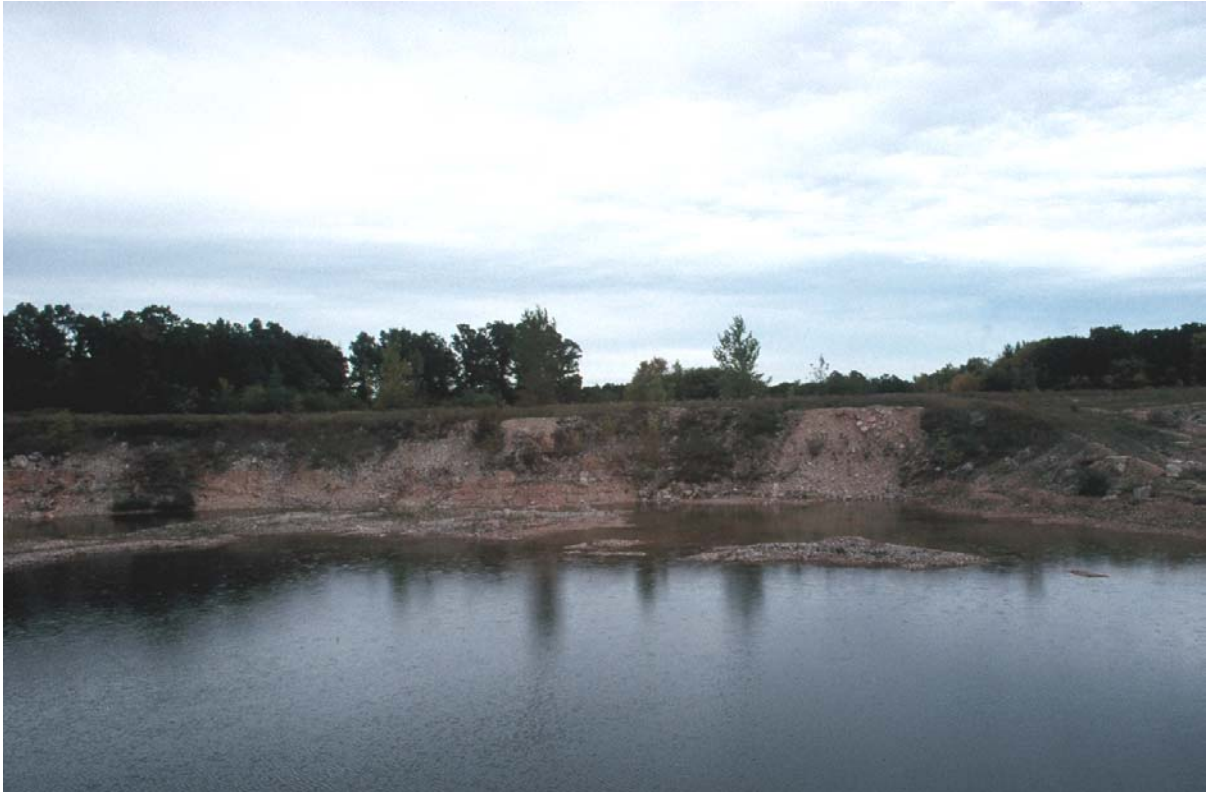
Mowatt 08 – 1996-05-30, Fort Garry Member of the Red River Formation. View towards the northeast, from the west wall.

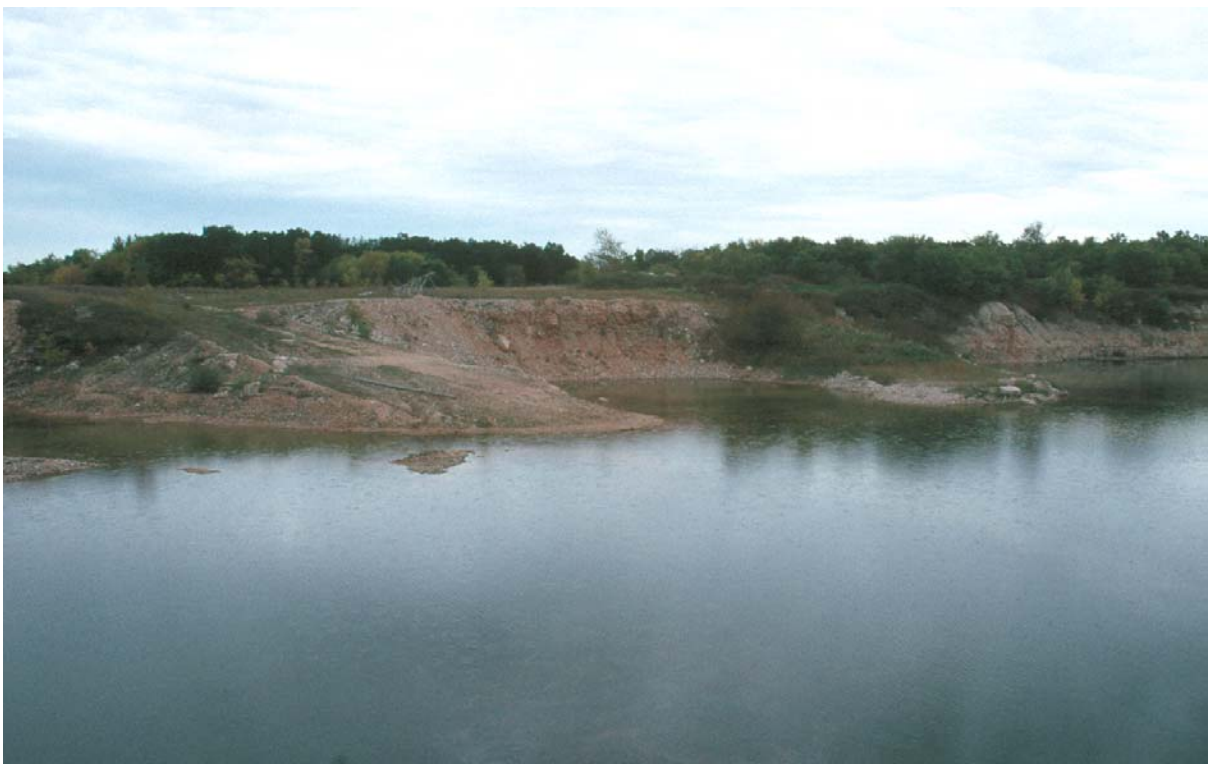
Mowatt 09 – 1996-05-30, Fort Garry Member of the Red River Formation. View towards the east, from the west wall.

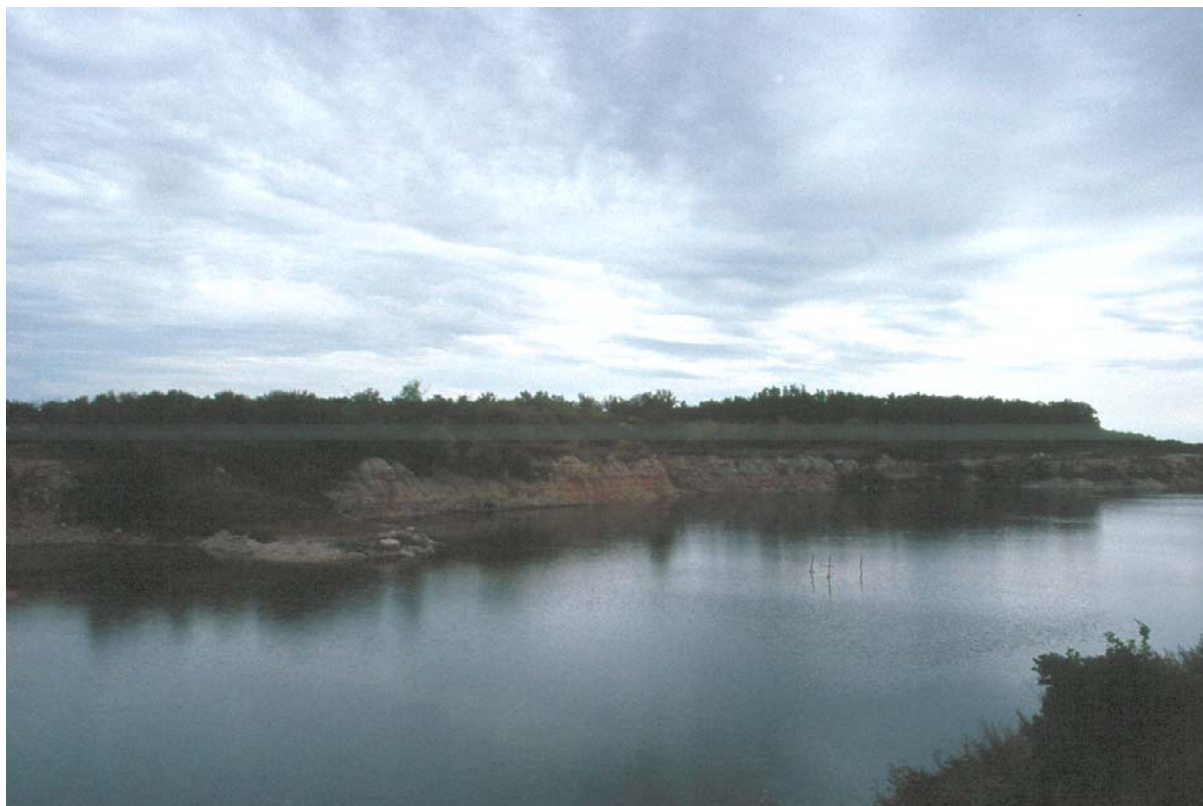
Mowatt 10 – 1996-05-30, Fort Garry Member of the Red River Formation. View towards the southeast, from the west wall.

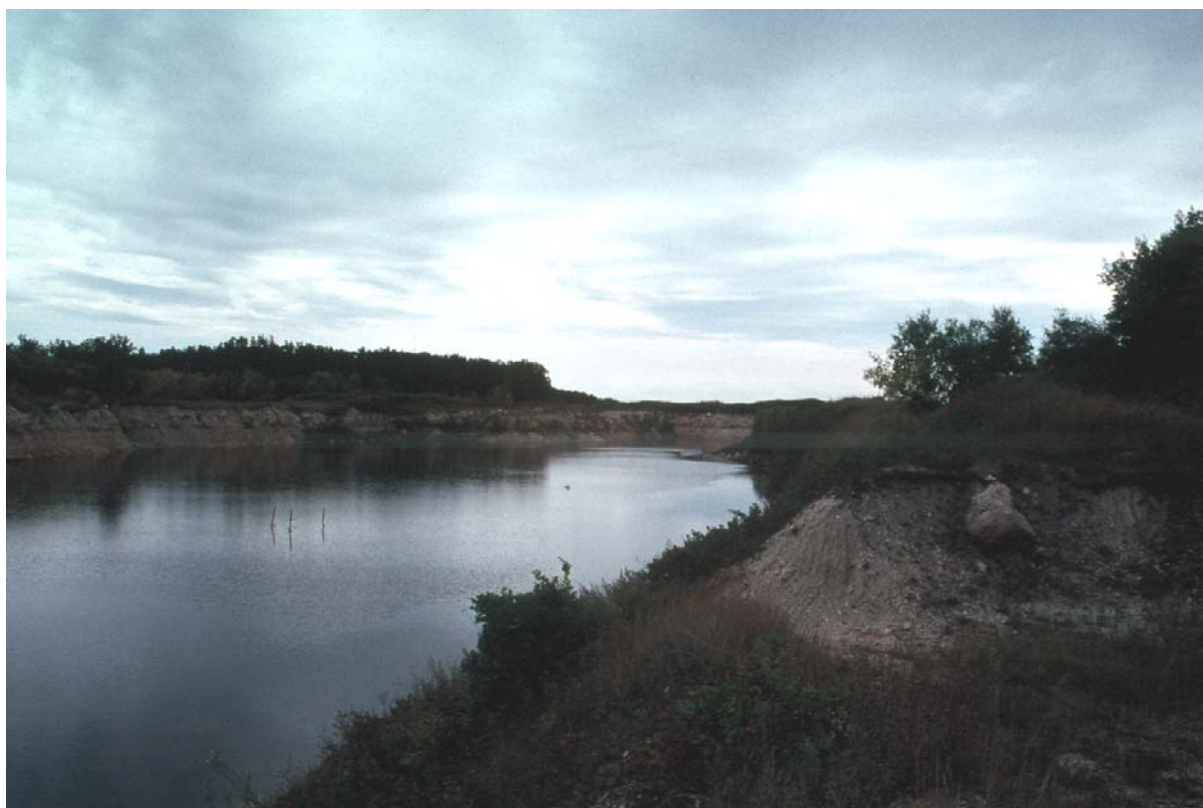
Mowatt 11 – 1996-05-30, Fort Garry Member of the Red River Formation. View towards the south, from the west wall.

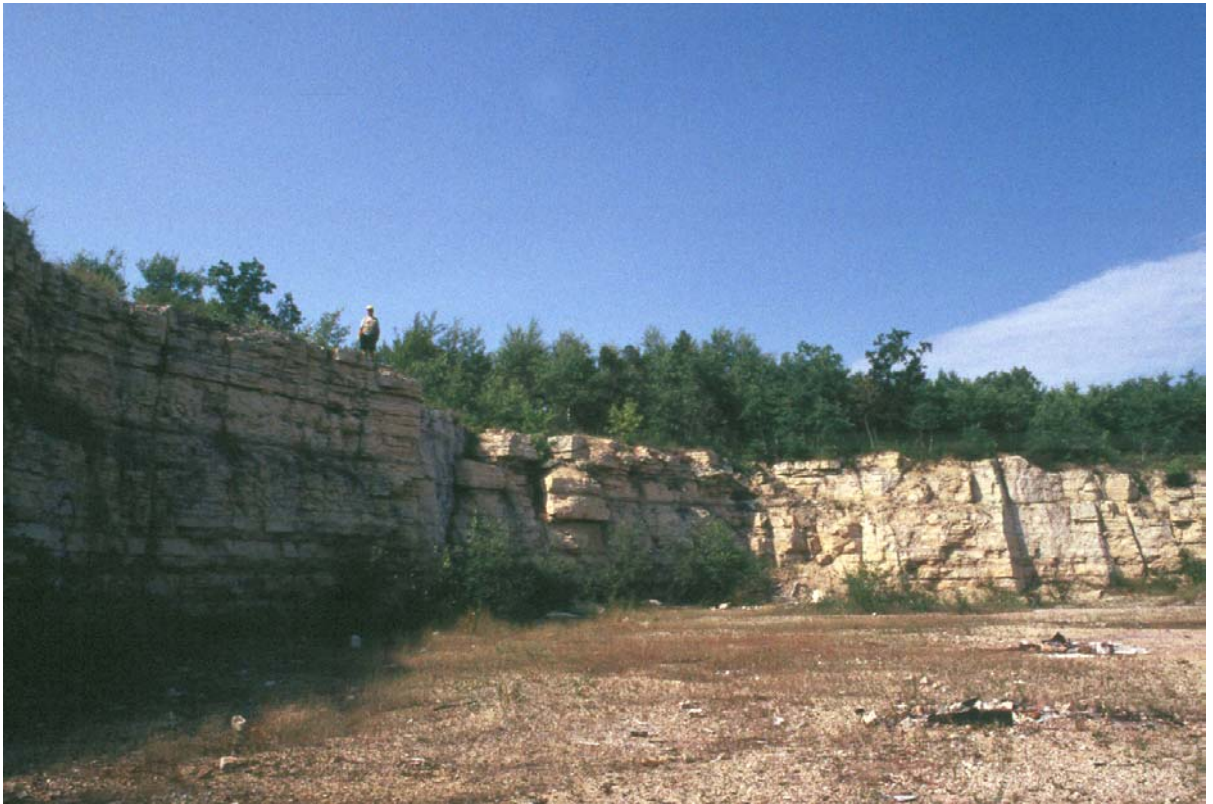
Gunn 01 – 1995-07-20, Gunn or No. 2 Quarry at Gunton. Gunton Member of the Stony Mountain Formation. View towards the northwest.

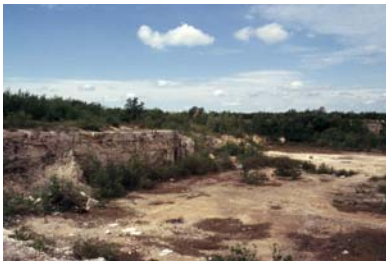
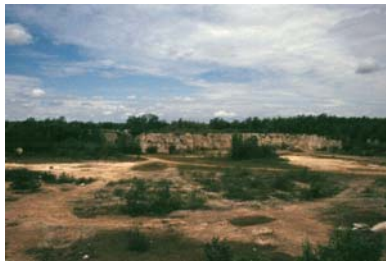
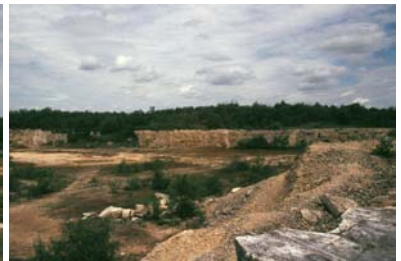
Gunn 02-04 – 1995-07-20, Gunn or No. 2 Quarry at Gunton. Gunton Member of the Stony Mountain Formation. Panorama view northeast to southeast.

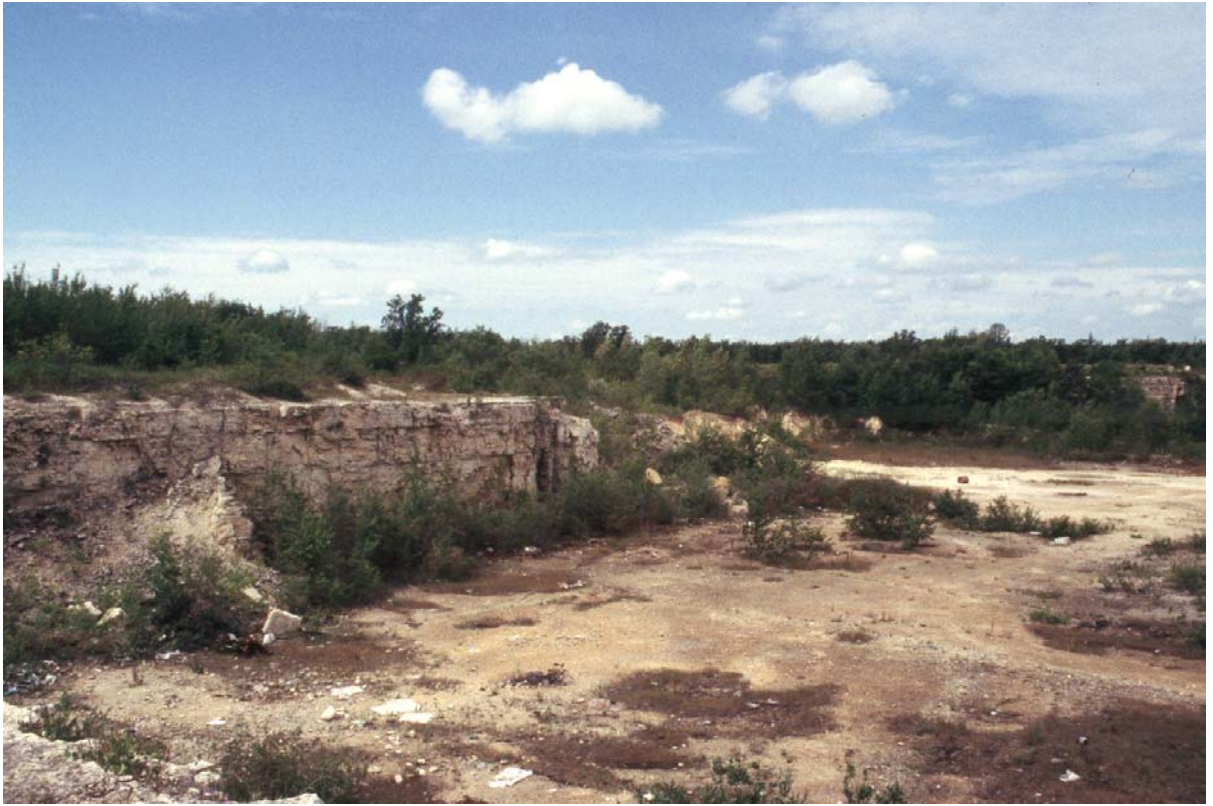
Gunn 02 – 1995-07-20, Gunn or No. 2 Quarry at Gunton. Gunton Member of the Stony Mountain Formation. Panorama view towards the northeast.

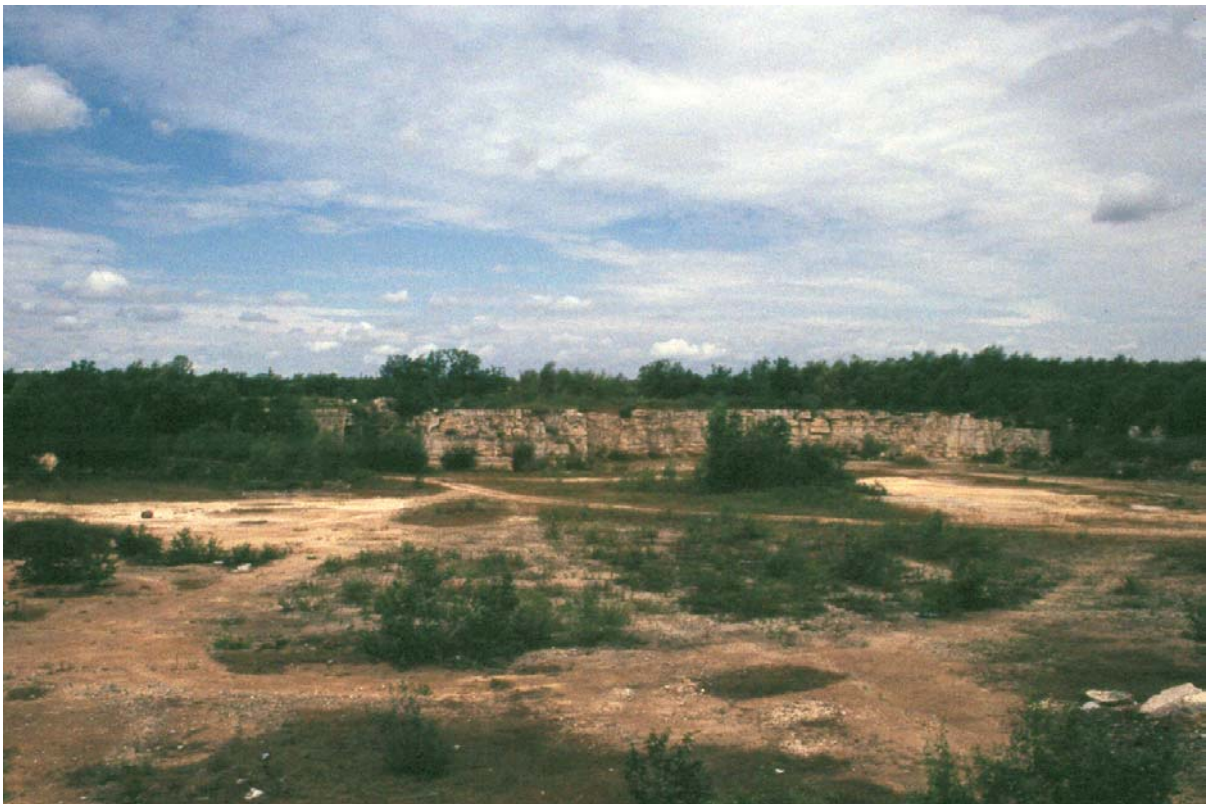
Gunn 03 – 1995-07-20, Gunn or No. 2 Quarry at Gunton. Gunton Member of the Stony Mountain Formation. Panorama view towards the east.

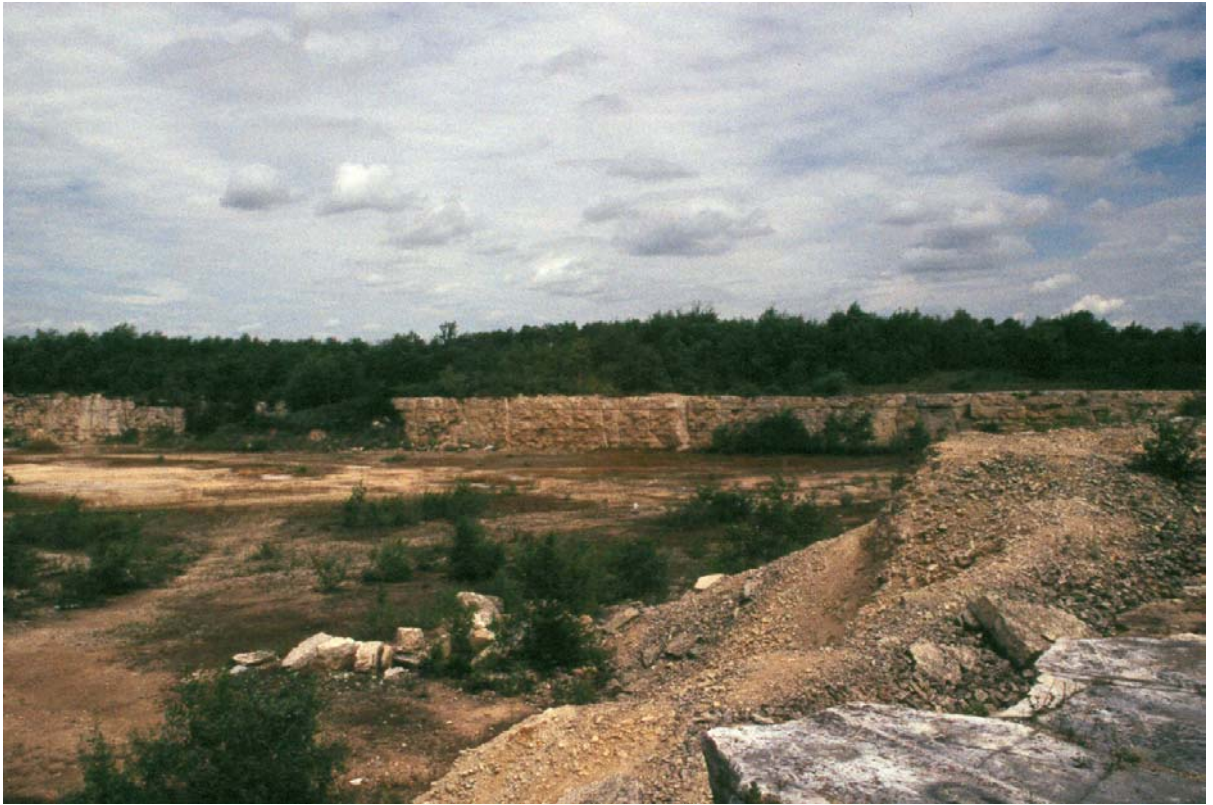
Gunn 04 – 1995-07-20, Gunn or No. 2 Quarry at Gunton. Gunton Member of the Stony Mountain Formation. Panorama view towards the southeast.

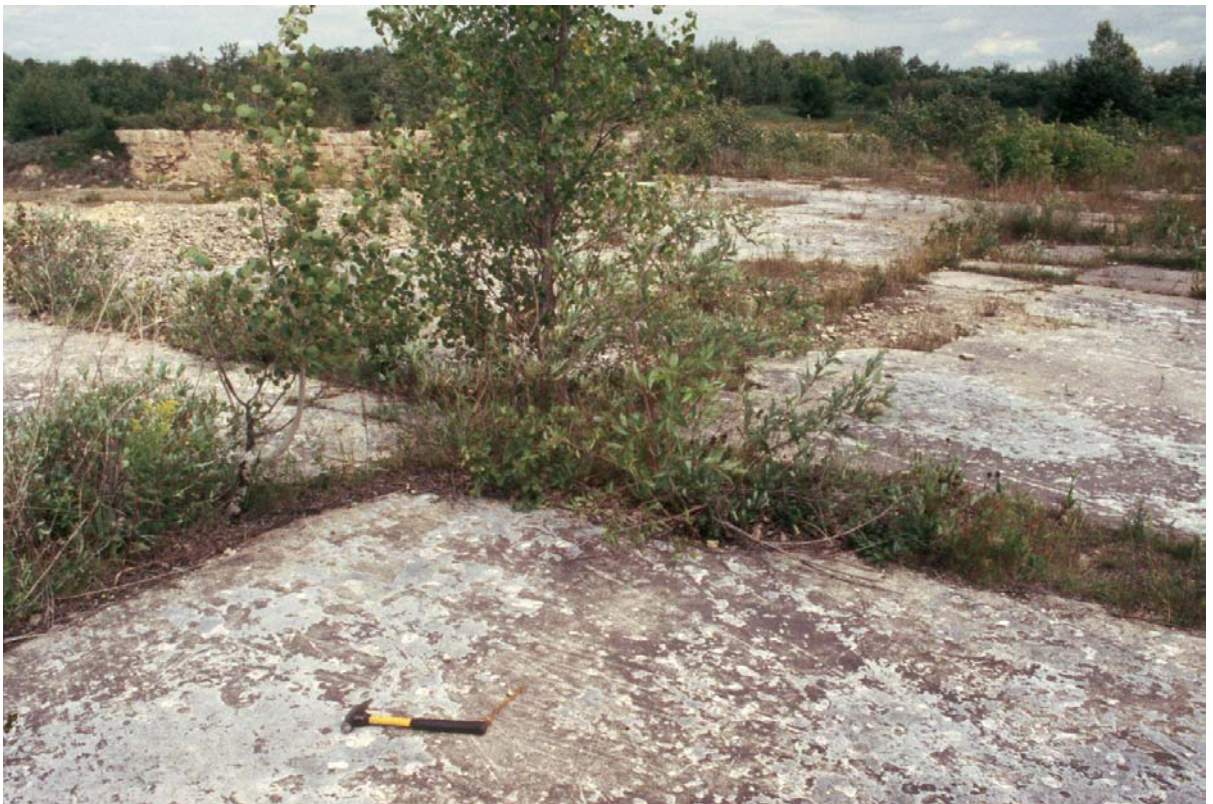
Gunn 05 – 1995-07-20, Gunn or No. 2 Quarry at Gunton. Gunton Member of the Stony Mountain Formation. Fracture pattern on stripped off surface of quarry, at southeast end.

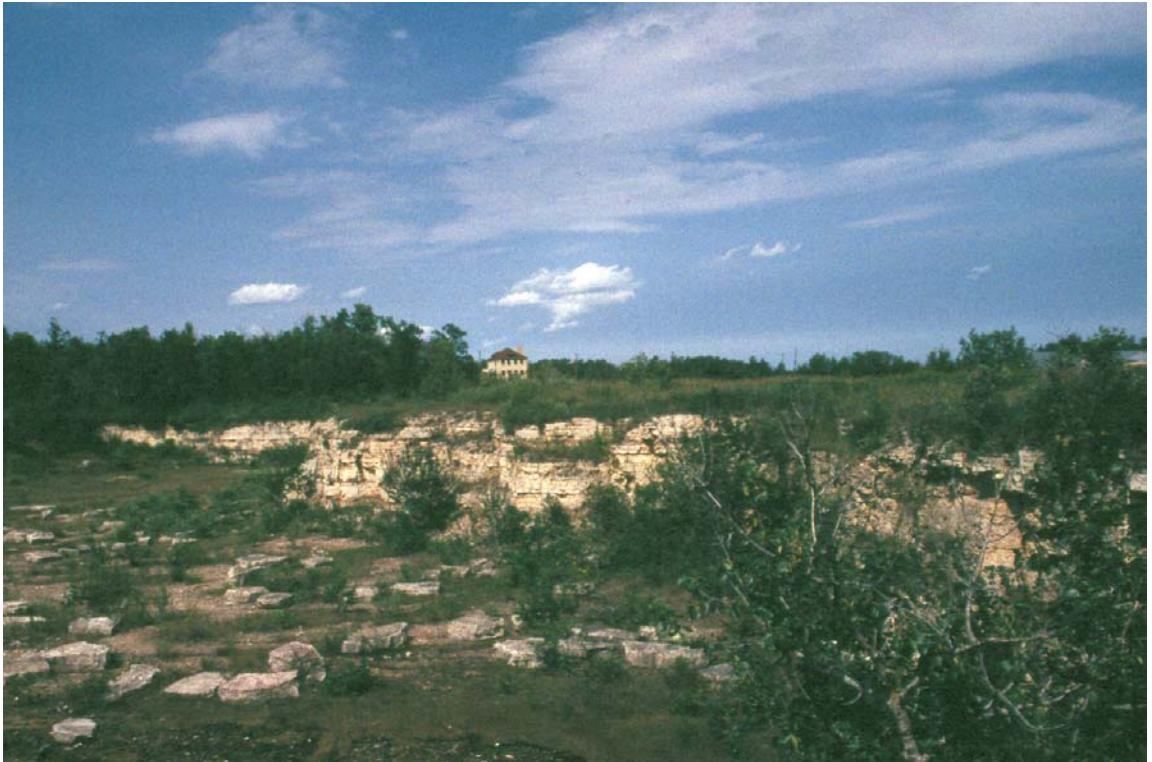
Lime 01 – 1995-07-20, Lime or No. 3 Quarry at Gunton, Gunton Member of the Stony Mountain Formation. School, in the background to the north, is constructed of Gunton Member material.

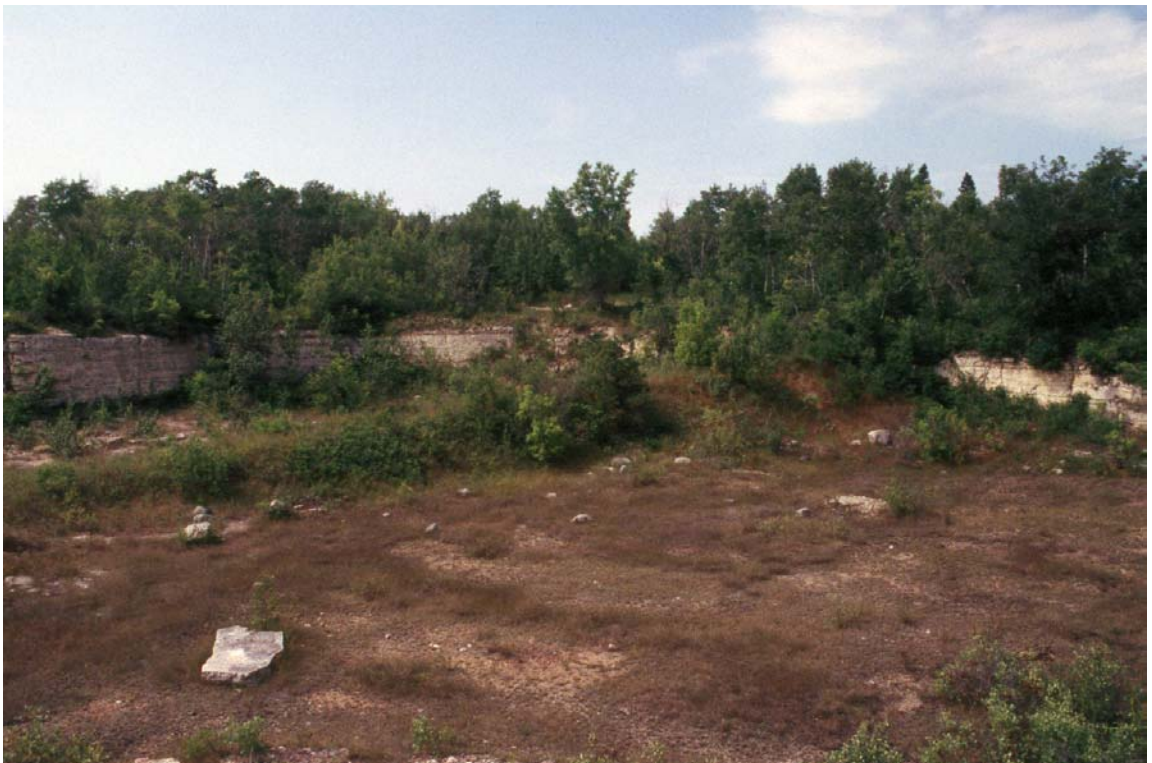
Lime 04 – 1995-07-20, Lime or No. 3 Quarry at Gunton, Gunton Member of the Stony Mountain Formation. Very overgrown and abandoned.
