## Appendix 1: Bedrock Quarries in the Capital Region Study Area

**NAME:** BORLAND QUARRY SOUTH

### Borland Quarry South

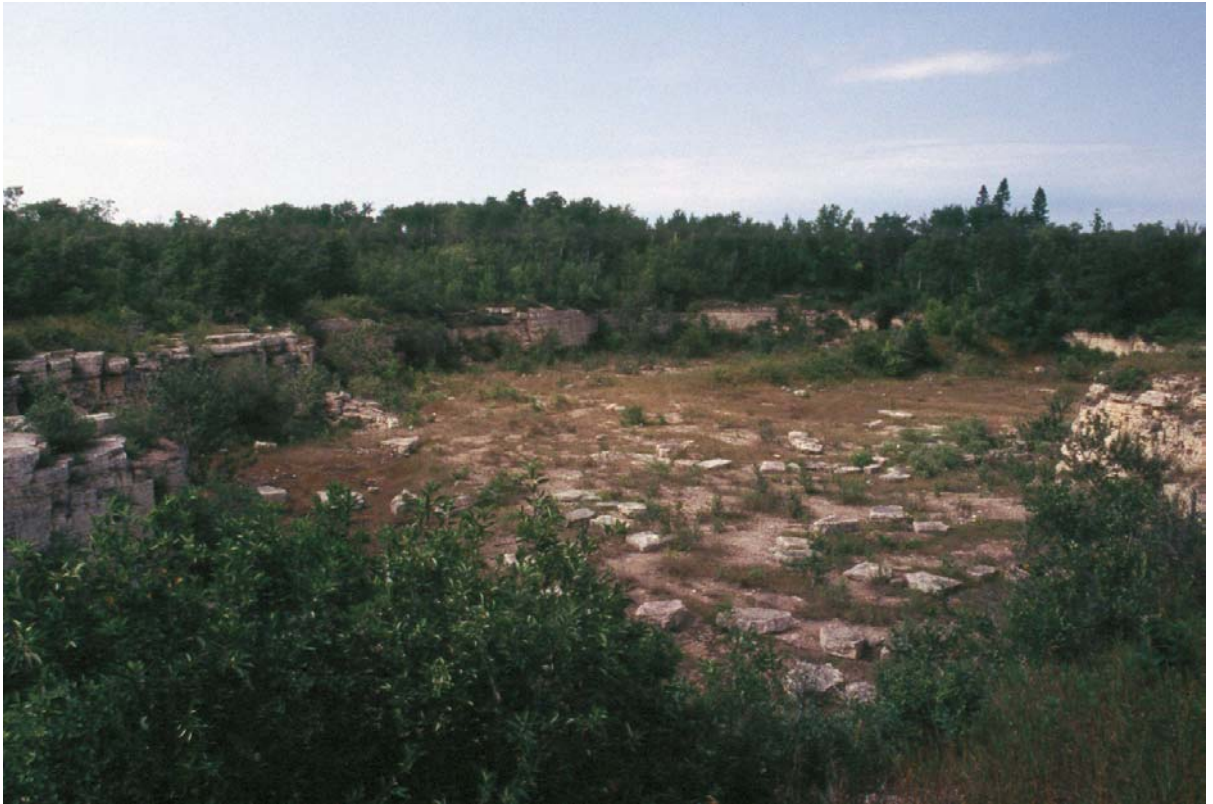
Lime 05 – 1995-07-20, Lime or No. 3 Quarry at Gunton, Gunton Member of the Stony Mountain Formation. Very overgrown and abandoned.

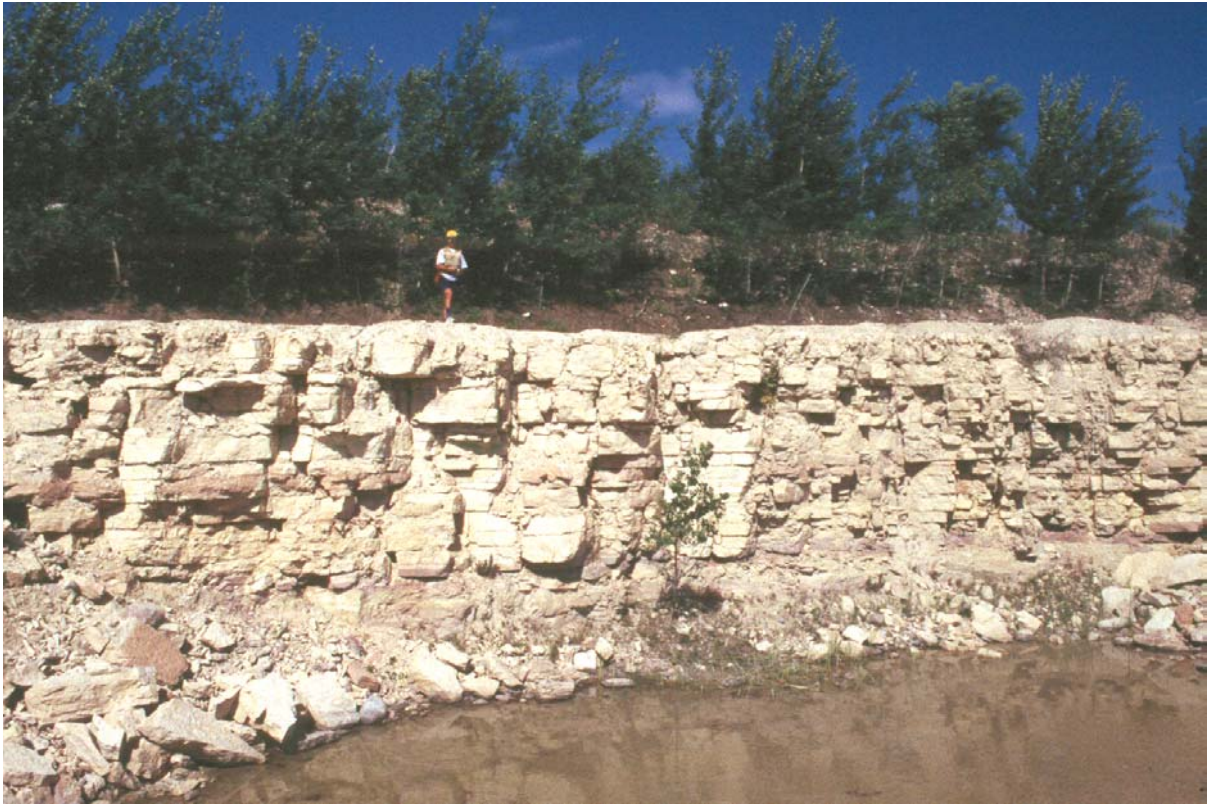
Gunton 01 – 1995-07-26, Gunton South Quarry, Gunton Member of the Stony Mountain Formation. West wall, near southwest corner of quarry. JDB for scale.

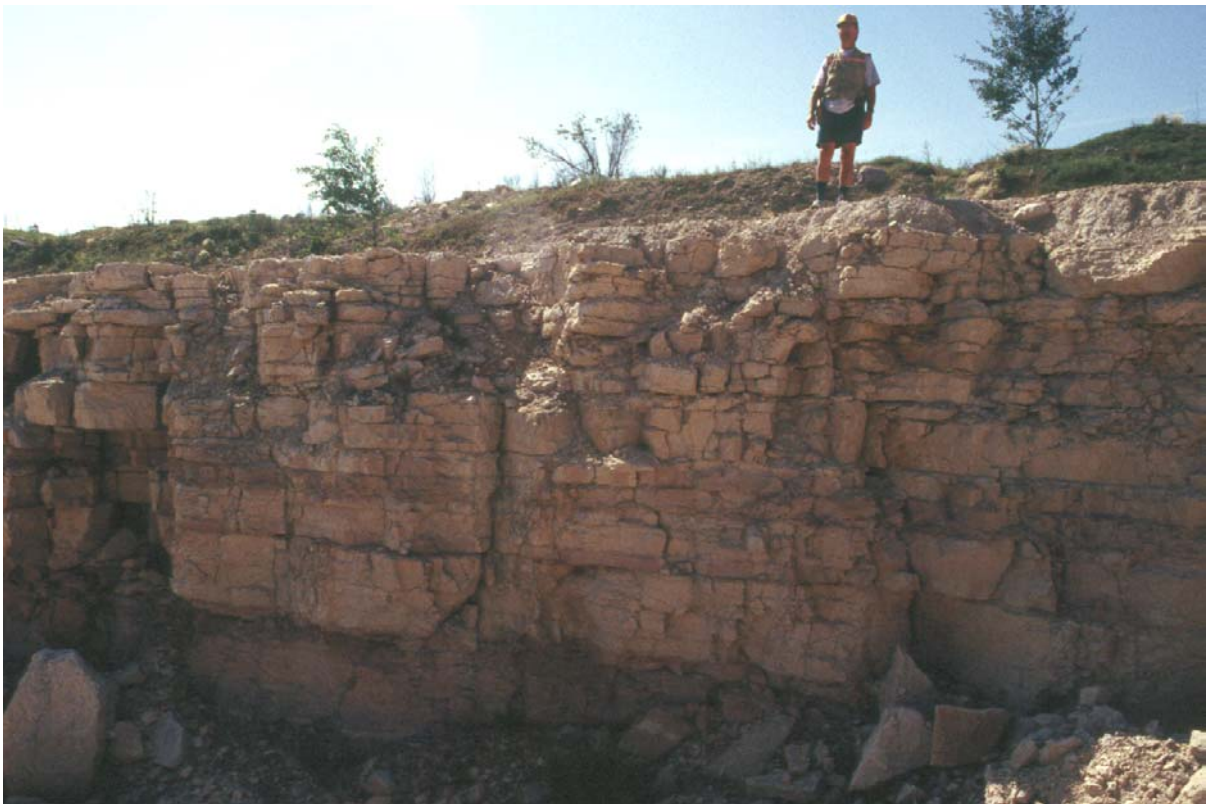
Gunton 02 – 1995-07-26, Gunton South Quarry, Gunton Member of the Stony Mountain Formation. South wall, near southwest corner of quarry. JDB for scale.

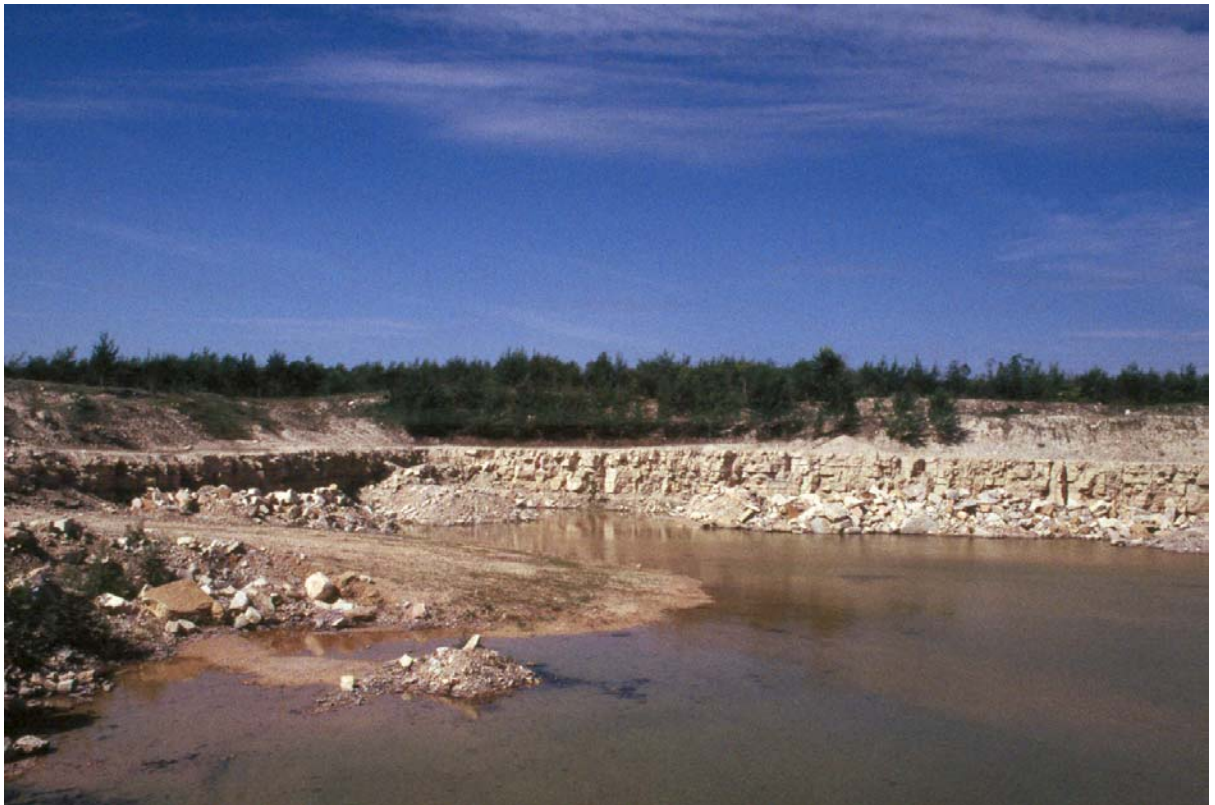
Gunton 03 – 1995-07-26, Gunton South Quarry, Gunton Member of the Stony Mountain Formation. Panorama view towards the southwest.

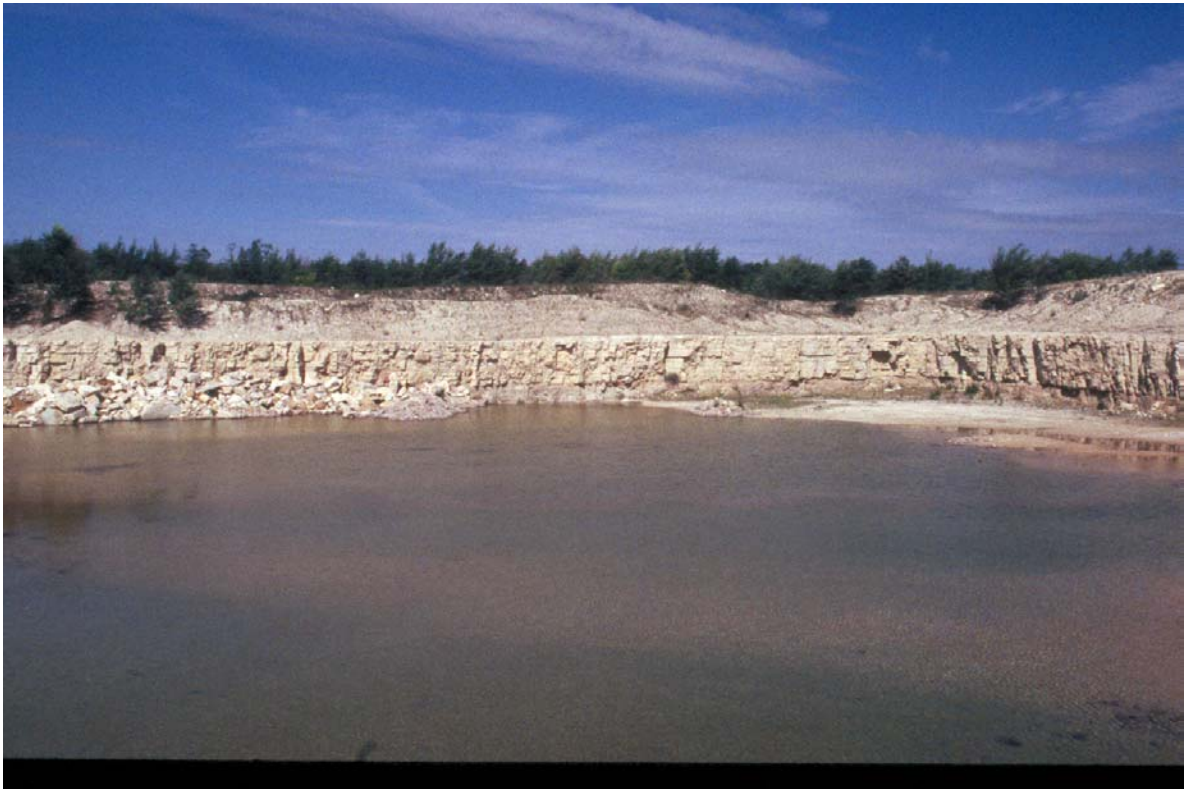
Gunton 04 – 1995-07-26, Gunton South Quarry, Gunton Member of the Stony Mountain Formation. Panorama view towards the west.

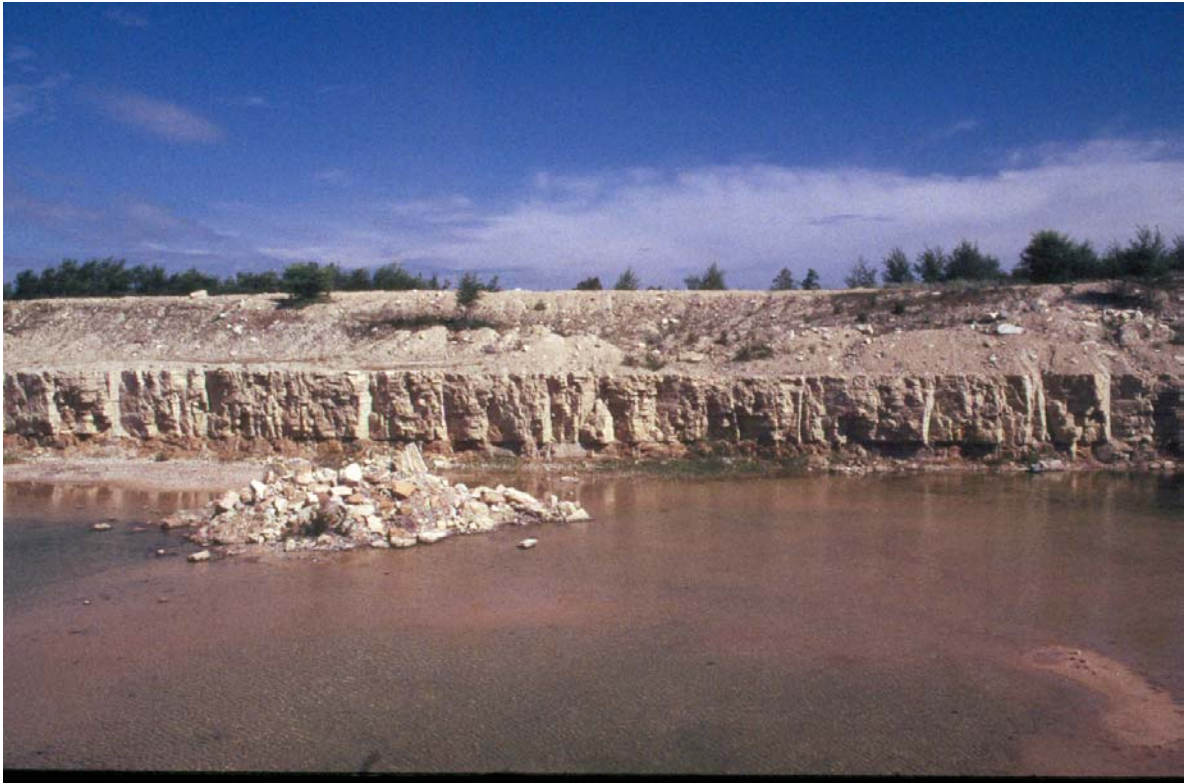
Gunton 05 – 1995-07-26, Gunton South Quarry, Gunton Member of the Stony Mountain Formation. Panorama view towards the northwest.

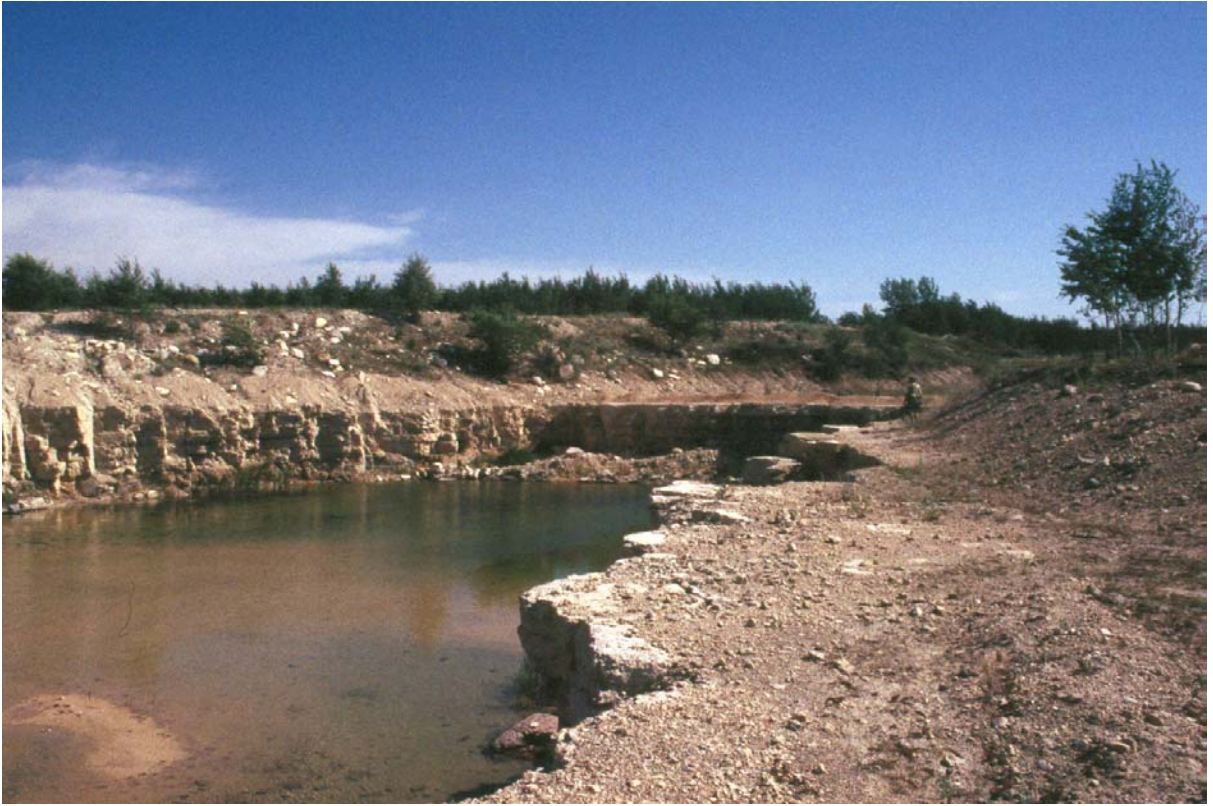
Gunton 06 – 1995-07-26, Gunton South Quarry, Gunton Member of the Stony Mountain Formation. Panorama view towards the north-northeast.

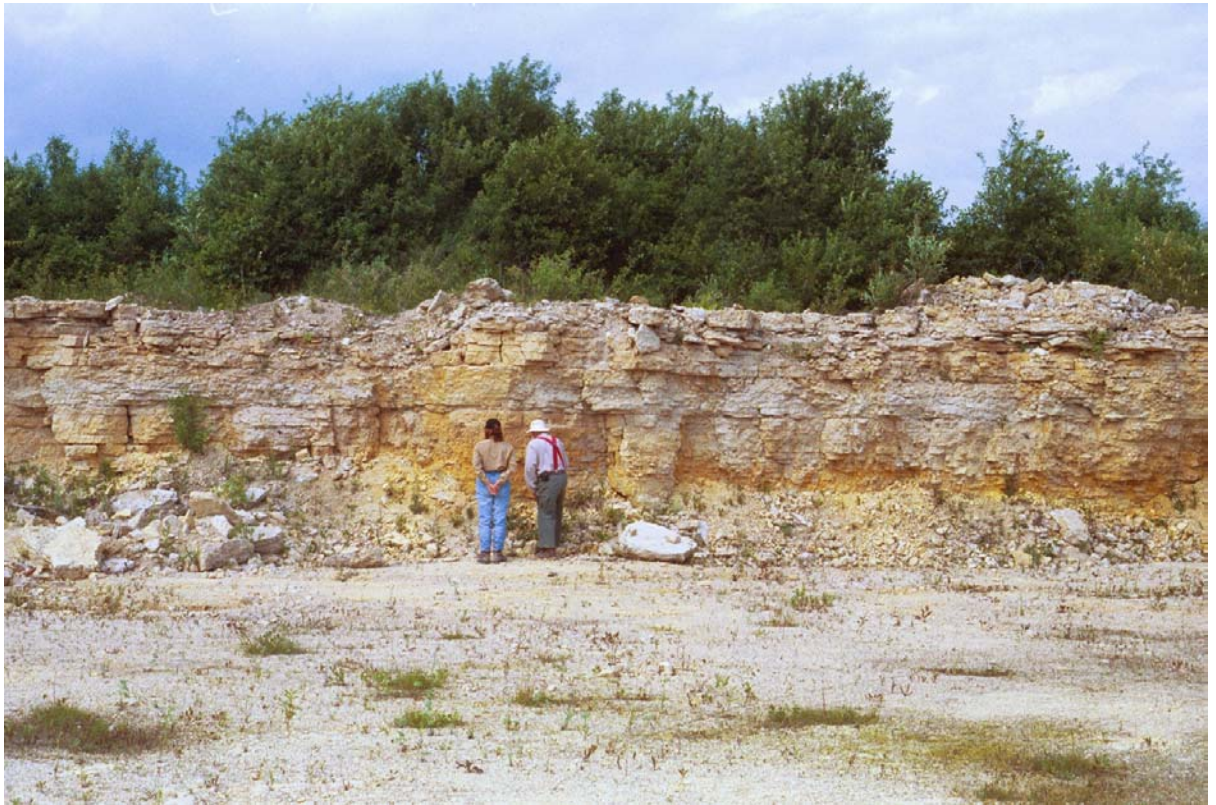
Komarno 014 – 2001-06-20, Gunton Member of the Stony Mountain Formation. View of the north wall. RKB and Ed Dobrzanski for scale.

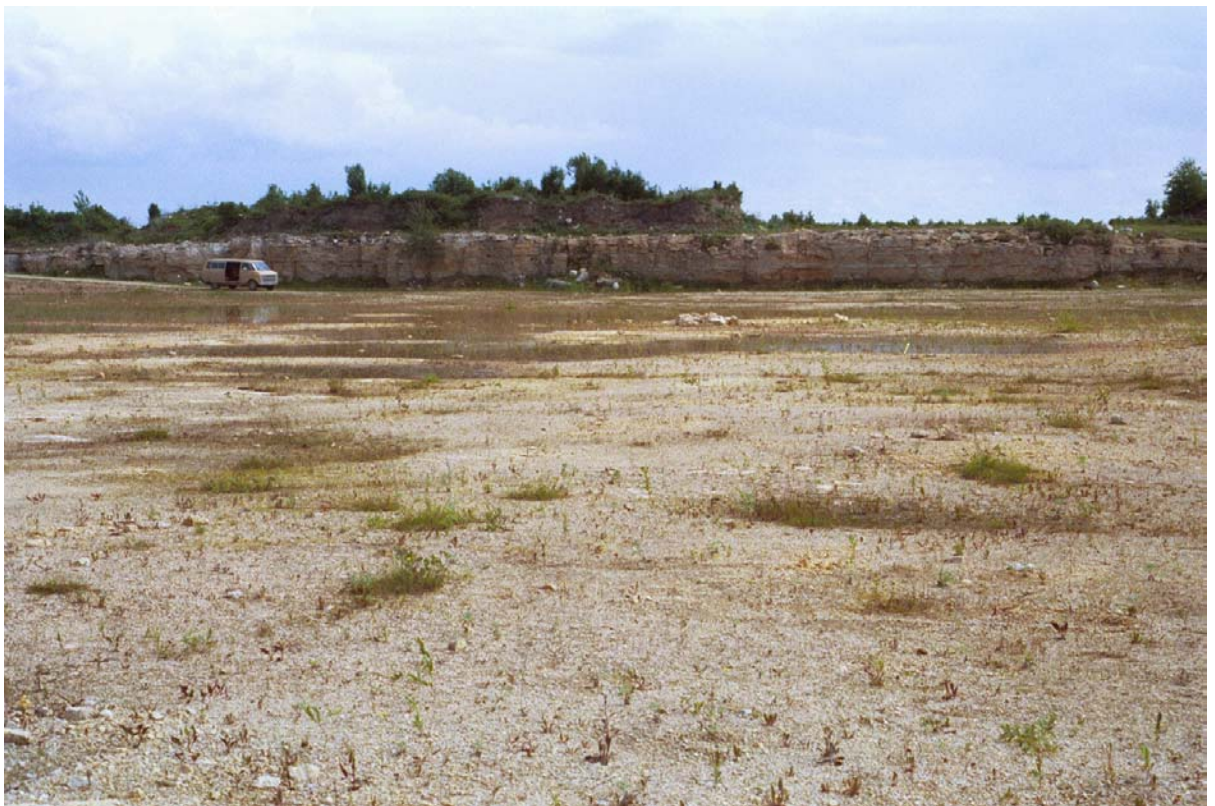
Komarno 013 – 2001-06-20, Gunton Member of the Stony Mountain Formation. View towards the south. Van for scale.

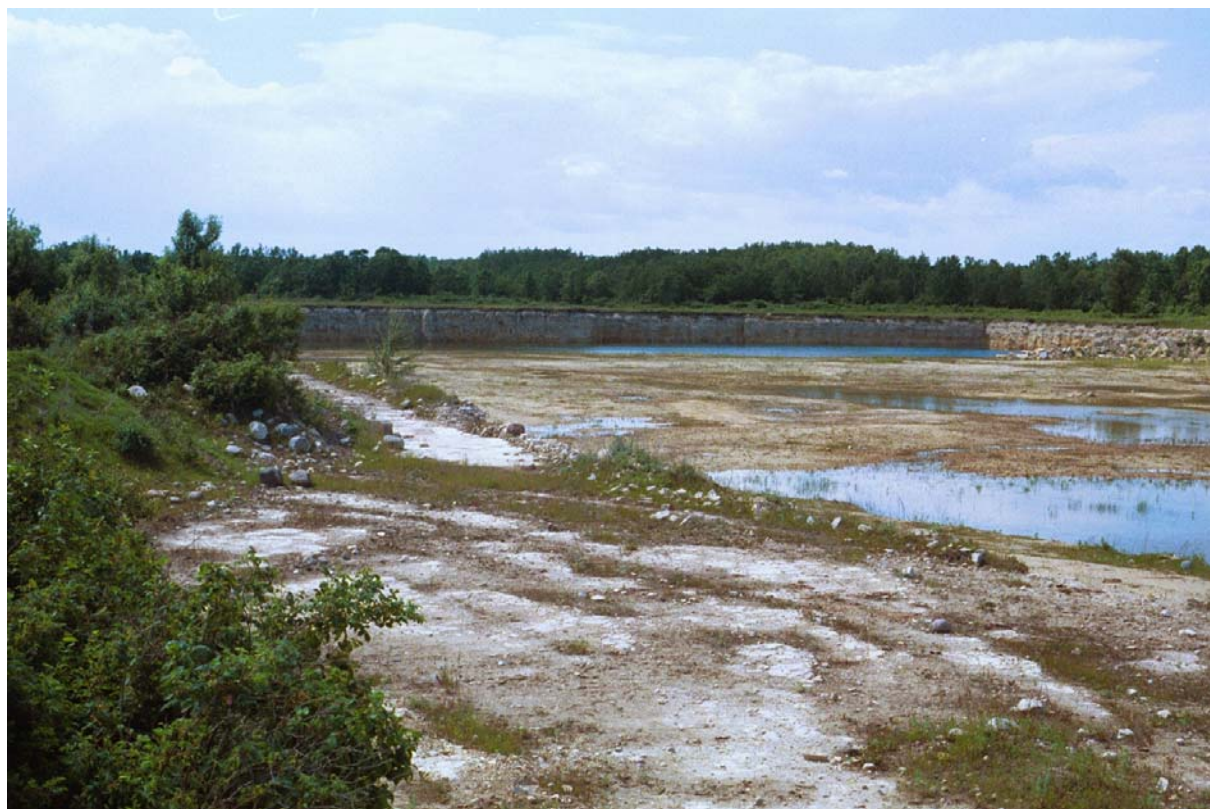
Komarno 012 – 2001-06-20, Gunton Member of the Stony Mountain Formation. View towards the west.

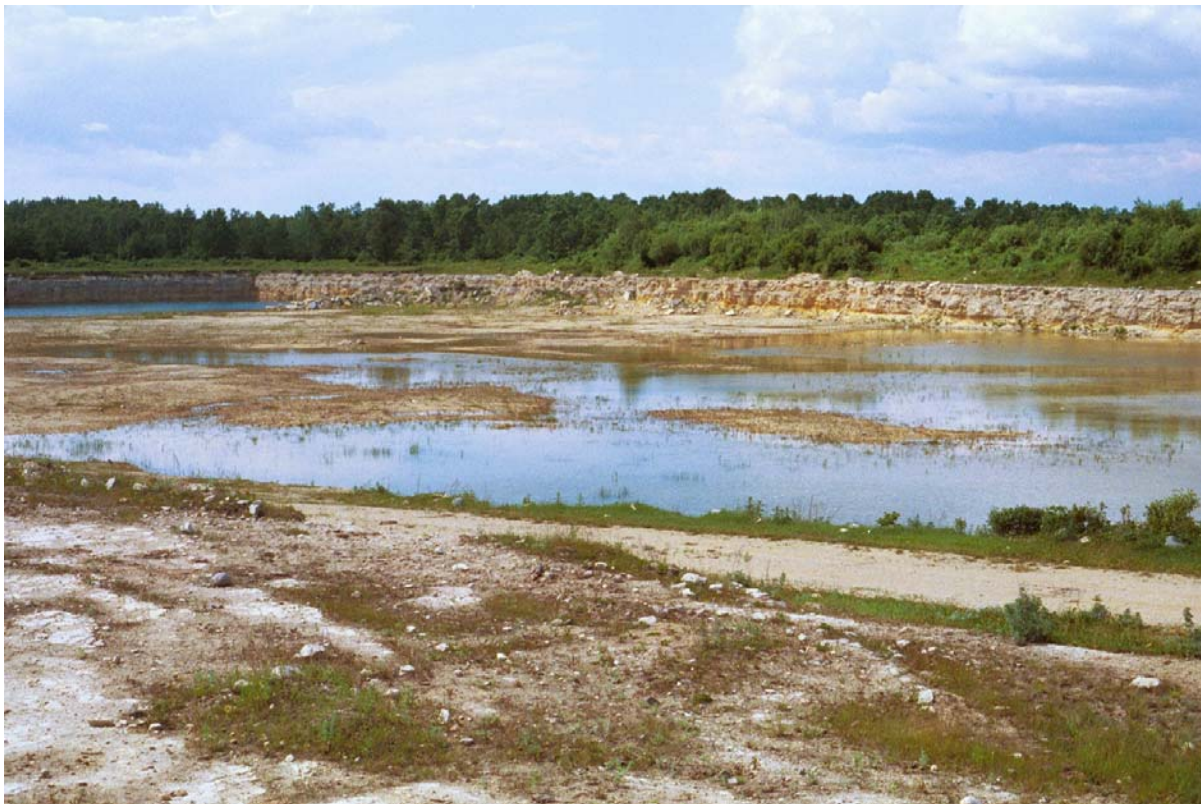
Komarno 011 – 2001-06-20, Gunton Member of the Stony Mountain Formation. View towards the northwest.

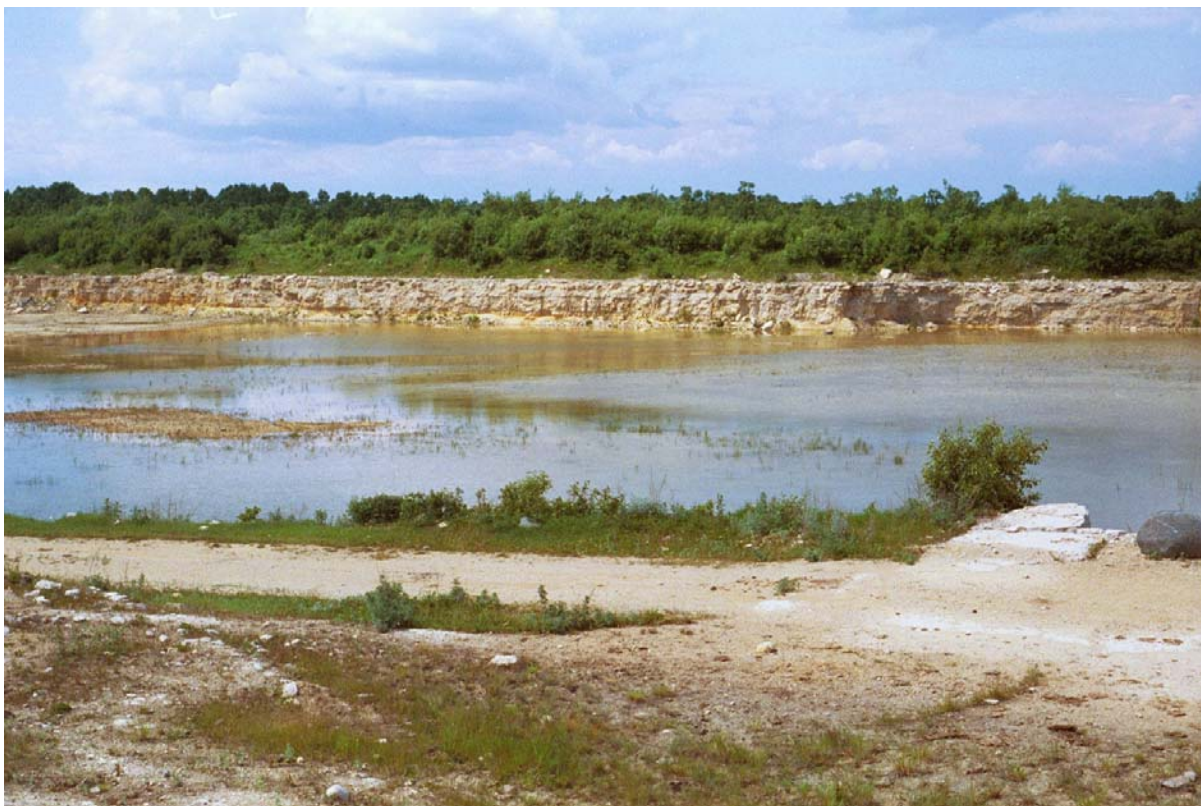
Komarno 010 – 2001-06-20, Gunton Member of the Stony Mountain Formation. View towards the north.

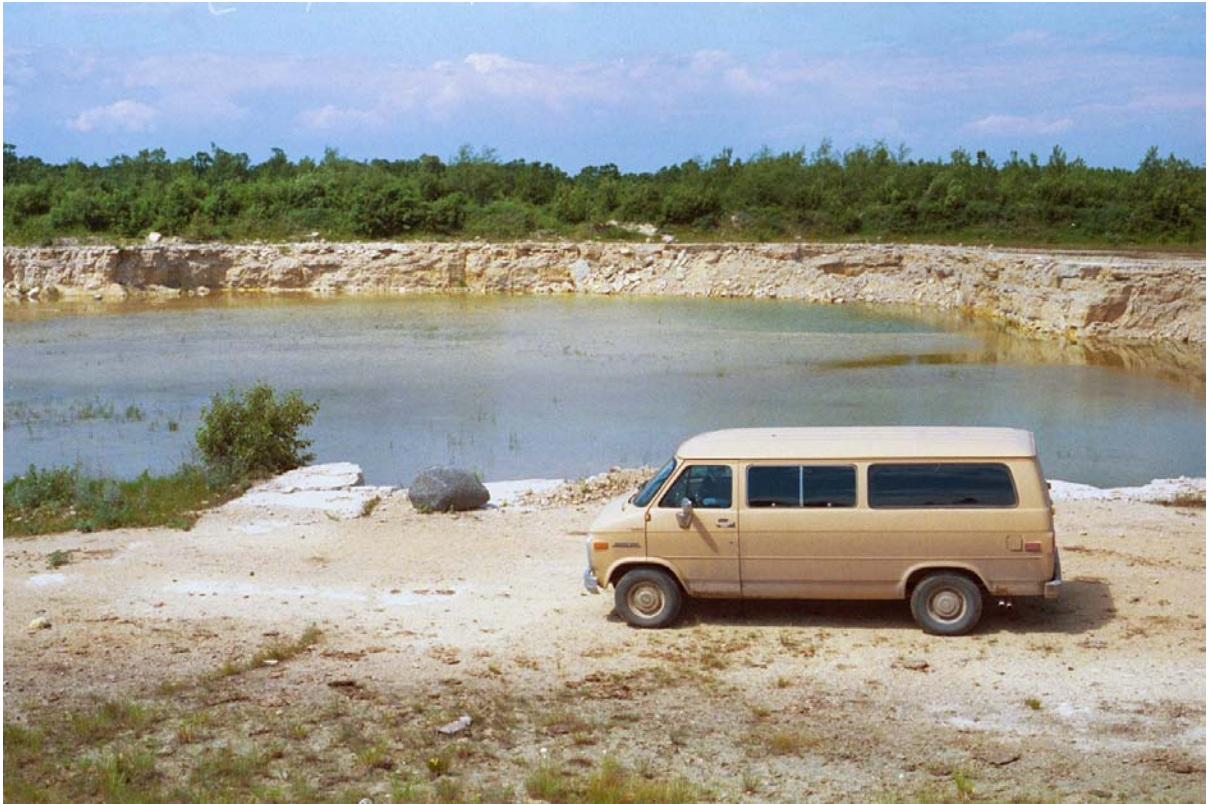
Komarno 09 – 2001-06-20, Gunton Member of the Stony Mountain Formation. View to the north-northeast.

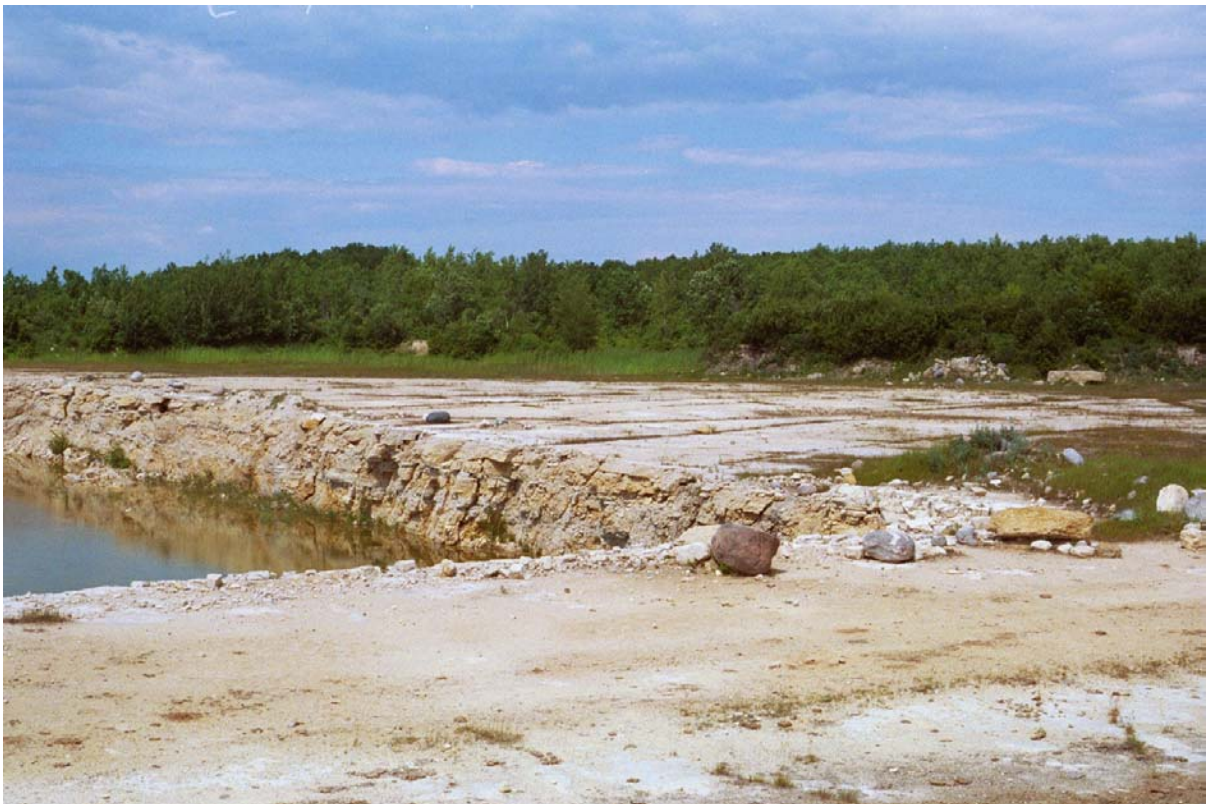
Komarno 08 – 2001-06-20, Gunton Member of the Stony Mountain Formation. View towards the northeast.

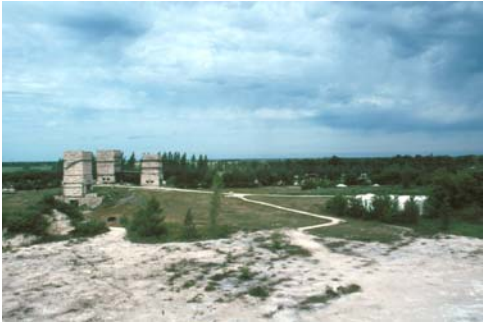
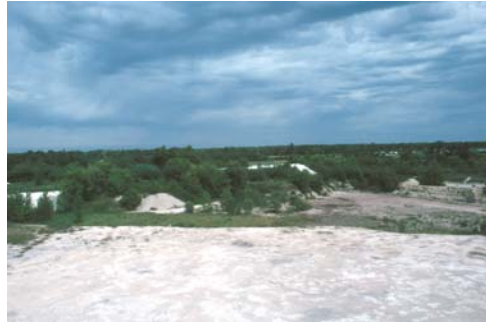
Stonewall 01 & 02 - 1995-08-02, Three lime kilns at Stonewall Quarry Park, formerly used to produce dolime or dolomitic lime. View to northwest and north.

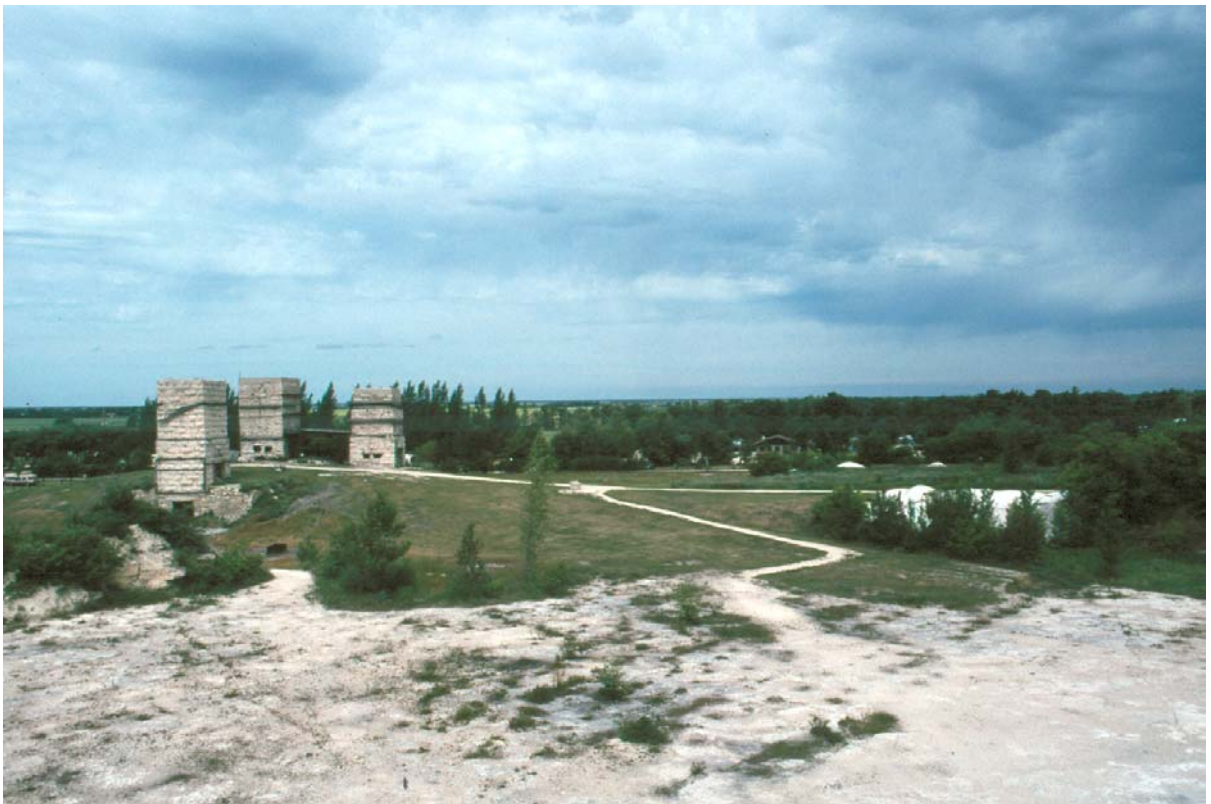
Stonewall 01 - 1995-08-02, Three lime kilns at Stonewall Quarry Park, formerly used to produce dolime or dolomitic lime. View towards the northwest.

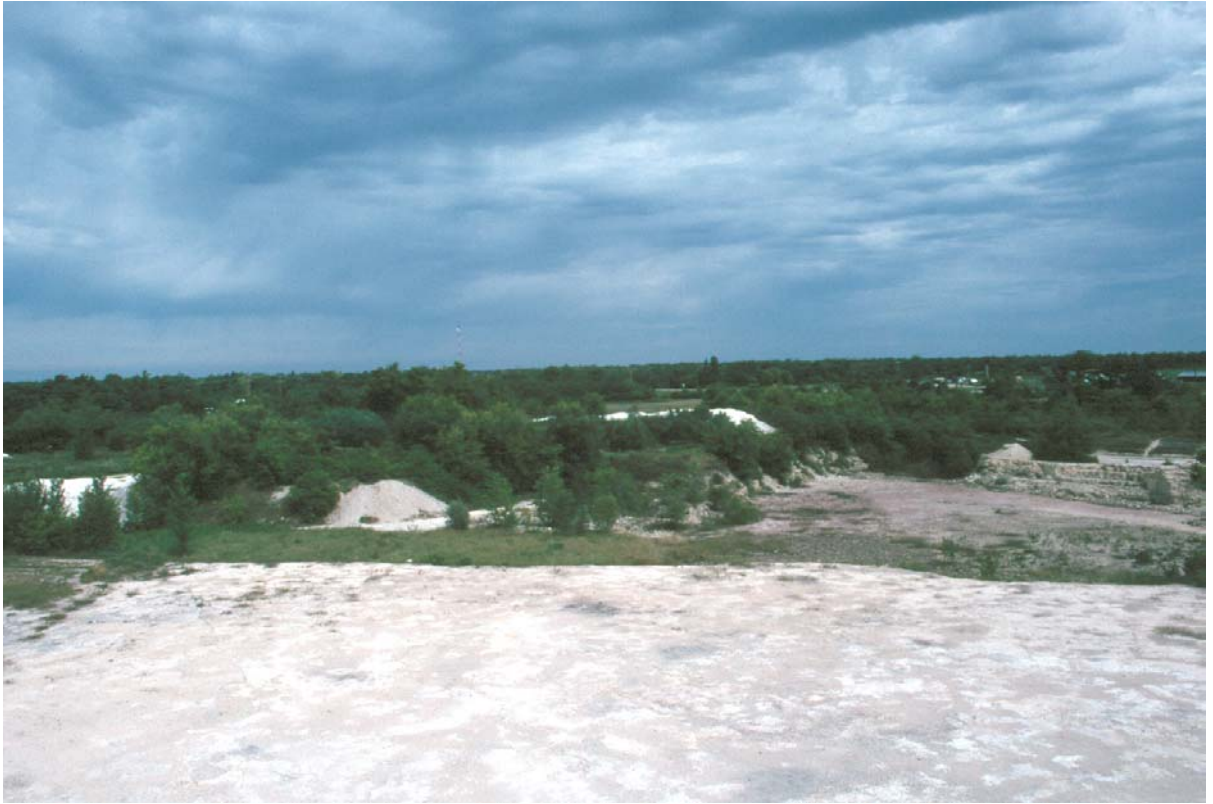
Stonewall 02 - 1995-08-02, Three lime kilns at Stonewall Quarry Park, formerly used to produce dolime or dolomitic lime. View towards the north.

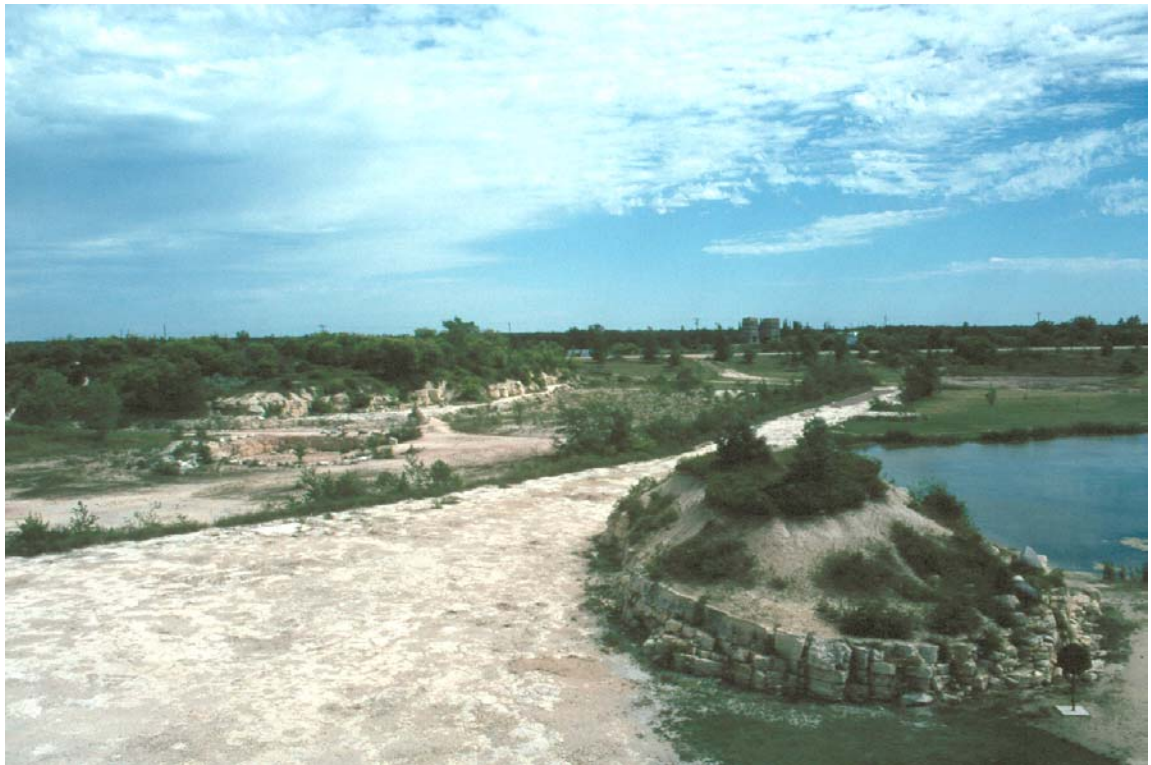
Stonewall 03 - 1995-08-02, Former quarry at Stonewall Quarry Park, looking east-northeast, kilns across PR236, in distant background.

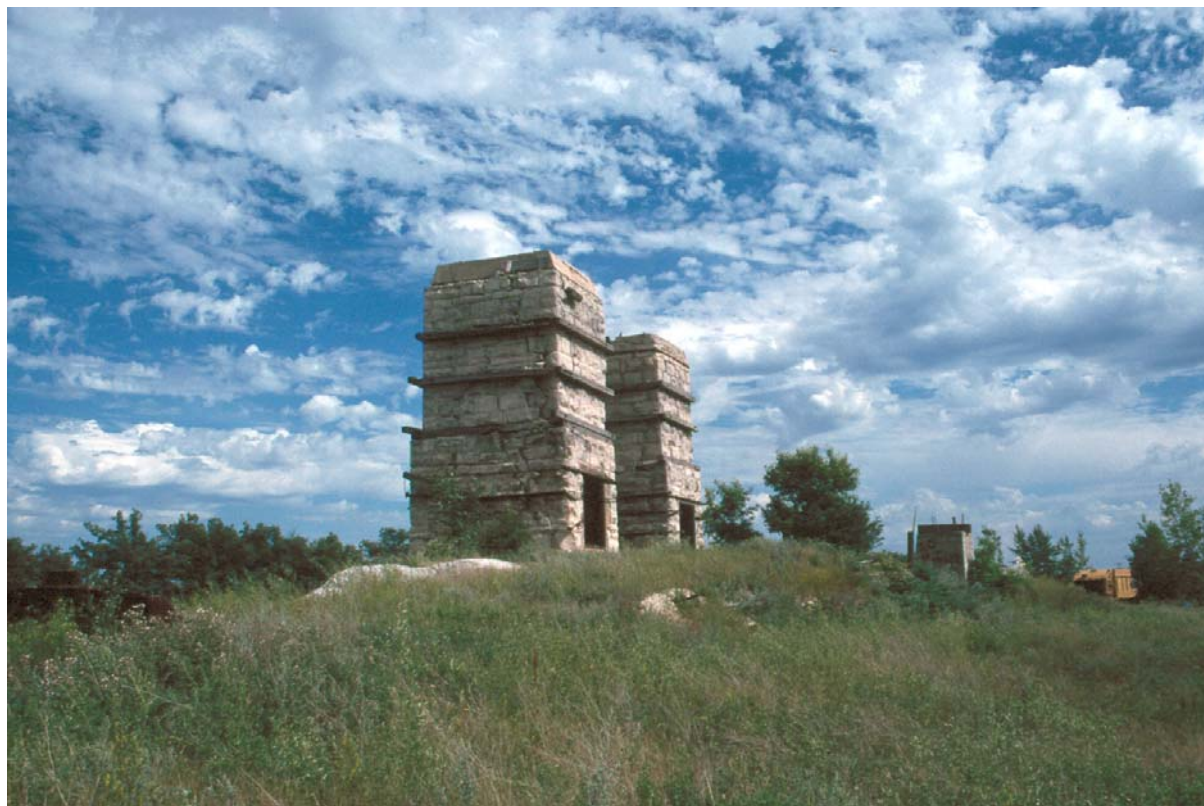
Stonewall 12 - 1995-08-02, Lime kilns east of PR236 and Stonewall Quarry Park.

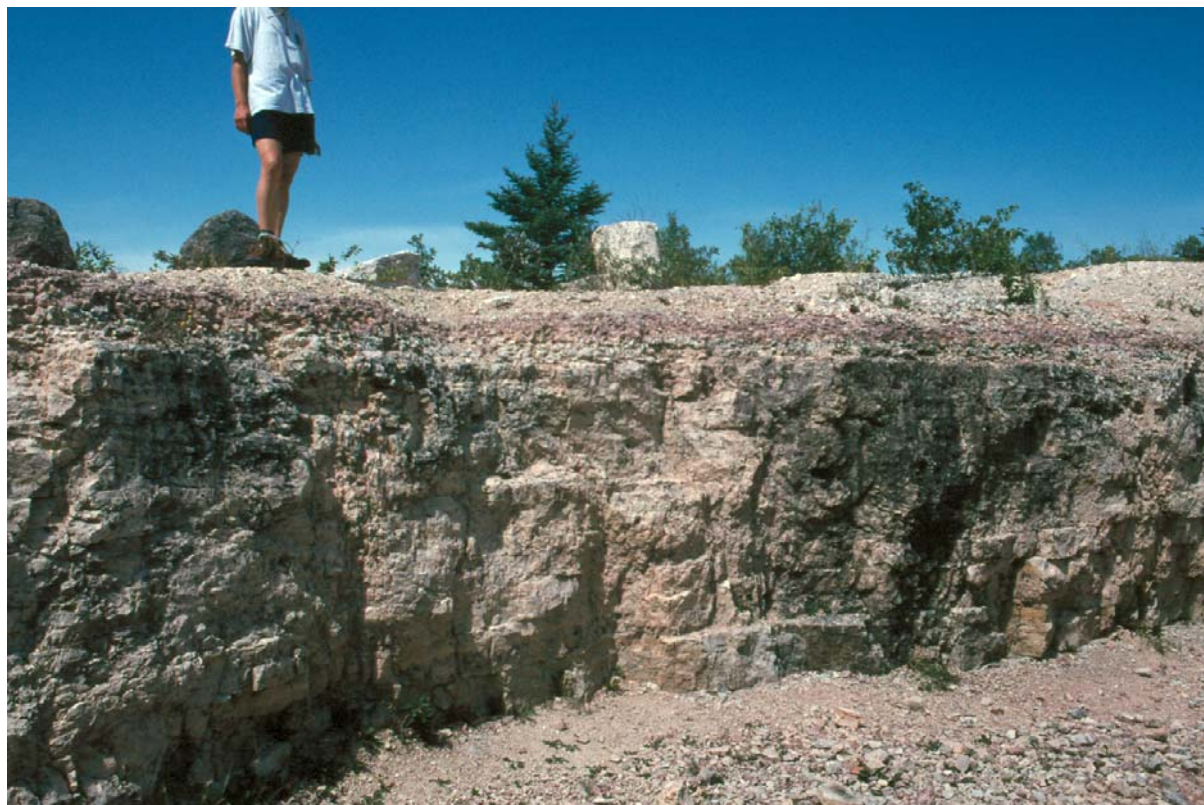
Stonewall 05 - 1995-08-02, Williams Member (Stonewall Formation) in pit within former quarry at Stonewall Quarry Park, west wall.

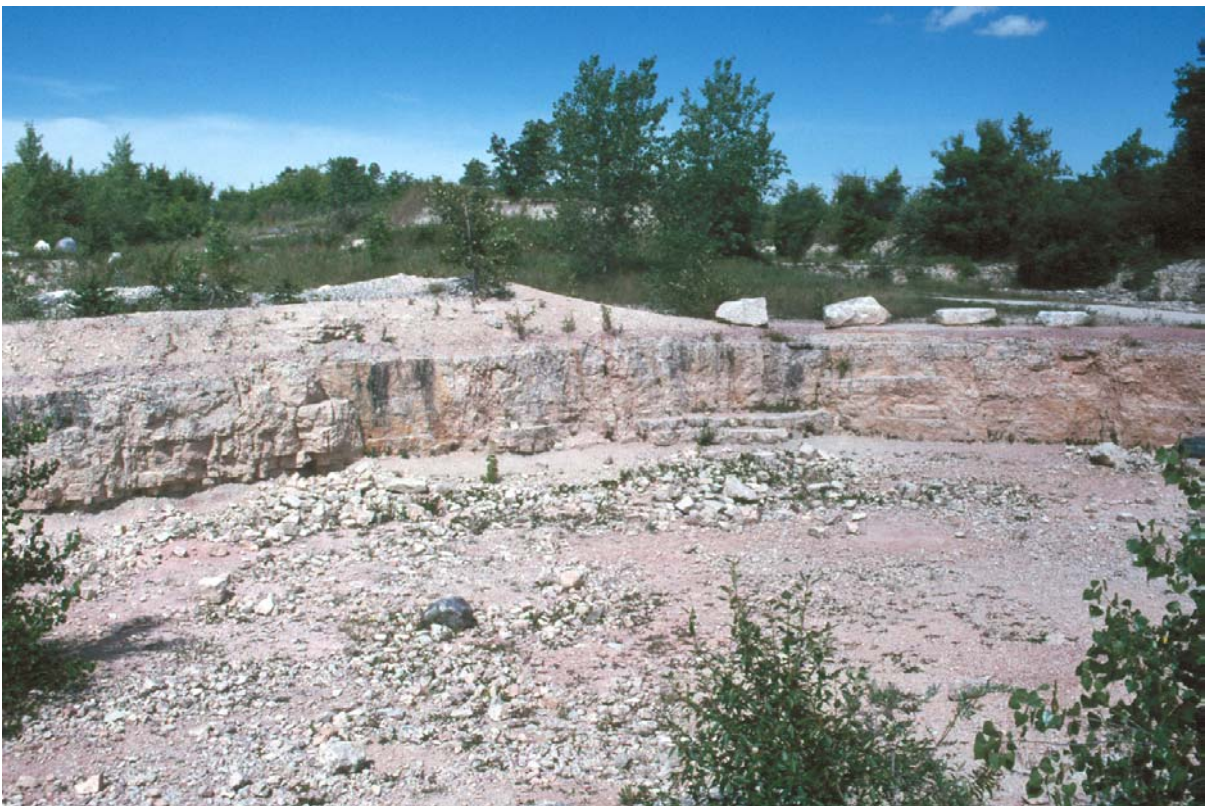
Stonewall 07 - 1995-08-02, Williams Member (Stonewall Formation) in pit within former quarry at Stonewall Quarry Park, north wall of pit.

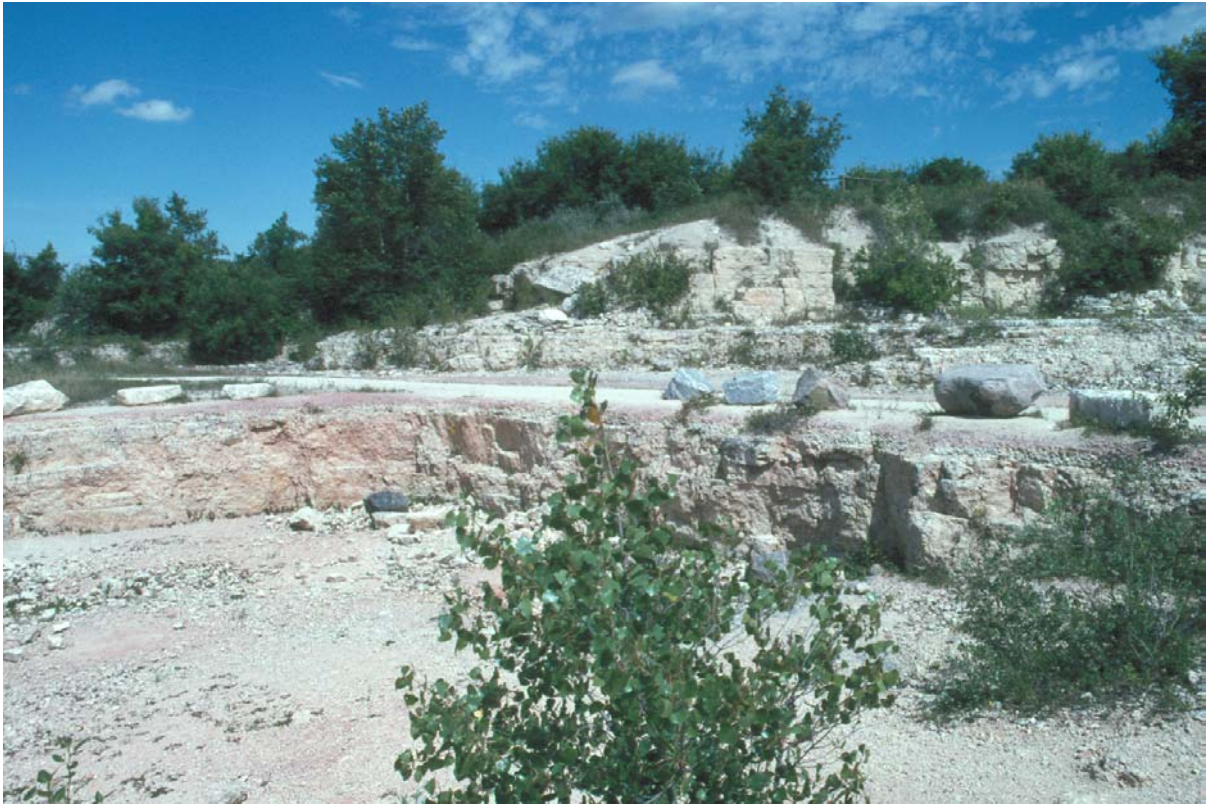
Stonewall 08 - 1995-08-02, Williams Member (Stonewall Formation) in pit within former quarry at Stonewall Quarry Park, northeast wall of pit.

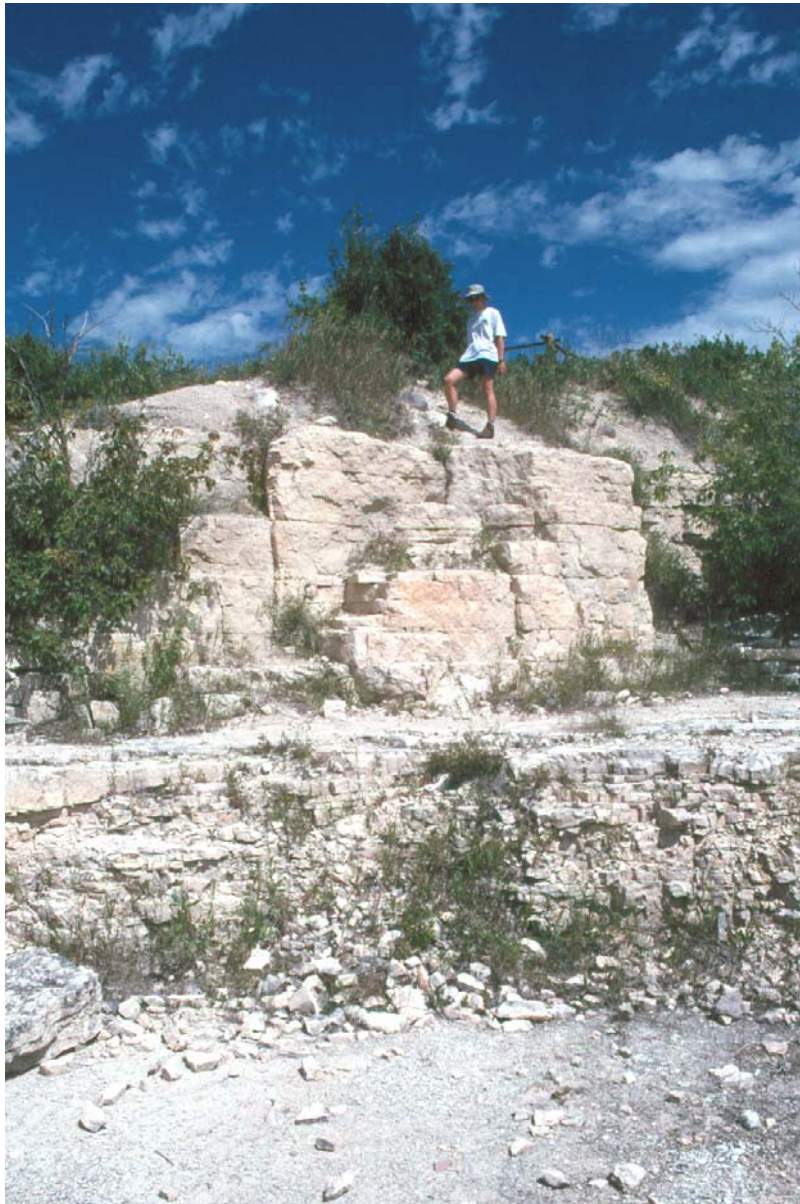
Stonewall 09 - 1995-08-02, Williams Member (Stonewall Formation) in pit in foreground. Lower Stonewall Formation in background, within former quarry at Stonewall Quarry Park, looking northeast. Karla Horsman for scale.
