## Appendix 1: Bedrock Quarries in the Capital Region Study Area

**NAME:** BORLAND QUARRY SOUTH

### Borland Quarry South

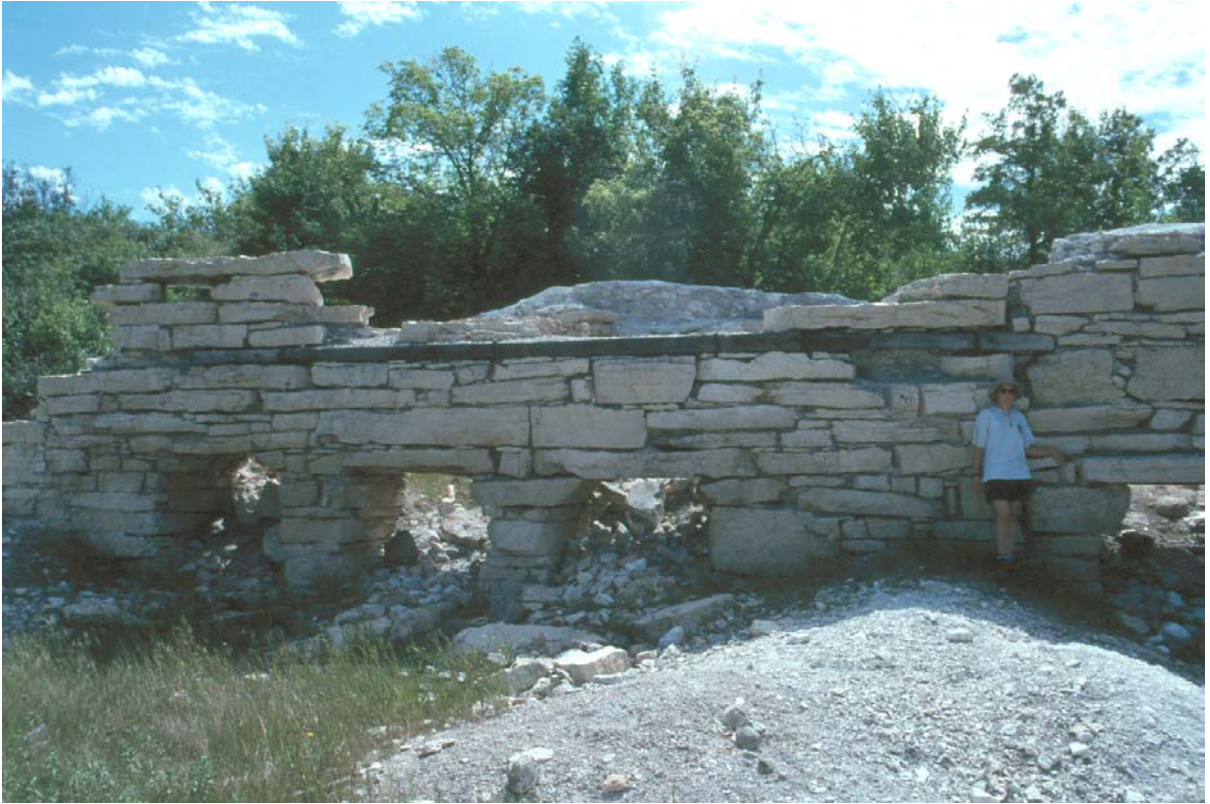
Stonewall 10 - 1995-08-02, Horizontal kilns (east side) at Stonewall Quarry Park, looking south.  
Karla Horsman for scale.

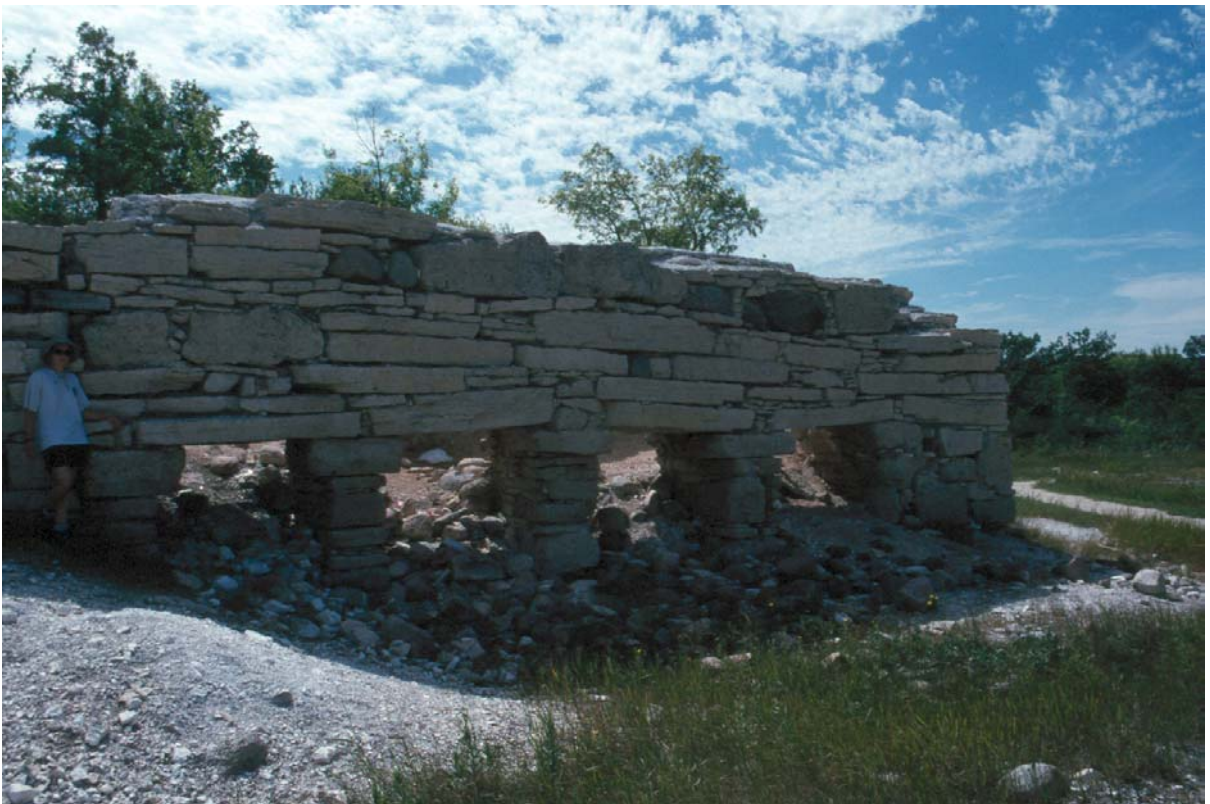
Stonewall 11 - 1995-08-02, Horizontal kilns (west side) at Stonewall Quarry Park, looking south.  
Karla Horsman for scale.

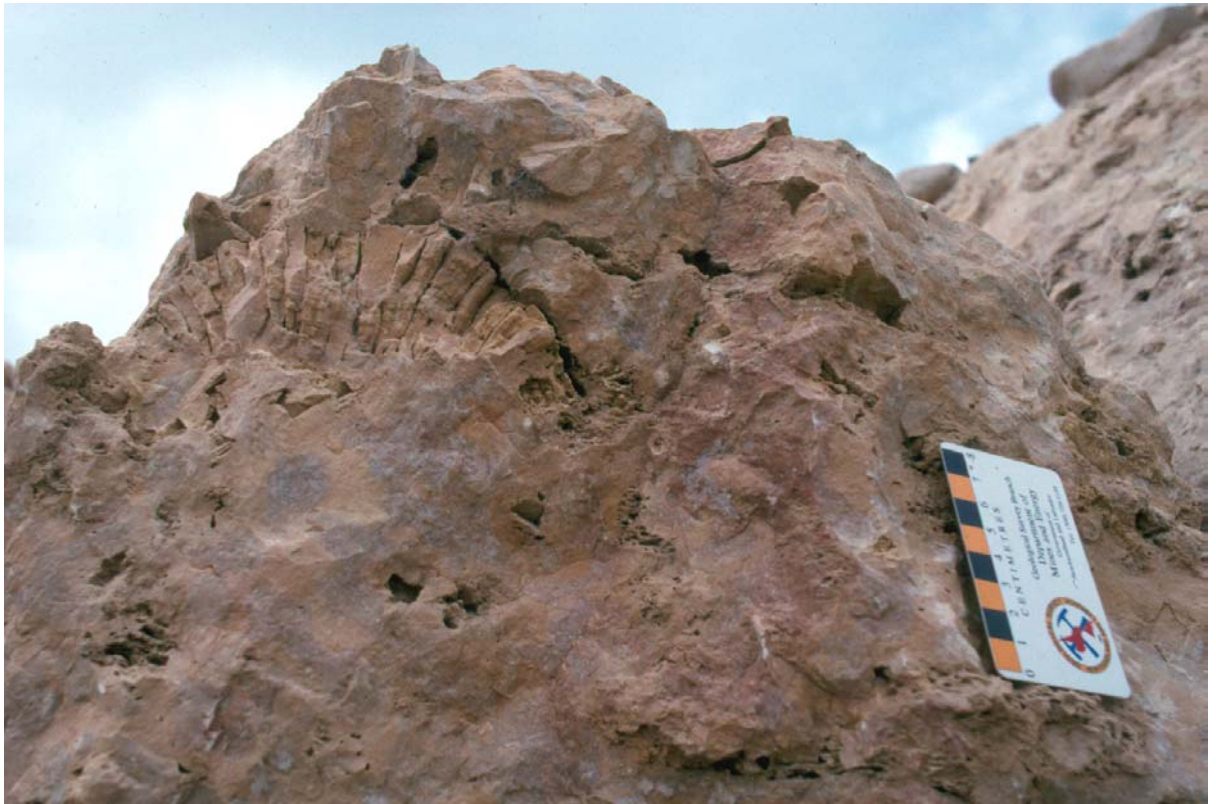
Lilyfield 01 - 1995-08-02, Close-up of vuggy mottled dolomite of the Gunton Member of the Stony Mountain Formation in the Lilyfield North Quarry.

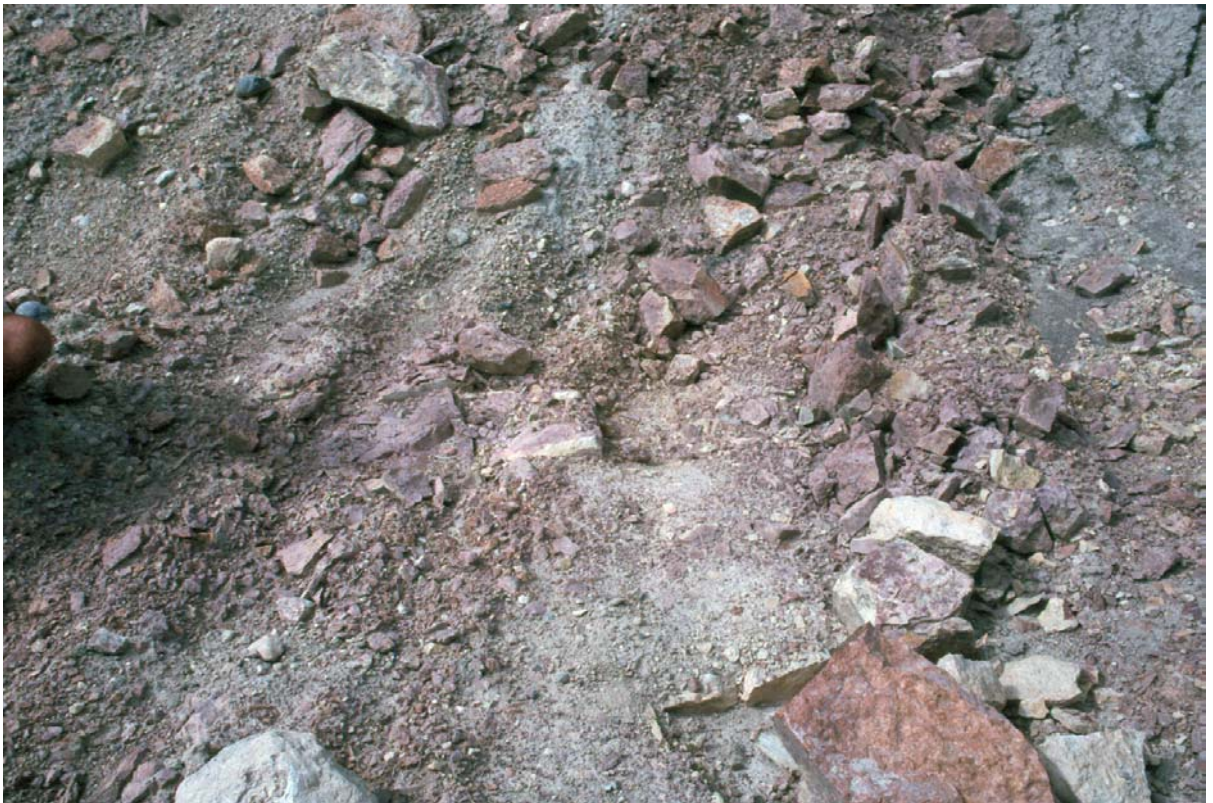
Lilyfield 05 - 1995-08-02, View of quarry floor, Penitentiary Member (Stony Mountain Formation)  
Lilyfield North Quarry.

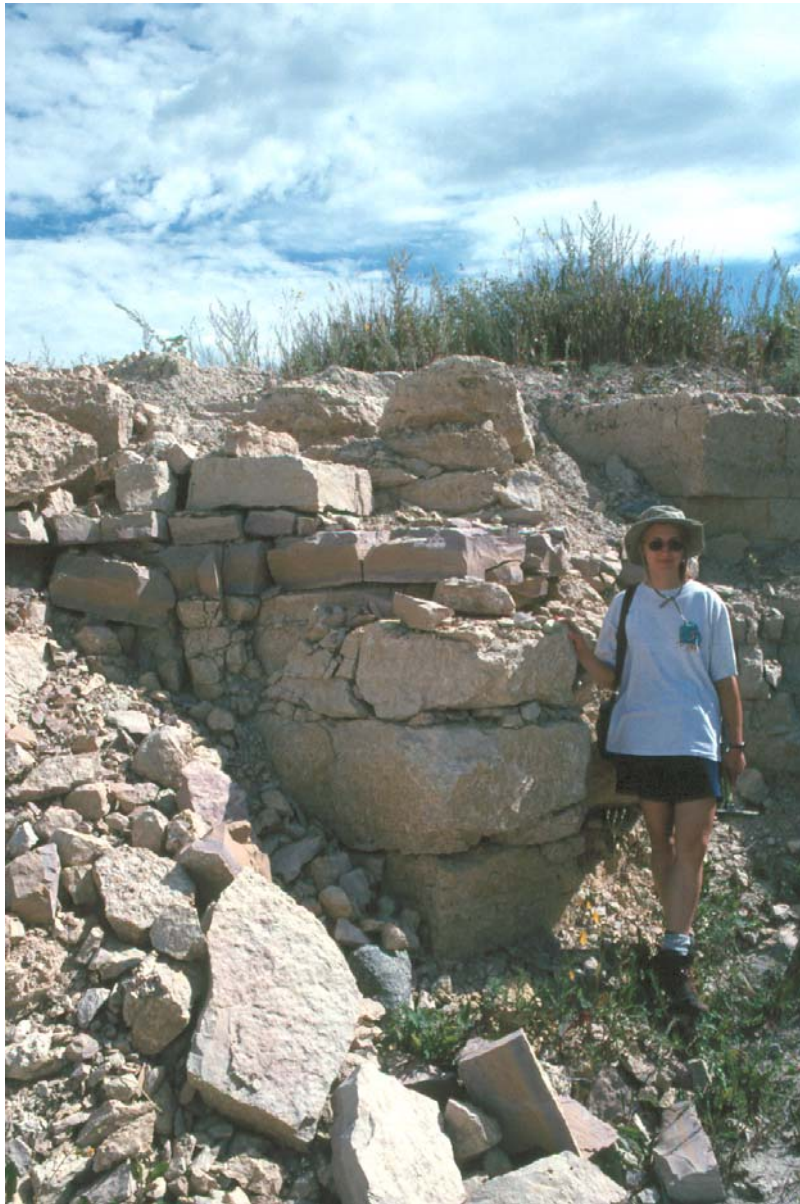
Lilyfield 06 - 1995-08-02, Caprock of Lilyfield North Quarry, Gunton Member of the Stony Mountain Formation. Karla Horseman for scale.

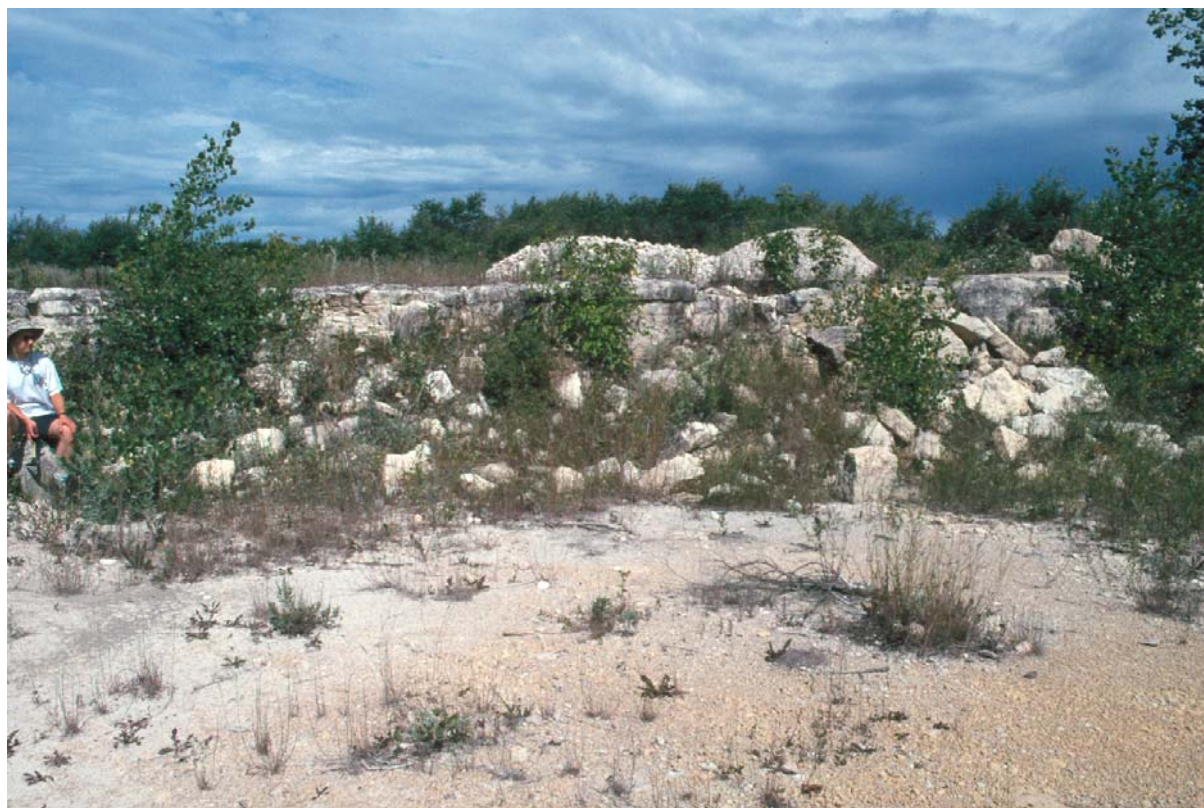
Lilyfield 07 - 1995-08-02, Lilyfield South Quarry, Gunton Member of the Stony Mountain Formation. View looking southeast.

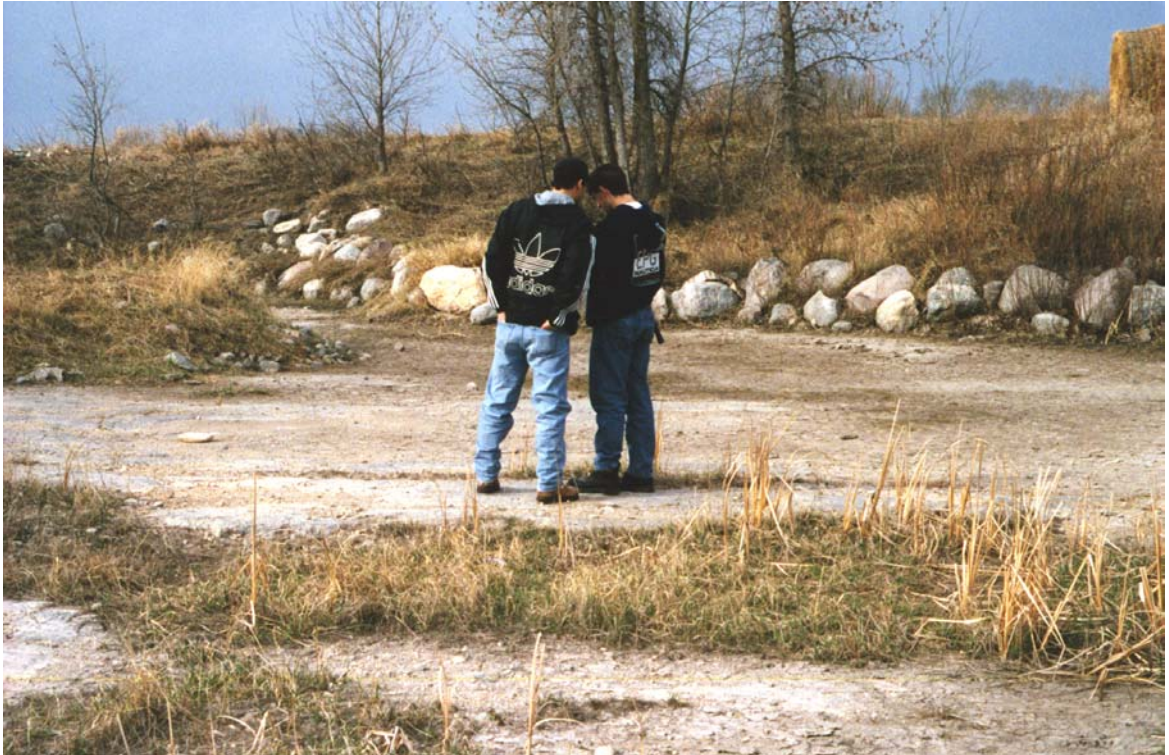
Rosser 01 - 1999-04-26, Rosser Pit, pavement is Gunton Member of the Stony Mountain Formation, looking southwest.

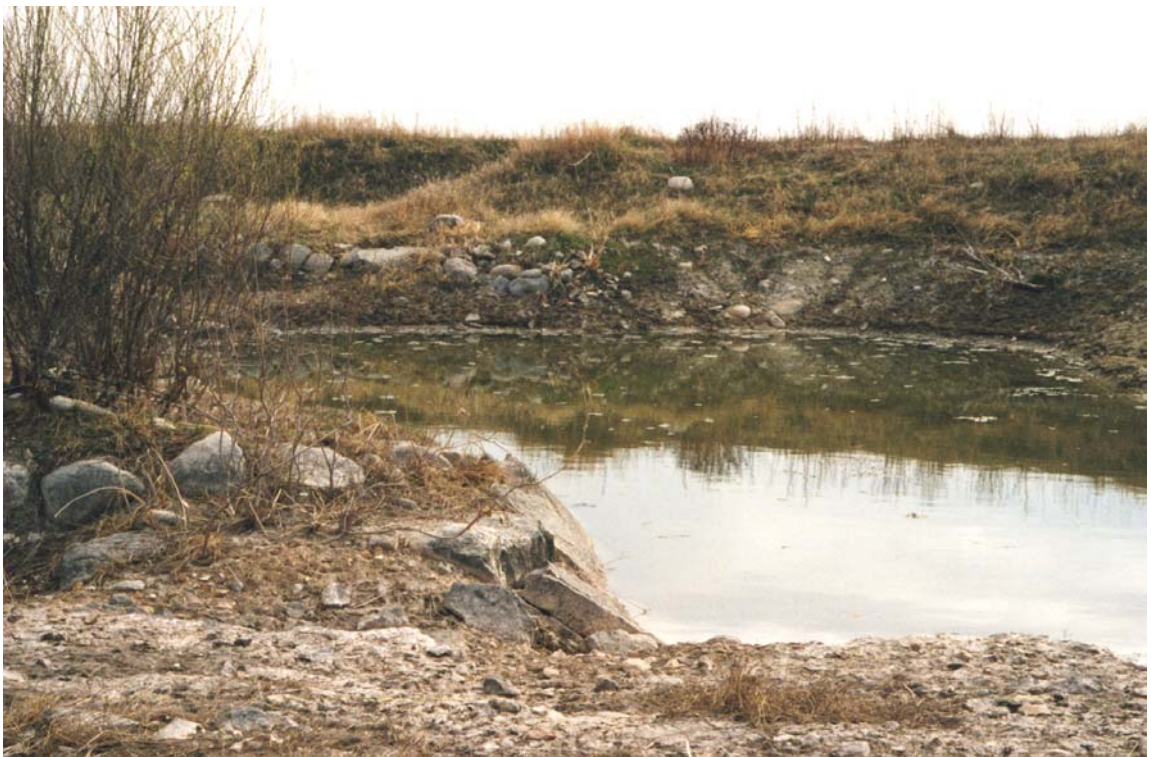
Rosser 02 - 1999-04-26, Rosser Pit, blocks of Penitentiary Member of the Stony Mountain Formation, looking northeast.

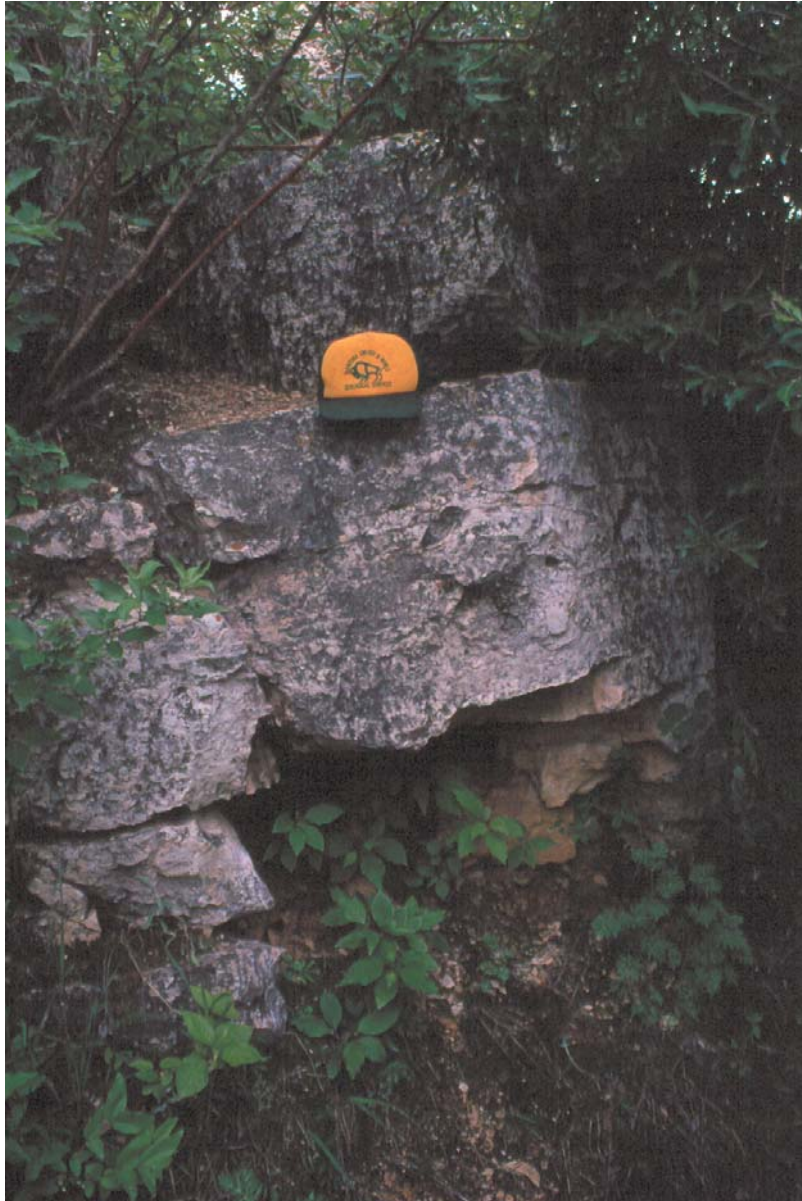
Little Mountain 01 - 2000-06-28, Little Mountain Quarry Park (Egan Quarry) Gunton Member of the Stony Mountain Formation (caprock). View of south wall at west end of quarry.

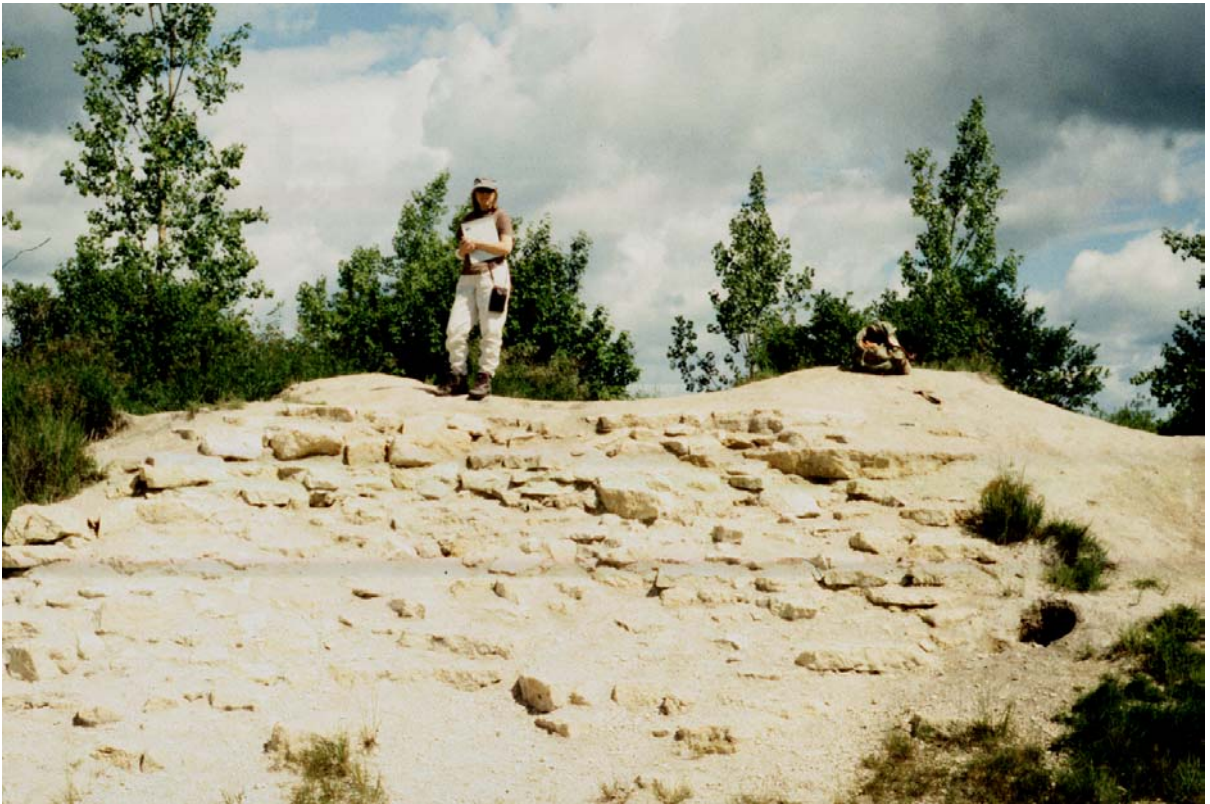
Little Mountain 02 - 2000-06-28, Little Mountain Quarry Park (Egan Quarry) amphitheater. Slabs of Gunton Member from the Stony Mountain Formation. View towards the north.

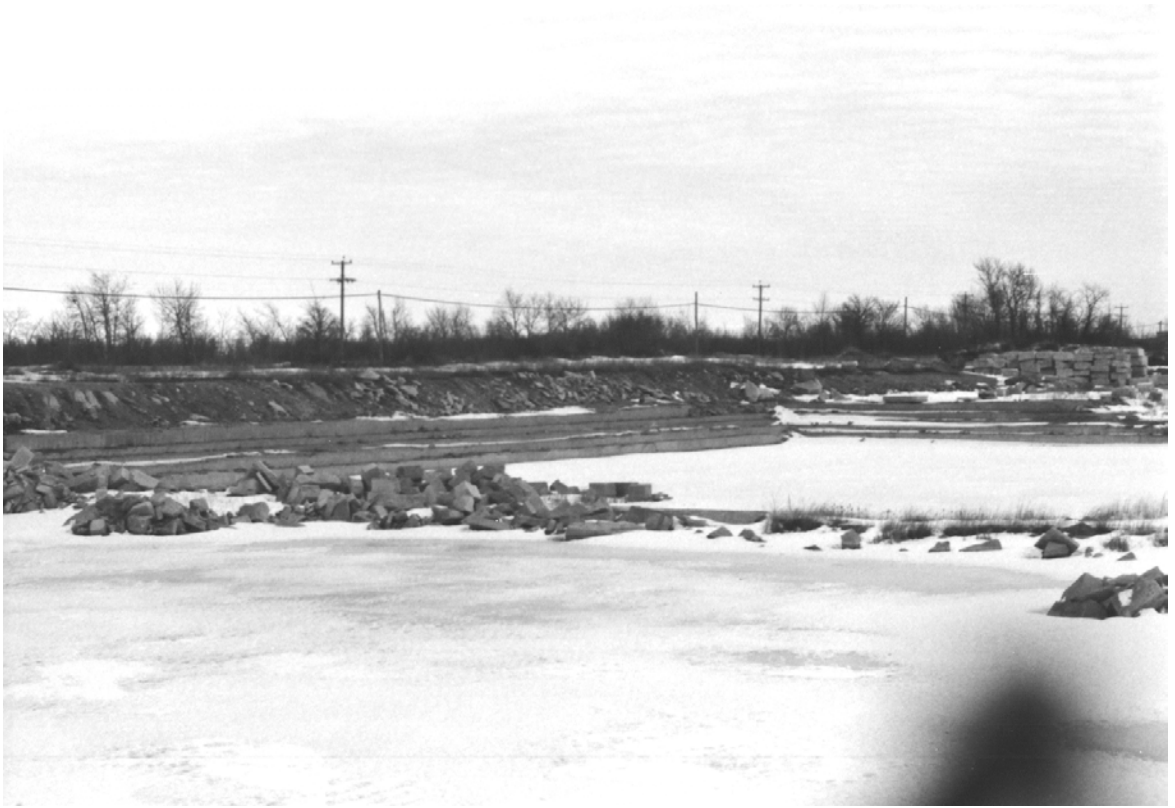
Garson 01: Old cutting area, now abandoned. Selkirk Member, Red River Formation.

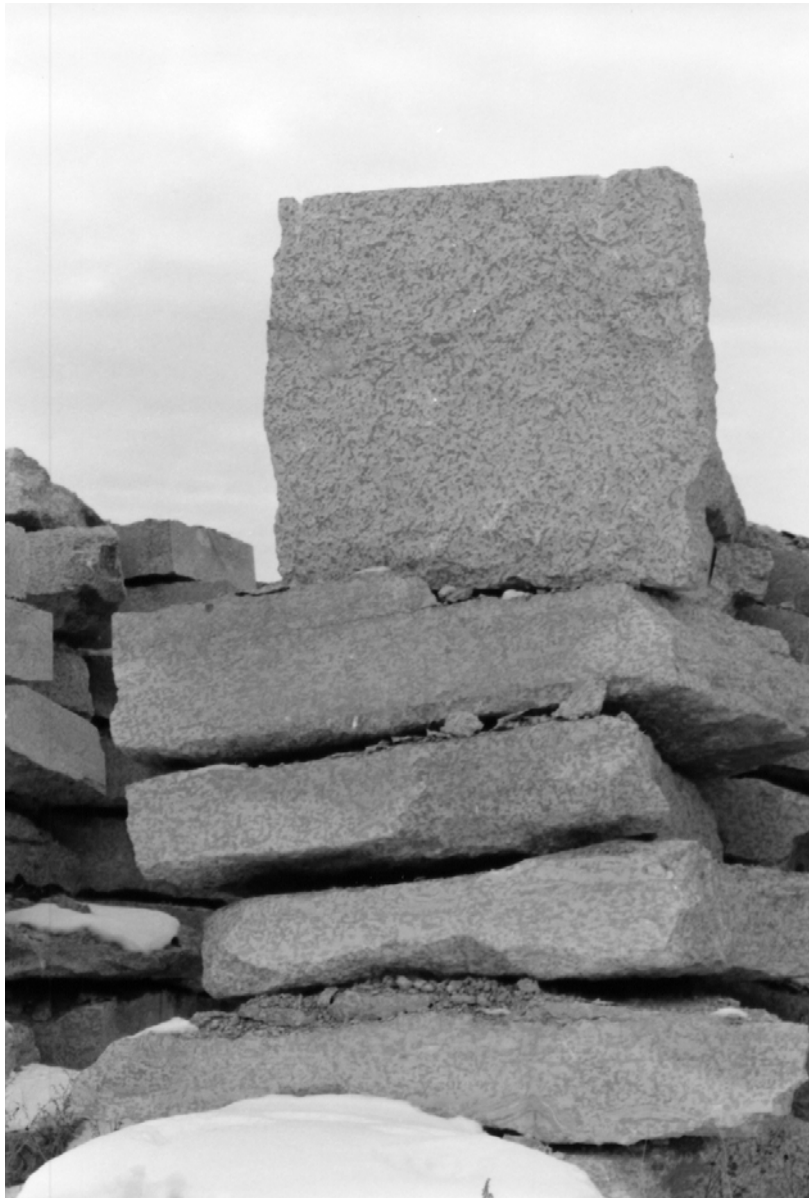
Garson 02: Large blocks of Selkirk Member, Red River Formation, ready for shipping.

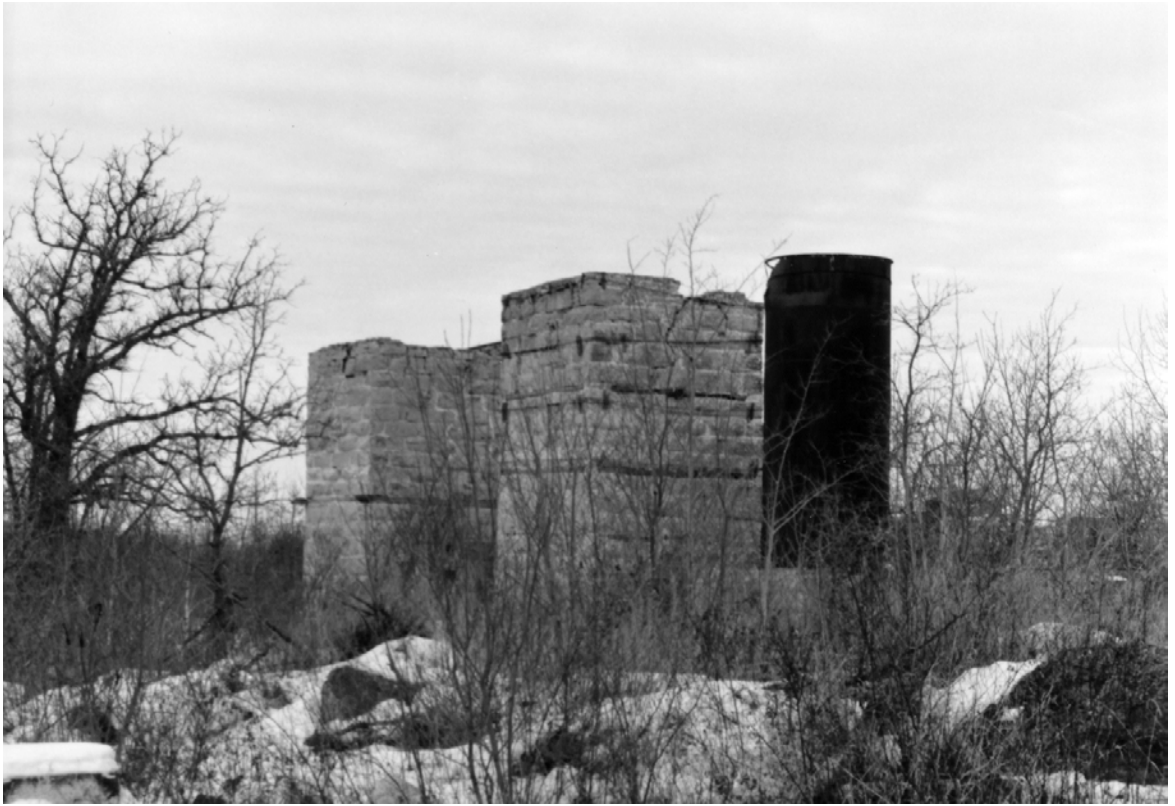
Garson 03: Old kiln at Garson Quarry (made of Selkirk Member, Red River Formation rocks).

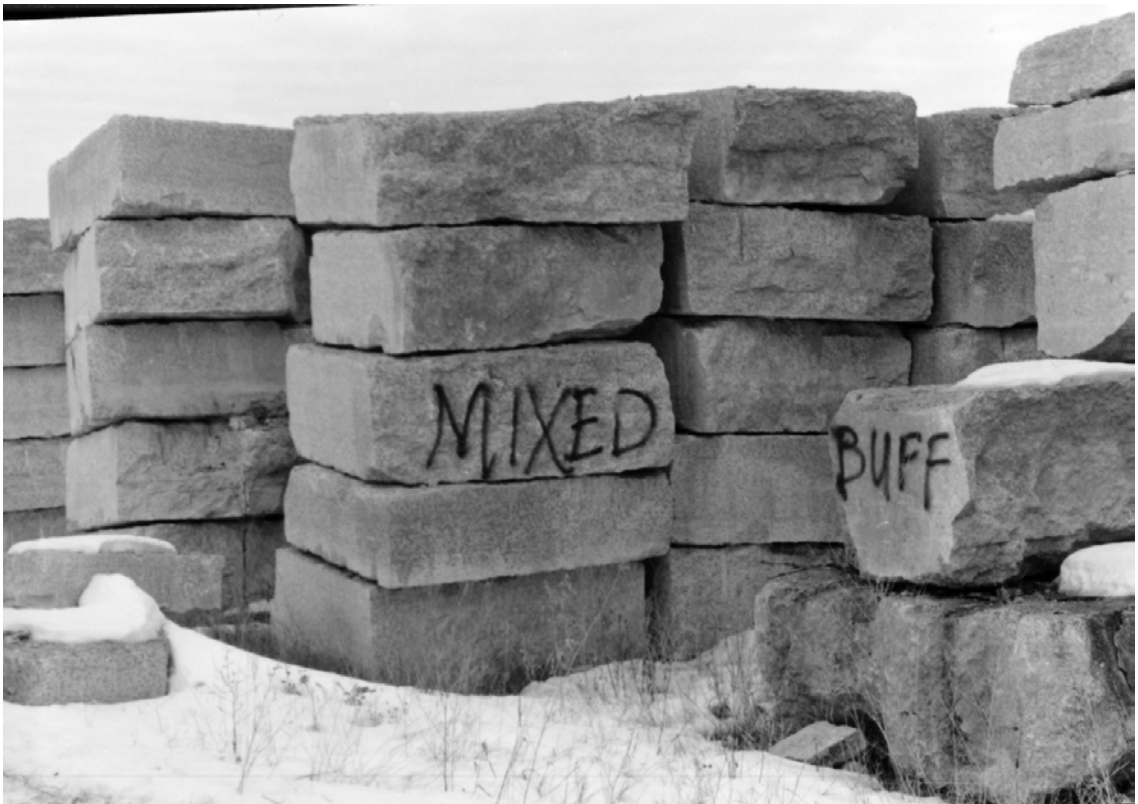
Garson 06: Large slabs of Selkirk Member (Red River Formation) ready for shipping.

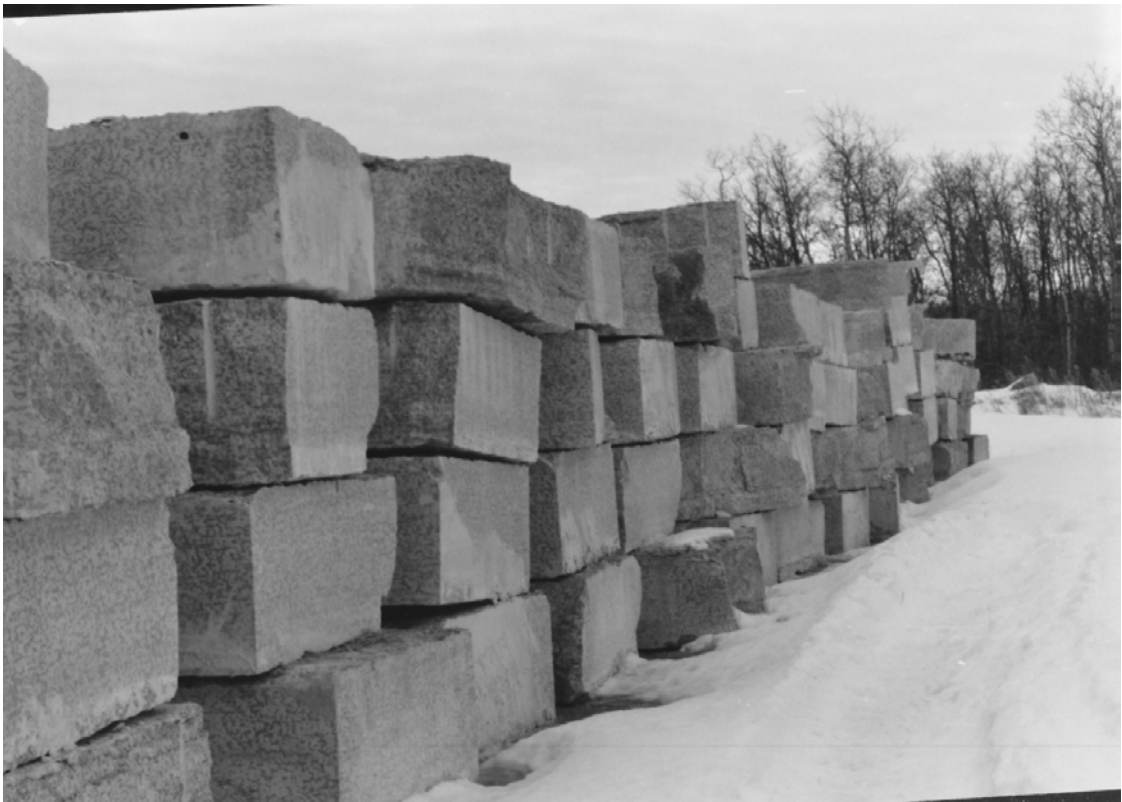
Garson 08: Large slabs of Tyndall Stone ready to be polished or to be shipped rough.

Large fossils, usually white are scattered through the rock, but the stone can be cut to avoid these. The stone occurs in beds caused by stylolitization of 0.5 to 1.8 m thick. The beds are lettered downward from 'A' to 'K'. Increasing amounts of chert nodules have been found below the 'I' bed.

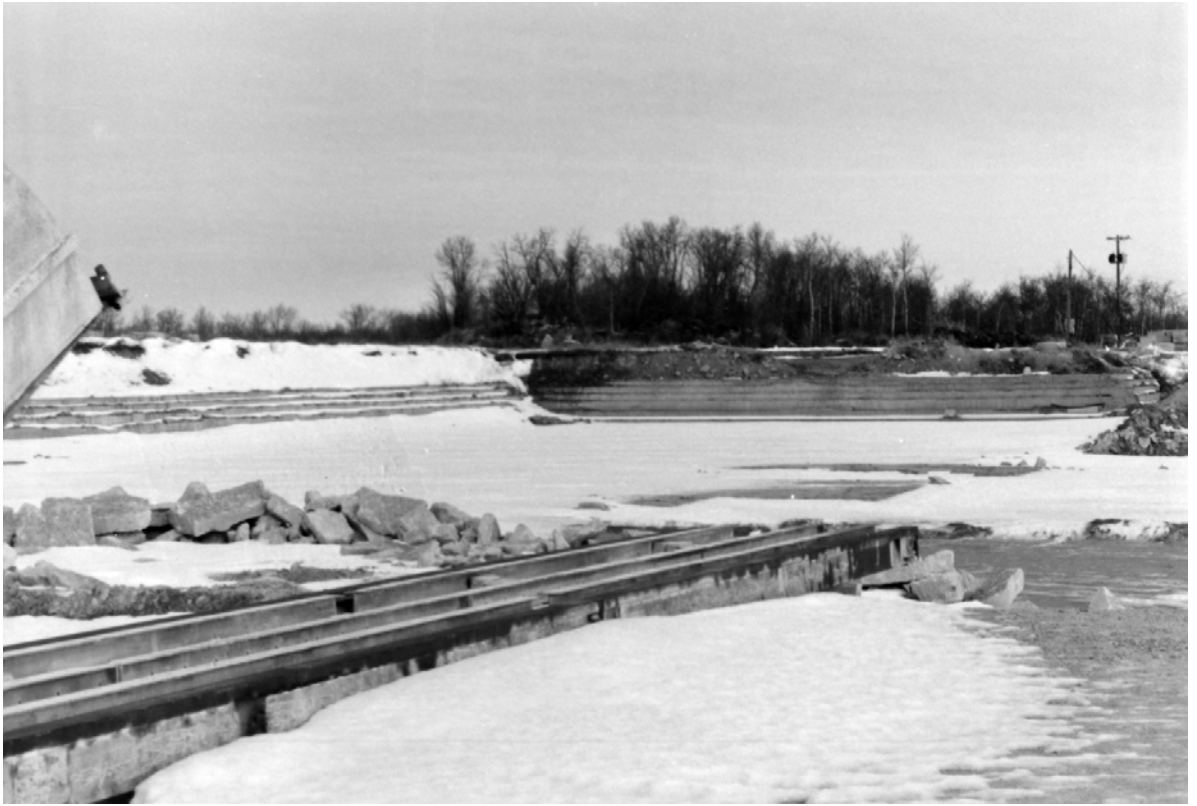
Garson 14: A recently worked area of the quarry with a large cutting saw to the left.

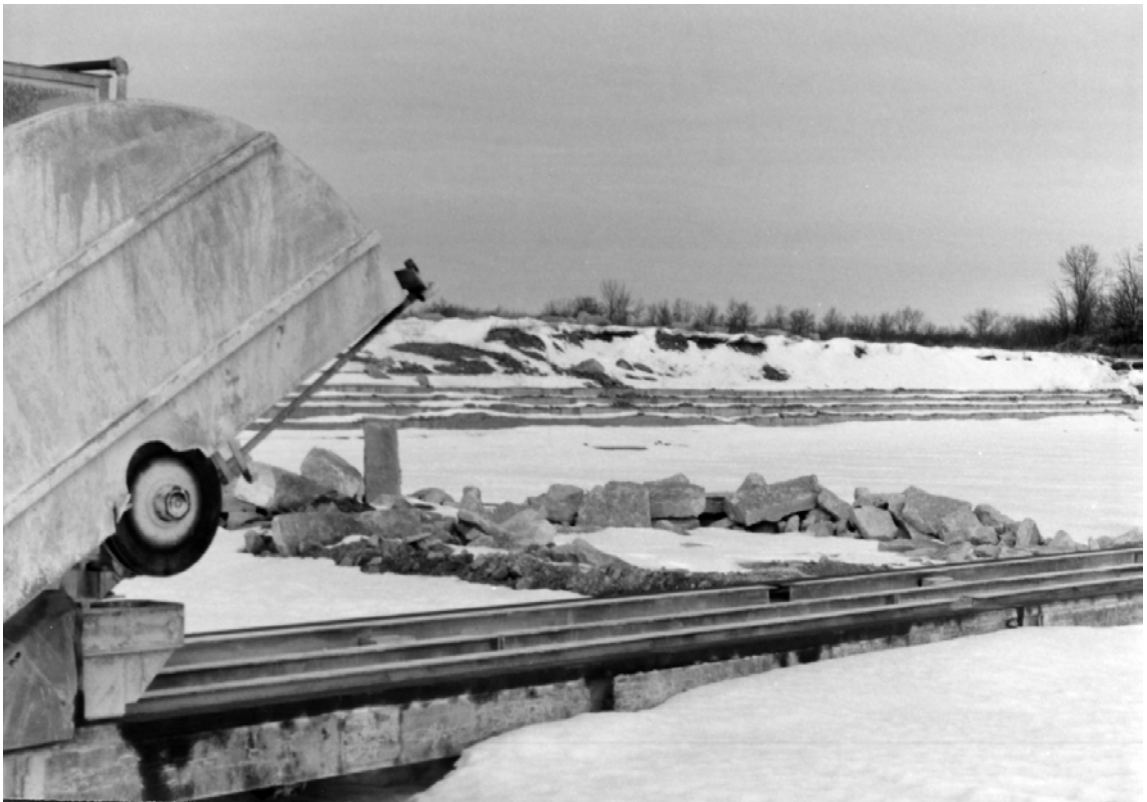
Garson 15: Large cutting saw.

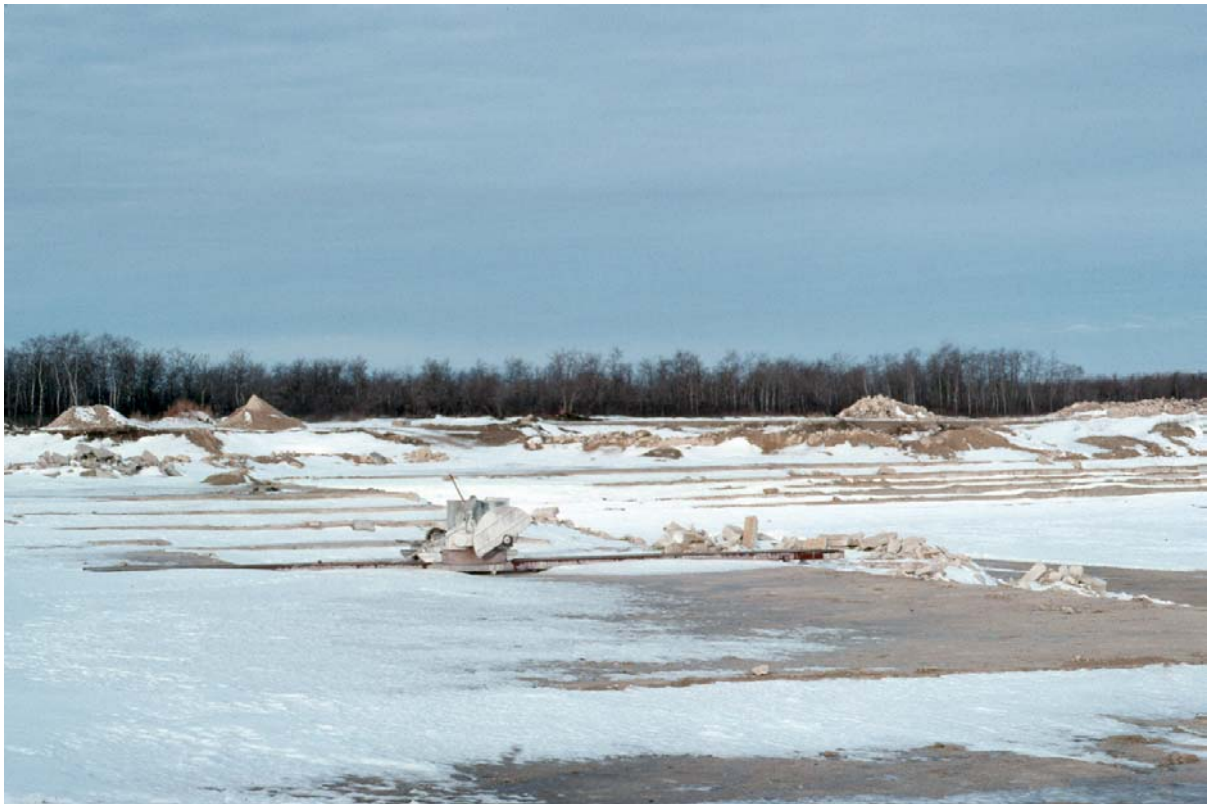
Garson 17: Panoramic view of a recently cut area with a large saw in the foreground. View towards the south.

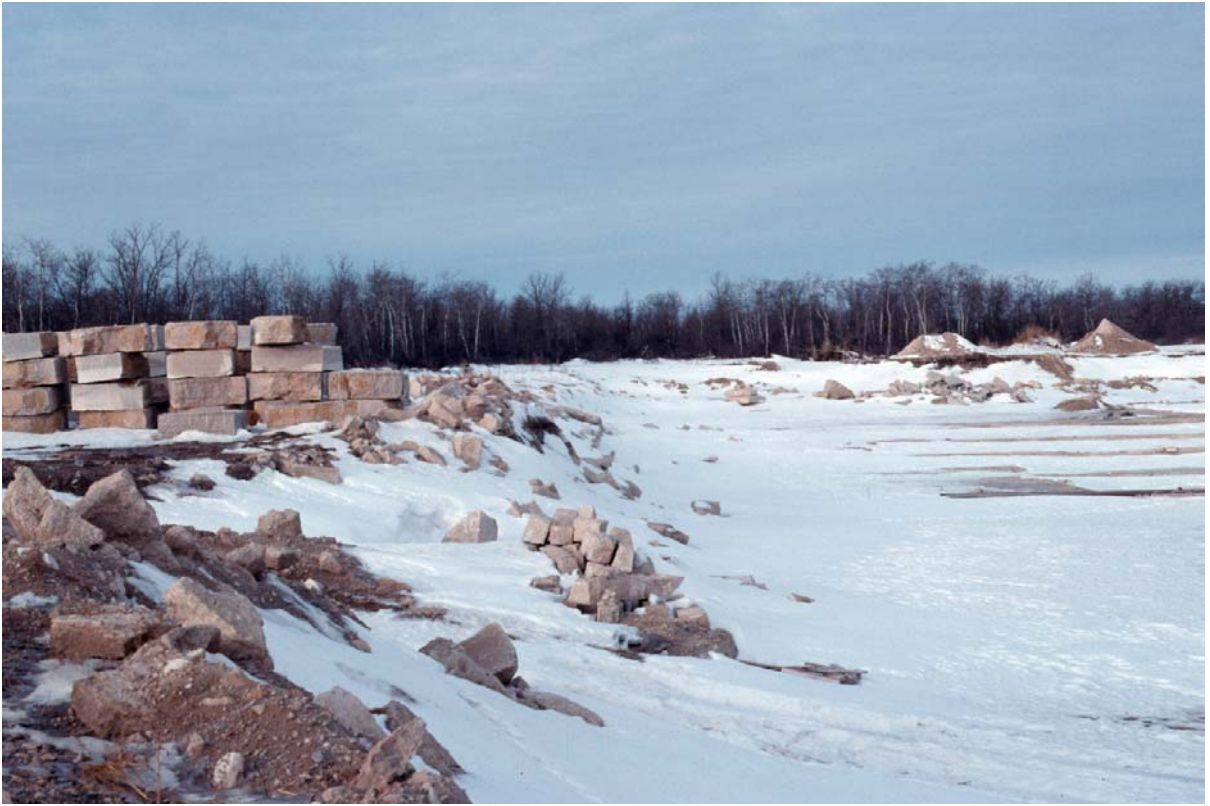
Garson 18: Large blocks ready for shipping.

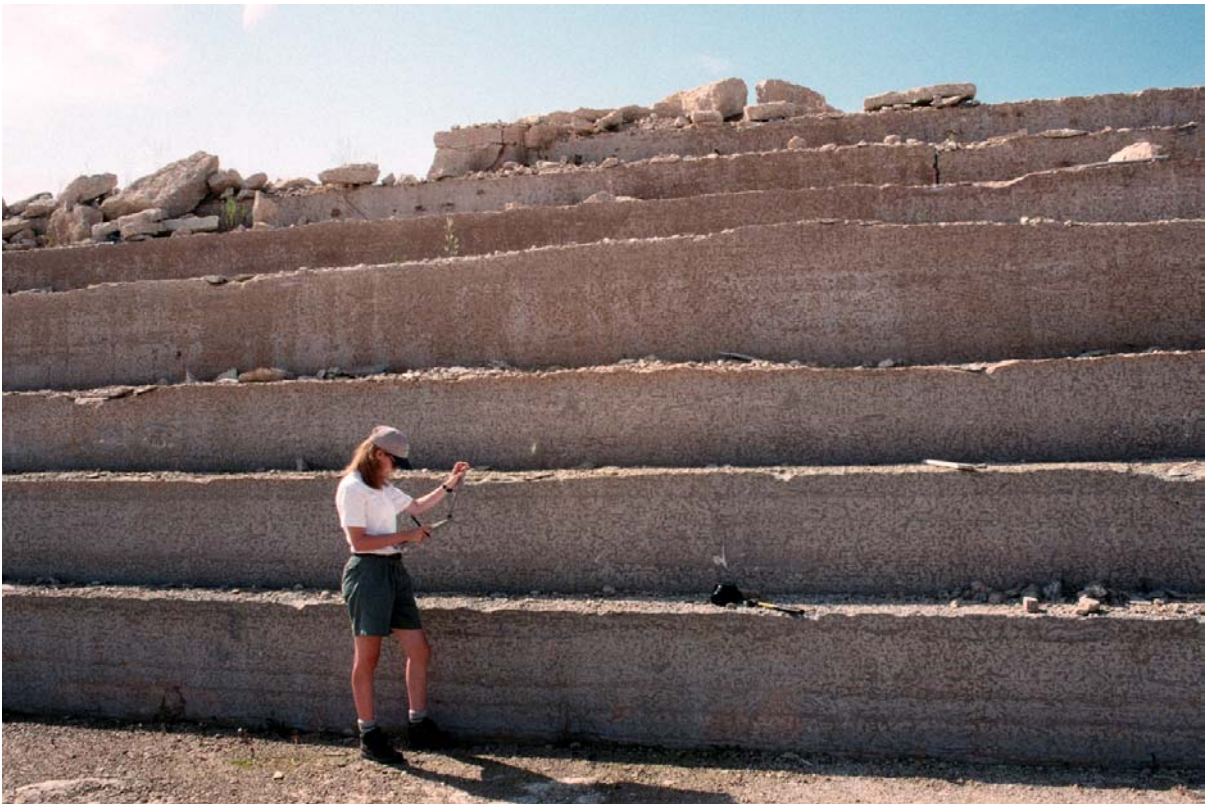
Garson 20: Close-up of a cut face. Karla Horseman for scale.

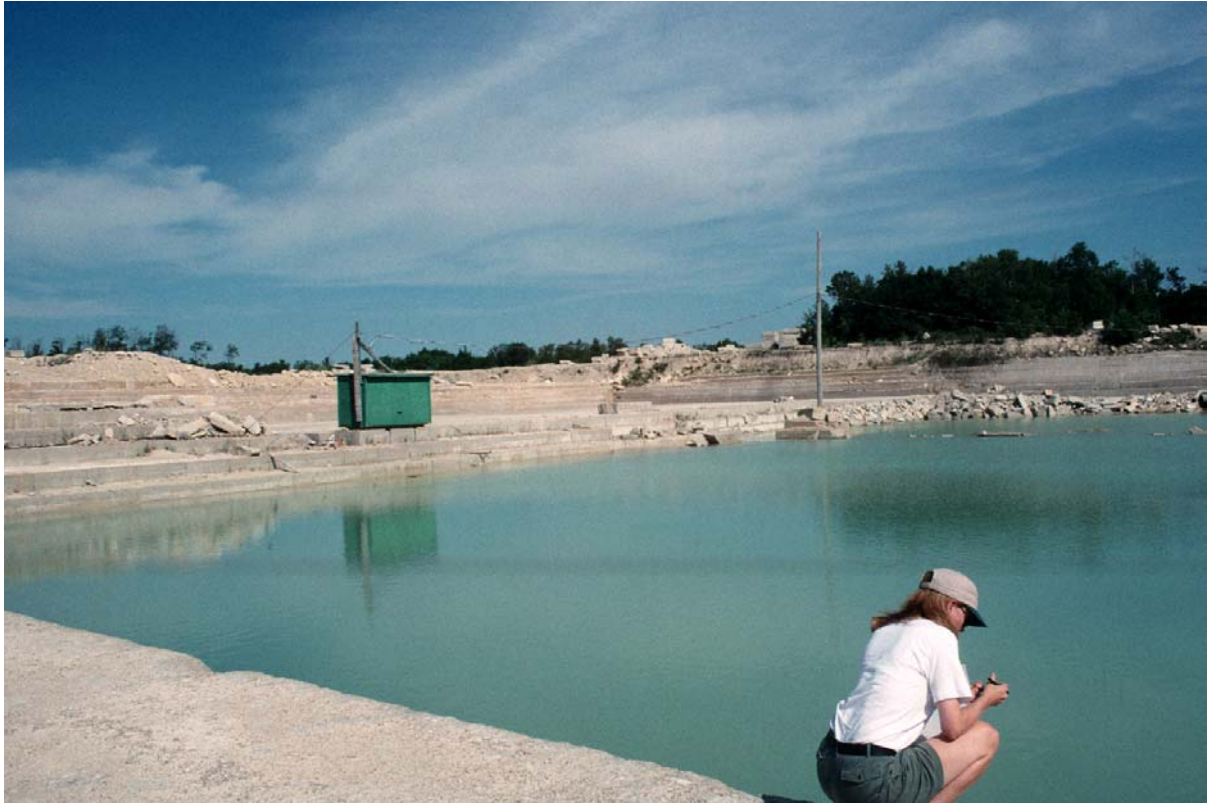
Garson 22: Sump pit.

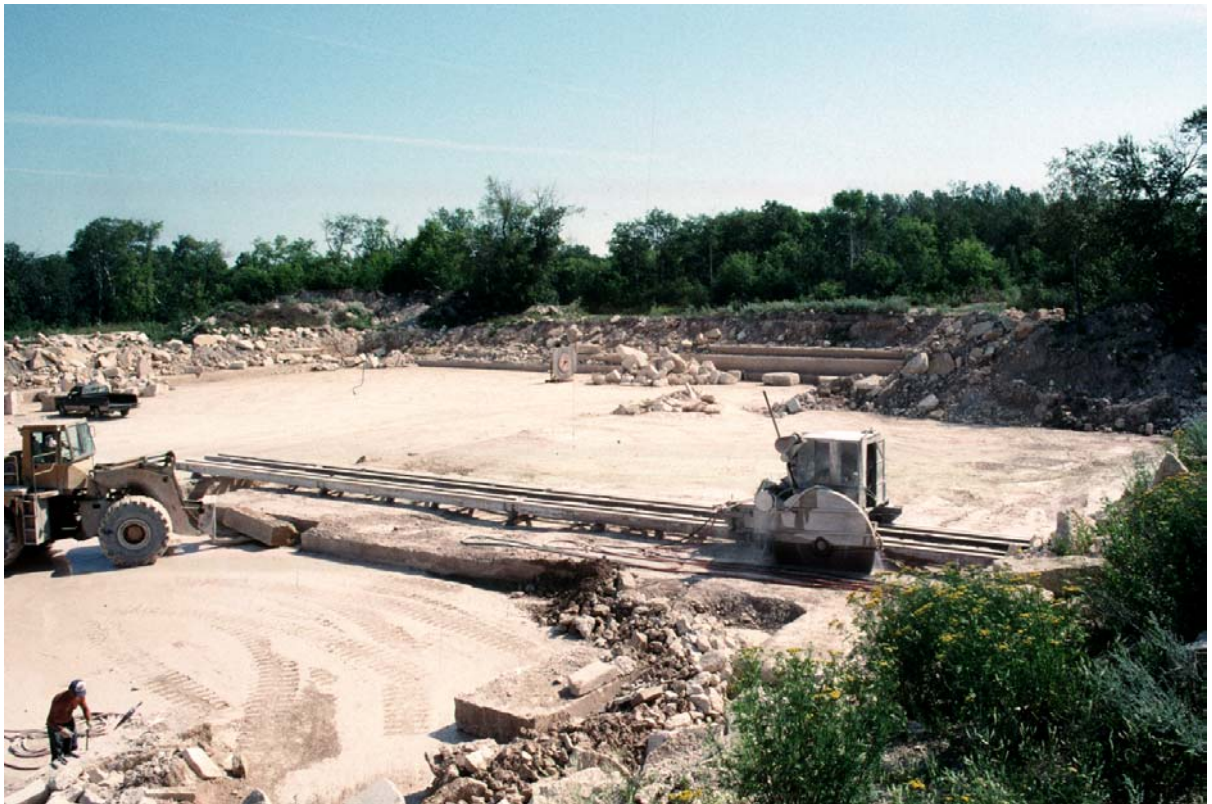
Garson 23: Active cutting area.

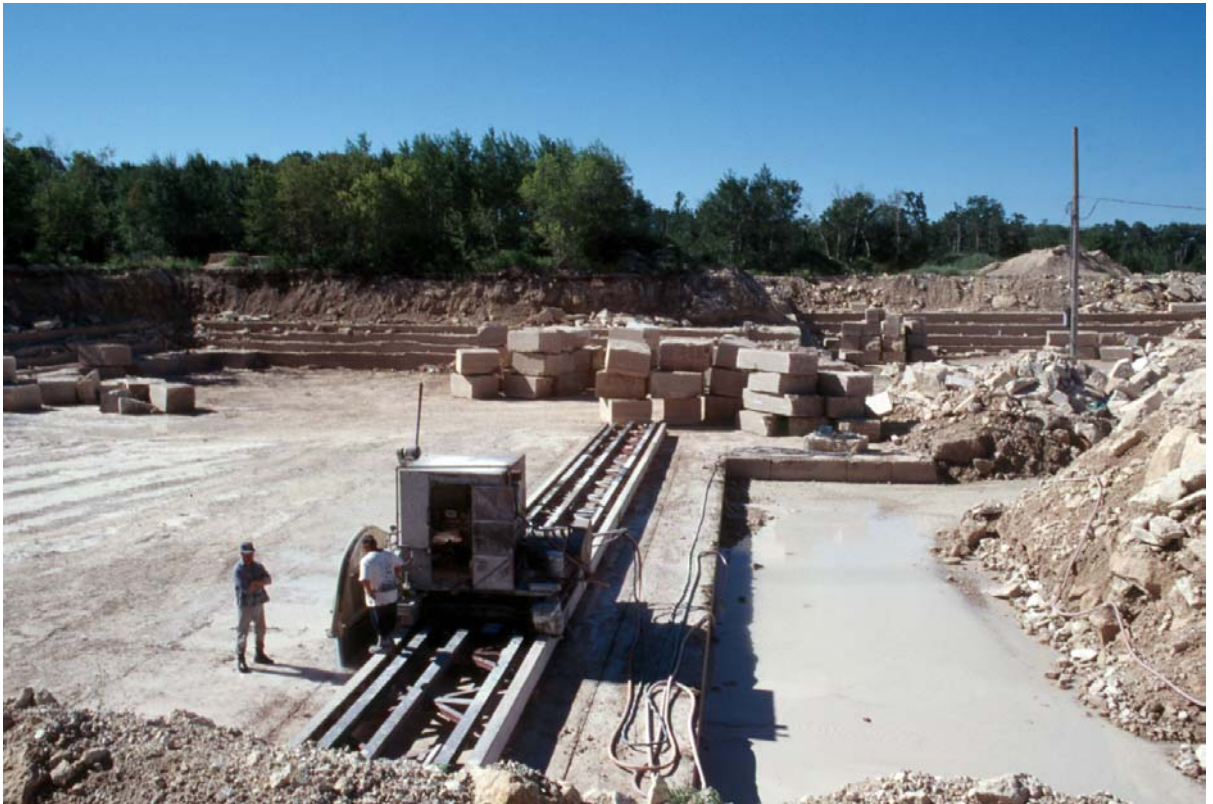
Garson 25: Close-up of cutting area.
