## Appendix 1: Bedrock Quarries in the Capital Region Study Area

**NAME:** BORLAND QUARRY SOUTH

### Borland Quarry South

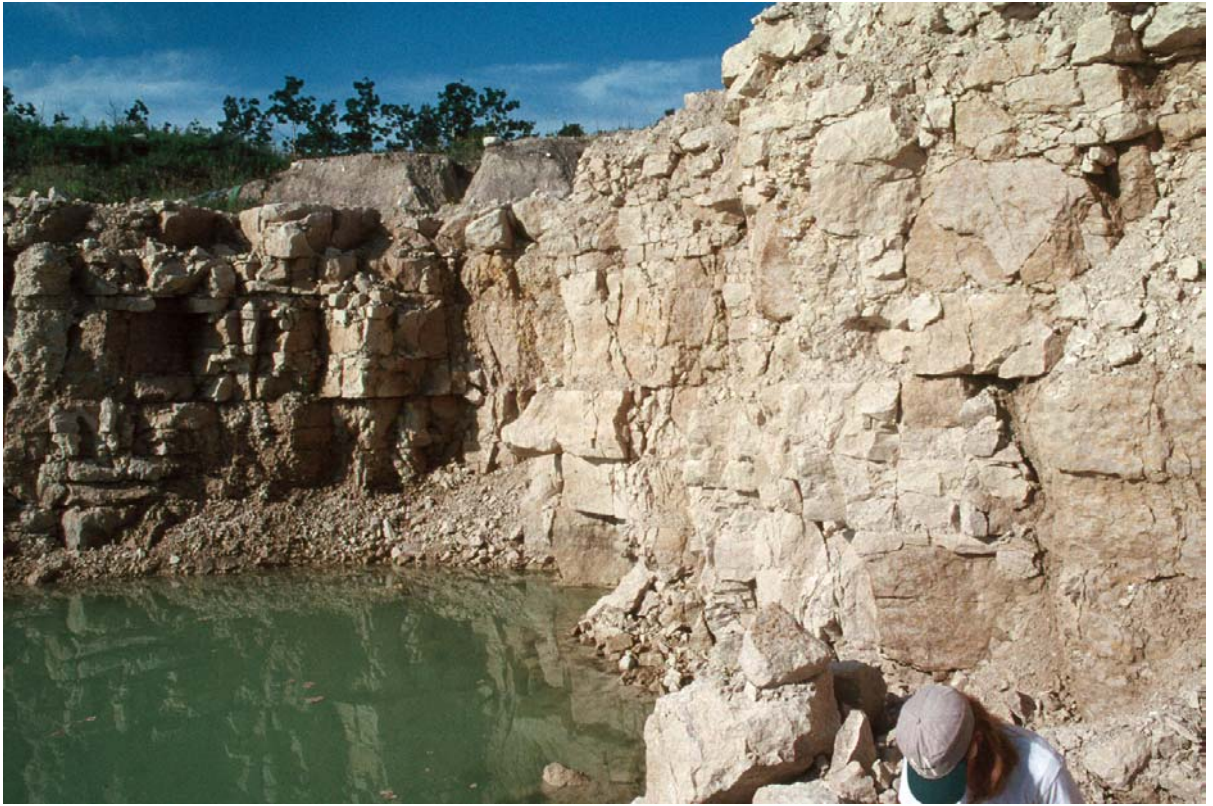
Hadiken 03 – 1996-01-08, Hadiken Quarry. Selkirk Member of the Red River Formation. . West wall and sump pit. Note the rubby nature of the rock face.

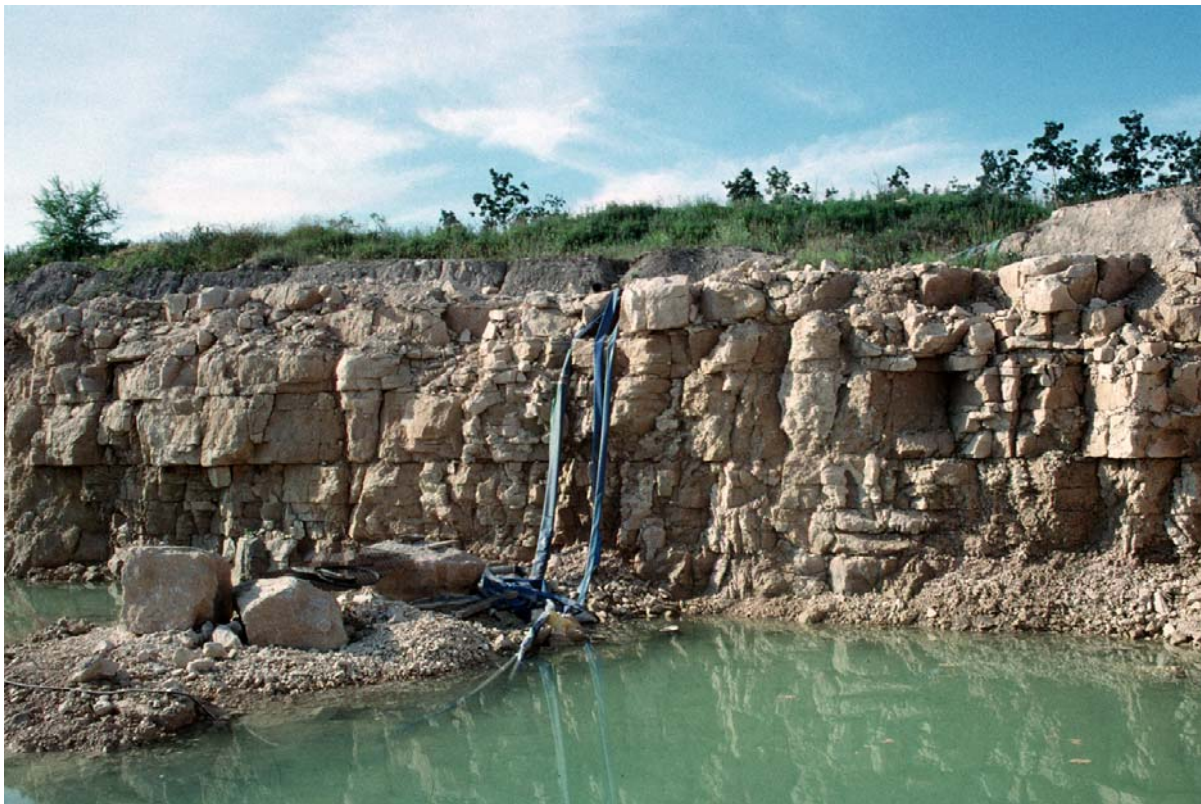
Hadiken 06 – 1996-01-08, Hadiken Quarry. Selkirk Member of the Red River Formation. South wall, sump pit and pump.

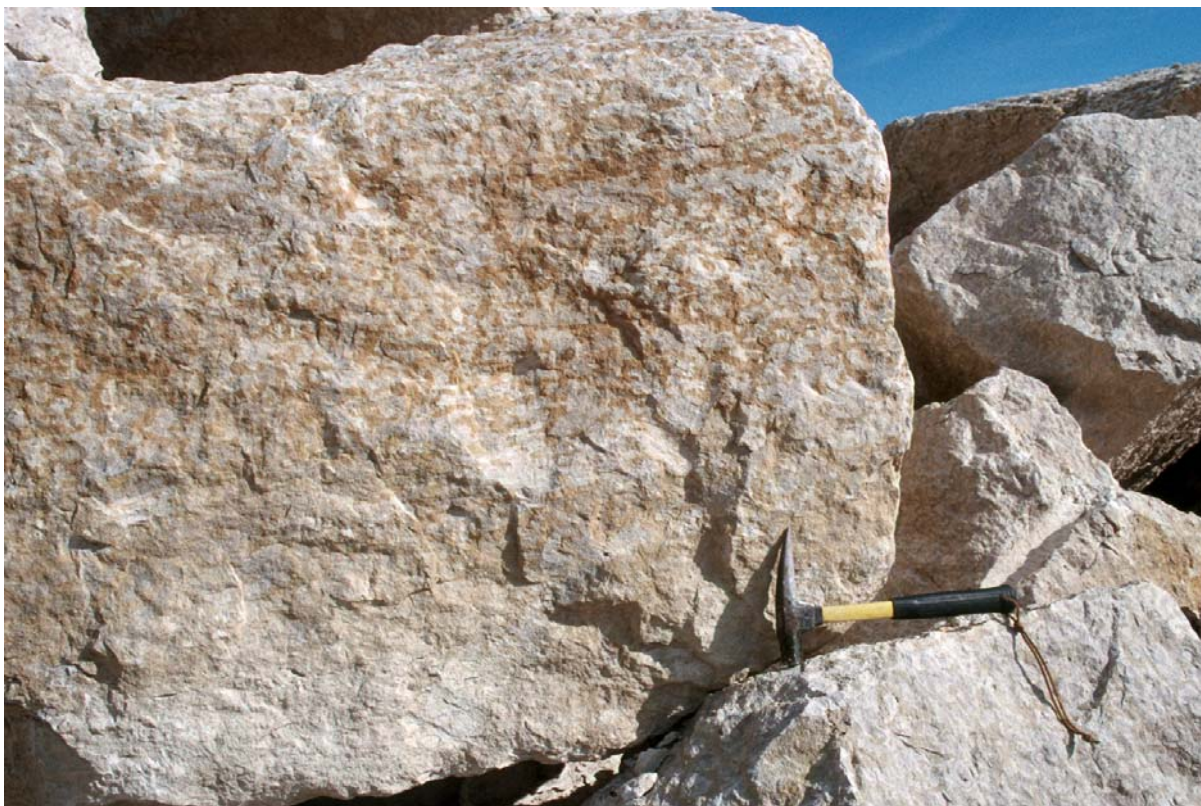
Hadiken 07 – 1996-01-08, Hadiken Quarry. Selkirk Member of the Red River Formation. Close-up of massive boulders next to sump pit.

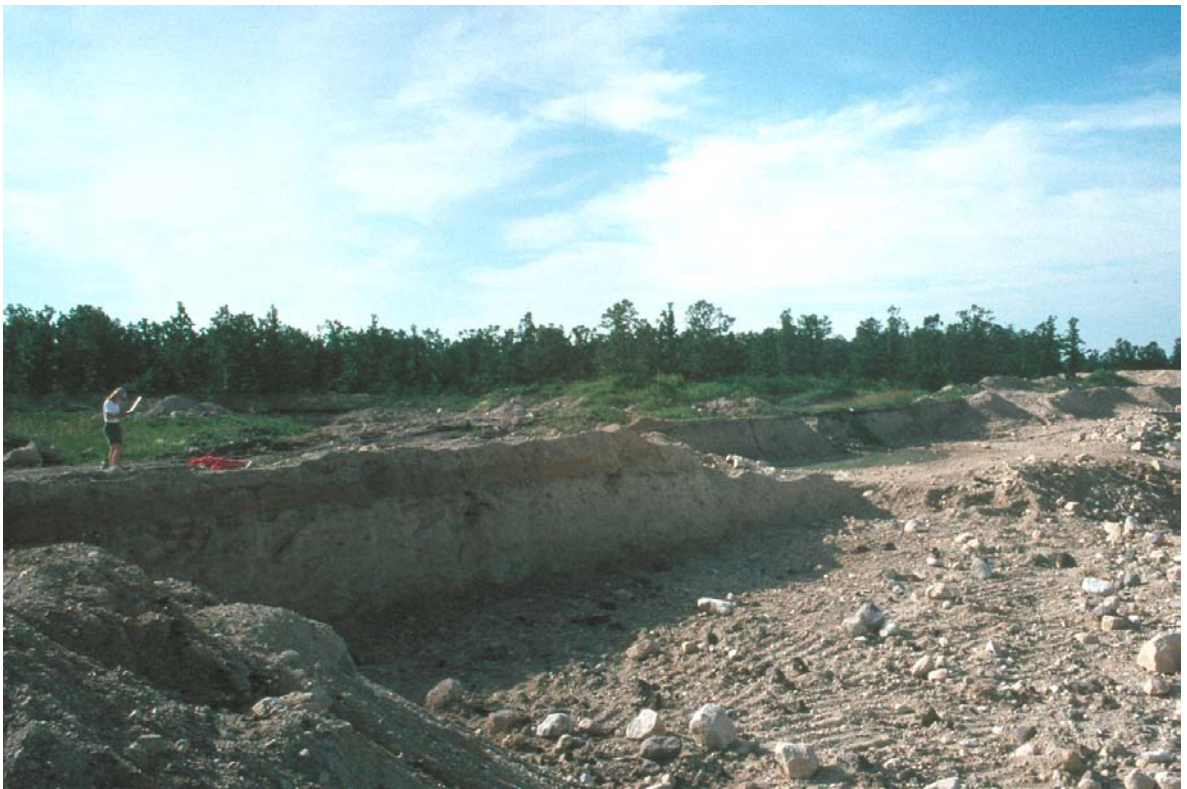
Hadiken 08 – 1996-01-08, Panorama of Hadiken Quarry. View towards the southeast. Selkirk Member of the Red River Formation. Overburden (1.5-2 m thick) and freshly blasted rock.

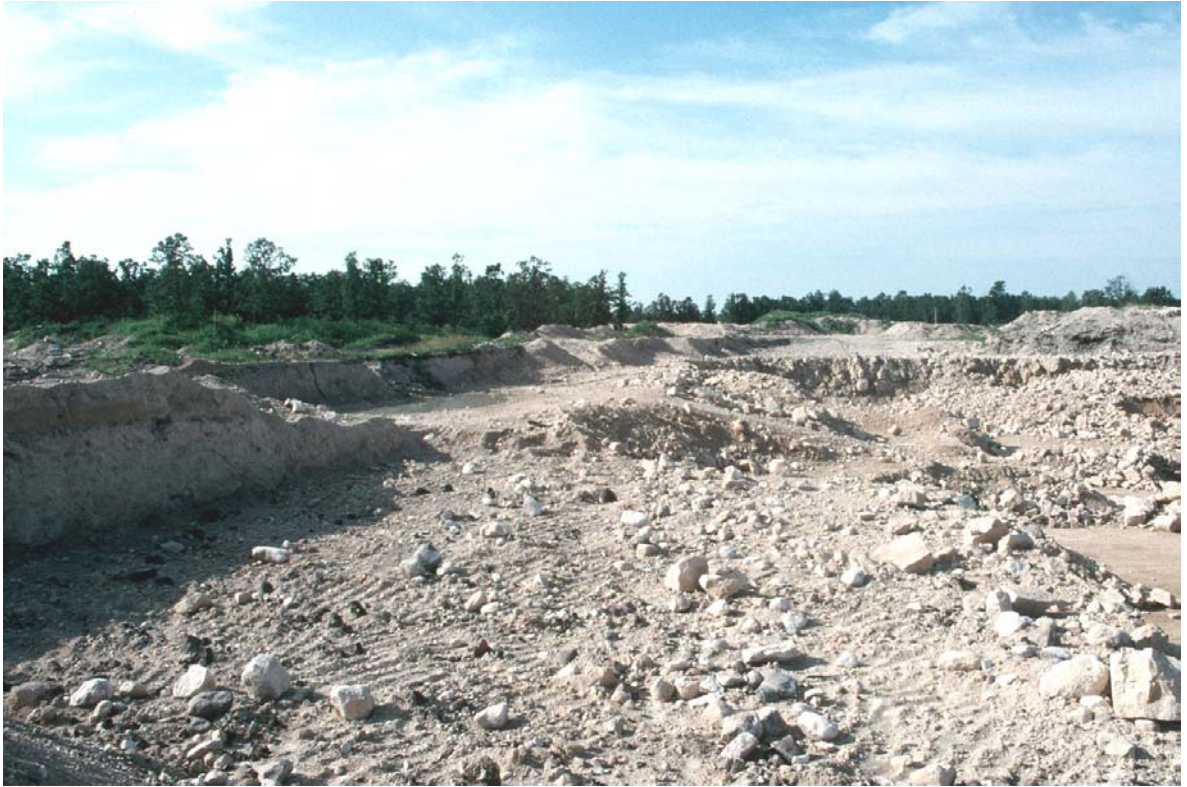
Hadiken 09 – 1996-01-08, Panorama of Hadiken Quarry. View towards the south-southeast. Selkirk Member of the Red River Formation. Overburden (1.5-2 m thick) and freshly blasted rock.

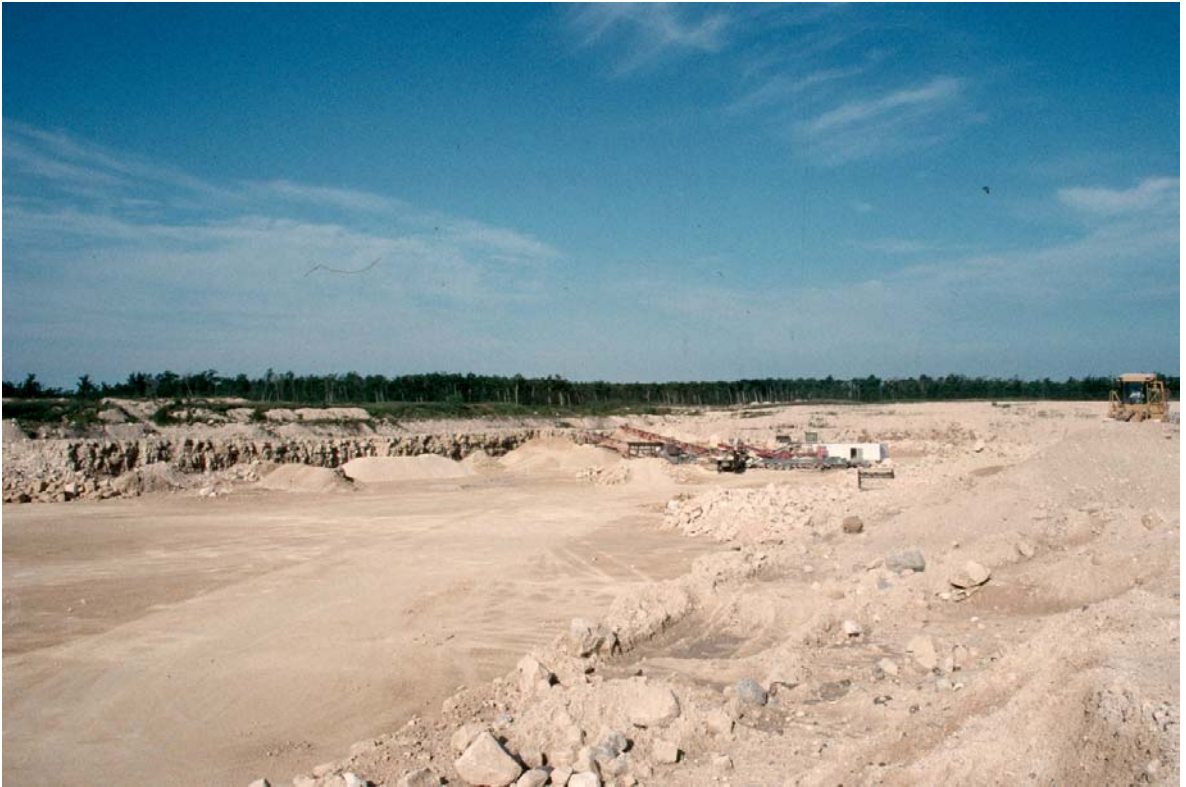
Hadiken 10 – 1996-01-08, Panorama of Hadiken Quarry. View towards the south-southwest. Selkirk Member of the Red River Formation. Overburden (1.5-2 m thick) and freshly blasted rock.

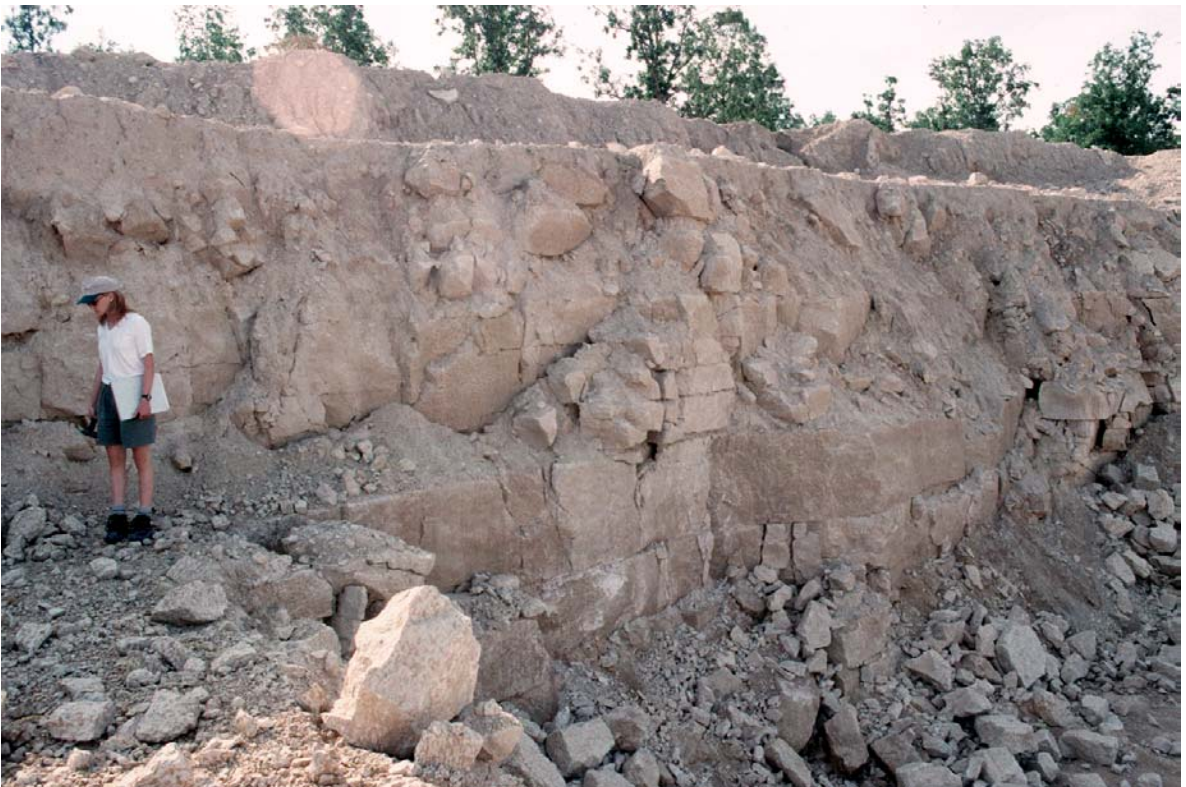
Hadiken 08-11 – 1996-01-08, Panorama of Hadiken Quarry. View towards the southwest. Selkirk Member of the Red River Formation. Overburden (1.5-2 m thick) and freshly blasted rock.
