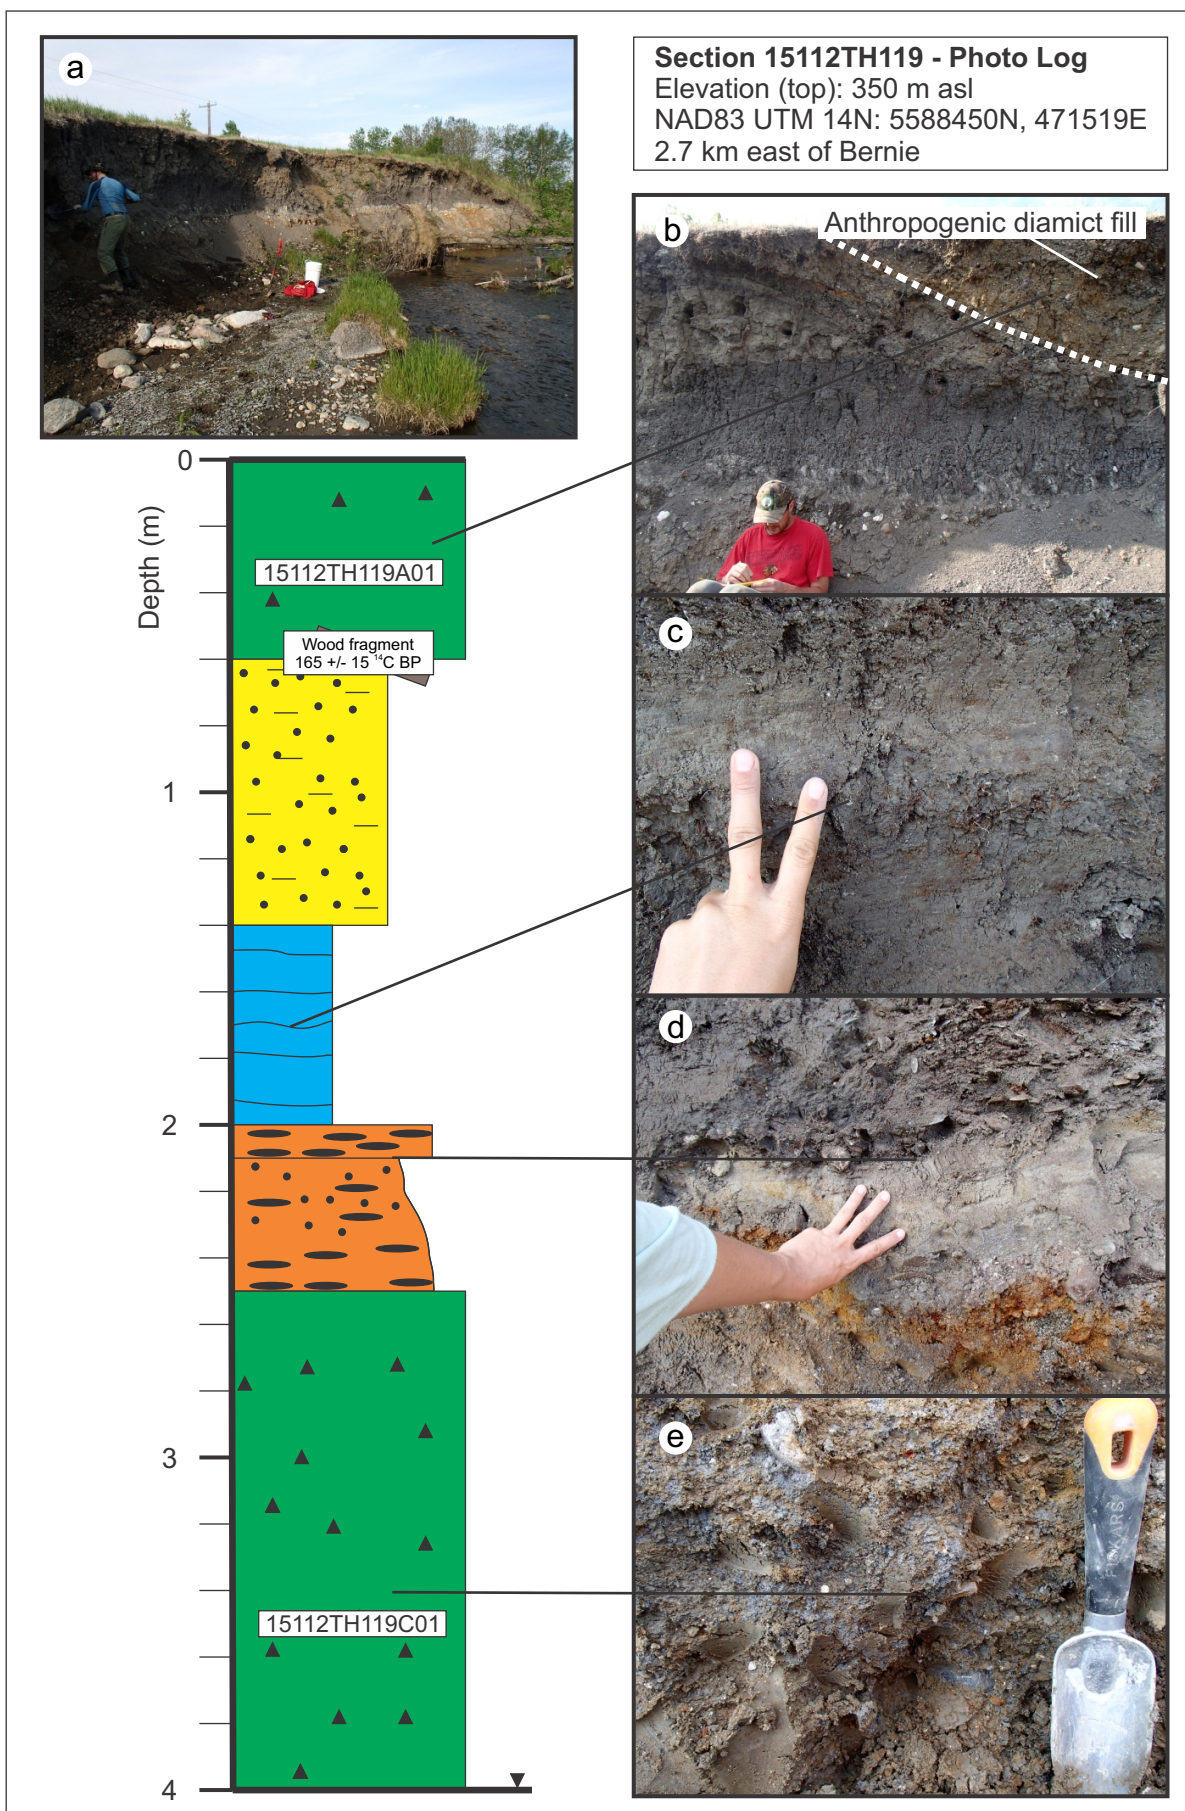
**Figure 32:** Photos of sediments present at section 15112TH119: **a)** stream-view of the cut exposing sediments; **b)** upper alluvial sediments and contact with anthropogenic diamict fill; **c)** bedded alluvial sediments; **d)** gravel at 2.2 m depth; **e)** lower mottled diamict exposed at the section.
