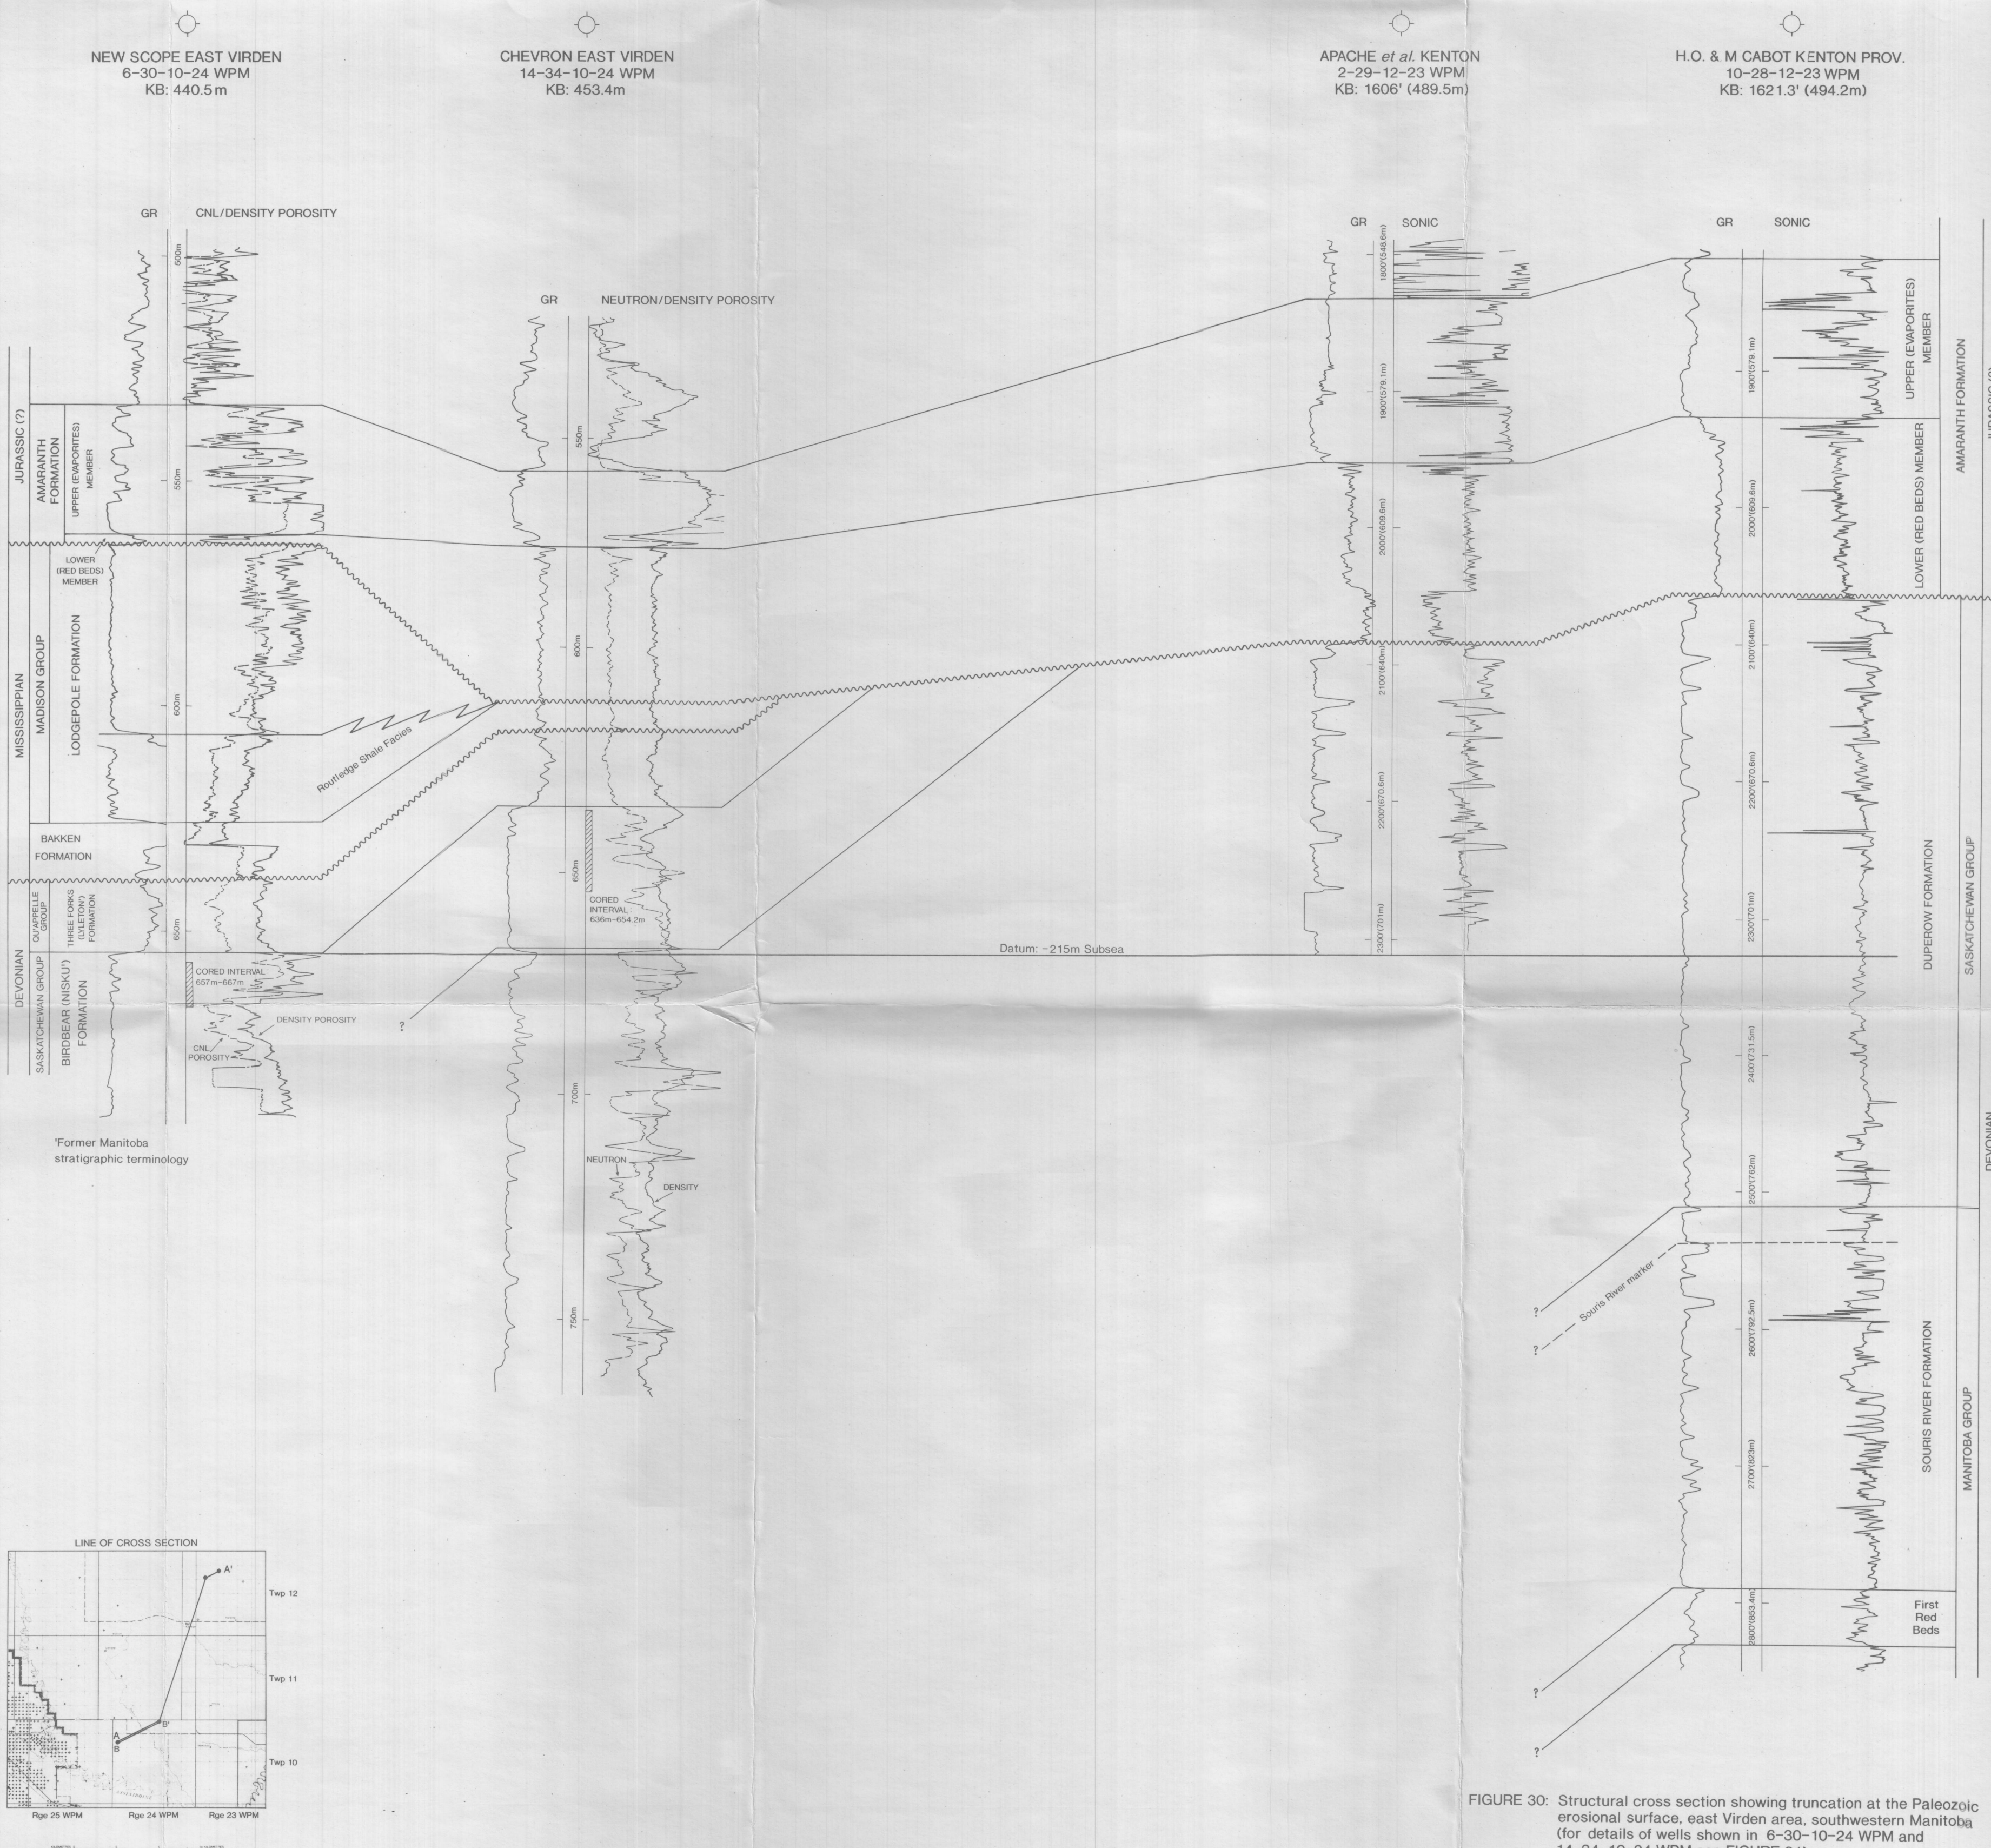
FIGURE 30: Structural cross section showing truncation at the Paleozoic erosional surface, east Virden area, southwestern Manitoba (for details of wells shown in 6-30-10-24 WPM and 14-34-10-24 WPM see FIGURE 31)
