# Manitoba Infrastructure

Project 6 - All Season Road Linking Manto Sipi Cree Nation, Bunibonibee Cree Nation and God's Lake First Nation

## Aquatic Environment Report: Existing Environment

#### **Aquatic Environment Report**

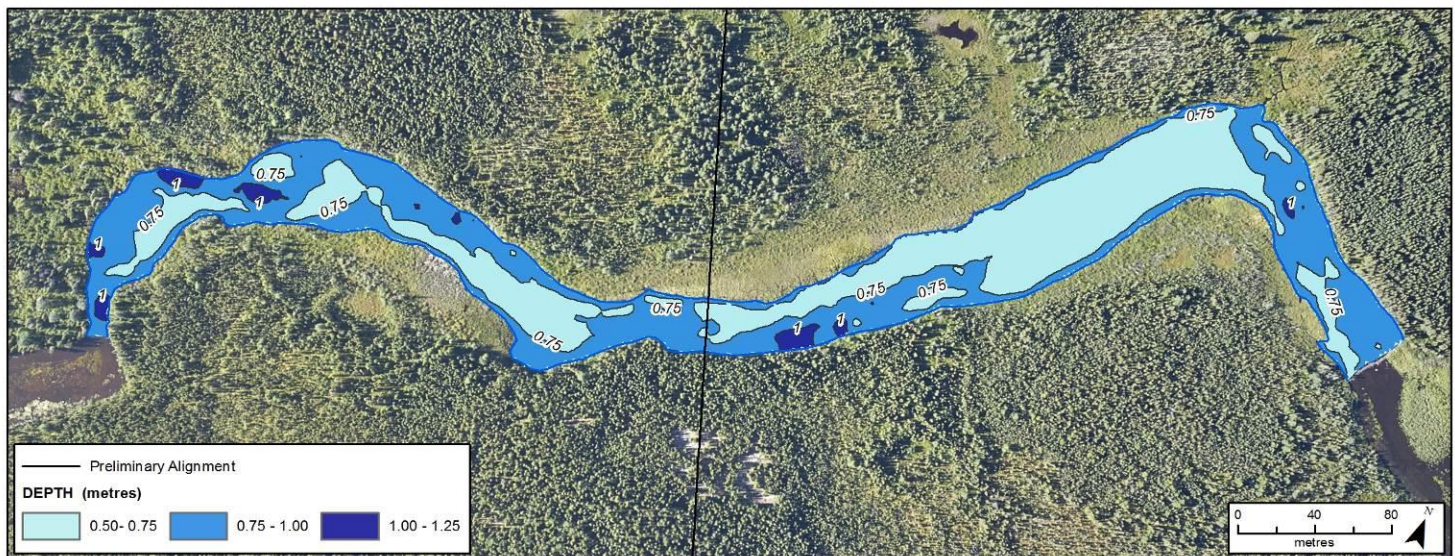
### + Bathymetric Map

Note: This is a generalized substrate map, intended for fish habitat assessment. It should not be used for navigation or design purposes.

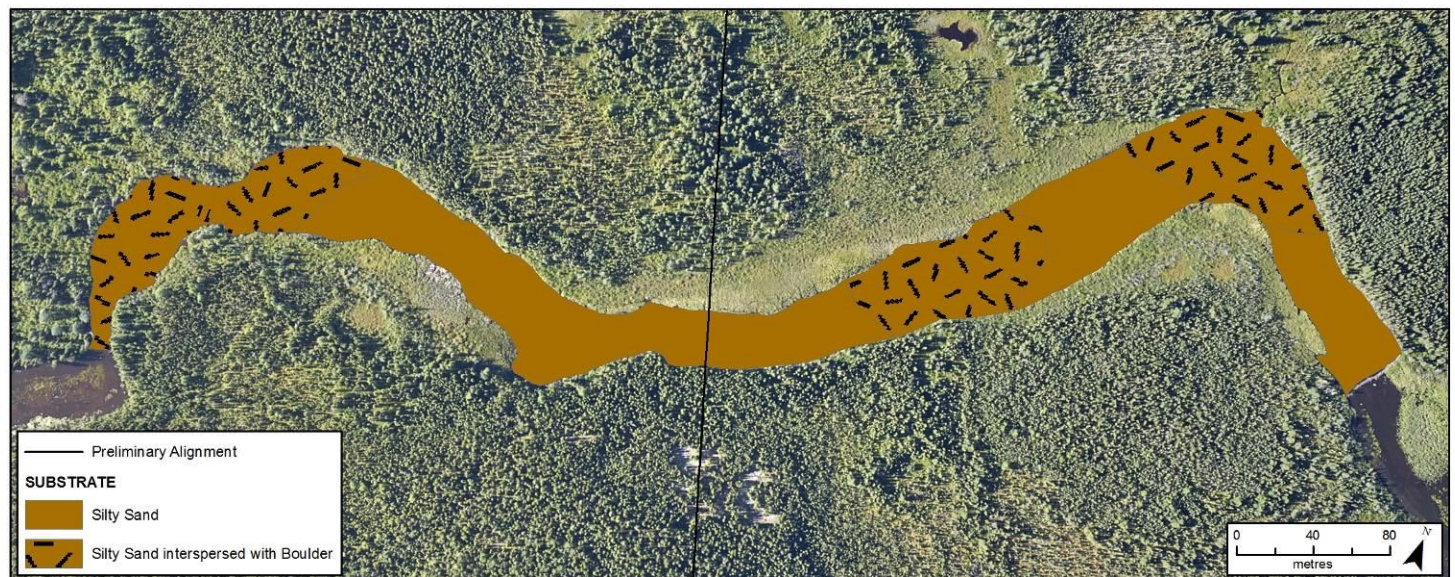
### + Substrate Map

Note: This is a generalized substrate map, intended for fish habitat assessment. It should not be used for navigation or design purposes.

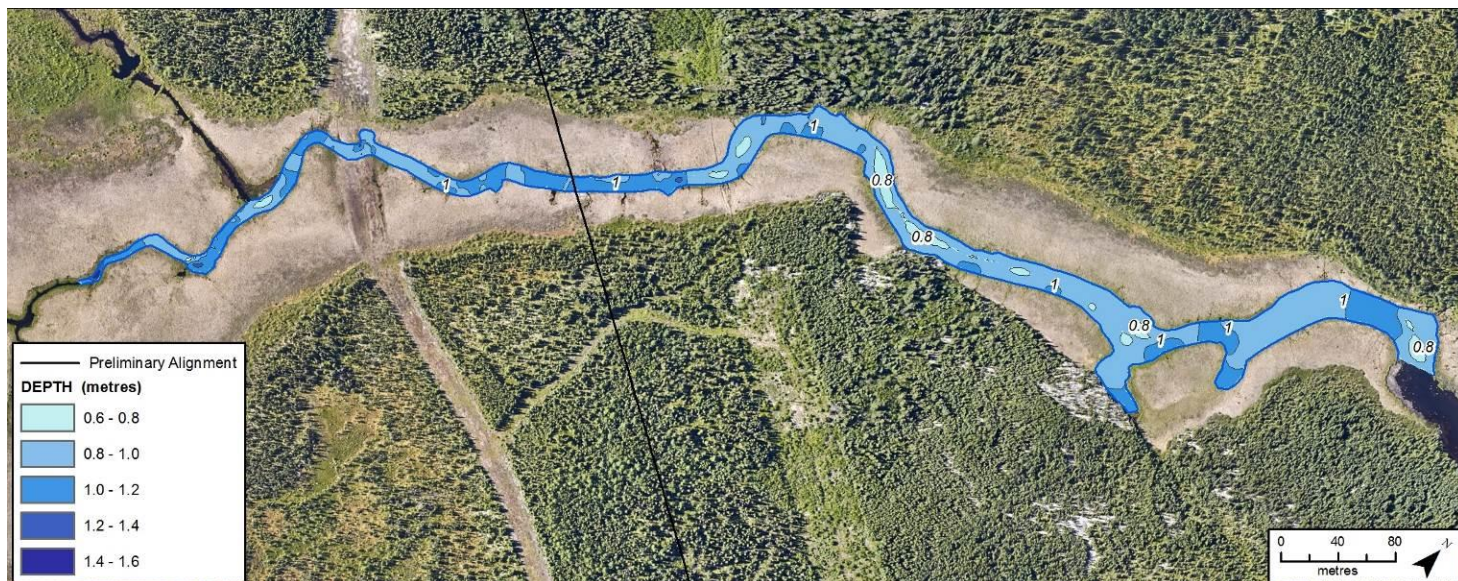
### + Bathymetric Map

Note: This map is intended for fish habitat assessments. It should not be used for navigation or design purposes.

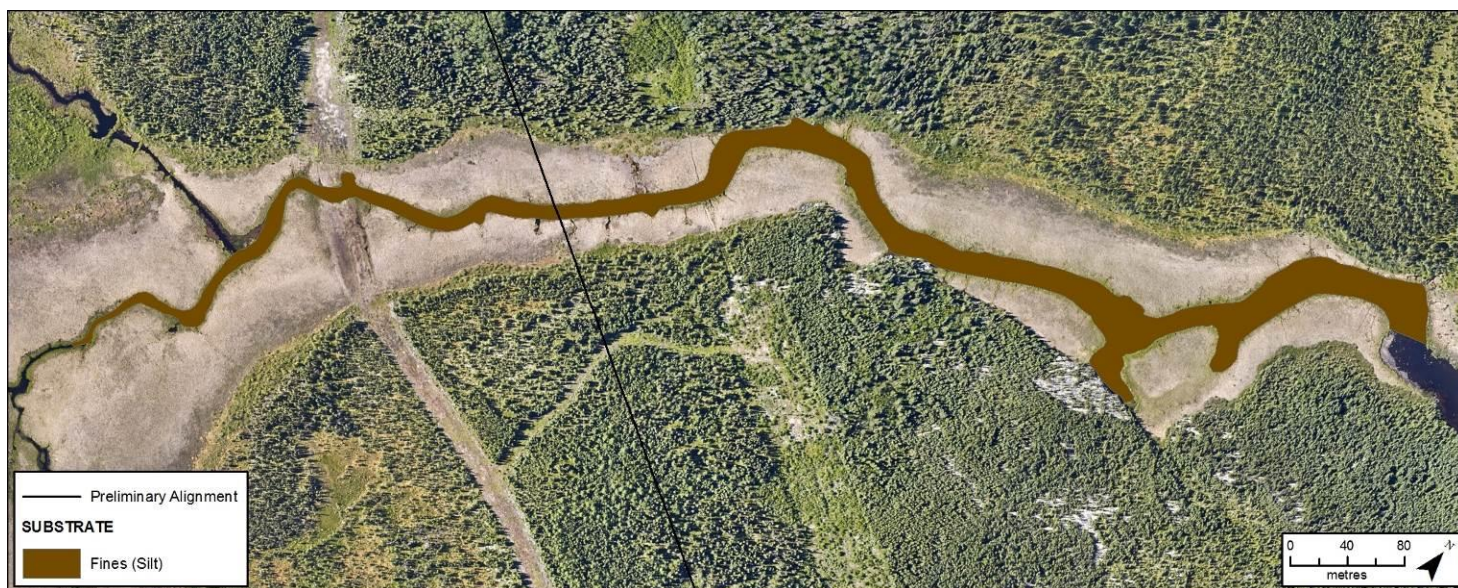
### + Substrate Map

Note: This map is intended for fish habitat assessments. It should not be used for navigation or design purposes.

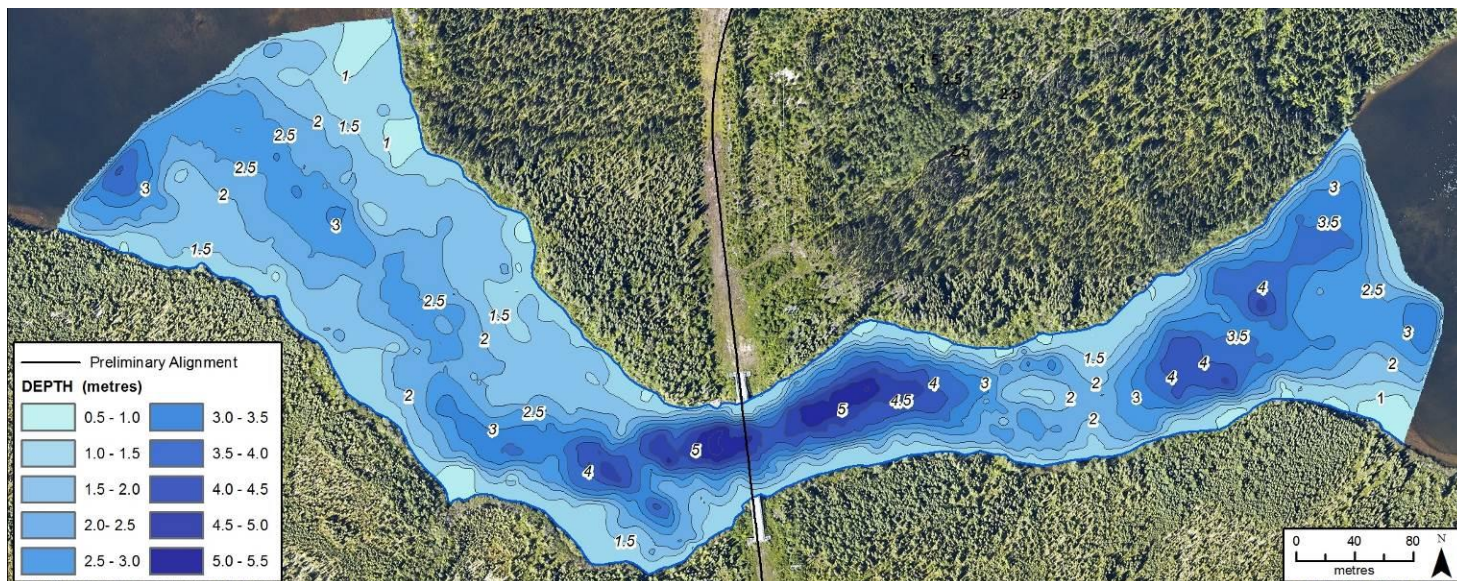
### + Bathymetric Map

Note: This map is intended for fish habitat assessments. It should not be used for navigation or design purposes.

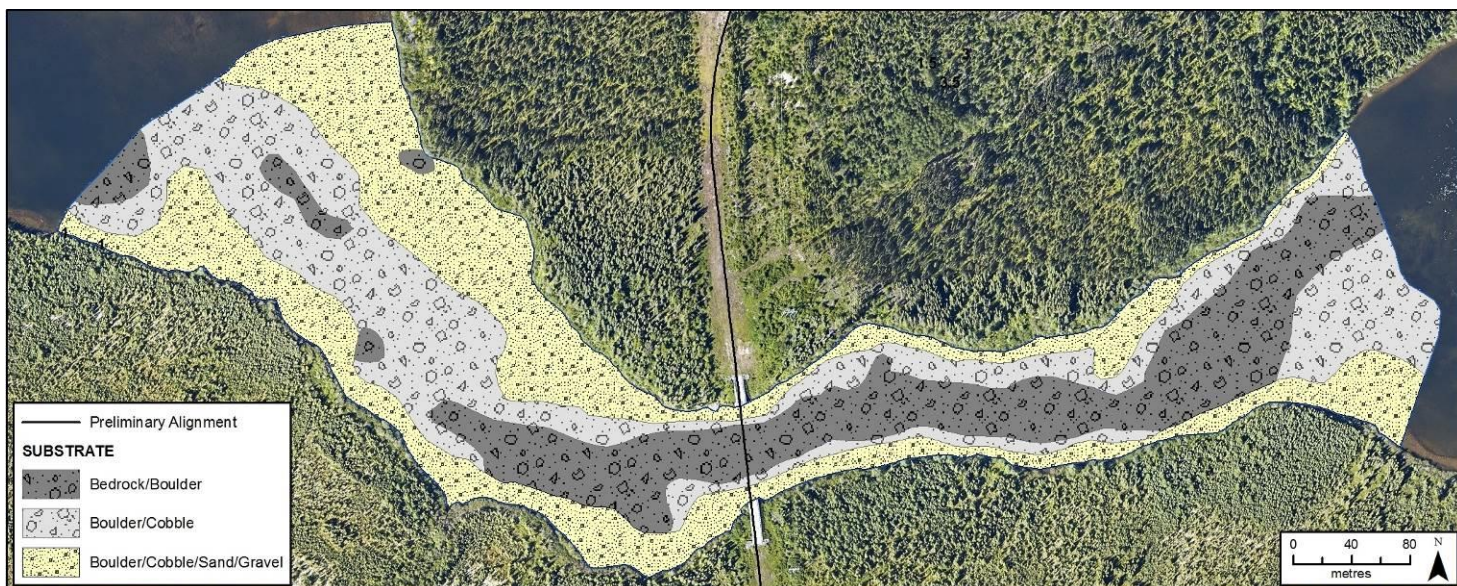
### + Substrate Map

Note: This is a generalized substrate map, intended for fish habitat assessment. It should not be used for navigation or design purposes.
