**INVESTIGATIONS AND PRELIMINARY ENGINEERING FOR  
LMB OUTLET CHANNELS OPTIONS C AND D  
SUMMARY REPORT**

16-0300-006

Final - Rev 0

May 2017

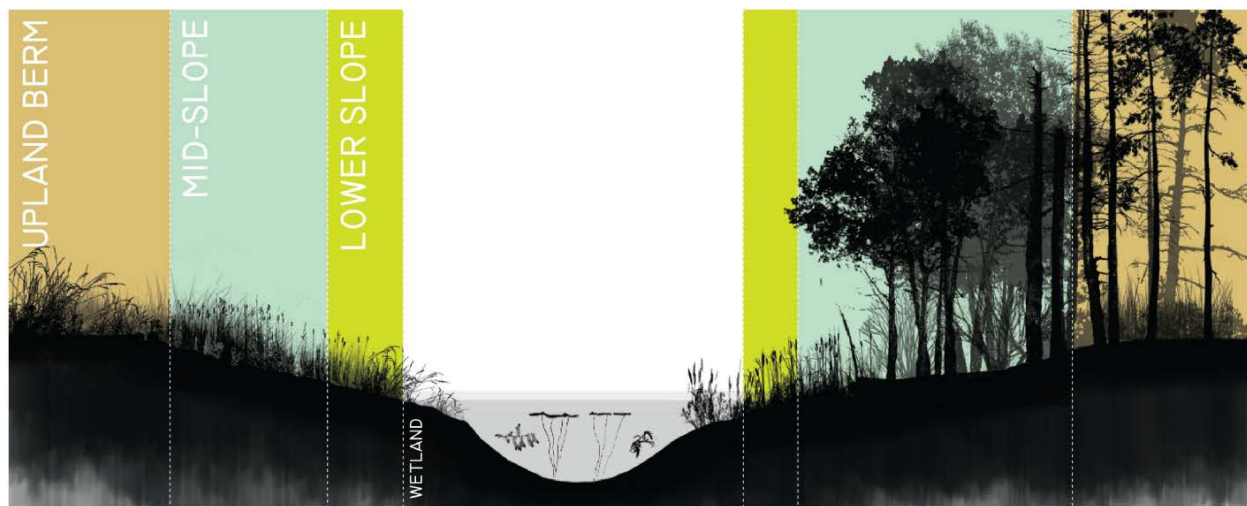
**FIGURE D7-2**  
**TYPICAL ELEMENTS OF REVEGETATION PLAN**

According to the proposed channel design, all or portions of the channel will permanently retain water. However, due to positioning of the control structure and the operating procedures, there will inevitably be portions of the channel side slopes that will experience alternating periods of submergence and exposure as a result of long term operation and closure of the outlet channel. Under these conditions vegetation would likely not survive, thus making the slopes susceptible to erosion. It is recommended that all upland and side-slope areas be seeded with a composition of species to reflect the changing moisture conditions (drought or flooding). Additional mitigation measures may also be required to address the risk of erosion along exposed side slopes such as installing riprap or implementing constructing management practices (Section 3.4.2). Cost allowances identified for mitigation and risk are documented separately in Deliverable D11.

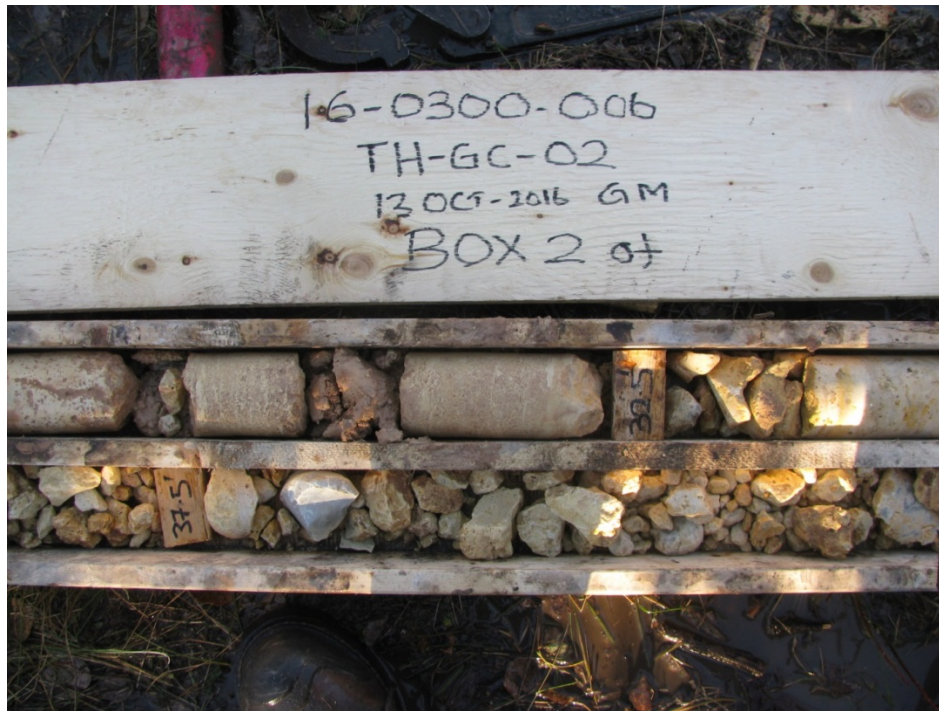
Photo D8-C3 – Example of broken core/rubble zone within bedrock along Route C (TH-GC02). Core diameter is 63.5 mm.

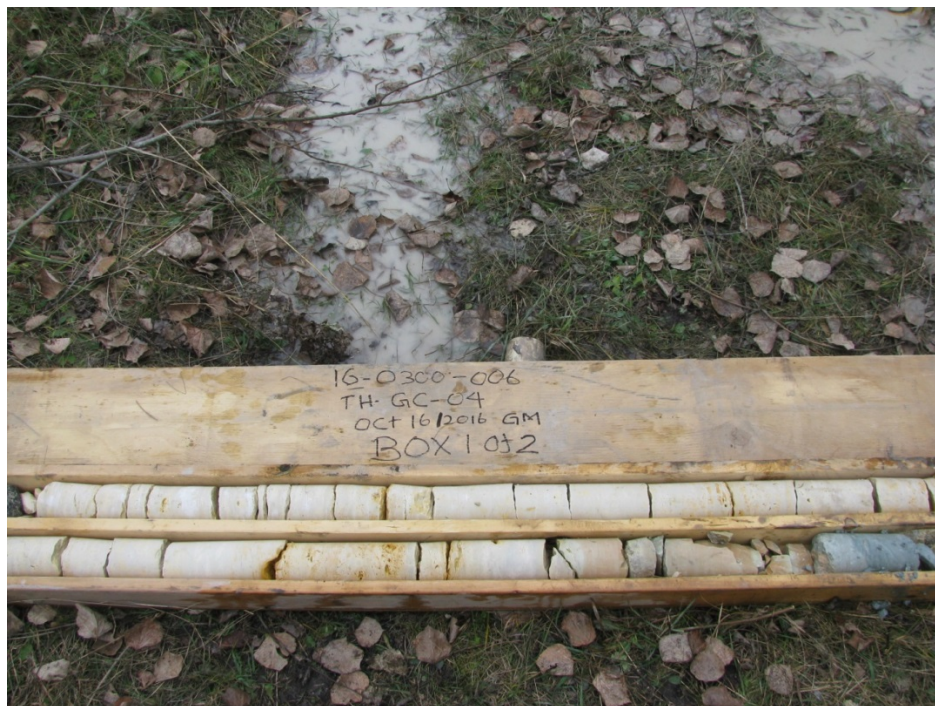
Photo D8-C4 – Example of good quality bedrock along Route C (TH-GC04). Core diameter is 63.5 mm; length of core box approximately 1.5 m.
