HERITAGE RESOURCE IMPACT ASSESSMENT BOISSEVAIN WASTEWATER TREATMENT LAGOON UPGRADES SE 23-03-20 & NW 14-03-20 WPM MUNICIPALITY OF BOISSEVAIN-MORTON

Heritage Permit A144-24

December 4, 2024

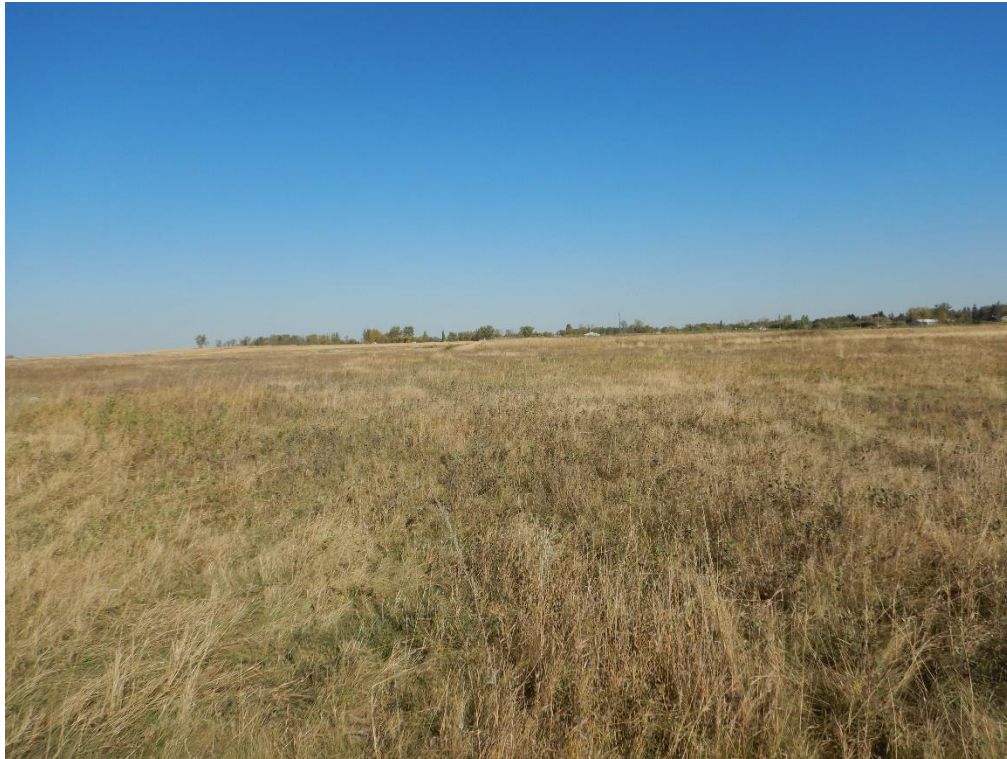
Figure 6. Open field south of existing lagoon – North aspect

The assessment of the proposed lagoon expansion occurred on October 8, 2024 under favourable field conditions. The expansion footprint is situated immediately south and adjacent to the existing lagoon. The property consists of an open pastureland that has limited terrain features (Figure 6). Pockets of slightly lower lying marshland were noted within the field.

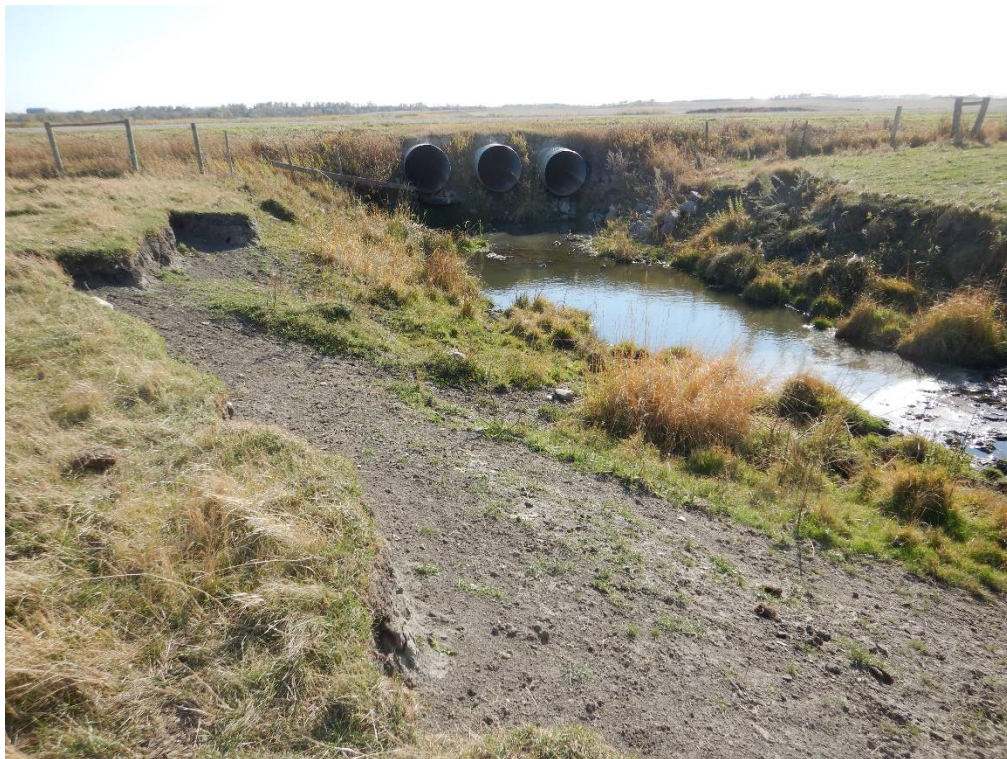
Figure 7. Large culverts along Cherry Creek – North aspect

Nearby is a branch of Cherry Creek which was visually examined but not shovel tested, as it is located outside the project area. The creek is approximately 3 m wide and has short, slumping banks which have been impacted from cattle pasturing. The creek appears to have been modified along its margins in certain sections, with a deepening and straightening of portions of the creek. Large culverts under Municipal Road 15N indicate that the creek has the capacity to hold large amounts of water, likely during the spring run-off (Figure 7).

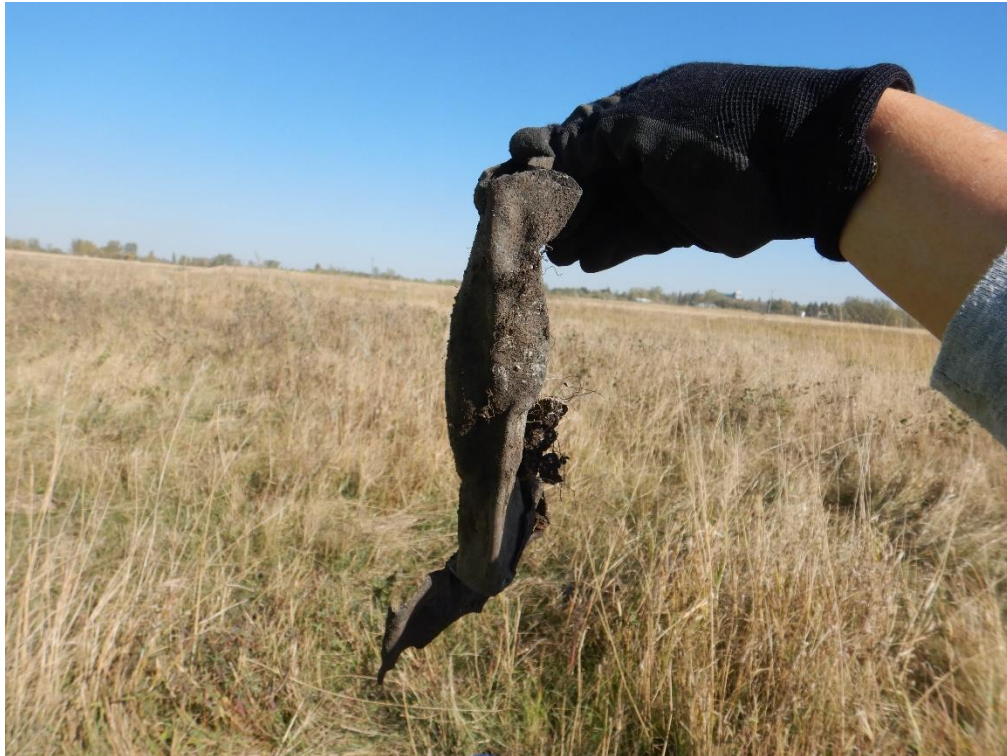
Figure 8. Recently crafted rag found in shovel test pit

Judgemental subsurface testing occurred across the area and near the relict channel, as there were no visible terrain features of interest in which to focus testing. One subsurface test (BM01), close to the existing lagoon, a rubberized fabric rag was discovered at a depth of 27 cm (Figure 8). This could corroborate that fill materials had been brought in for the original construction of the lagoon or to grade or resurface the surrounding area. The soils encountered in the tests consisted of very dense grey to brown hardpacked silty clays and many tests showed a mottling of soils indicating previous disturbance (Figure 9). Surface compaction would likely be due to livestock and if heavy machinery was used in the area.

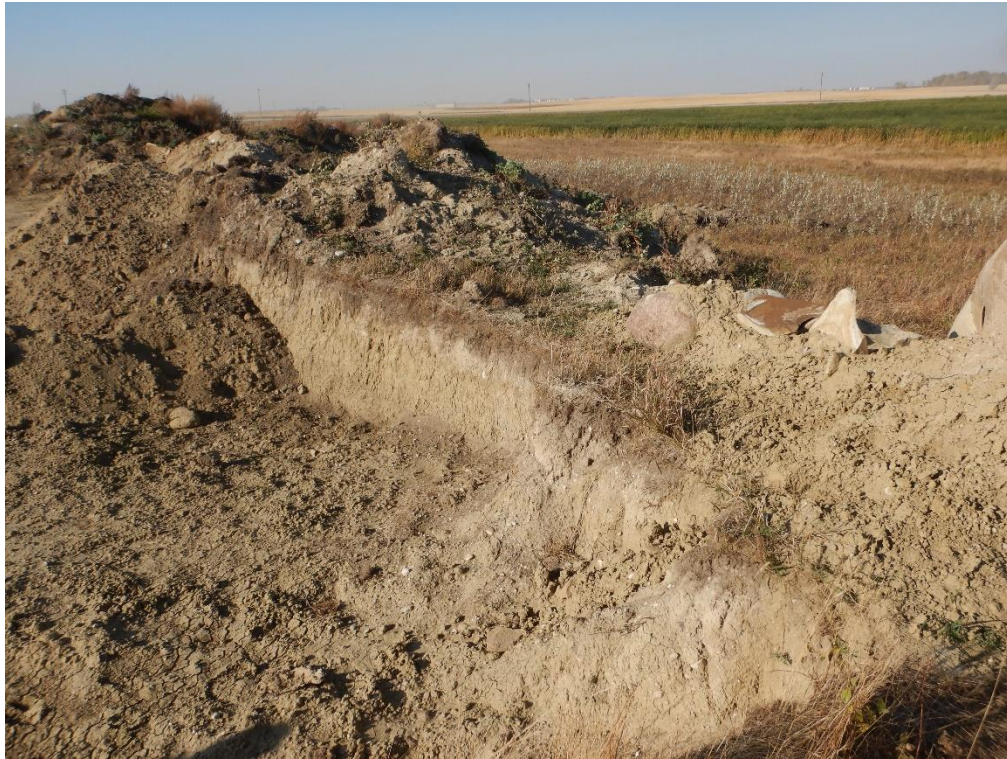
Figure 10. Borrow pit in NW 14-03-20 WPM – North aspect

The assessment of the proposed borrow pit area occurred on October 8 and 9, 2024. The property consists of open pastureland with grasses and thistle with some small shrubbery. The property has been previously impacted through former borrow source extraction. A large open pit covers an area measuring 115 m E-W and 125 m N-S within the northern half of the proposed borrow area (Figure 10). Smaller depressions were observed surrounding the main pit and are likely overgrown, smaller borrow pits. Northward from the main pit is the highest elevation on the property. However, the ground quickly transitions sloping downwards towards an expansive marshland which covers a large portion of the quarter section (Figure 11). To the south of the pit, the ground slopes down towards a cattle dugout which also forms part of the marshland (Figure 12).

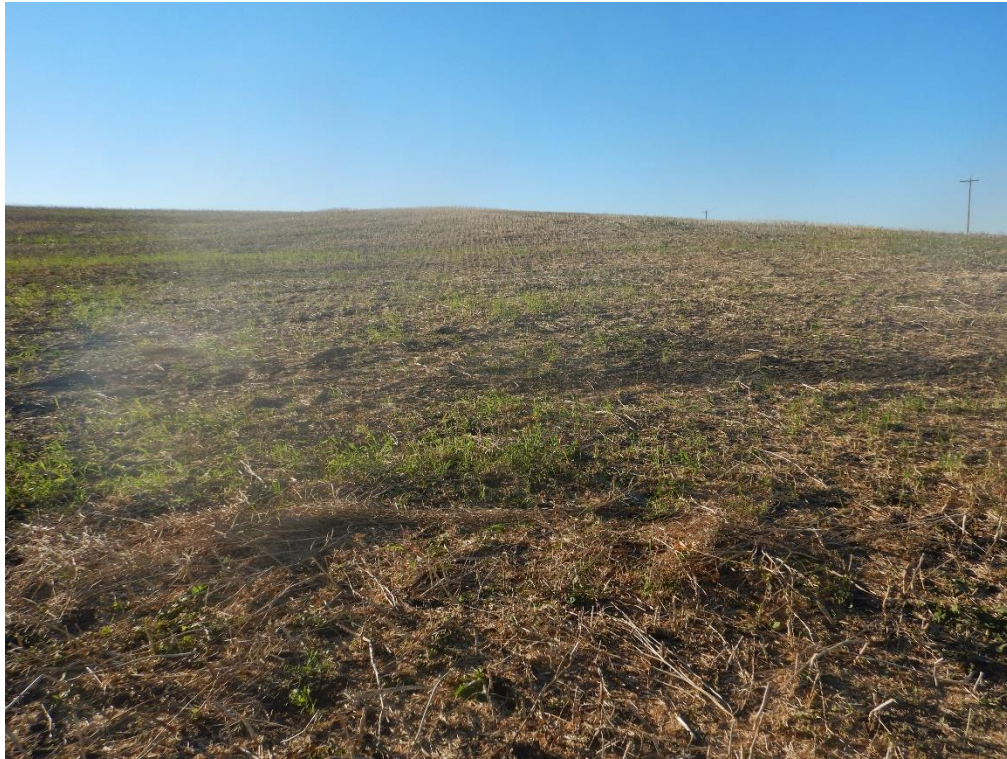
Figure 14. Slight hill in southern part of NW 14-03-20 WPM – South aspect

The assessment continued toward the southern part of the proposed borrow area, crossing over a barbed wire fence which separated the pasture from an agricultural field. The field rises above the marshland forming another hill with a good view of the general area (Figure 14 & 15). To the south and east, signs of additional borrow source extraction were noted. At the time of the survey, the field was a harvested crop of canola with a layer of chaff which had fair surface visibility. (Figure 15). There were no surface heritage resource finds during the pedestrian survey.

Subsurface testing (n=7) occurred across the hill, along its side slope and the foot of the hill situated above the marshland, was undertaken. In total 15 tests were excavated in the proposed borrow area with negative results.
