RE: **Dauphin Anhydrous Ammonia Tank Farm, Rural Municipality of Dauphin, MB**
Environment Act Proposal

ANHYDROUS AMMONIA TANK FARM, RM OF DAUPHIN, MB *ENVIRONMENT ACT PROPOSAL REPORT*

6 DECEMBER 2023

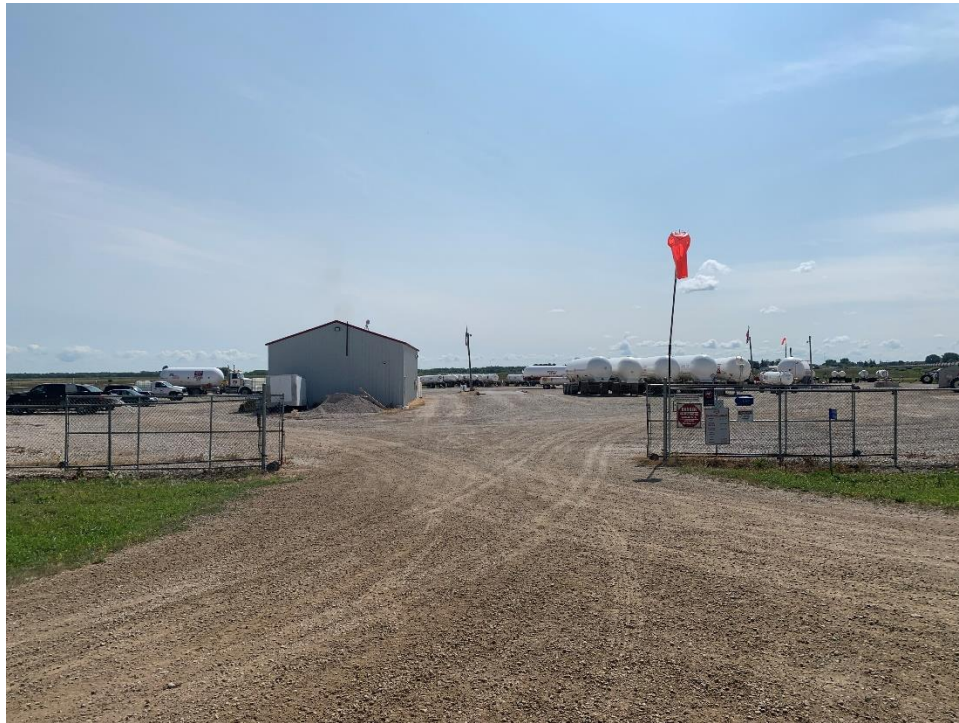
Photo 1 – Showing exterior of Site building, facing east.

The Site consisted of a slab-on-grade building. The southern portion of the building was utilized as office space. The northern portion of the building was utilized as a garage and small mechanical maintenance area for the facility. A 3,785 L cistern is stored within the southeast corner of the Site building and is the Site's water source. A septic tank is located adjacent to the west of the Site building. The interior walls and ceilings were observed to consist of painted plywood. Flooring in the building consisted of concrete. Lighting was provided by a mixture of fluorescent tube lighting and incandescent bulbs. Cooling was provided via a wall-mounted air conditioning unit. Heating was provided via electric baseboard heaters. Exterior building materials and roofing were observed to consist of corrugated metal.

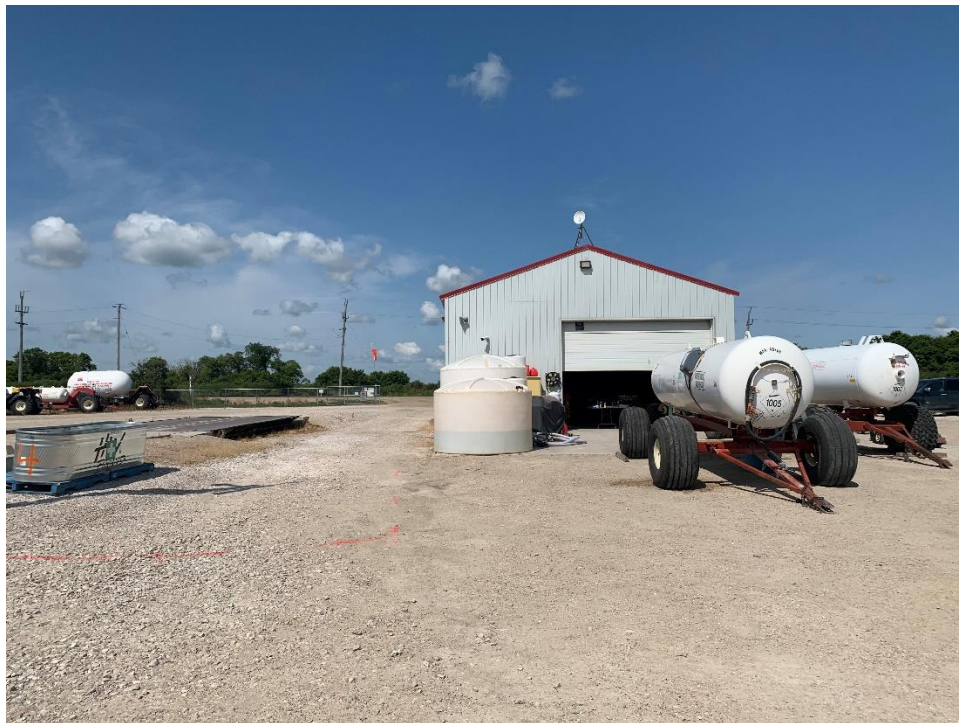
Photo 2 – Showing exterior of Site building, facing west.

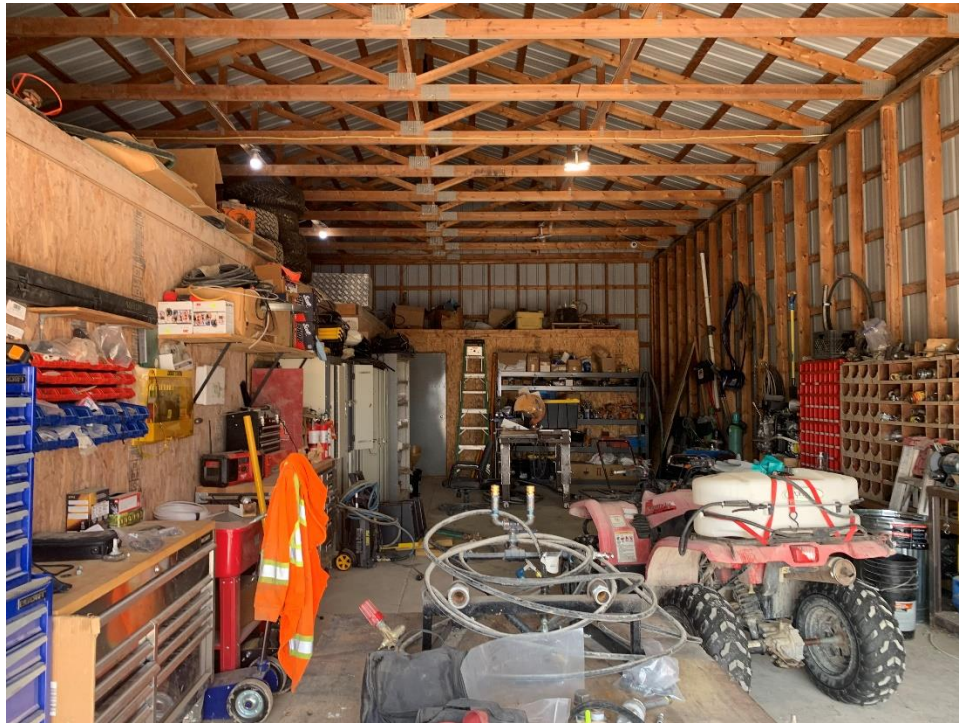
Photo 3 – Interior of Site Building, garage portion.

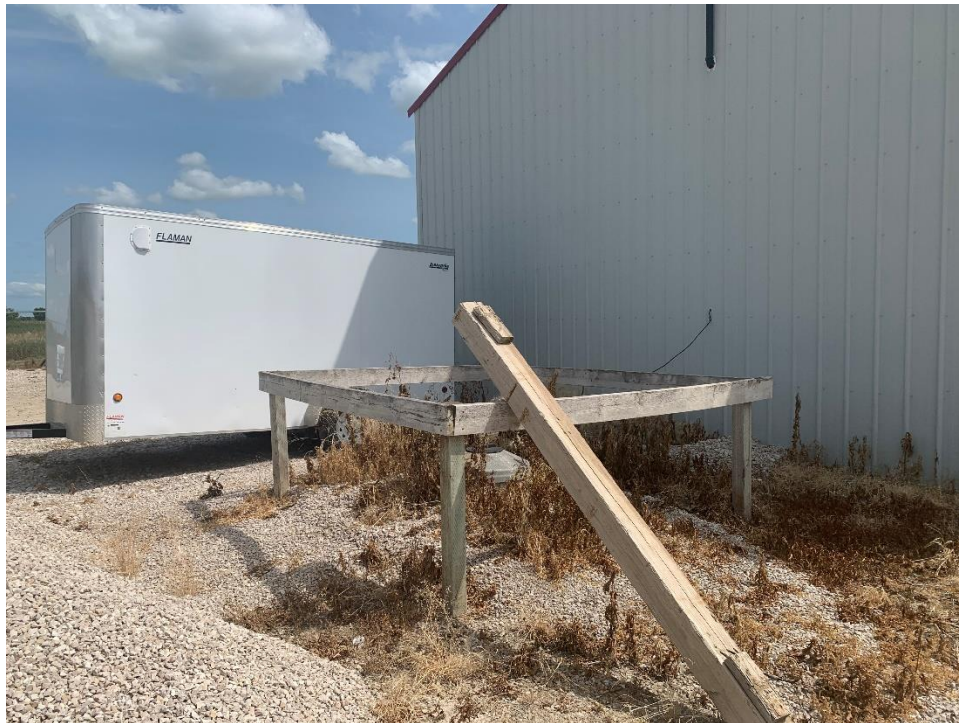
Photo 6 – Septic tank, located along the west side of the Site building.

The Project will rely on water drawn from an on-Site cistern filled on an as needed basis for its water needs. The current septic tank will be replaced with a new tank, which will be cleaned out as needed by a contracted septic tank services provider. Office waste generated at the Project Site will be disposed of at the City of Dauphin's waste disposal ground (WDG).

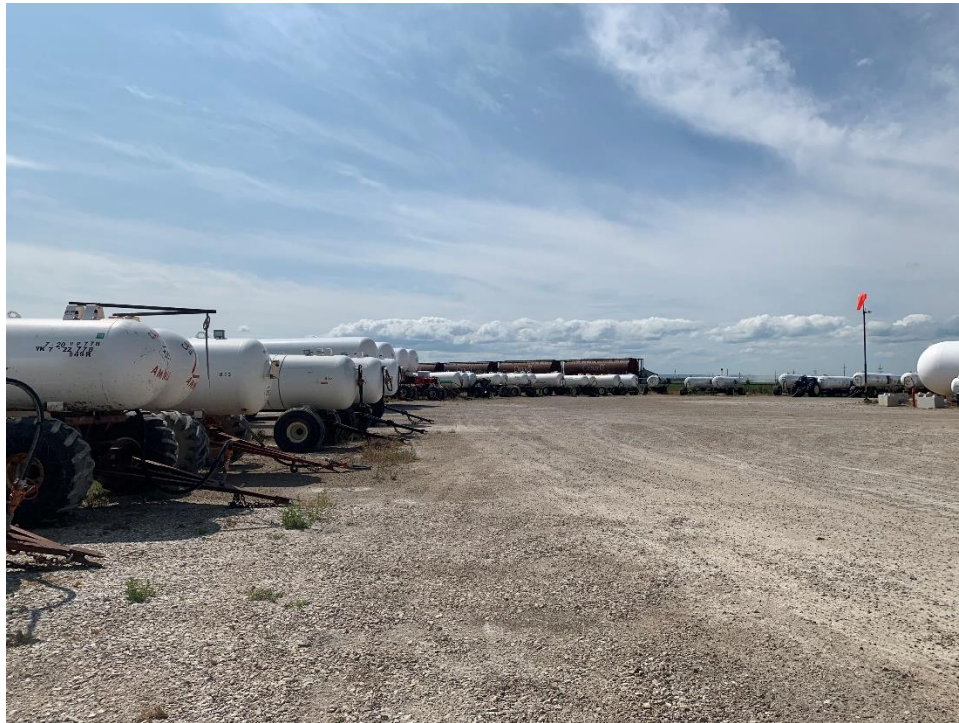
Photo 7 – Near the northeast corner of the Facility, facing south. Nurse tank storage.

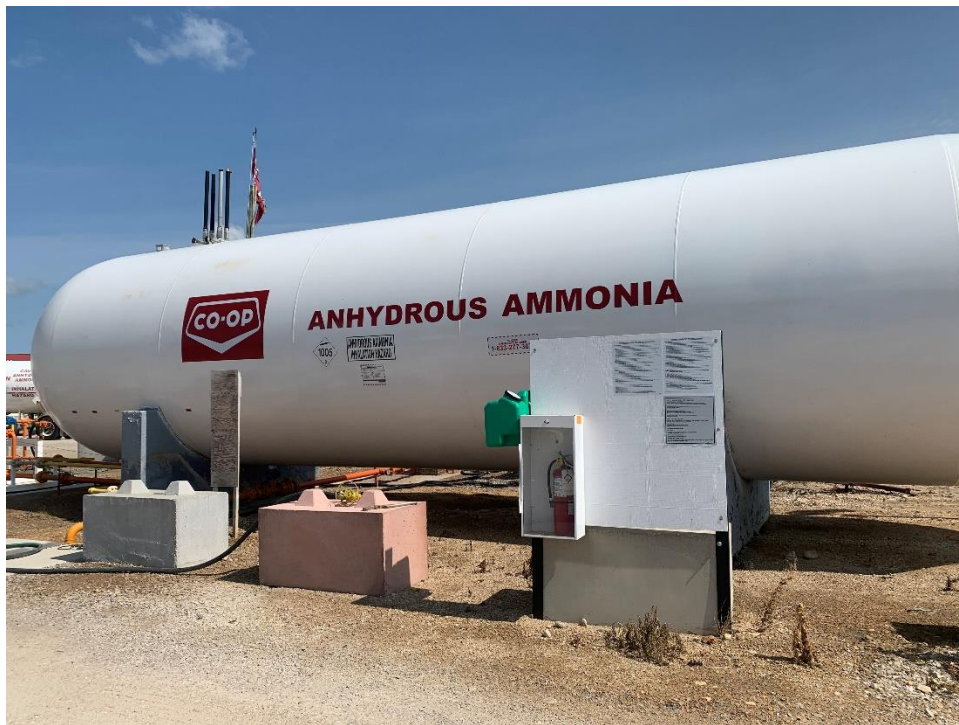
Photo 8 - 60 metric tonne tank containing anhydrous ammonia.

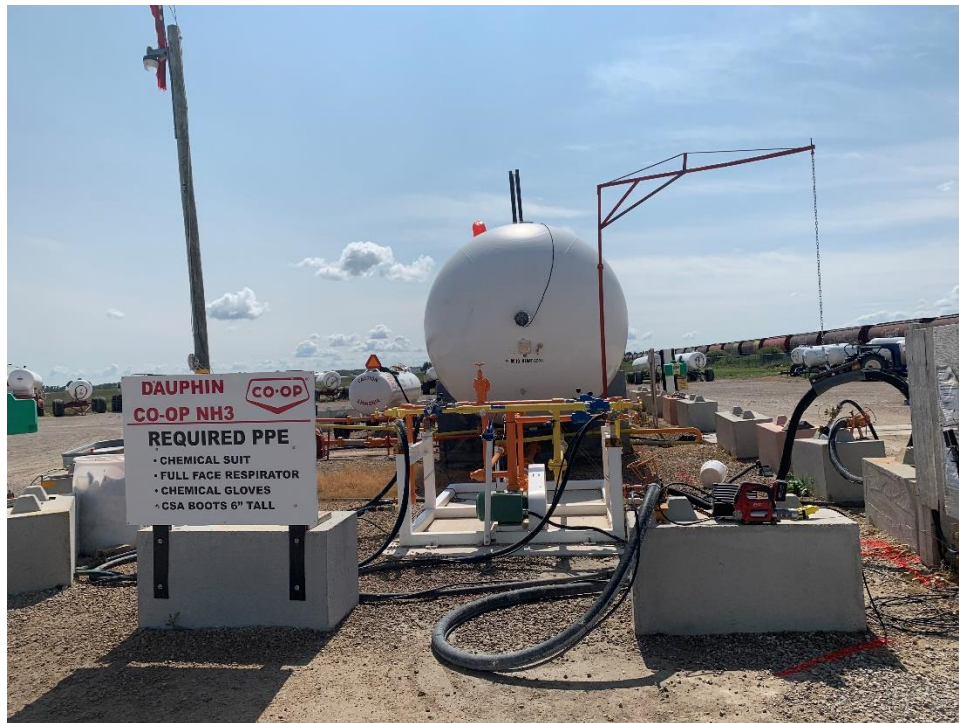
Photo 9 – Infrastructure associated with 60 metric tonne tank.

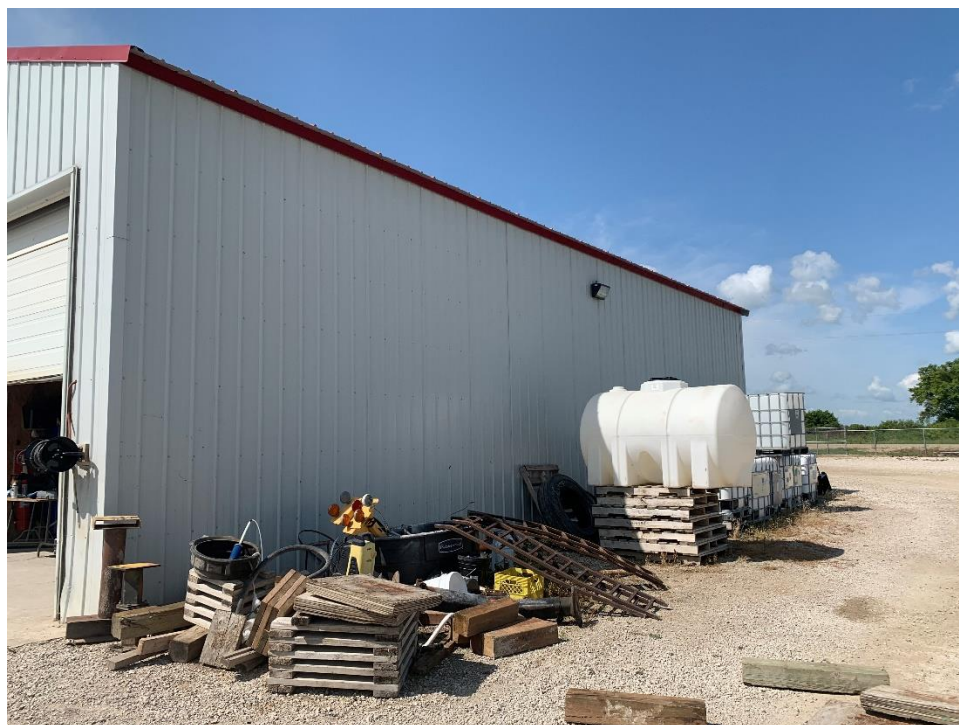
Photo 109 – Miscellaneous storage on north side of Site building. Totes were empty.

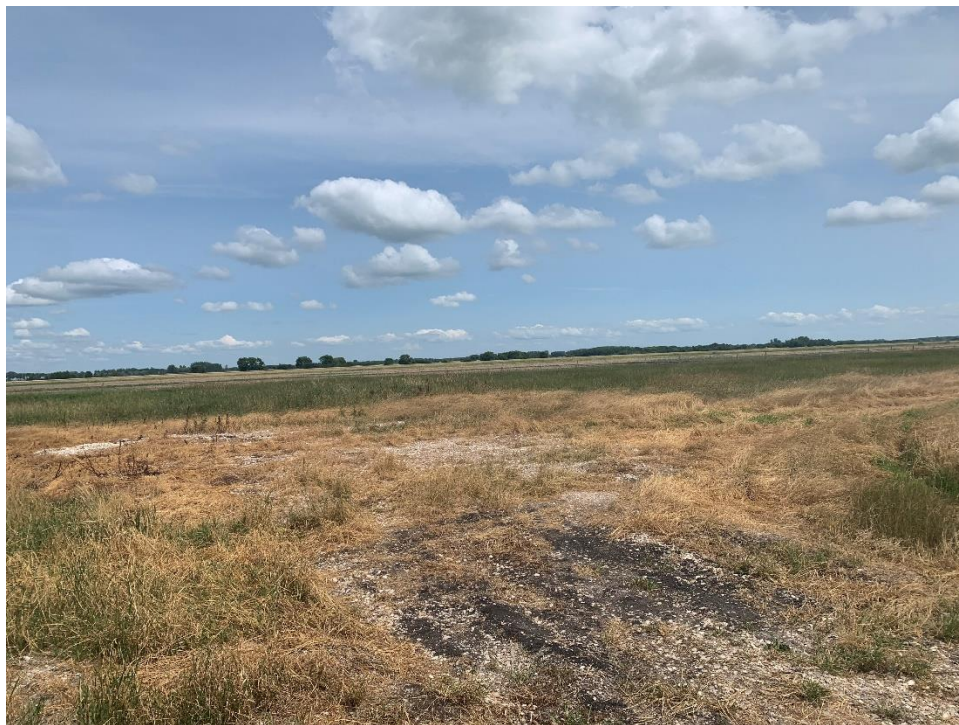
Photo 12 – Near center of northern boundary, north of fenced facility, facing north. Area of distressed vegetation.

The Site is gravel-surfaced and enclosed by a six-foot high chain link fence. The northern and western portions of the Site, outside of the chain-linked fenced area, were observed to consist of grasses, shrubs, and other low-lying flora. A small area of distressed vegetation was observed in the north center of the Site.
