**EAST INTERLAKE CONSERVATION DISTRICT:  
WATERSHED 050J RIPARIAN ASSESSMENT SURVEY – WITH  
EMPHASIS ON THIRD ORDER DRAINS and HIGHER – 2007 and 2008**

P. G. Graveline

2008

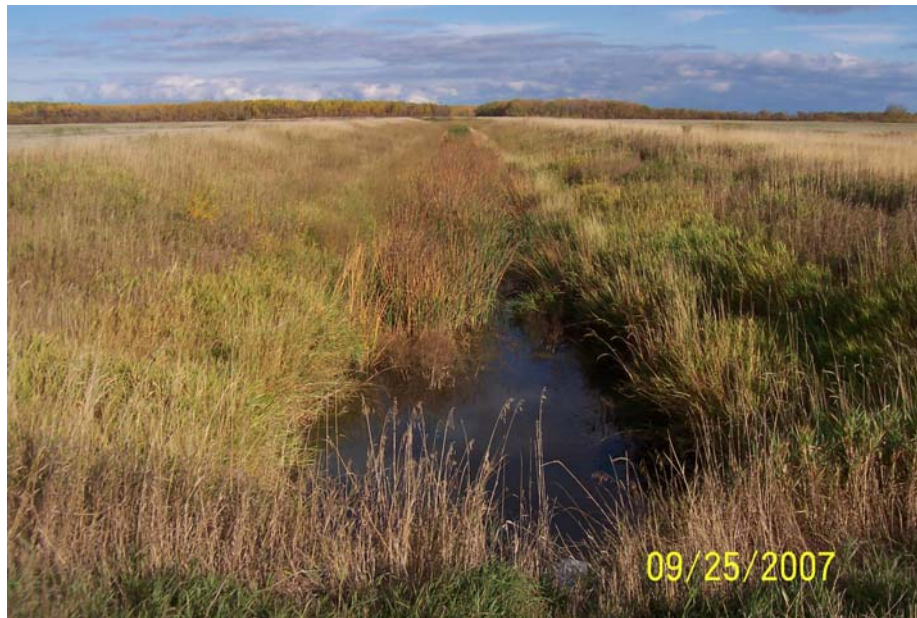
Cochrane Creek was visited on the ground, where possible, for the collection of ground based photographs. No fisheries investigations were conducted in Cochrane Creek during the summer/fall of 2007 due to limited to non-existent flow conditions (Photo 2). Cochrane Creek was not identified for spring 2008 fisheries investigations.

Photo 2. Looking downstream along Cochrane Creek, Wpt. 85, September 25, 2007.

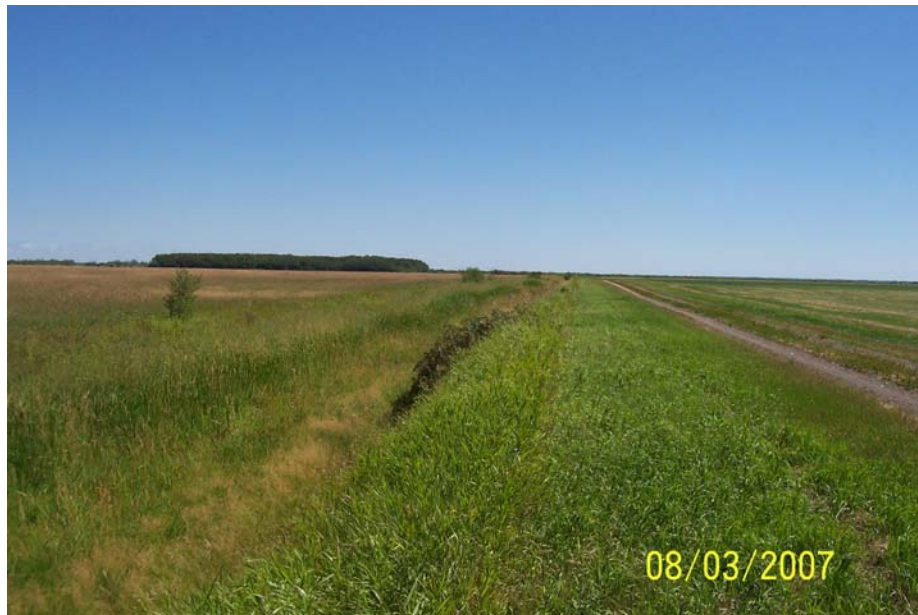
This highly channelized watercourse was given an aquatic habitat quality rating of Class C (highly impacted) (Table 6, Figure 9). The fish habitat observed (between waypoints 13 and 19) exhibited Class 4 fish habitat (i.e., severe limitations to production of fish) and should be considered as marginal (Figure 6).

Photo 3. Looking downstream on Fisher Drain at Wpt. 17, August 3, 2007.

One potential rehabilitation site was identified on the Fisher Drain (Table 7, Figure 9). Involving bank erosion, this site (#30) was given a priority 3 due to the close proximity of the agricultural practice (i.e., crops).

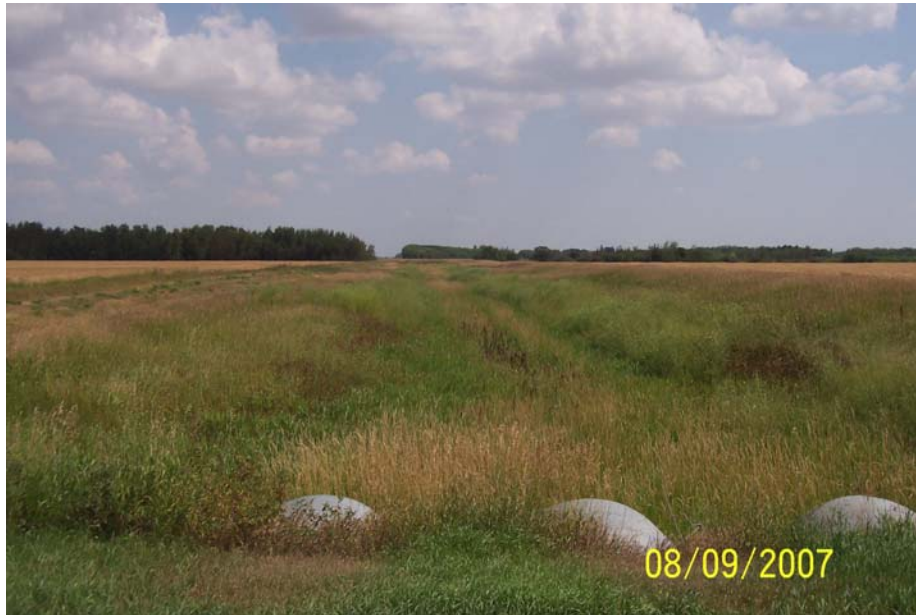
All (100%) of the 8.8 km of the Gramiak Drain reviewed for land use/cover was determined to be other agricultural land (Table 5). The Gramiak Drain is primarily a ‘grassed ditch’, channelized (likely) to accelerate the flow of water from agricultural land, and was therefore rated as Class C (highly impacted) (Table 6, Figure 11). In addition, the fish habitat along this drain is considered as Class 4 (severe limitations to fish production) and/or comprising marginal habitat.

Photo 4. Looking downstream along Gramiak Drain, Wpt. 35, August 8, 2007.

No potential rehabilitation sites were observed along the Gramiak Drain.

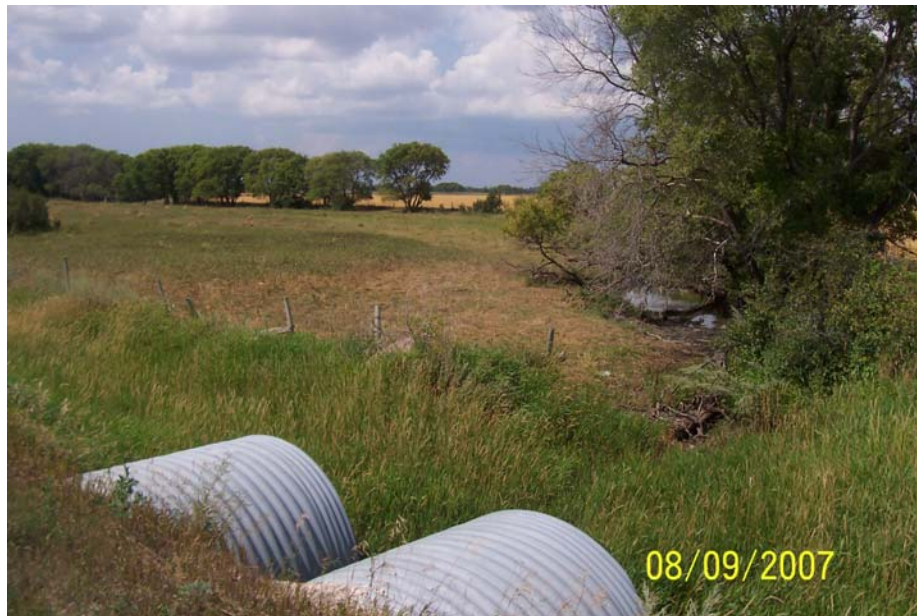
No discharge measurements or fisheries investigations were conducted on Jackfish Creek in 2007 due to minimal/non-existent water levels (Photo 7). Jackfish Creek was also not identified for spring fisheries investigations in 2008 .

Photo 7. Looking upstream on Jackfish Creek at Wpt. 38, August 9, 2007.

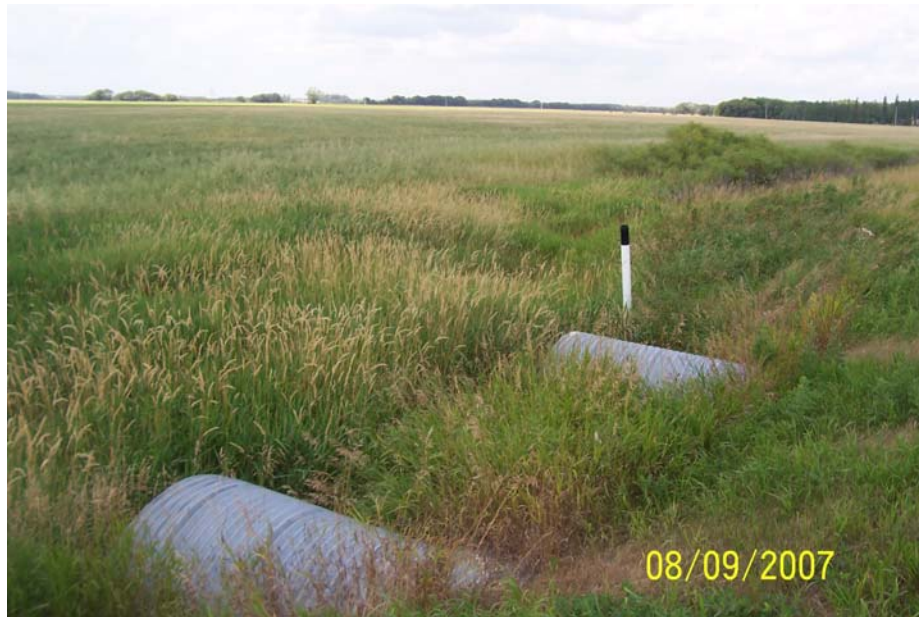
Photo 8. Looking upstream on Jennifer Creek at Wpt. 36, August 9, 2007.

Along Jennifer creek, other agricultural land (59.6%) (i.e., cropland and hayland) was the primary land use/cover, followed by pasture/grazing (38.2%), and mixed forest (2.2%) (Table 5, Figure 7). The two reaches of pasture/grazing identified along this creek appear to be extensive and may warrant additional investigation.

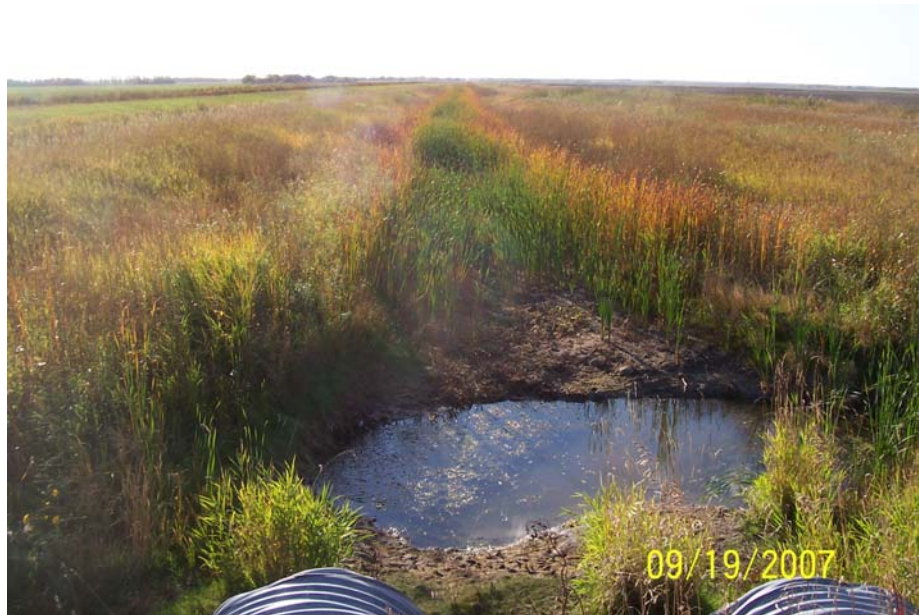
No stream properties (i.e., discharges, depths, substrate composition) or summer/fall fish utilization surveys were conducted on Ross Creek in 2007 due to non-existent and/or marginal stream flows (Photo 12).

Photo 12. Looking upstream along Ross Creek (Wpt. 79), September 19, 2007.

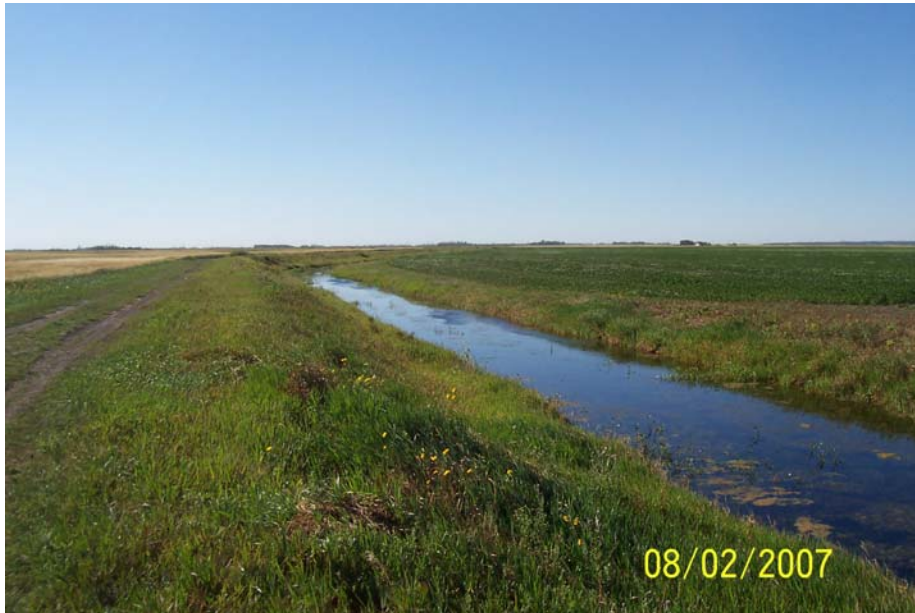
Wpt. 5, but wetted between Wpts. 3 and 4. The water between these waypoints appeared to maintain a constant depth (due to channelization) and did not exhibit any flow (Photo 13).

Photo 13. Looking upstream along Steele Drain (Wpt. 4), August 2, 2007.

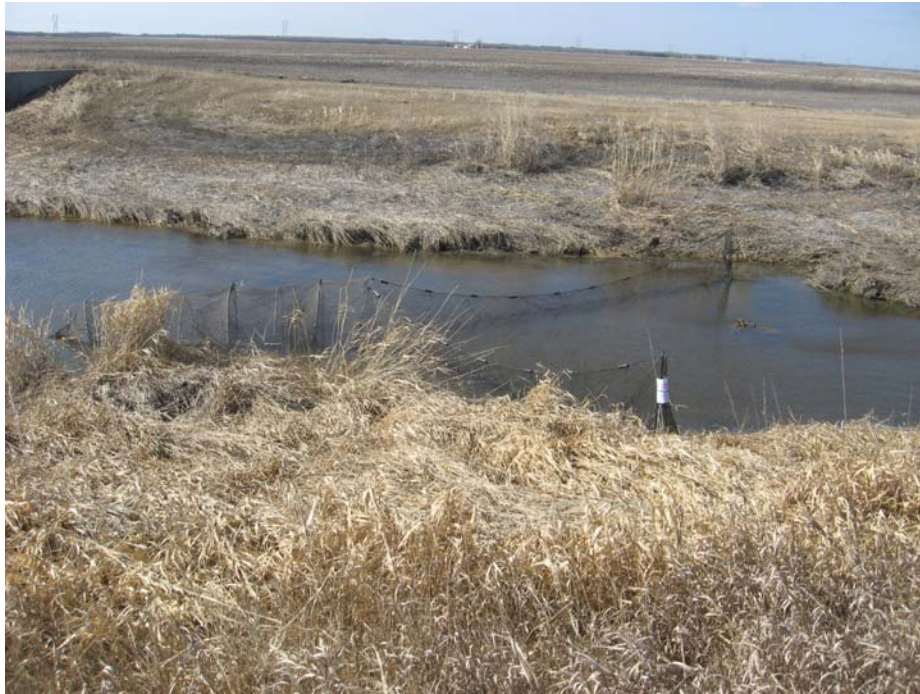
The aquatic habitat quality along Wavey Creek was determined to be primarily Class C (69.4%), followed by Class A (27.1%) and Class B (3.5%) habitat (Table 6, Figure 10). The relatively high percentage of Class A habitat may be attributable to the remaining natural riparian areas and lack of channelization of this watercourse from its confluence with Netley Creek upstream to Wpt. 22 (Figure 7). With its natural sinuosity, varying depths and substrates, healthy riparian, etc. this section of Wavey Creek (i.e., confluence to Wpt. 22) can be defined as having Class 1 fish habitat (i.e., high capability for fish production) and/or

Photo 15. Hoop net set on Wavey Creek, just downstream of the control structure at Wpt. 78, spring 2008.

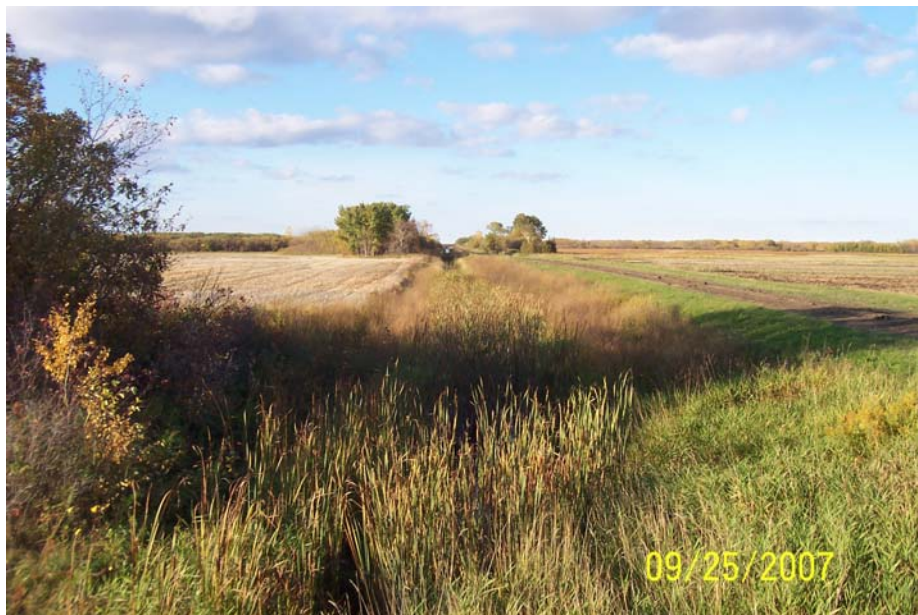
With the exception of ground based photography and aerial reconnaissance, no field inspections (i.e., hydrometric surveys or fisheries investigations) were conducted on Whiskey Ditch in 2007. The area of this ditch that was accessible by road exhibited minimal to non-existent flow conditions (i.e., dry) (Photo 17).

Photo 17. Looking downstream along Whiskey Ditch (Wpt. 86), September 25, 2007.
