Manitoba Transportation and Infrastructure

IN-SERVICE ROAD SAFETY REVIEW – PTH 1 AND PTH 5 INTERSECTION

FINAL REPORT

DECEMBER 2023

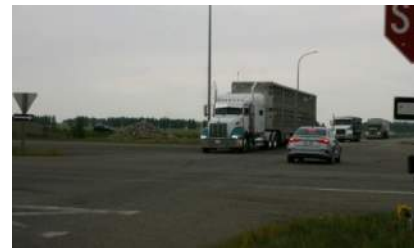
Truck and passenger vehicle crossing narrow median at same time

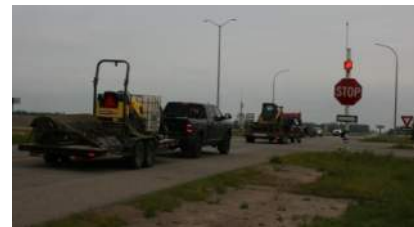
Pick-up truck with trailer stopped within narrow median

Several vehicles were observed occupying the narrow median at the same time. This provides significant opportunities for conflict, including conflicting vehicle orientations while waiting in the median and the potential for queuing traffic to extend into the high speed through lanes. Vehicles occupying the median also create sightline obstructions for other vehicles.

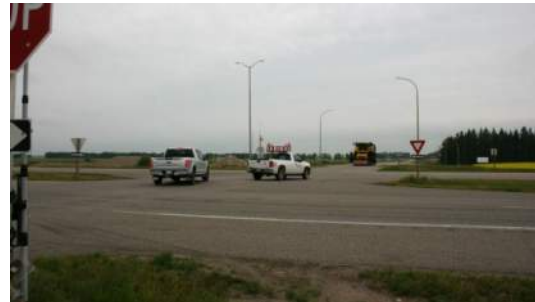
Two northbound vehicles occupying the median at the same time

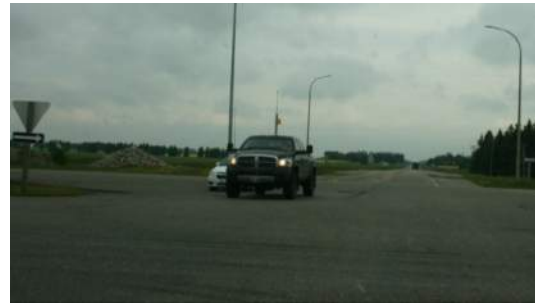
Two southbound vehicles occupying the median at the same time

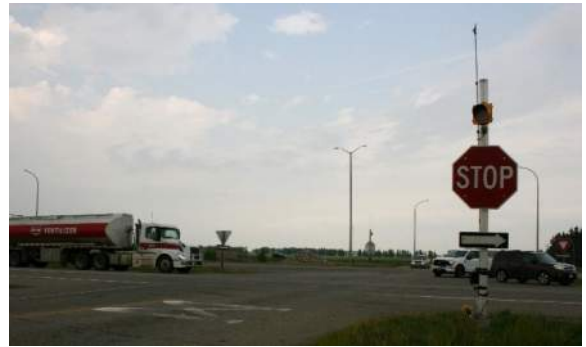
The PTH 1 left-turn lanes have a negative offset which can limit sightlines for opposing left-turning vehicles.

Large trucks occupying these left-turn lanes as they wait for the median to clear can also obstruct sightlines for other traffic crossing or waiting in the median.

Truck waiting in the left-turn lane limits sightlines for vehicles using the median

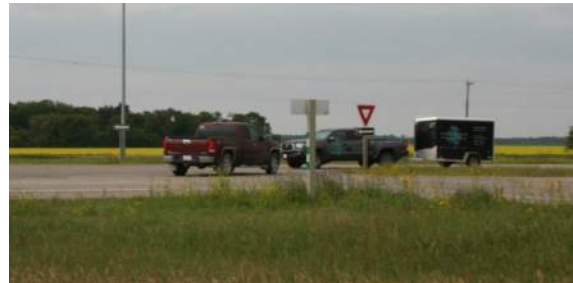
Two pick-up trucks making opposing left-turns from PTH 1 onto PTH 5 at the same time

Different driving behaviors were observed at the median for vehicles making left-turns from both PTH 1 and PTH 5. Some drivers make “simultaneous left-turns”, while others make “interlocking left-turns.”

In addition to the left-turn issue identified above, vehicles were observed turning left from PTH 1 at the same time vehicles were turning left from PTH 5. These conflicting turning behaviours contribute to an increased risk of driver error and collision at the intersection.

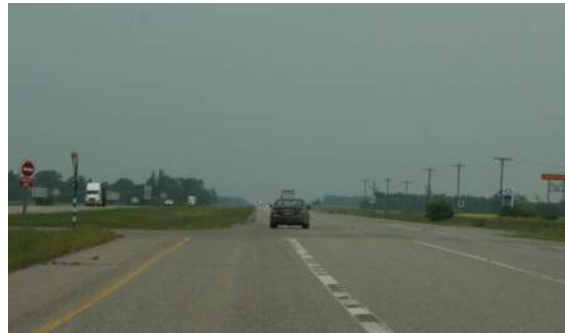
Field observations suggest a significant volume of traffic is turning left from PTH 5 southbound onto PTH 1 eastbound. No median left-turn acceleration lane is provided in the eastbound direction on PTH 1. As a result, southbound to eastbound left-turning vehicles merge directly into the high-speed mainline lane or use the median shoulder to accelerate. This introduces a speed differential on the mainline lanes and an increased risk of collision. This is a particular concern for large trucks that generally take longer to accelerate and often merging at lower speed.

Passenger vehicle making left-turn directly into eastbound through lane

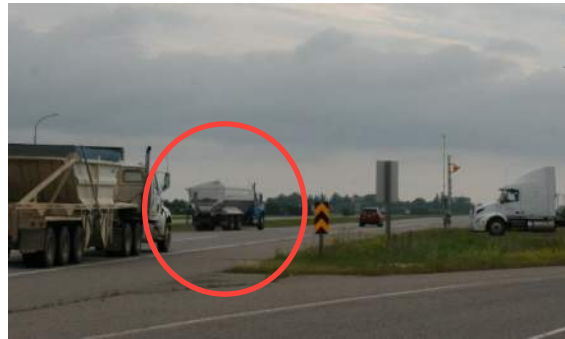
Truck making left-turn directly into eastbound through lane

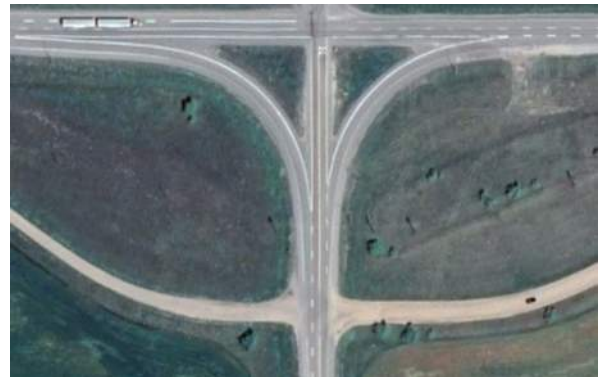
Service Road, south of intersection

The close proximity of these intersections (located within the right turn merge and diverge points and the main intersection area of influence) may cause conflicts between through traffic and vehicles turning to/from the service road, especially if there are northbound or southbound queues at the intersection. During the site visit, queues were occasionally observed to extend to the service roads when there were limited gaps available in traffic on PTH 1.

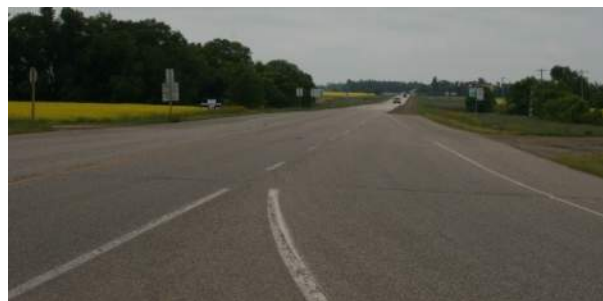
The merge tapers from PTH 1 right-turn lanes onto PTH 5 extend through the service road intersections north and south of the main intersection. As a result, vehicles slowing or stopping to turn left or right from PTH 5 onto the service road at these locations may not be anticipated by drivers approaching from behind. This may contribute to an increased risk of rear end and sideswipe collisions at these locations.

Merge taper at Service Road, south of the intersection

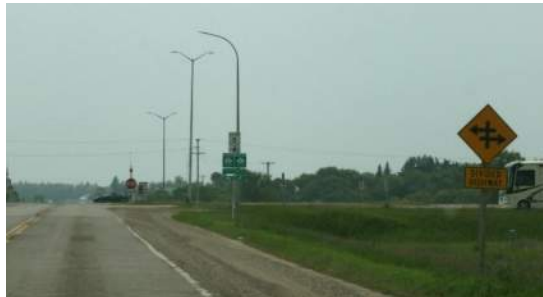
| Comment #11 | |
|--|---|
| <p>A Divided Highway Ahead Warning Sign (WA-34) is provided on the PTH 5 southbound approach to the intersection. This sign is not provided on the PTH 5 northbound approach. This is a consistency issue.</p> | <p style="text-align: center; color: #4F81BD;">Divided Highway Ahead Sign on the PTH 5 southbound approach</p> |

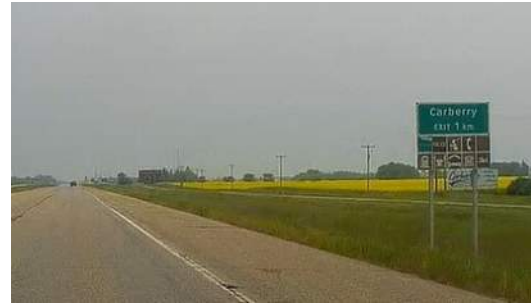
Guide signage on the eastbound and westbound approaches to the intersection is not consistent. On the eastbound approach, an advance destination distance sign and destination direction sign are provided. On the westbound approach, only a destination direction sign is provided.

There are also numerous information and tourist-oriented signage tabs that create sign clutter that may reduce the effectiveness of the guide sign.

Advance destination distance sign on the eastbound approach to the intersection

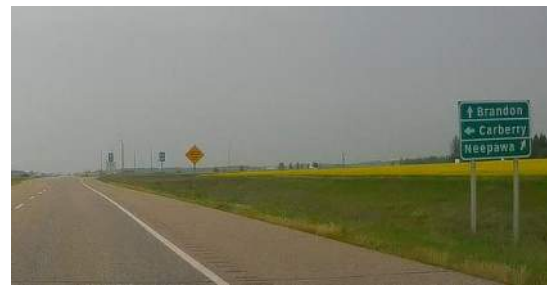
Destination direction sign on the westbound approach to the intersection

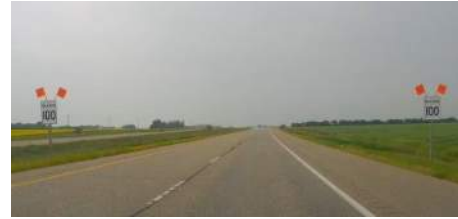
In the westbound direction, the speed reduction zone starts approximately 1.6 km east of the PTH 5 intersection and ends approximately 4.0 km west of PTH 5. In the eastbound direction, the speed reduction zone starts approximately 5.5 km west of the PTH 5 intersection (approximately 3.0 km west of the at-grade rail crossing) and ends immediately east of the PTH 5 intersection.

These speed reduction zones are long (approximately 5.5-5.6 km in length), and no speed management is provided to promote and reinforce the reduced speed within these zones. As a result, the effectiveness of the speed reduction zones may be limited.

Westbound approach double posted “Maximum 100 km/h” signage

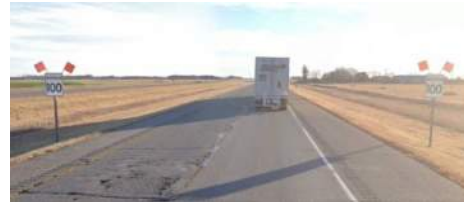
Eastbound approach double posted “Maximum 100 km/h” signage (approximately 5.5 km from intersection)

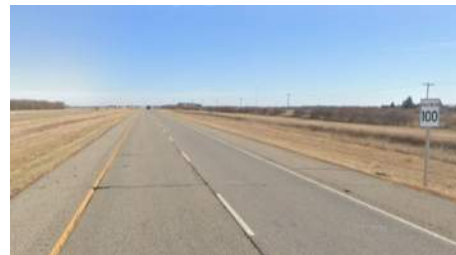
Eastbound approach single posted “Maximum 100 km/h” signage (approximately 4.0 km from intersection)

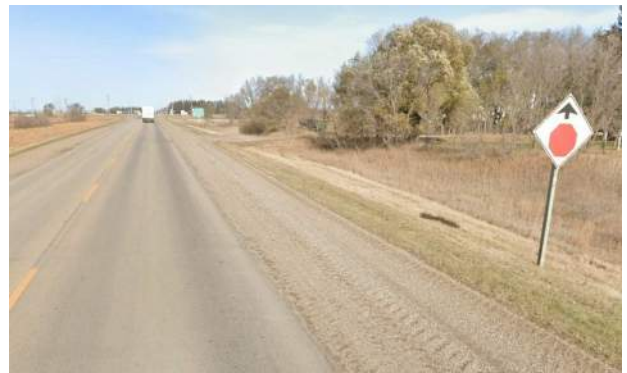
The posted speed on PTH 5 is 100 km/h and no speed reduction zone is provided on the approaches to the stop-controlled intersection.

PTH 5 approach to intersection with no speed limit reduction

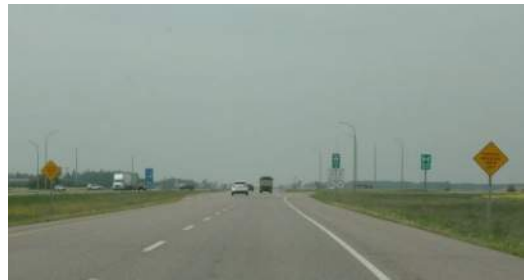
Although signage informing drivers about the median left-turn acceleration lane is provided, its effectiveness may be limited. This signage includes the following:

- White information sign "Left Turn Traffic, Use Acceleration Lane on PTH 1" provided on the PTH 5 northbound approach to the intersection (approximately 250 m upstream). This sign is small and may be difficult for some drivers to read.
- Double posted warning signs "Traffic Merging from Left" provided on the PTH 1 westbound approach to the intersection.

Double posted warning signs "Traffic Merging from Left" on westbound approach

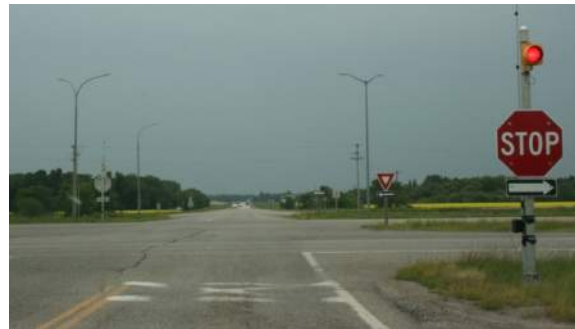
Due to the wide median opening, the yield signs in the median are located at an increased offset from the travel path. As a result, the effectiveness of these signs may be reduced.

Large yield signs are located at increased offset from the travel path

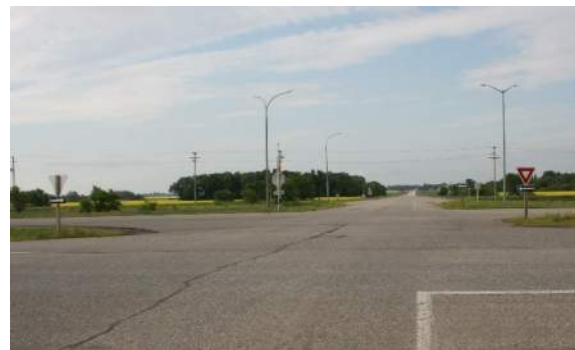
Due to the narrow median, no positive guidance is provided to help drivers navigate and position themselves in the median. This absence of positive guidance contributes to an increased risk of collision.

No positive guidance in the median

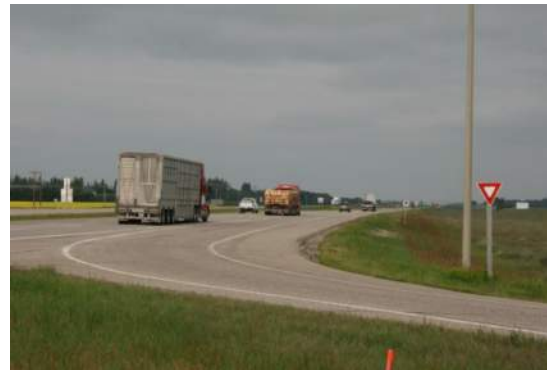
The right-turn acceleration lane geometry (in both eastbound and westbound direction) suggests to drivers that they should speed up and merge onto PTH 1. However, the yield signs provided suggest drivers should slow down and yield to oncoming traffic. This sends a mixed message to drivers and may contribute to speed differentials at this location. The provincial standard for signing this type of ramp should be confirmed to ensure appropriate signage has been provided.

Southbound to westbound channelized right-turn lane with yield sign

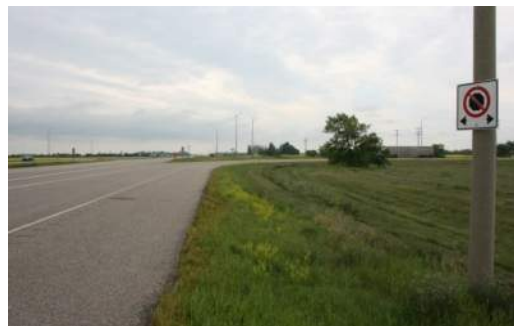
During the field review, trucks stopped on the roadway shoulder were observed on all quadrants of the intersection at the end of the channelized right-turn lanes. These locations are currently posted with “No stopping” signs.

“No Stopping” signage on PTH 1

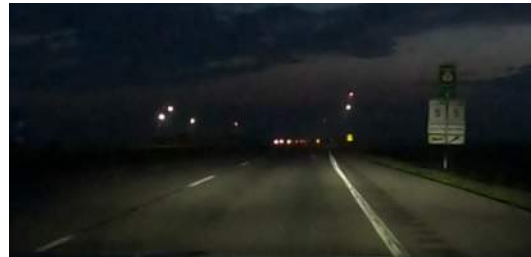
Approaching intersection on PTH 1 while travelling westbound at night

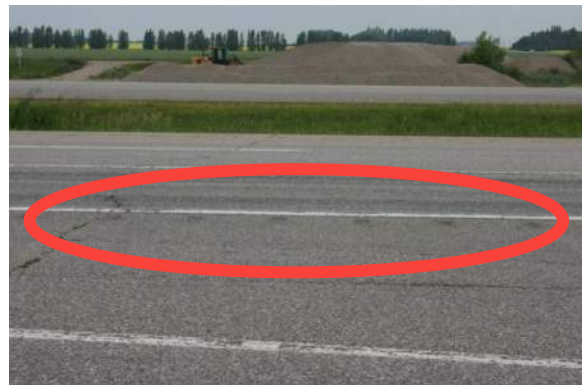
The transverse rumble strips on both PTH 5 approaches to the intersection are worn in the wheel paths. This may impact their effectiveness.

Rumble strips on the eastbound approach

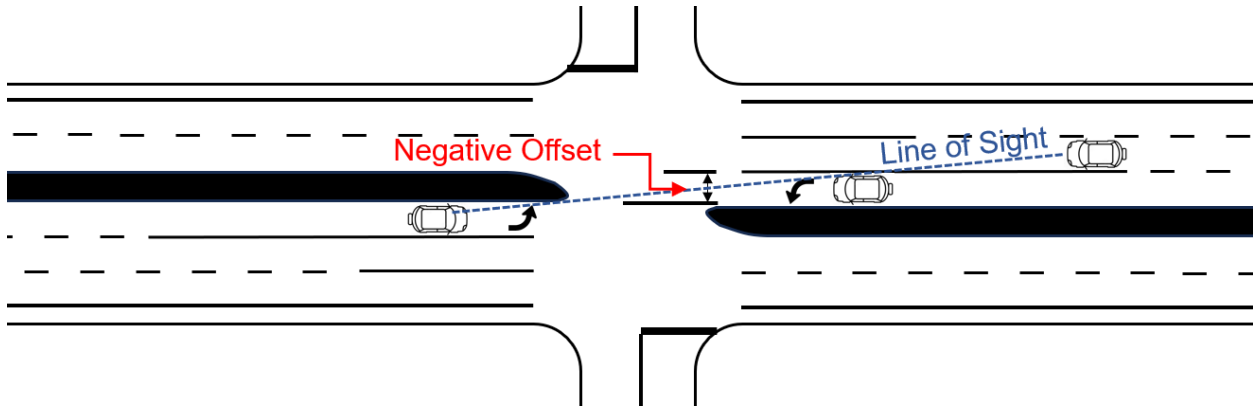
Figure 4.2: Negative Offset Example

- The PTH 1 left-turn lanes have a negative offset, meaning that opposing left turn vehicles can block each others view of the traffic in adjacent through lanes (**Figure 4.2**).

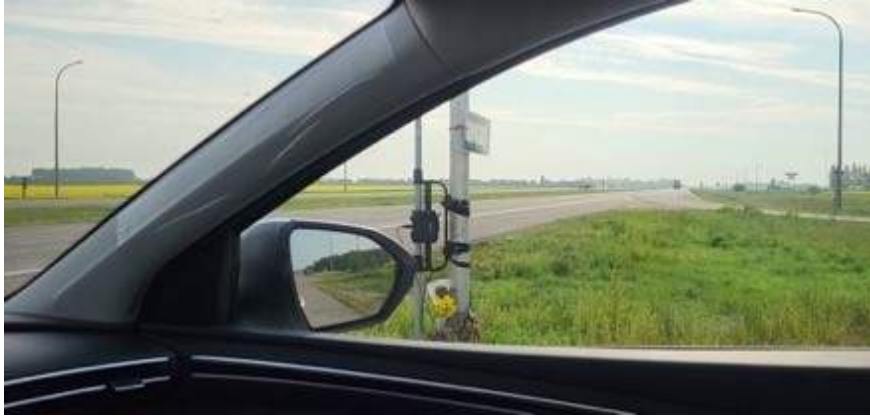
Figure 4.17: Northbound position, looking right

- Also, even though there are clear sightlines in both directions, as the road is straight and flat, drivers have difficulty assessing the rate at which distant vehicles are approaching. As noted above, drivers also underestimate how fast large vehicles are approaching as larger vehicles appear to be moving slower than smaller vehicles. To complicate this task even more, the vehicle A-pillars can obstruct the view to approaching vehicles on PTH 1, which is particularly a problem when looking to the right during a left turn as the A-pillar blocks the view of a driver on PTH 5 to approaching vehicles on PTH 1 as they drive towards the intersection. **Figure 4.15**, **Figure 4.16** and **Figure 4.17** illustrate the view of a northbound driver on PTH 5 stopped at the PTH 1 intersection. The view obstruction from the A-pillar is indicated in **Figure 4.17**.

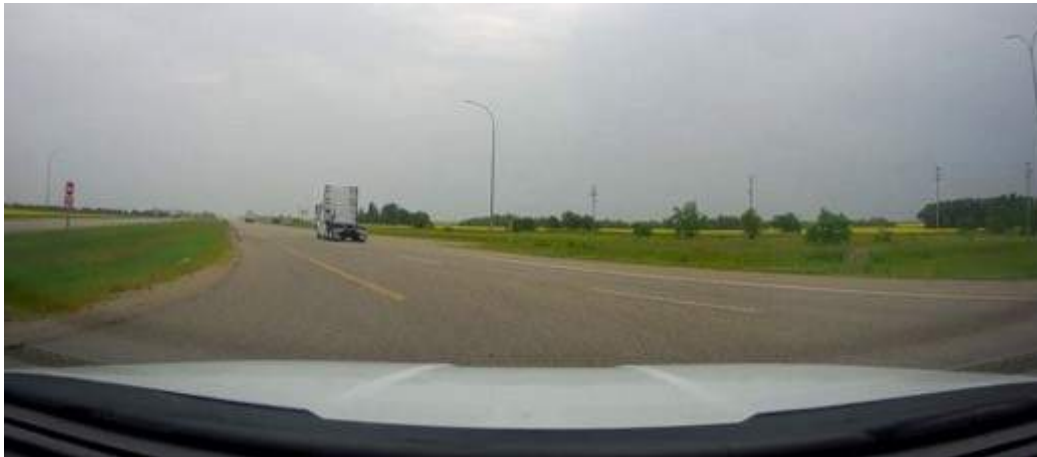
Figure 4.18: Southbound to eastbound left turn view

- Left turn lanes are desirable for traffic turning onto PTH 1, especially for large, heavy vehicles. This is because their rate of acceleration is low and it takes a long distance (and time) for them to reach highway speed. This can result in large speed differences in the eastbound direction on PTH 1 where an acceleration lane is not provided. At this location, large speed differences are expected, and crashes are much more likely to occur since, as described in the discussion on perception of closing velocity in [Section 4.6.1](#), drivers have difficulty assessing the rate at which the distance between their vehicle and the vehicle ahead is decreasing when the difference in speed is large. The view of drivers turning left onto PTH 1 are shown below in [Figure 4.18](#) and [Figure 4.19](#).

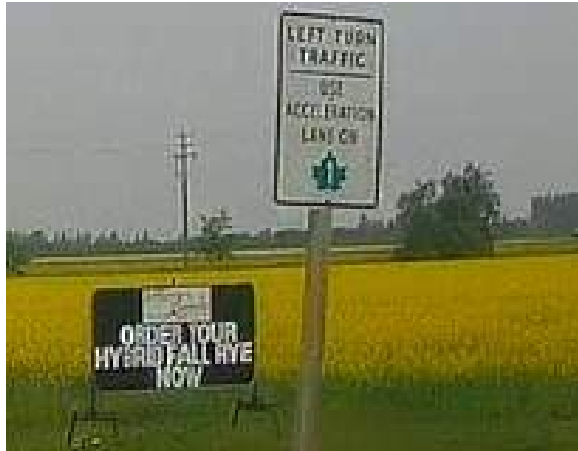
Figure 4.20: Northbound approach: Left Turning Traffic Use Acceleration Lane sign

- In the westbound direction on PTH 1, a 1000m parallel acceleration lane with 200m taper is provided. However, this acceleration lane is not marked with signs or pavement markings specific for the acceleration lane and could be misunderstood to be a passing lane. A small sign is provided on the northbound approach on PTH 5 which informs left turning drivers that they should use the acceleration lane on PTH 1 ([Figure 4.20](#) and [Figure 4.21](#)). This sign is not placed where drivers would be looking to receive this information. It is also a small sign with small letter heights, which makes it more likely to be missed (by comparison, the adjacent commercial billboard has larger letter heights). We note that traffic control devices such as signs and pavement markings are important roadway features as they provide positive guidance which leads to more predictable driving behaviour and greater overall safety.

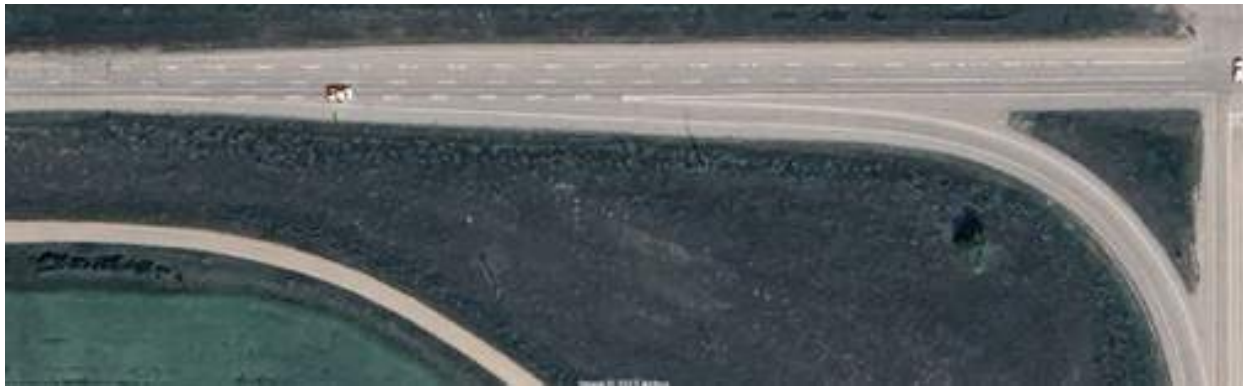
Figure 4.22: Eastbound approach on PTH 1 to PTH 5

- Left turn lanes are helpful to allow drivers who want to turn left to decelerate in an auxiliary lane so that they do not slow down traffic in the left through lane. Left turn lanes on PTH 1 develop 280 m upstream from the intersection (**Figure 4.22** and **Figure 4.23**), equivalent to 10 seconds of travel time at the posted speed limit. Although the left turn lanes may meet provincial geometric guidelines, some drivers of heavy trucks may need to decelerate in the left through lane before moving into the left turn lane to decelerate to a stop at a comfortable rate. Drivers slowing down in the through lane increases speed variability, which increases crash risk. As described above, drivers have difficulty assessing the rate at which they are approaching slower moving vehicles ahead, which increases the risk of rear-end collisions.

- Also, these left turn lanes are not marked with signs or pavement markings. This could give drivers the impression that the additional lane can be used for passing. The provision of these traffic control devices is important as they provide positive guidance to drivers.

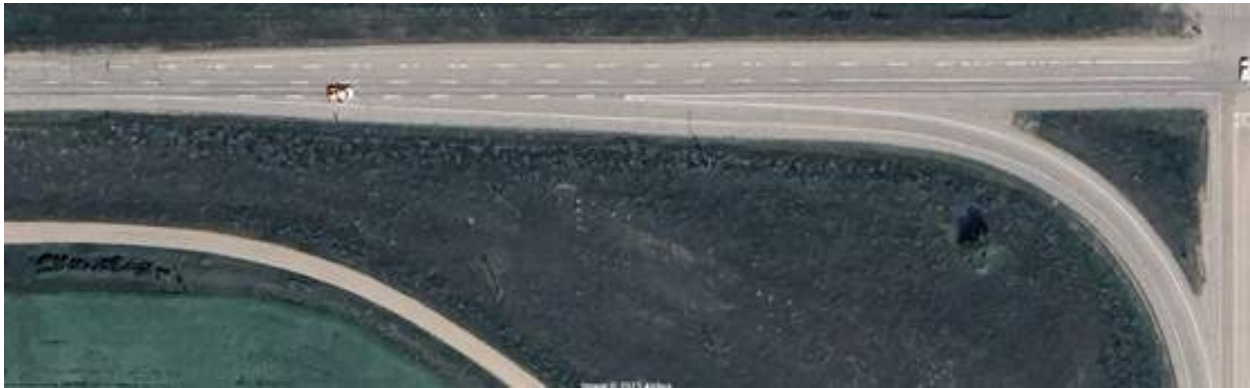
Figure 4.24: Eastbound approach on PTH 1 to PTH 5

- The PTH 1 right-turn deceleration lanes are provided with a 40 km/h advisory speed but the deceleration lanes are very short. Based on a review of the most recent available aerial photograph, these lanes are also not wide enough to accommodate a vehicle until the last 35 to 40 metres before the painted gore (**Figure 4.24** and **Figure 4.25**). As a result, drivers are required to decelerate while in the right through lane of PTH 1 which increases speed variability. As described above, drivers have difficulty assessing the rate at which they are approaching slower moving vehicles ahead, which increases the risk of rear-end collisions.

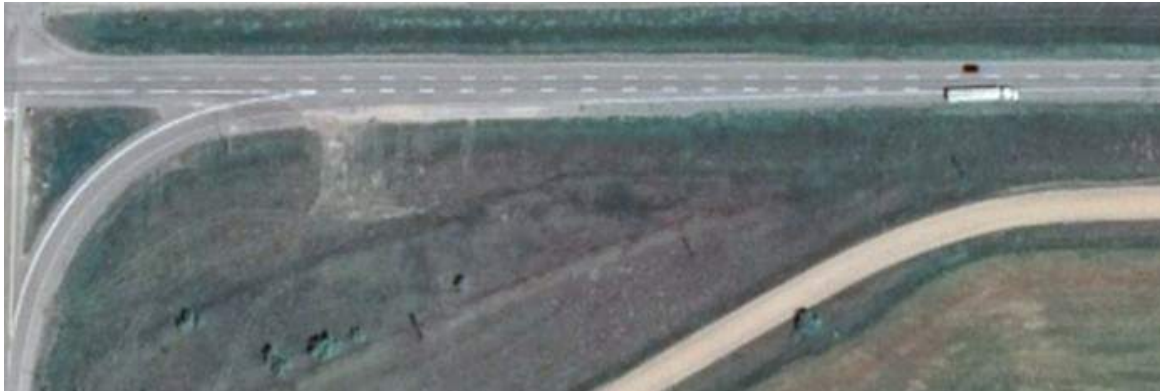
Figure 4.26: Eastbound onramp from PTH 5 to PTH 1

- Based on measurements from the most recent available aerial photograph, the length of the eastbound and westbound right-turn acceleration lanes were 100 m and 40 m, respectively (**Figure 4.26** and **Figure 4.27**). This is not enough distance to allow drivers of motorized vehicles to accelerate up to freeway speed. This is particularly a problem with heavy trucks which require much more distance to reach highway speed. As a result, large speed differences are likely to be present on PTH 1 downstream of PTH 5 in both directions. When there are large speed differences crashes are much more likely to occur since drivers have difficulty assessing the rate at which the distance between their vehicle and the vehicle ahead is decreasing when the difference in speed is large.
