Anderson TIA Terrestrial Shoreline Survey Memo

Anderson TIA Expansion NOA:
Terrestrial Shoreline Survey

Memo

Subject: Anderson Tailings Impoundment Area - Terrestrial Shoreline Survey
Hudbay Minerals Inc. – Anderson Tailings Impoundment Area Expansion Notice of Alteration

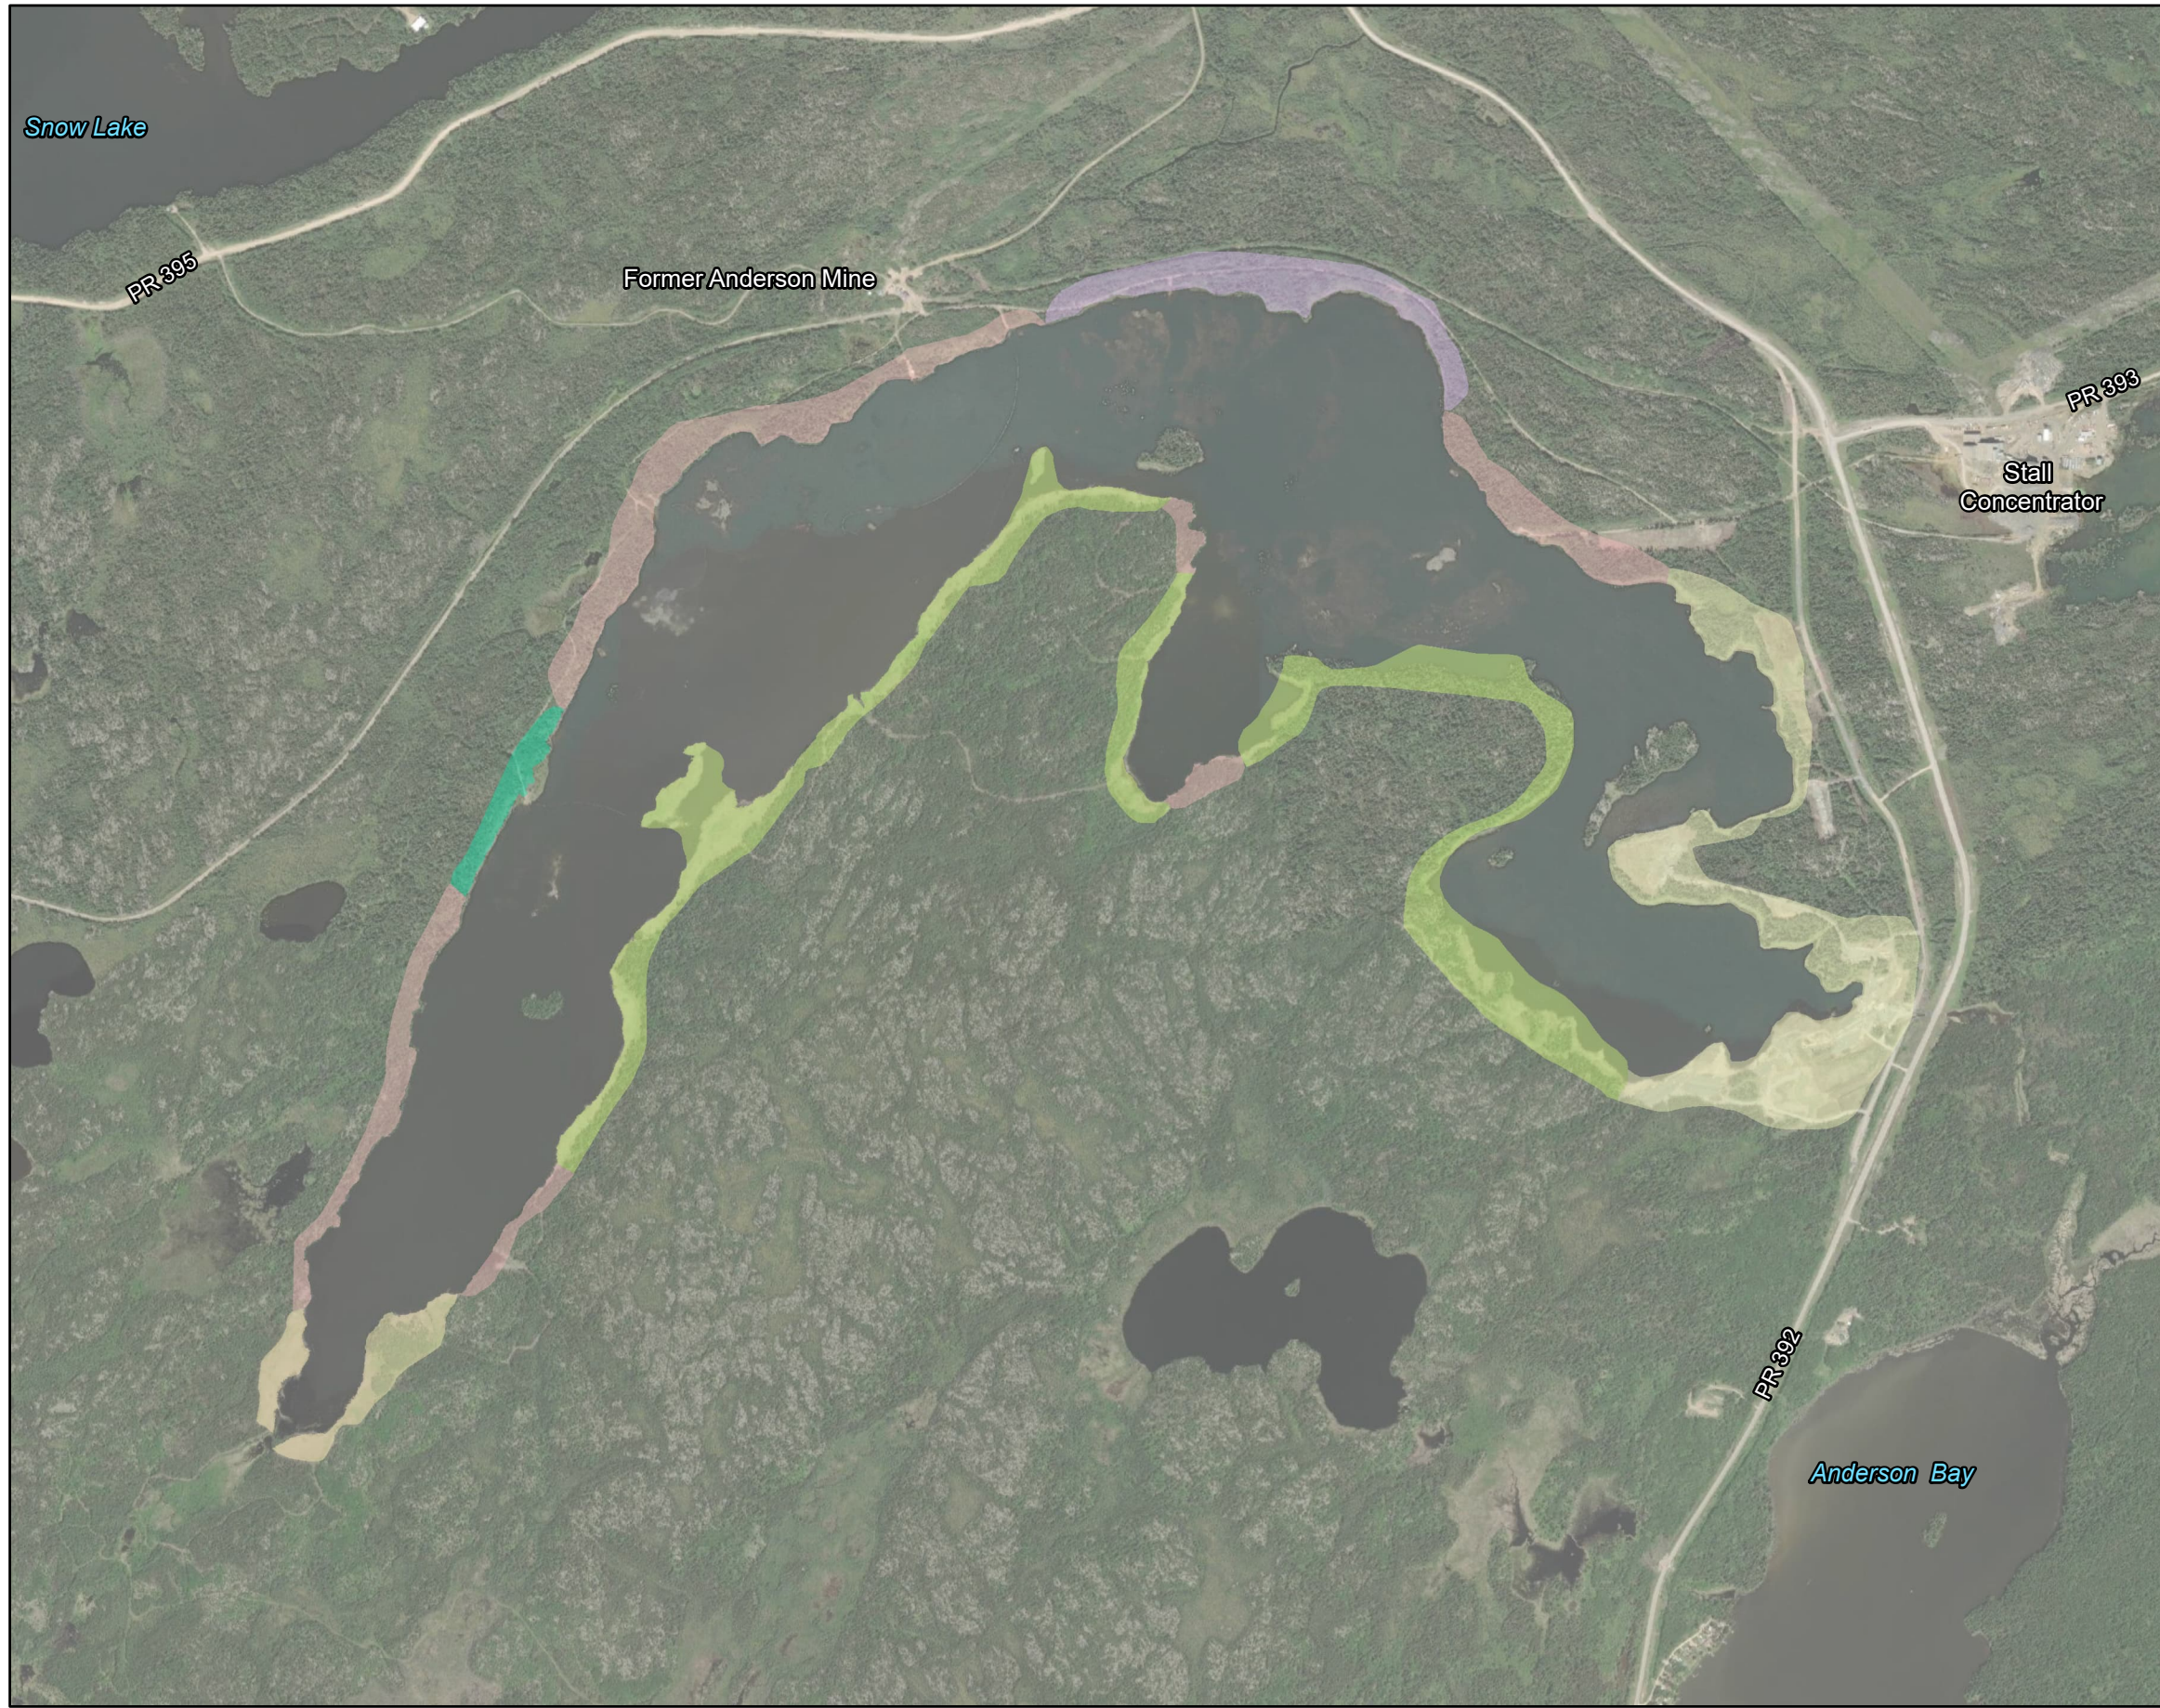
Appendix A – Terrestrial Shoreline Survey Map

This report summarizes the results of a terrestrial shoreline survey conducted along the Anderson Tailings Impoundment Area (Anderson TIA) shoreline during the September 2023 water quality sampling program. The terrestrial shoreline survey was completed as a part of the pending Anderson TIA Expansion Notice of Alteration to be completed by AECOM on behalf of Hudbay. The following report describes the riparian shoreline environment, and terrestrial shoreline environment of six (6) types of shorelines in the Anderson TIA. Shoreline types are broadly defined by their habitat composition. Much of the Anderson TIA shoreline environment is relatively similar, with slight variations in current conditions. A map indicating the shoreline types can be found in **Appendix A**.
