# Notice of Alteration Form

**Subject: Notice of Alteration – Birds Hill Provincial Park Wastewater Treatment Lagoon**  
**Client ref.: File no. 166.10**

# BIRDS HILL PROVINCIAL PARK LAGOON DYKE ASSESSMENT REPORT

# BIRDS HILL PROVINCIAL PARK LAGOON DYKE REPAIR

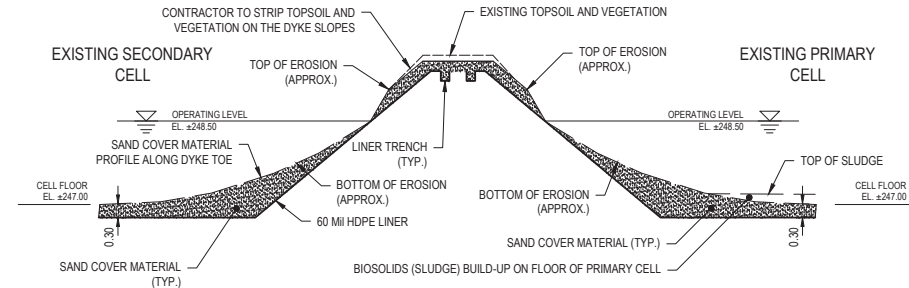
1  
-  
TYPICAL EXISTING INTERCELL DYKE CROSS SECTION  
SCALE: NTS

Due to erosion observed on the majority of the interior dyke slopes, coupled with the lack of any erosion protection (i.e. rip rap), WSP recommends that the both the primary and secondary cells dyke erosion be repaired. This can be completed by placing either imported sand cover material or recovered sand material deposited at the toe of the dyke and placing rip rap for erosion protection.
