# Geokwan Environmental Ltd

RE: Progress Report No. 4  
Asphalt Paving and Installation of Vapour Extraction System  
Canadian Tire Store, Brandon, Manitoba  
Our Project No.'s E238 & E239

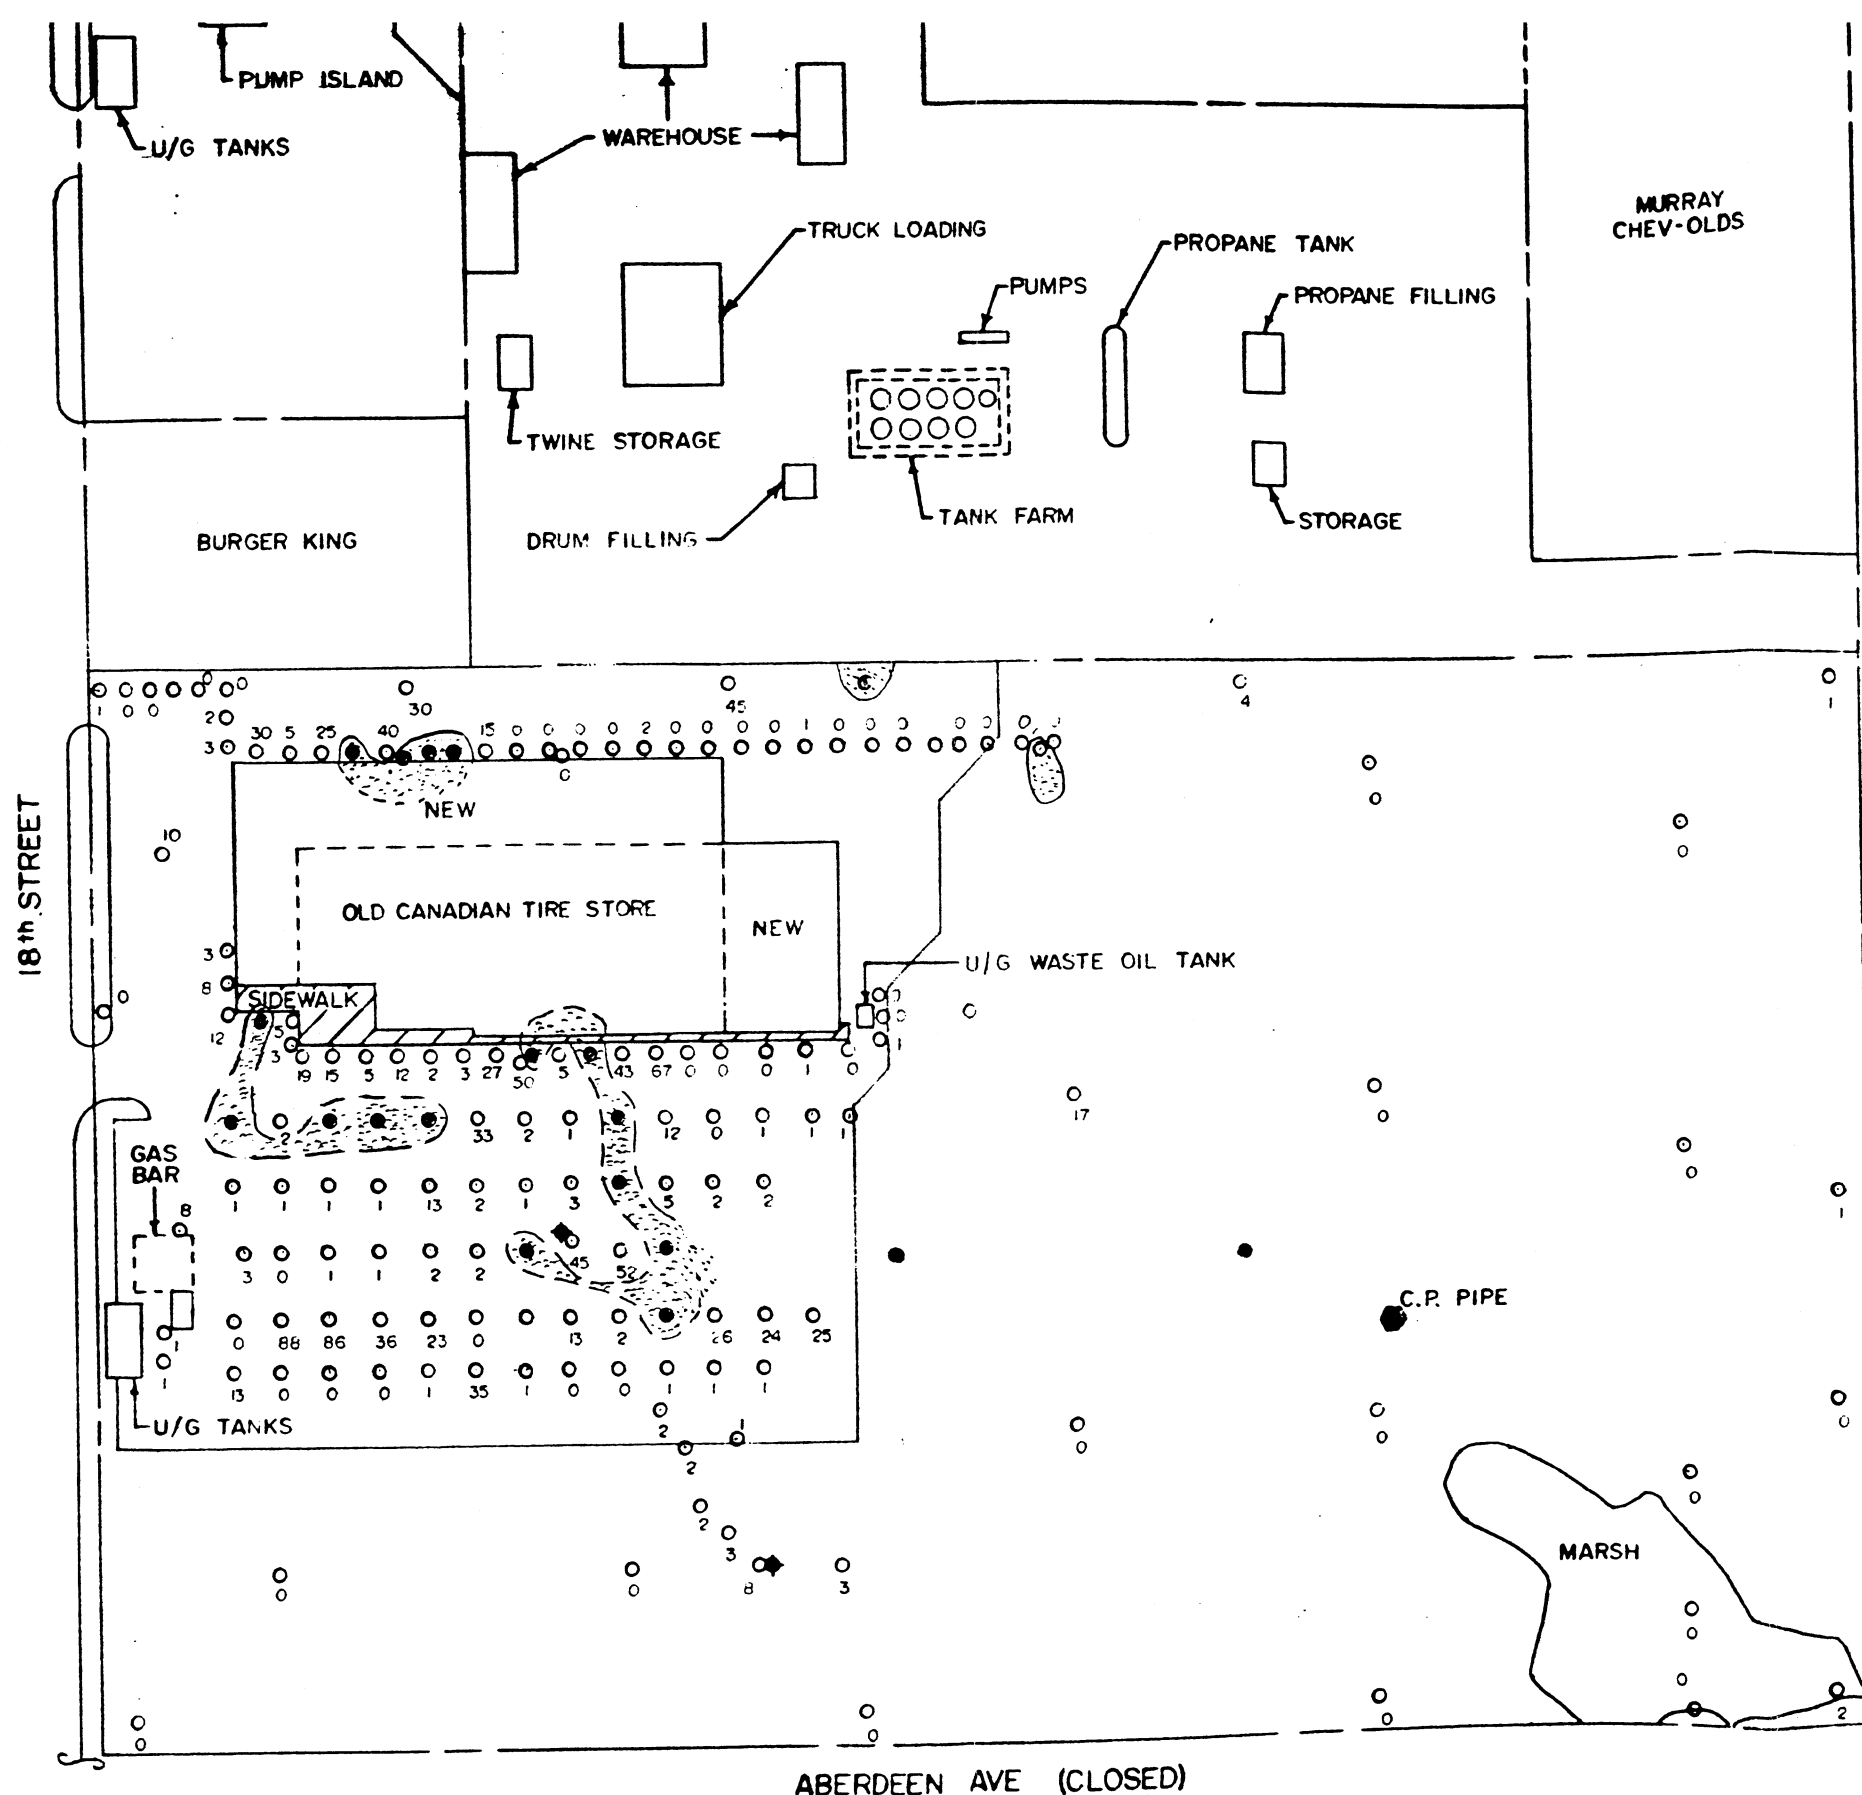
| SCALE: 1" = 120' | DATE: June 19/91 | MADE: RK | CHKD: WK | JOB: E238 & E239 | PLATE: PR4-1A |

SOIL VAPOUR DISTRIBUTION (% LEL) - JUNE 11-13/91  
CANADIAN TIRE CORPORATION LTD.  
18TH STREET & ABERDEEN AVENUE  
BRANDON, MANITOBA

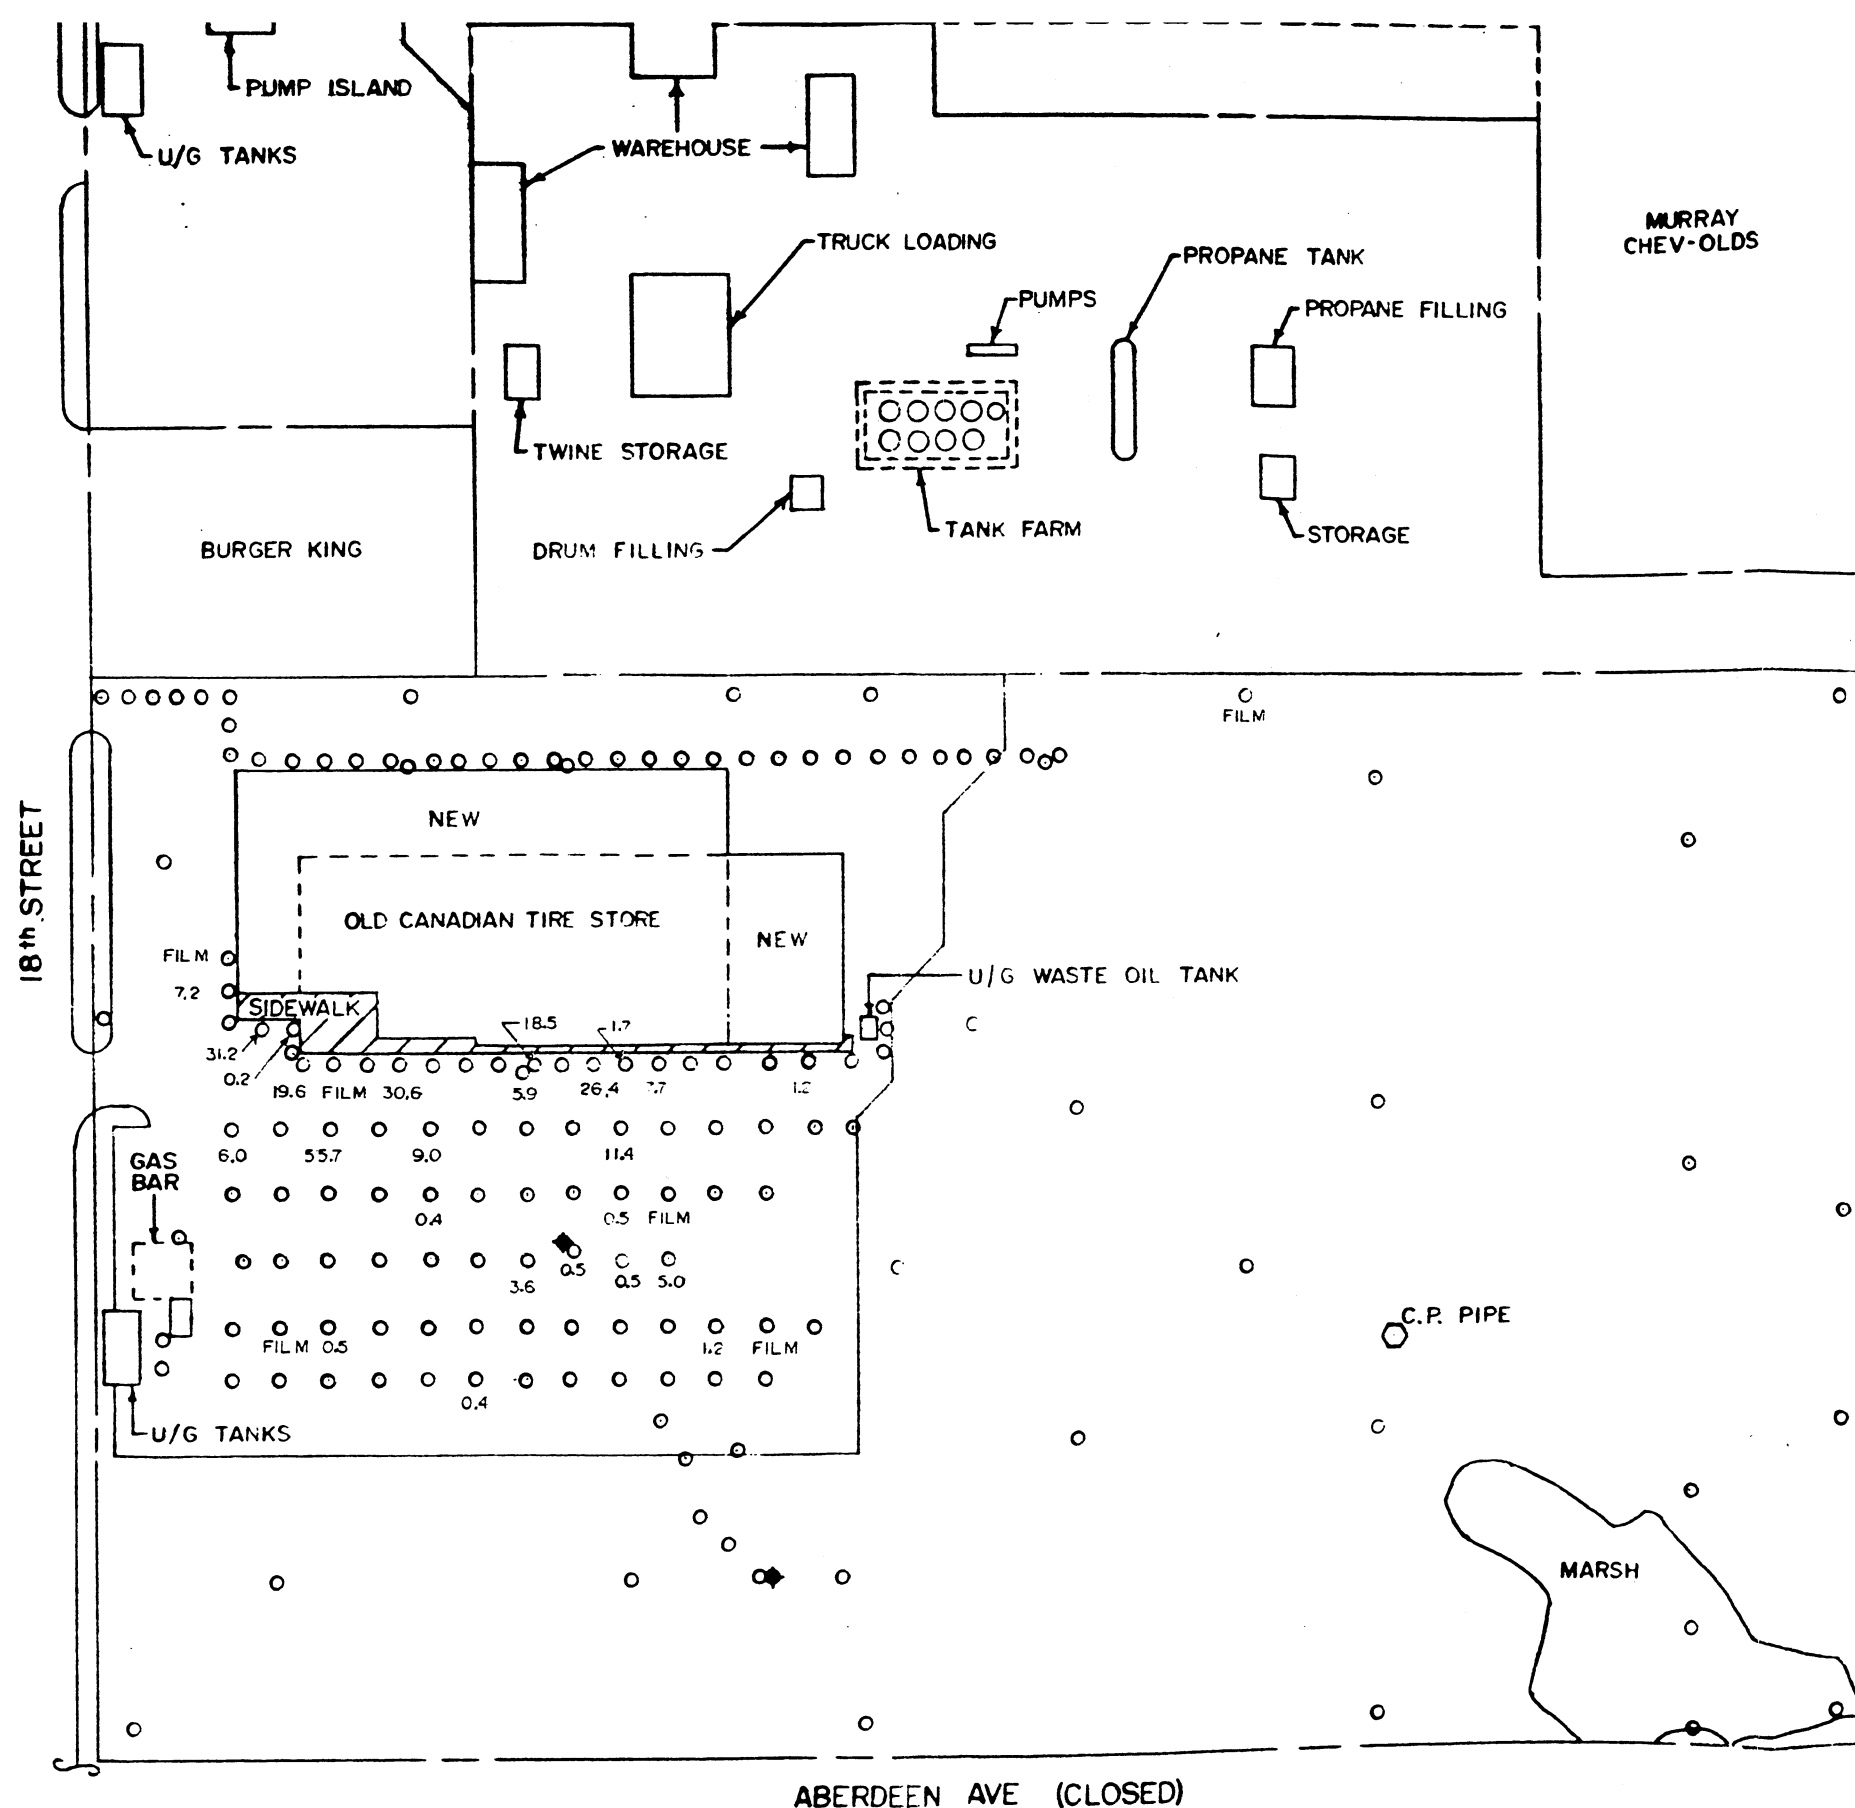
PLATE: PR4-2A

FREE PHASE HYDROCARBON THICKNESS (INCHES)  
MEASURED JUNE 11 - 13, 1991  
CANADIAN TIRE CORPORATION LTD.  
18TH STREET & ABERDEEN AVENUE  
BRANDON, MANITOBA

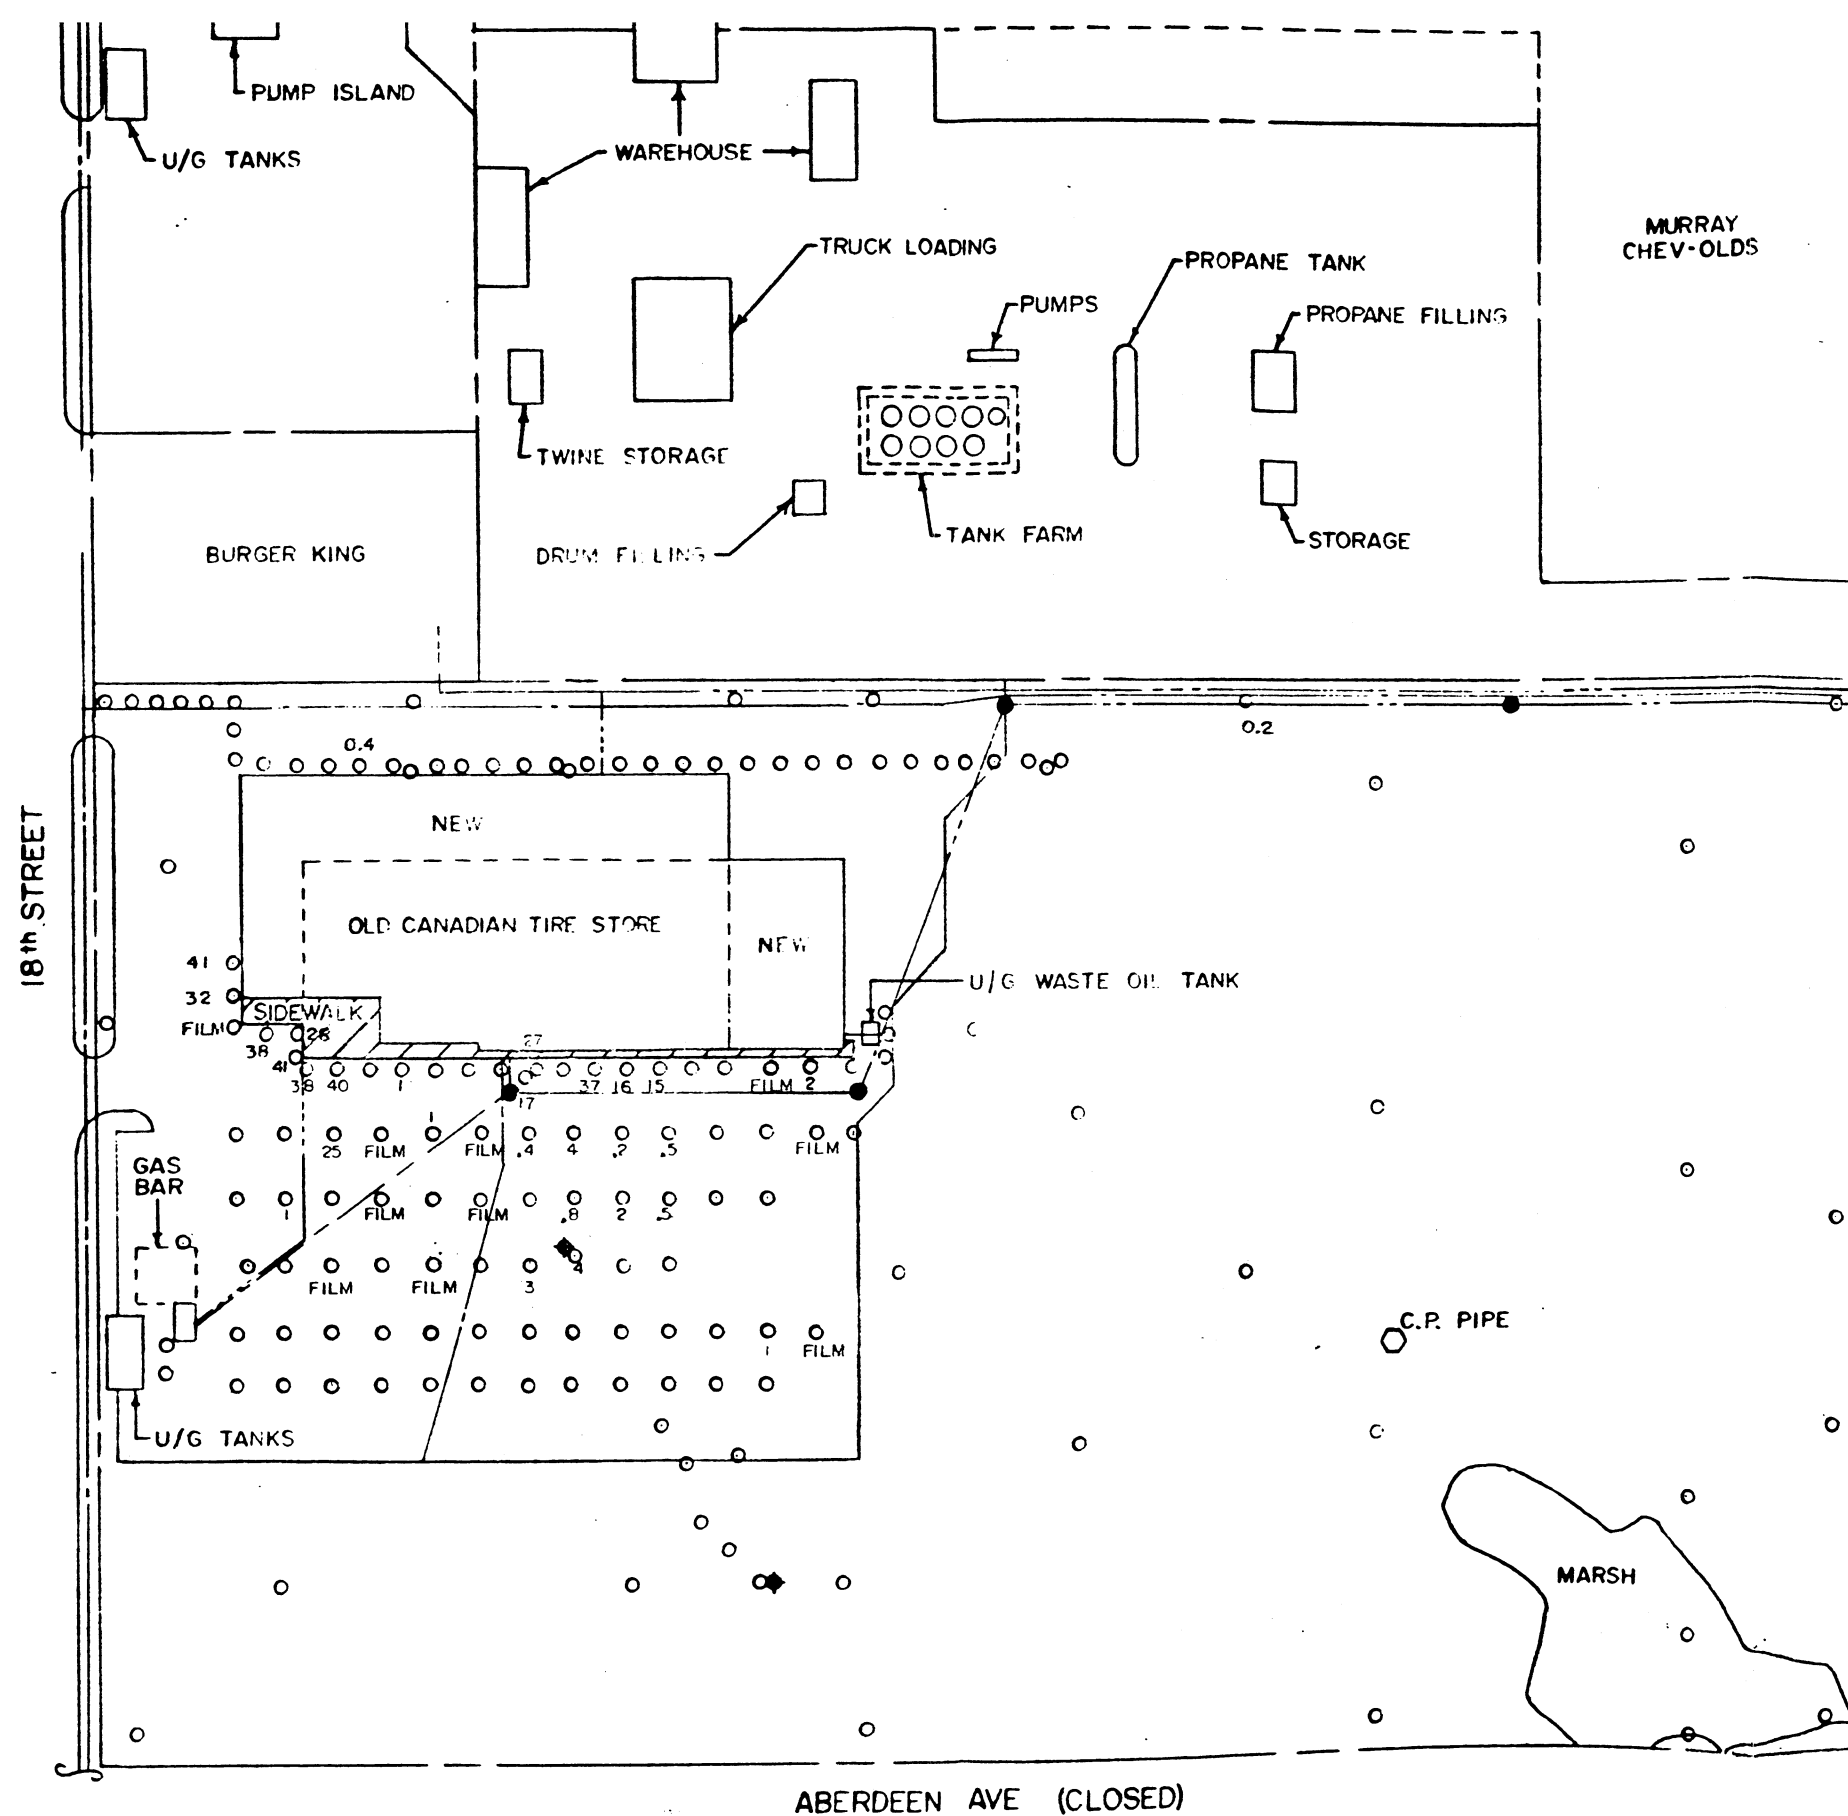
| SCALE: 1"=120' | DATE: 01/07/91 | MADE: JDT | CHKD: WK | JOB: E 238<br>E 239 | PLATE: PR4-2B |

HYDROCARBON THICKNESS (INCHES)  
MEASURED AUG. 22-23/91  
CANADIAN TIRE PROPERTY  
BRANDON, MANITOBA
