O'CONNOR ASSOCIATES

January 3, 1989.

Re: Red River Esso

Selkirk, Manitoba

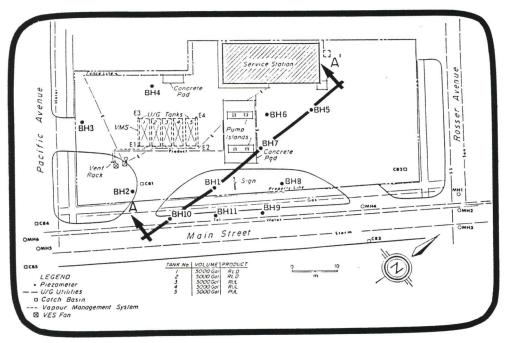
JOB NO.: 10-907	DATE : 88/12/22
DRAWN BY: JR	DWG. NO.: 1,3

The natural soil profile encountered in the boreholes consisted of silt topsoil overlying silty clay which extended below the 6.1 m depth of investigation. The clay unit was fractured, laminated and contained silt and sand lenses. Surficial asphalt and sand and gravel fill were noted in BH5, BH6, BH7, BH9, BH10 and BH11. A cross-section illustrating the stratigraphy is presented on Drawing No. 1.3.
