Willow Creek Watershed

Groundwater Input to Technical Process

Hydrogeology

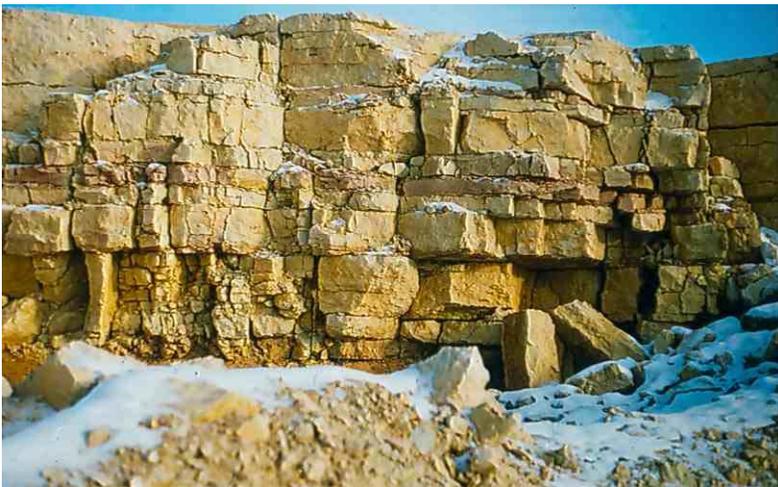
Figure ##: Exposure of carbonate rock showing sub-vertical fractures and sub-horizontal bedding planes that form the principal pathways for groundwater movement in the Carbonate aquifer.

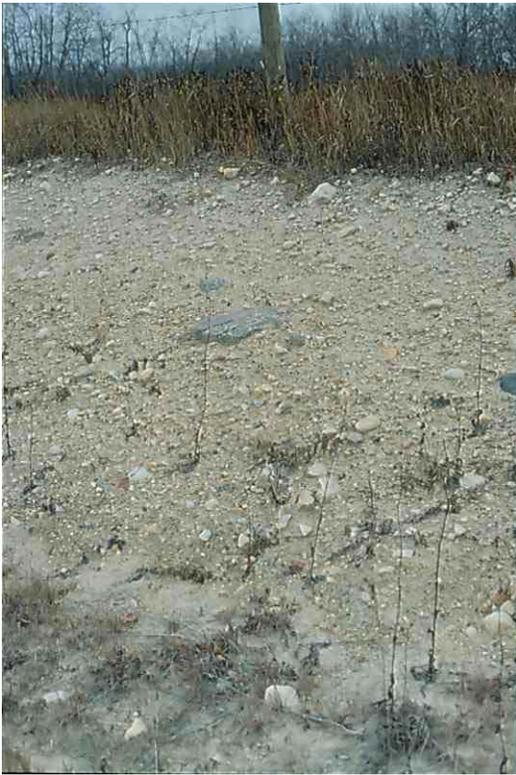
Figure ##: outcrop of glacial till. Note the stony nature to these deposits. Most tills in the Interlake are composed of about 50% silt sized particles, and the remainder of the consisting of about equal portions of sand and clay.

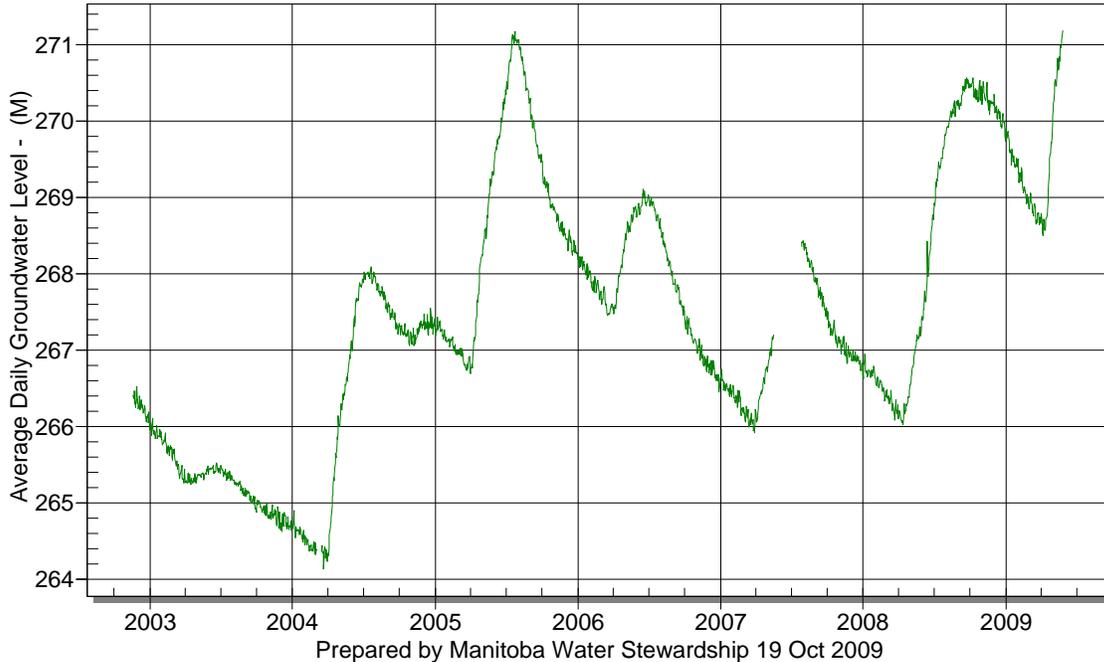
G05LN012 NARCISSE #1 NW10-20-1W
GROUND LEVEL ELEVATION

Figure ##: hydrograph showing groundwater level response in the Carbonate aquifer near Narcisse. Note the rises in water level associated with spring to early summer recharge and declining water levels through most of the summer, fall and winter.

anthropogenic rates of withdrawal are likely only a very small portion of the average recharge rates in the watershed. Long-term hydrographs from observation wells located distant from significant pumping centers are generally used to record groundwater level (and groundwater quality) changes due to short to long period climatic fluctuations and short term weather events. Unfortunately, no good quality long-term records exist within the watershed but a hydrograph for a provincial monitoring well located near Narcisse which has about a 9 year water level record is shown in Figure #. This hydrograph shows the normal season water level response expected in Manitoba with recharge occurring in late spring to early summer followed by declines in water levels until the next recharge event. A small fall recharge even was observed in 2004 – fall recharge can occur in years where significant precipitation occurs as rain following the cessation of plant growth. Note that water levels in the Carbonate aquifer at this site have varied by about 7 m over the term of record. The locations of all provincial monitoring wells are shown on Figure #. This does not include monitoring
