Map 173

Bipole III Transmission Project struction Environmental Protection Plan Construction Section N4 Environmentally Sensitive Site Locations

Map 175

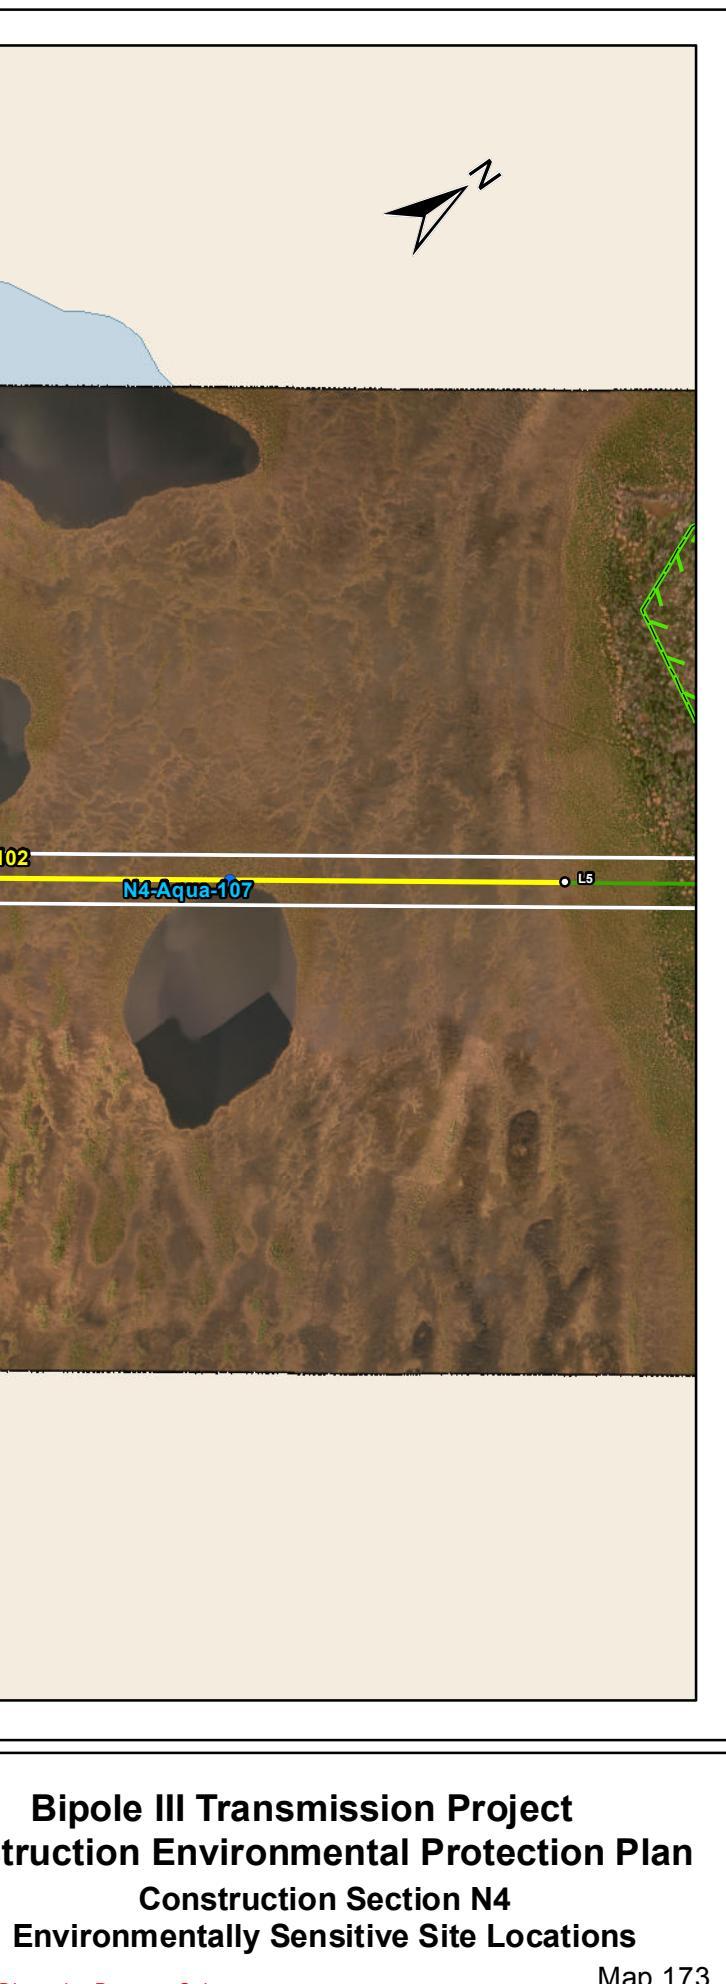
ESS Group: Water Crossing

Sec-Seg ID	ESS I D	ESS Name	Easting	Northing	UTM Zone	Channel Width	Wet Width	Fish Habitat Class	Habitat Sensitivity
N4-S04	N4-Aqua- 107	Unnamed Lake	363120	5901515	14N	N/A	N/A	None	None

Potential Effects:

Habitat loss and contamination from structure foundations & installations; increased erosion & sedimentation of streams; Damage to stream banks; Loss of riparian vegetation; Fish habitat disturbances and impeded fish movement; Rutting of floodplain

ESS Group: Birds and Habitat

Sec-Seg I D	ESS ID	ESS Name	Location	Start	Stop	UTM Zone	Distance
N2-S04	N4-Wild- 102	Waterfowl sensitivity area, nearby Bonapartes gull colony	Site: L5 to L6	E-363376 N-5901876	E-362590 N-5900770	14N	1357m

Higher risk of wire collision, Risk of wire collision is localized to the right-of-way

ESS Group: Mammals and Habitat

Sec-Seg ID	ESS I D	ESS Name	Location	Start	Stop	UTM Zone	Distance
N4-S04	N4-Wild-200	MCWS Caribou Sensitive Area	Site: 32 to 34	E-364031 N-5902798	E-354352 N-5889174	14N	16712m

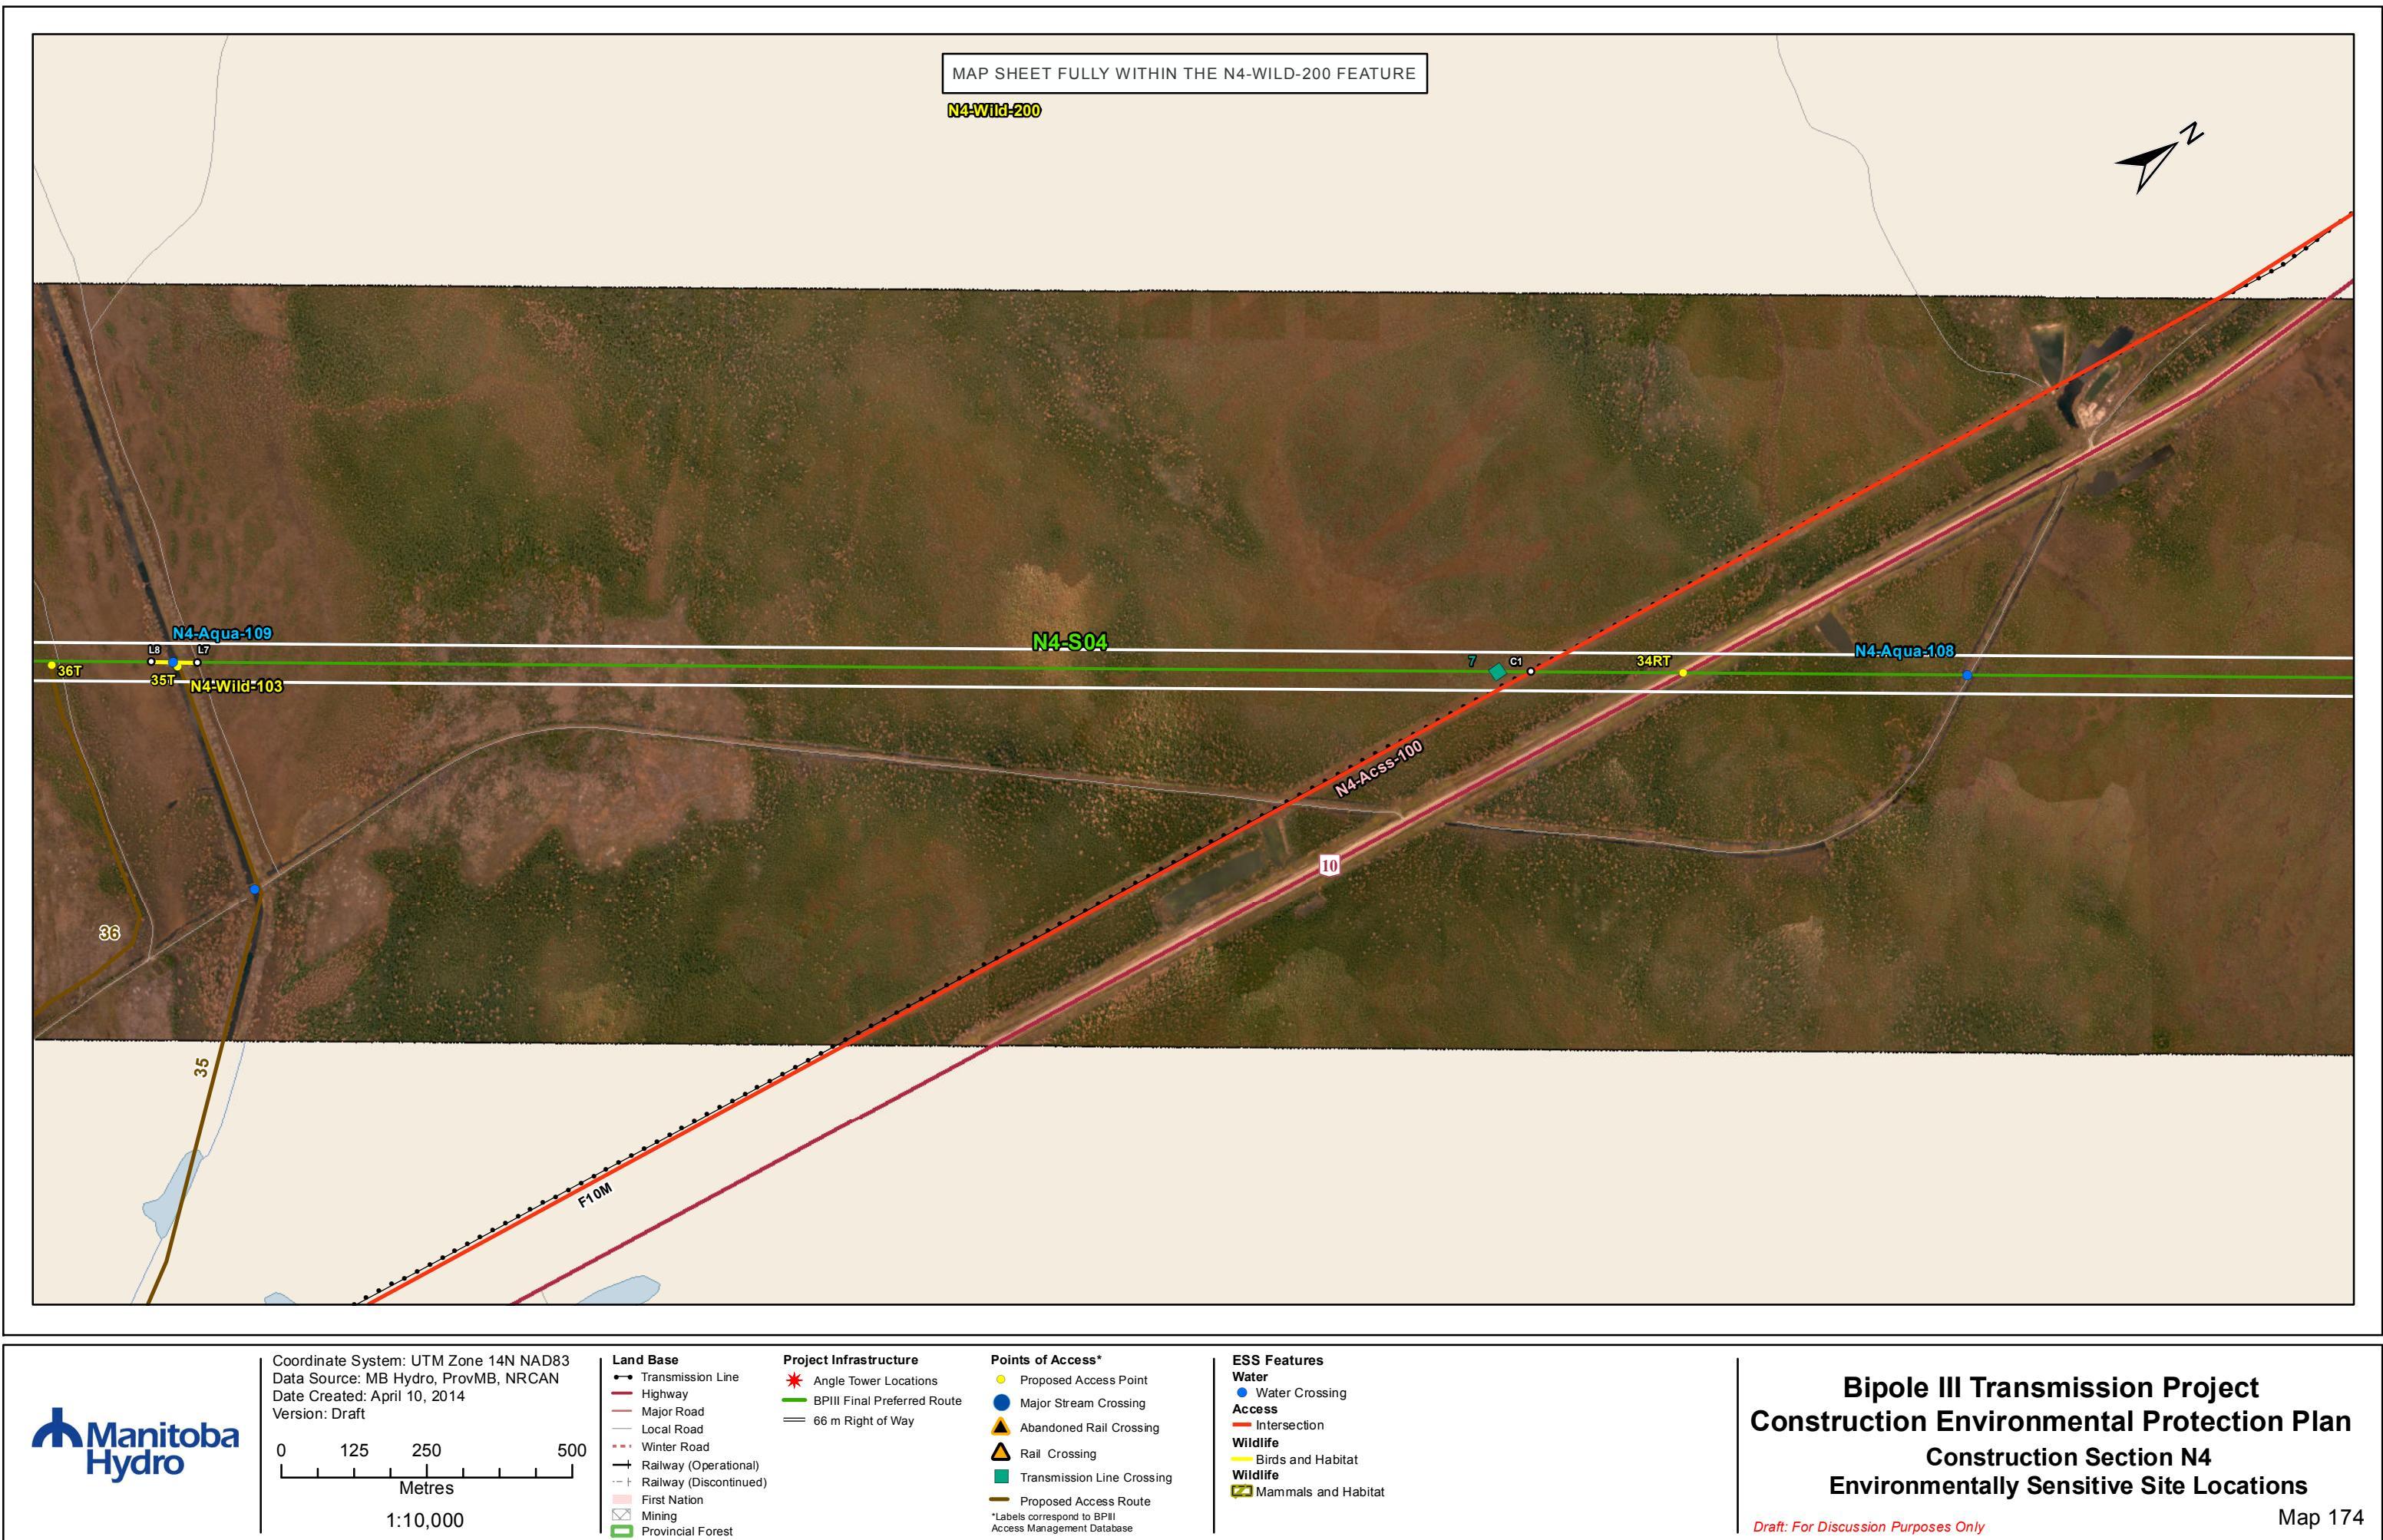
ESS Group: Water Crossing

Sec-Seg ID	ESS I D	ESS Name	Easting	Northing	UTM Zone	Channel Width	Wet Width	Fish Habitat Class	Habitat Sensitivity
N4-S04	N4-Aqua- 108	Unnamed drain	360798	5898247	14N	13m	13m	Low	Important
N4-S04	N4-Aqua- 109	Unnamed drain	358993	5895707	14N	13m	13m	Low	Important

Potential Effects:

Habitat loss and contamination from structure foundations & installations; increased erosion & sedimentation of streams; Damage to stream banks; Loss of riparian vegetation; Fish habitat disturbances and impeded fish movement; Rutting of floodplain

ESS Group: Birds and Habitat

Sec- Seg ID	ESS ID	ESS Name	Location	Start	Stop	UTM Zone	Distance
N2-S04	N4-Wild- 103	Waterfowl sensitivity area, nearby Bonapartes gull colony	Site: L7 to L8	E-359030 N-5895759	E-358984 N-5895695	14N	78m

ESS Group: Intersection

Sec-Seg ID	ESS I D	Location	ESS Name	Crossing Coordinates	UTM Zone
N4-S04	N4-Acss-100	C1	Snowmobile Trail	E-360362 N-5897633	14N

Potential interference with snowmobilers; safety issues

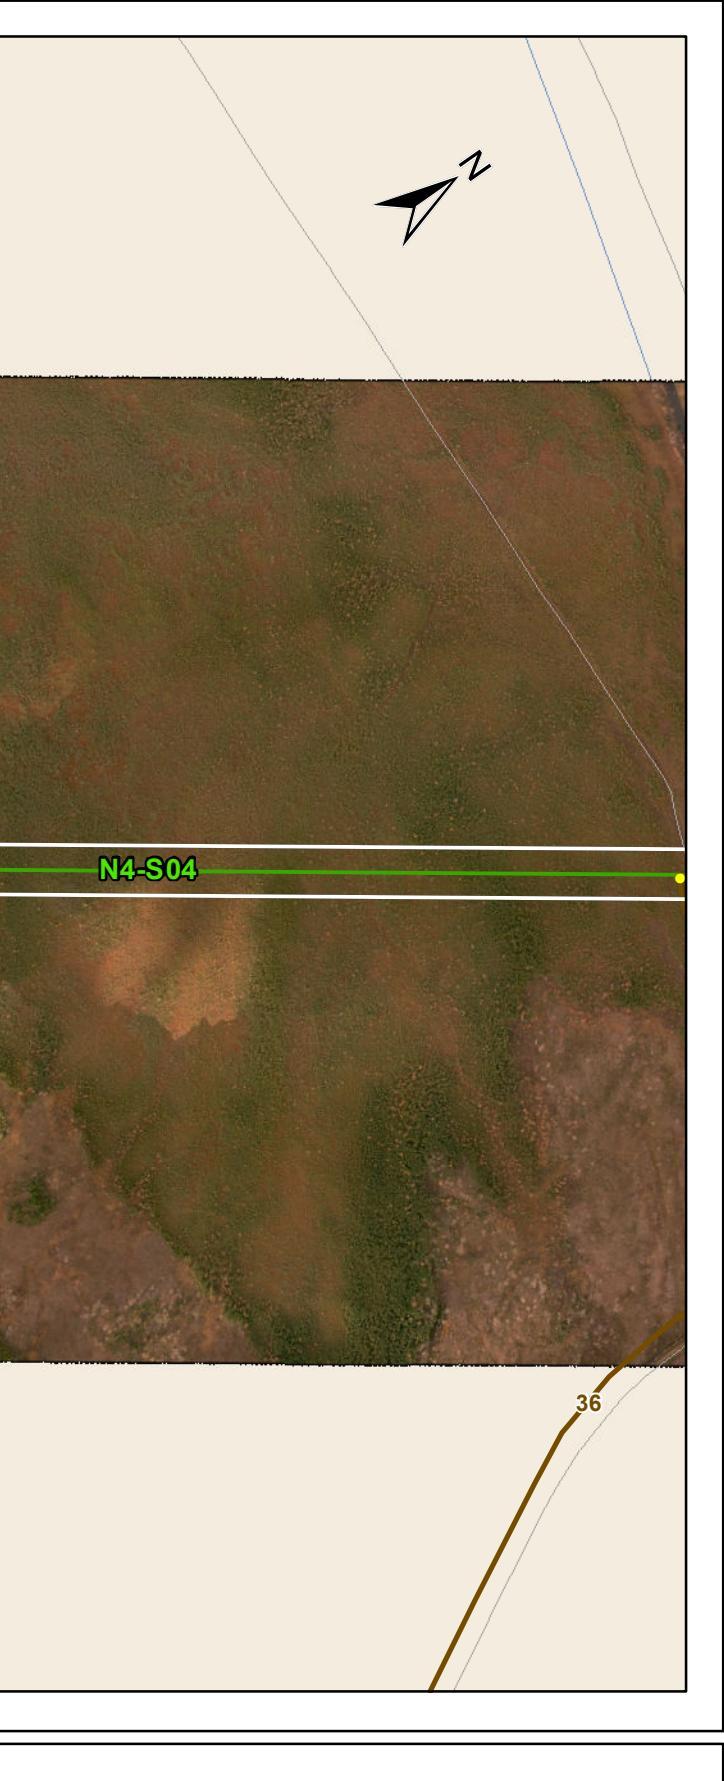
ESS Group: Archaeological

Sec-Seg ID	ESS I D	ESS Name	Easting	Northing	UTM Zone	
N4-S04	N4-Hert-100	Overflowing River 3-10	356864	5892715	14N

Potential Effects:

potential disturbance to heritage Resources

ESS Group: Water Crossing

Sec- Seg I D	ESS ID	ESS Name	Easting	Northing	UTM Zone	Channel Width	Wet Width	Fish Habitat Class	Habitat Sensitivity
N4-S04	N4- Aqua- 110	Overflowing River	356837	5892672	14N	30m	32m	Low	Important
N4-S04	N4- Aqua- 111	Unnamed tributary of Overflowing River	356775	5892584	14N	N/A	N/A	N/A	N/A

ESS Group: Food/Medicinal

Sec-Seg ID	ESS I D	Location	ESS Name	Crossing Coordinates	UTM Zone
N4-S04	N4-RUse-201	C2	Plant Gathering	E-356879 N-5892730	14N

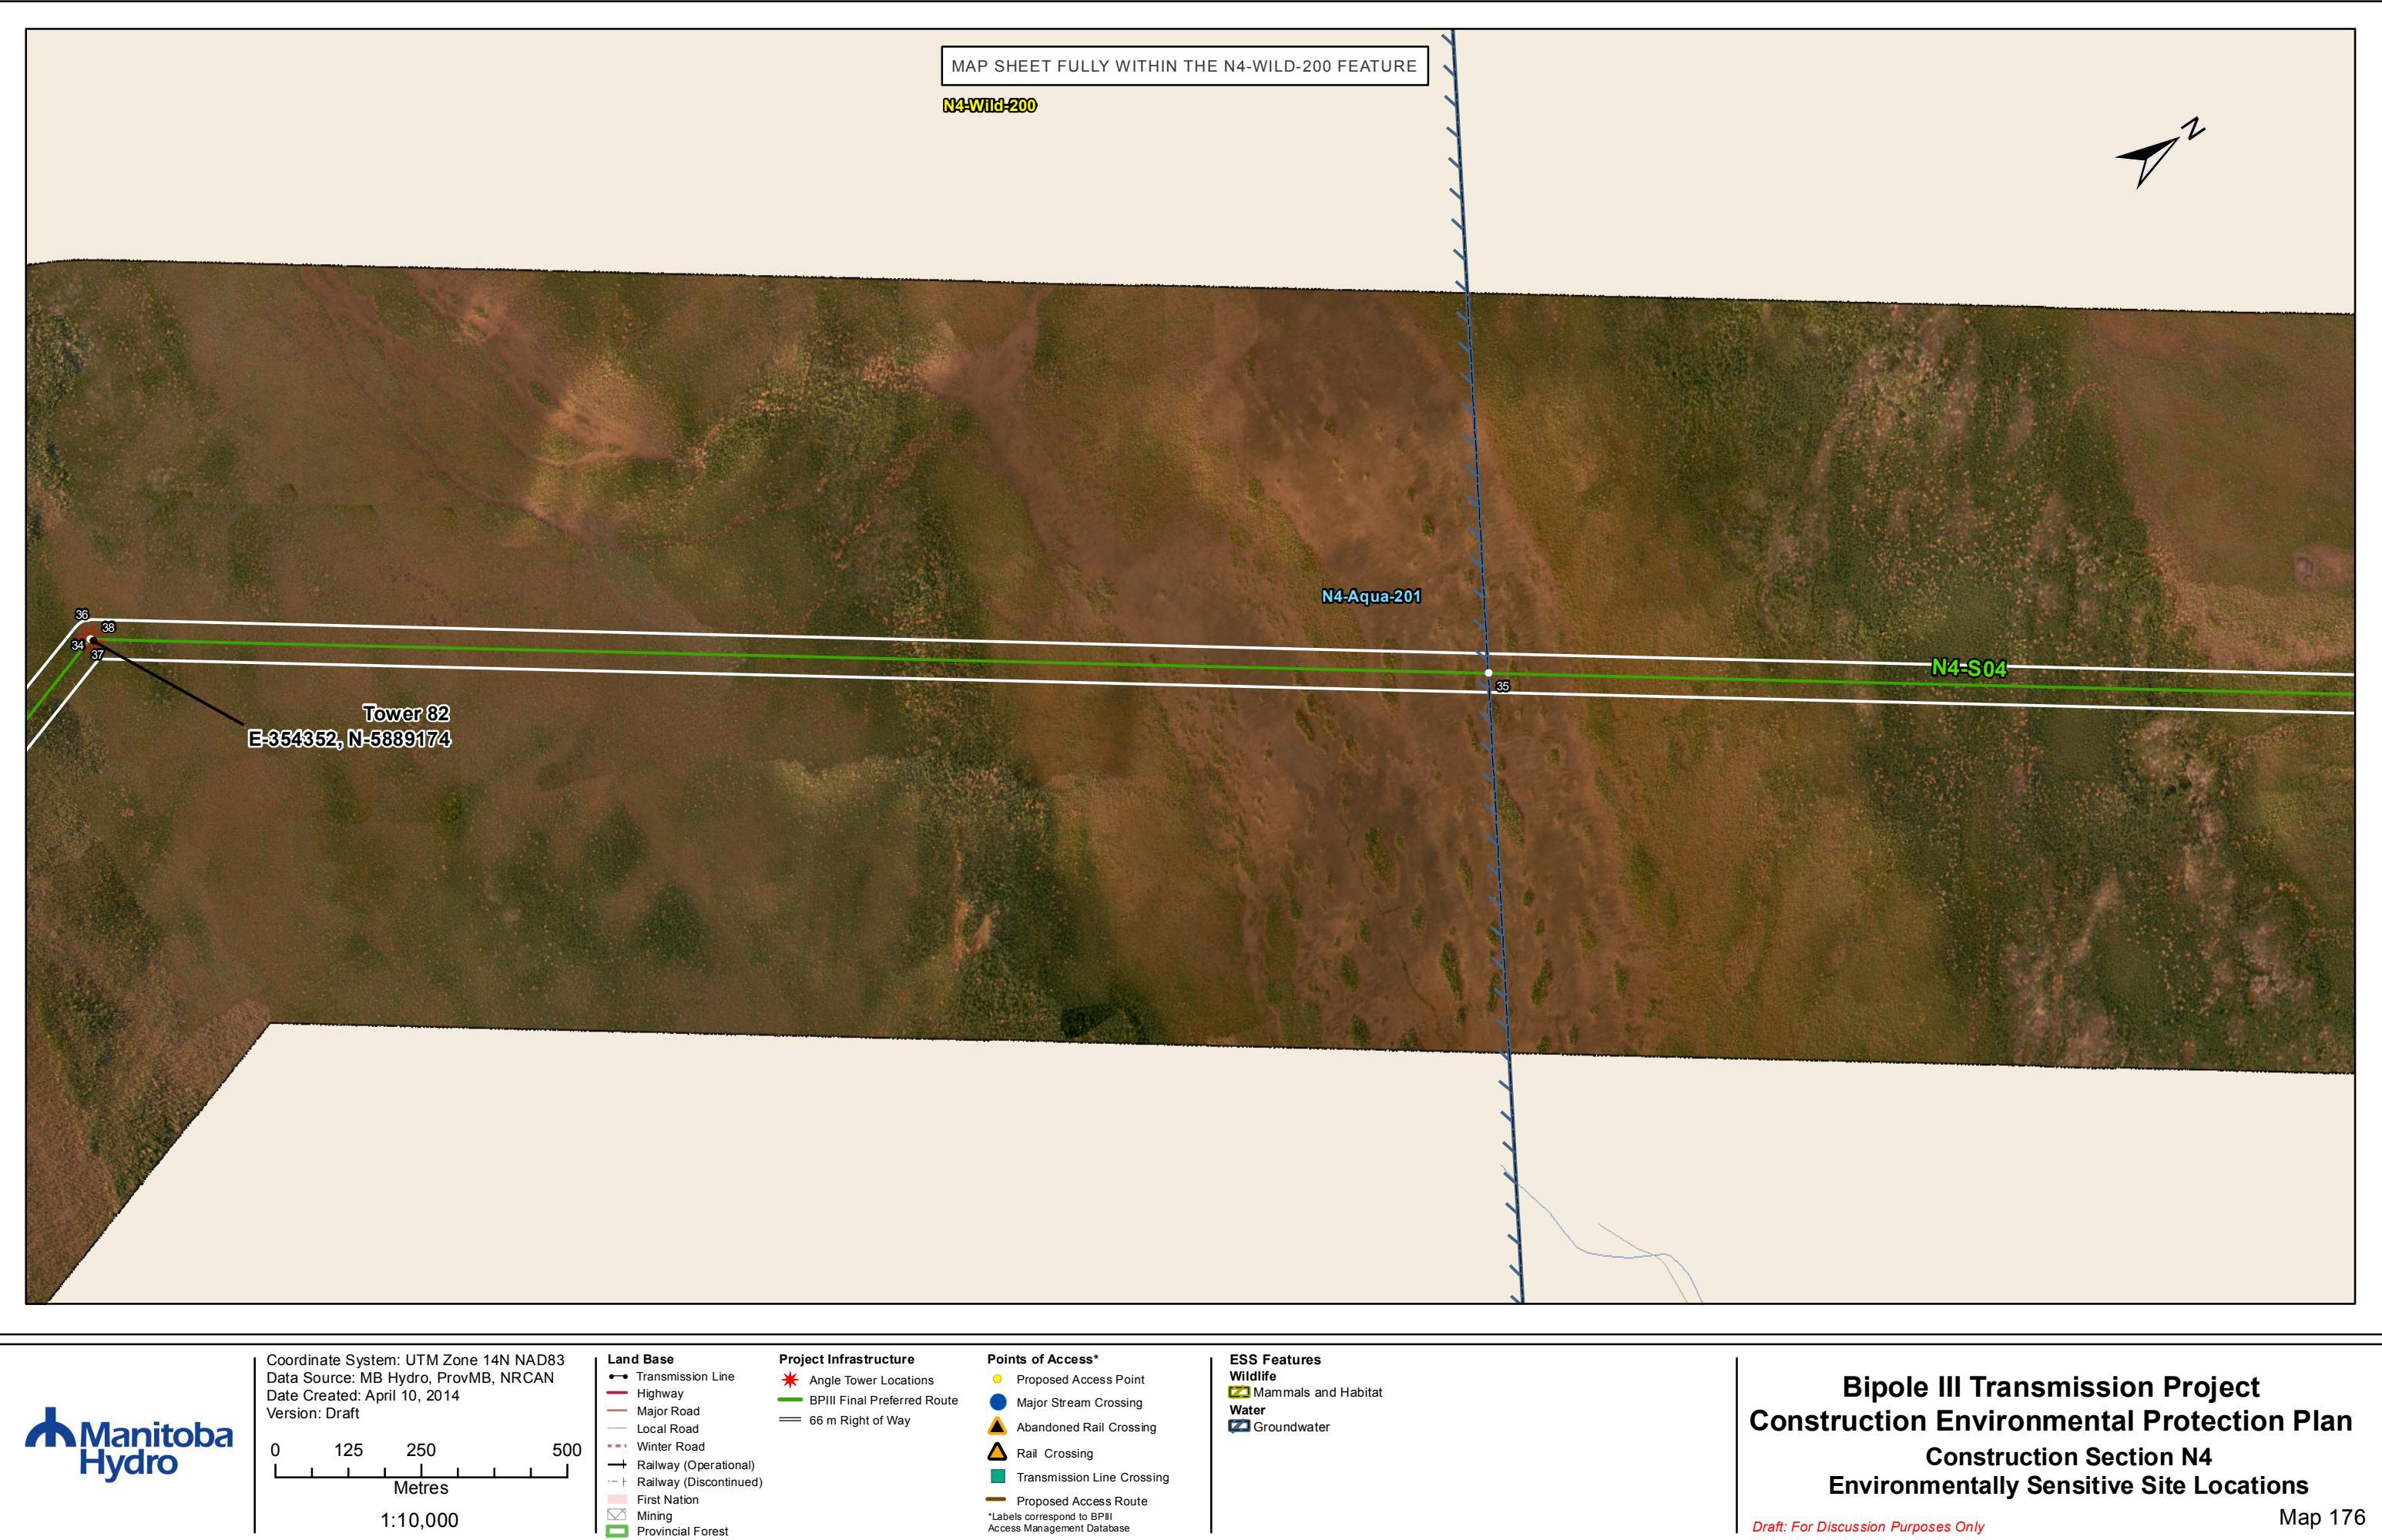
ESS Group: Groundwater

Sec-Seg ID	ESS ID	ESS Name	Location	Start	Stop	UTM Zone	Distance
N4-S04	N4-Aqua-201	Saline artesian areas	Site: 35 to 36	E-355743 N-5891132	E-354352 N-5889174	14N	2402m
N4-S05	N4-Aqua-201	Saline artesian areas	Site: 37 to 39	E-354352 N-5889174	E-357885 N-5877929	14N	11786m

Potential Effects:

Increase in salinity of soils and surface water in case of potential groundwater discharge to the surface. Also, wetting the surficial environment (ground saturation); effect on local vegetation

ESS Group: Mammals and Habitat

Sec-Seg ID	ESS I D	ESS Name	Location	Start	Stop	UTM Zone	Distance
N4-S04	N4-Wild-200	MCWS Caribou Sensitive Area	Site: 32 to 34	E-364031 N-5902798	E-354352 N-5889174	14N	16712 m
N4-S05	N4-Wild-200	MCWS Caribou Sensitive Area	Site: 38 to 40	E-354352 N-5889174	E-362119 N-5864457	14N	25908 m

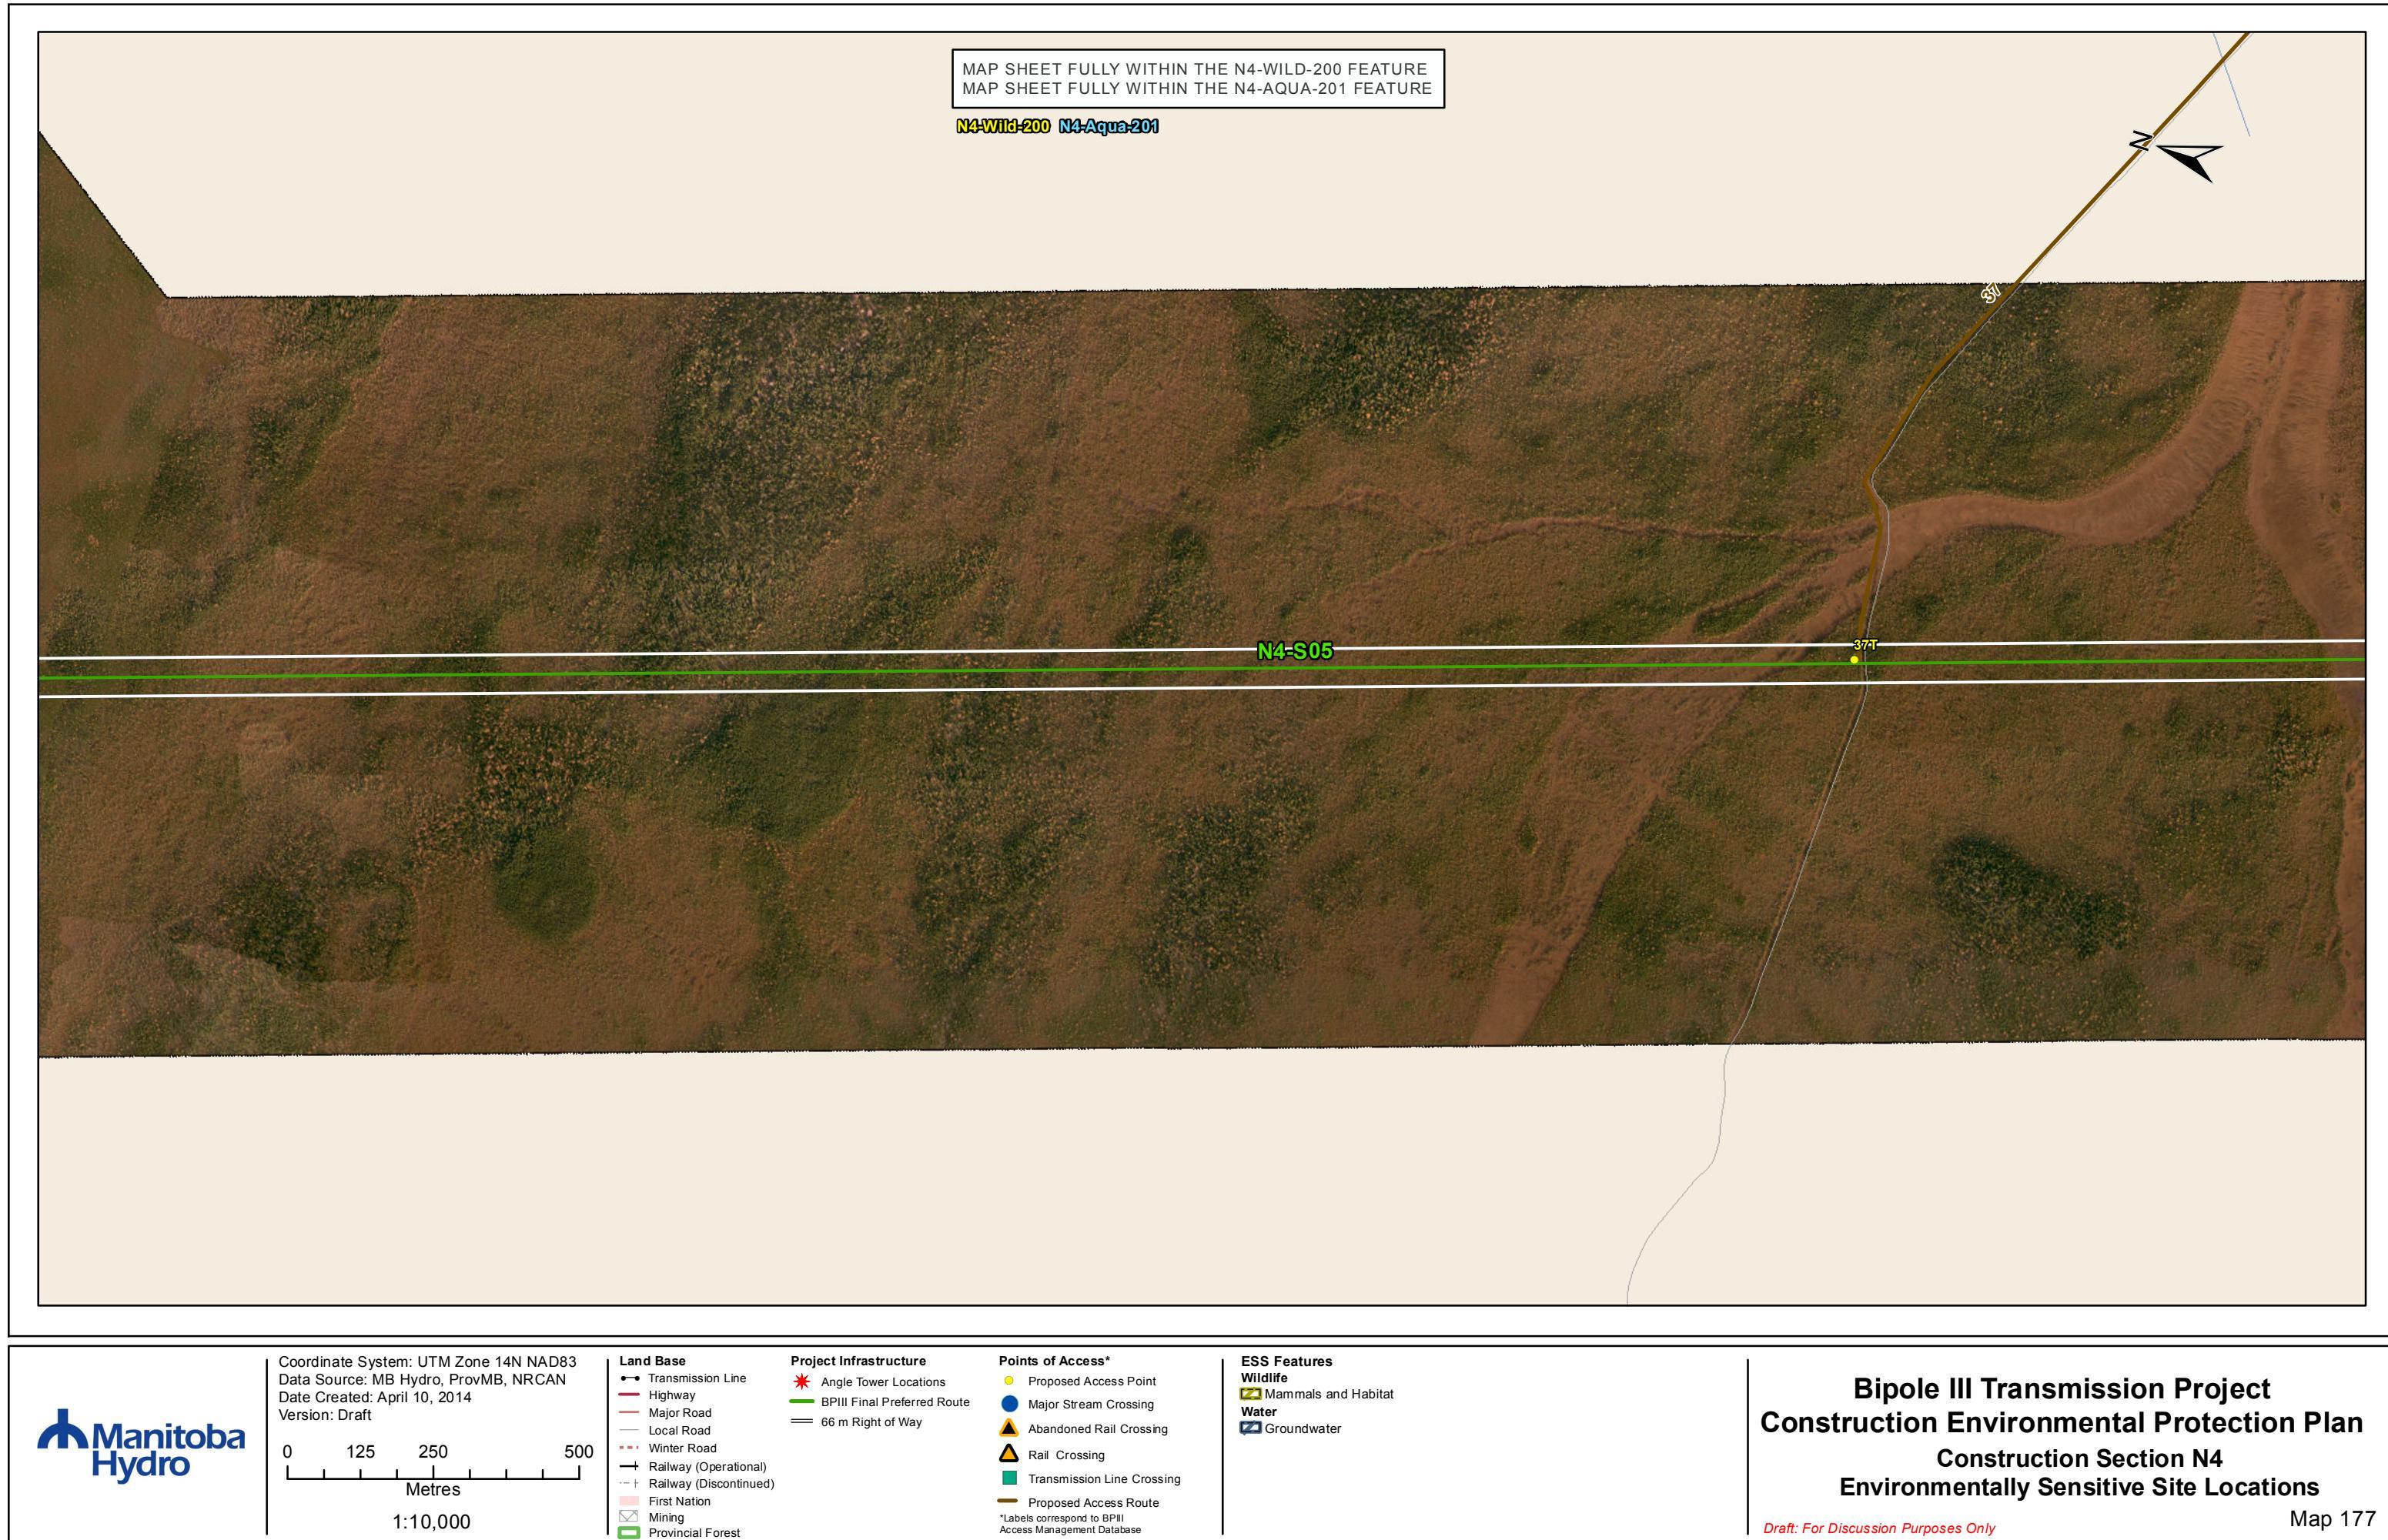
ESS Group: Groundwater

Sec-Seg ID	ESS ID	ESS Name	Location	Start	Stop	UTM Zone	Distance
N4-S05	N4-Aqua-201	Saline artesian areas	Site: 37 to 39	E-354352 N-5889174	E-357885 N-5877929	14N	11786m

Potential Effects:

Increase in salinity of soils and surface water in case of potential groundwater discharge to the surface. Also, wetting the surficial environment (ground saturation); effect on local vegetation

ESS Group: Mammals and Habitat

Sec-Seg ID	ESS ID	ESS Name	Location	Start	Stop	UTM Zone	Distance
N4-S05	N4-Wild-200	MCWS Caribou Sensitive Area	Site: 38 to 40	E-354352 N-5889174	E-362119 N-5864457	14N	25908 m

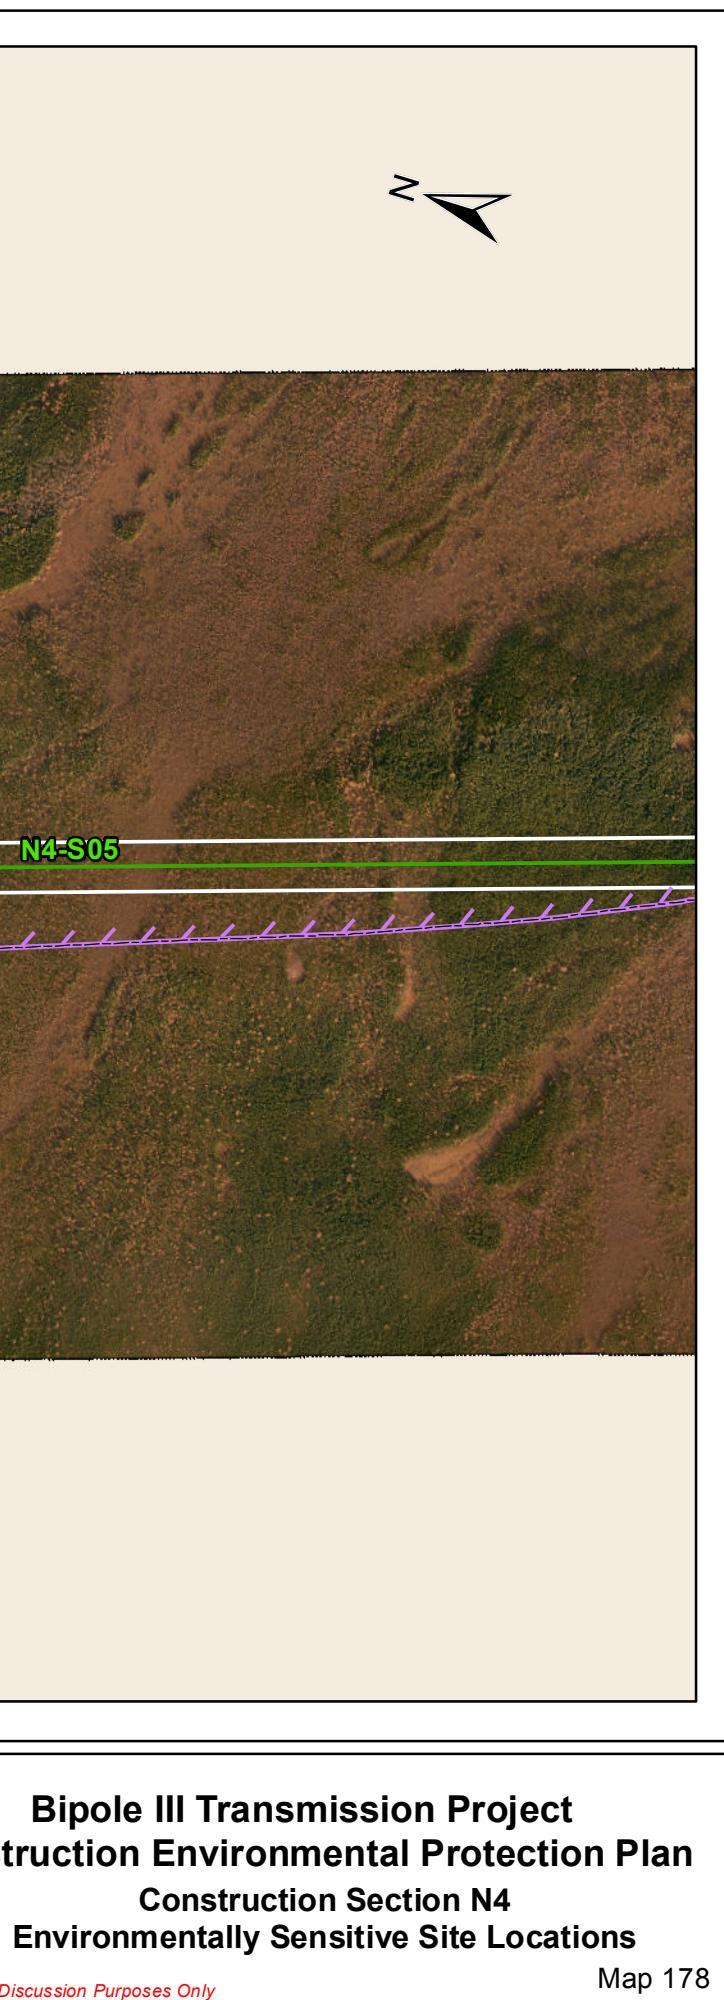
ESS Group: Mammals and Habitat

Sec-Seg ID	ESS I D	ESS Name	Location	Start	Stop	UTM Zone	Distance
N4-S05	N4-Wild-200	MCWS Caribou Sensitive Area	Site: 38 to 40	E-354352 N-5889174	E-362119 N-5864457	14N	25908 m

ESS Group: Food/Medicinal

Sec-Seg ID	ESS I D	ESS Name	Location	Start	Stop	UTM Zone	Distance
N4-S05	N4-Ruse-202	Plant Harvest	Site: 41 to 42	E-356181 N-5883353	E-356896 N-5881077	14N	2385m

ESS Group: Groundwater

Sec-Seg ID	ESS ID	ESS Name	Location	Start	Stop	UTM Zone	Distance
N4-S05	N4-Aqua-201	Saline artesian areas	Site: 37 to 39	E-354352 N-5889174	E-357885 N-5877929	14N	11786 m

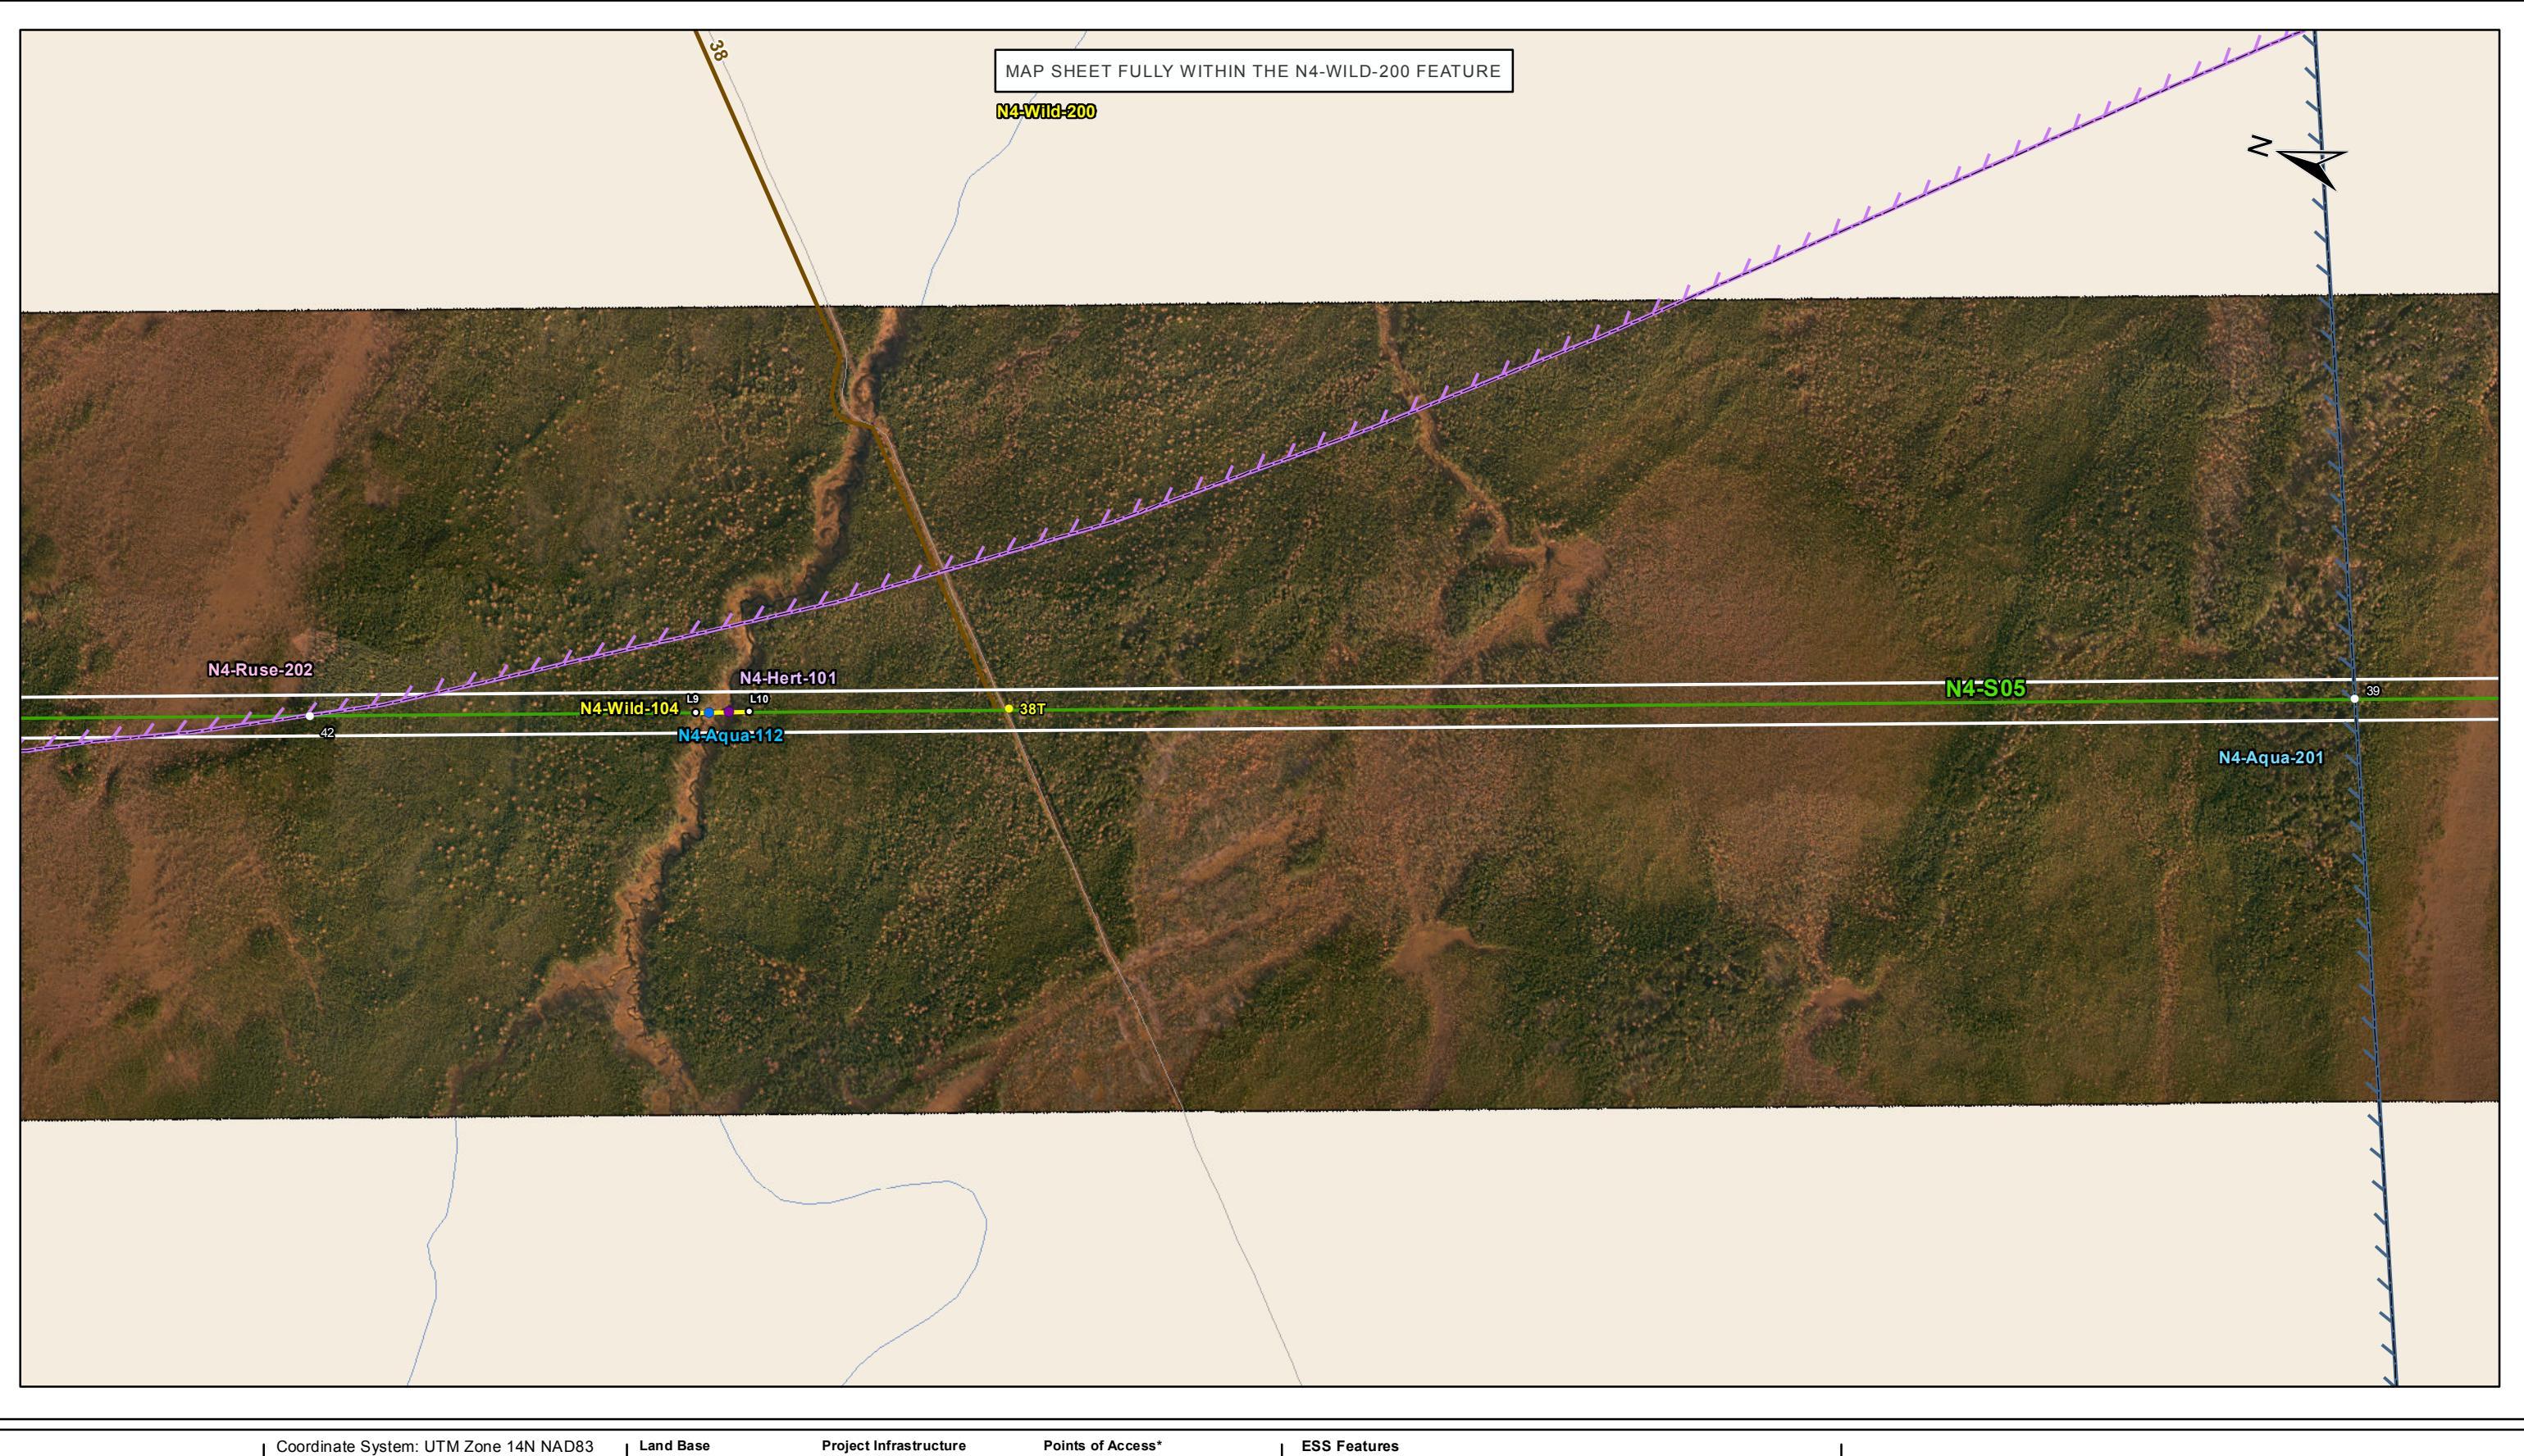
ESS Group: Archaeological

Sec-Seg ID ESS ID		ESS Name	Easting	Northing	UTM Zone
N4-S05	N4-Hert-101	Creek	357096	5880436	14N

Potential Effects:

potential disturbance to heritage Resources

ESS Group: Water Crossing

Sec- Seg I D	ESS ID	ESS Name	Easting	Northing	UTM Zone	Channel Width	Wet Width	Fish Habitat Class	Habitat Sensitivity
N4- S05	N4- Aqua- 112	Unnamed tributary of Lake Winnipegosis	357088	5880463	14N	N/A	5m	Moderate	Important

Habitat loss and contamination from structure foundations & installations; increased erosion & sedimentation of streams; Damage to stream banks; Loss of riparian vegetation; Fish habitat disturbances and impeded fish movement; Rutting of floodplain
