Map 173

Bipole III Transmission Project struction Environmental Protection Plan Construction Section N4 Environmentally Sensitive Site Locations

Map 175

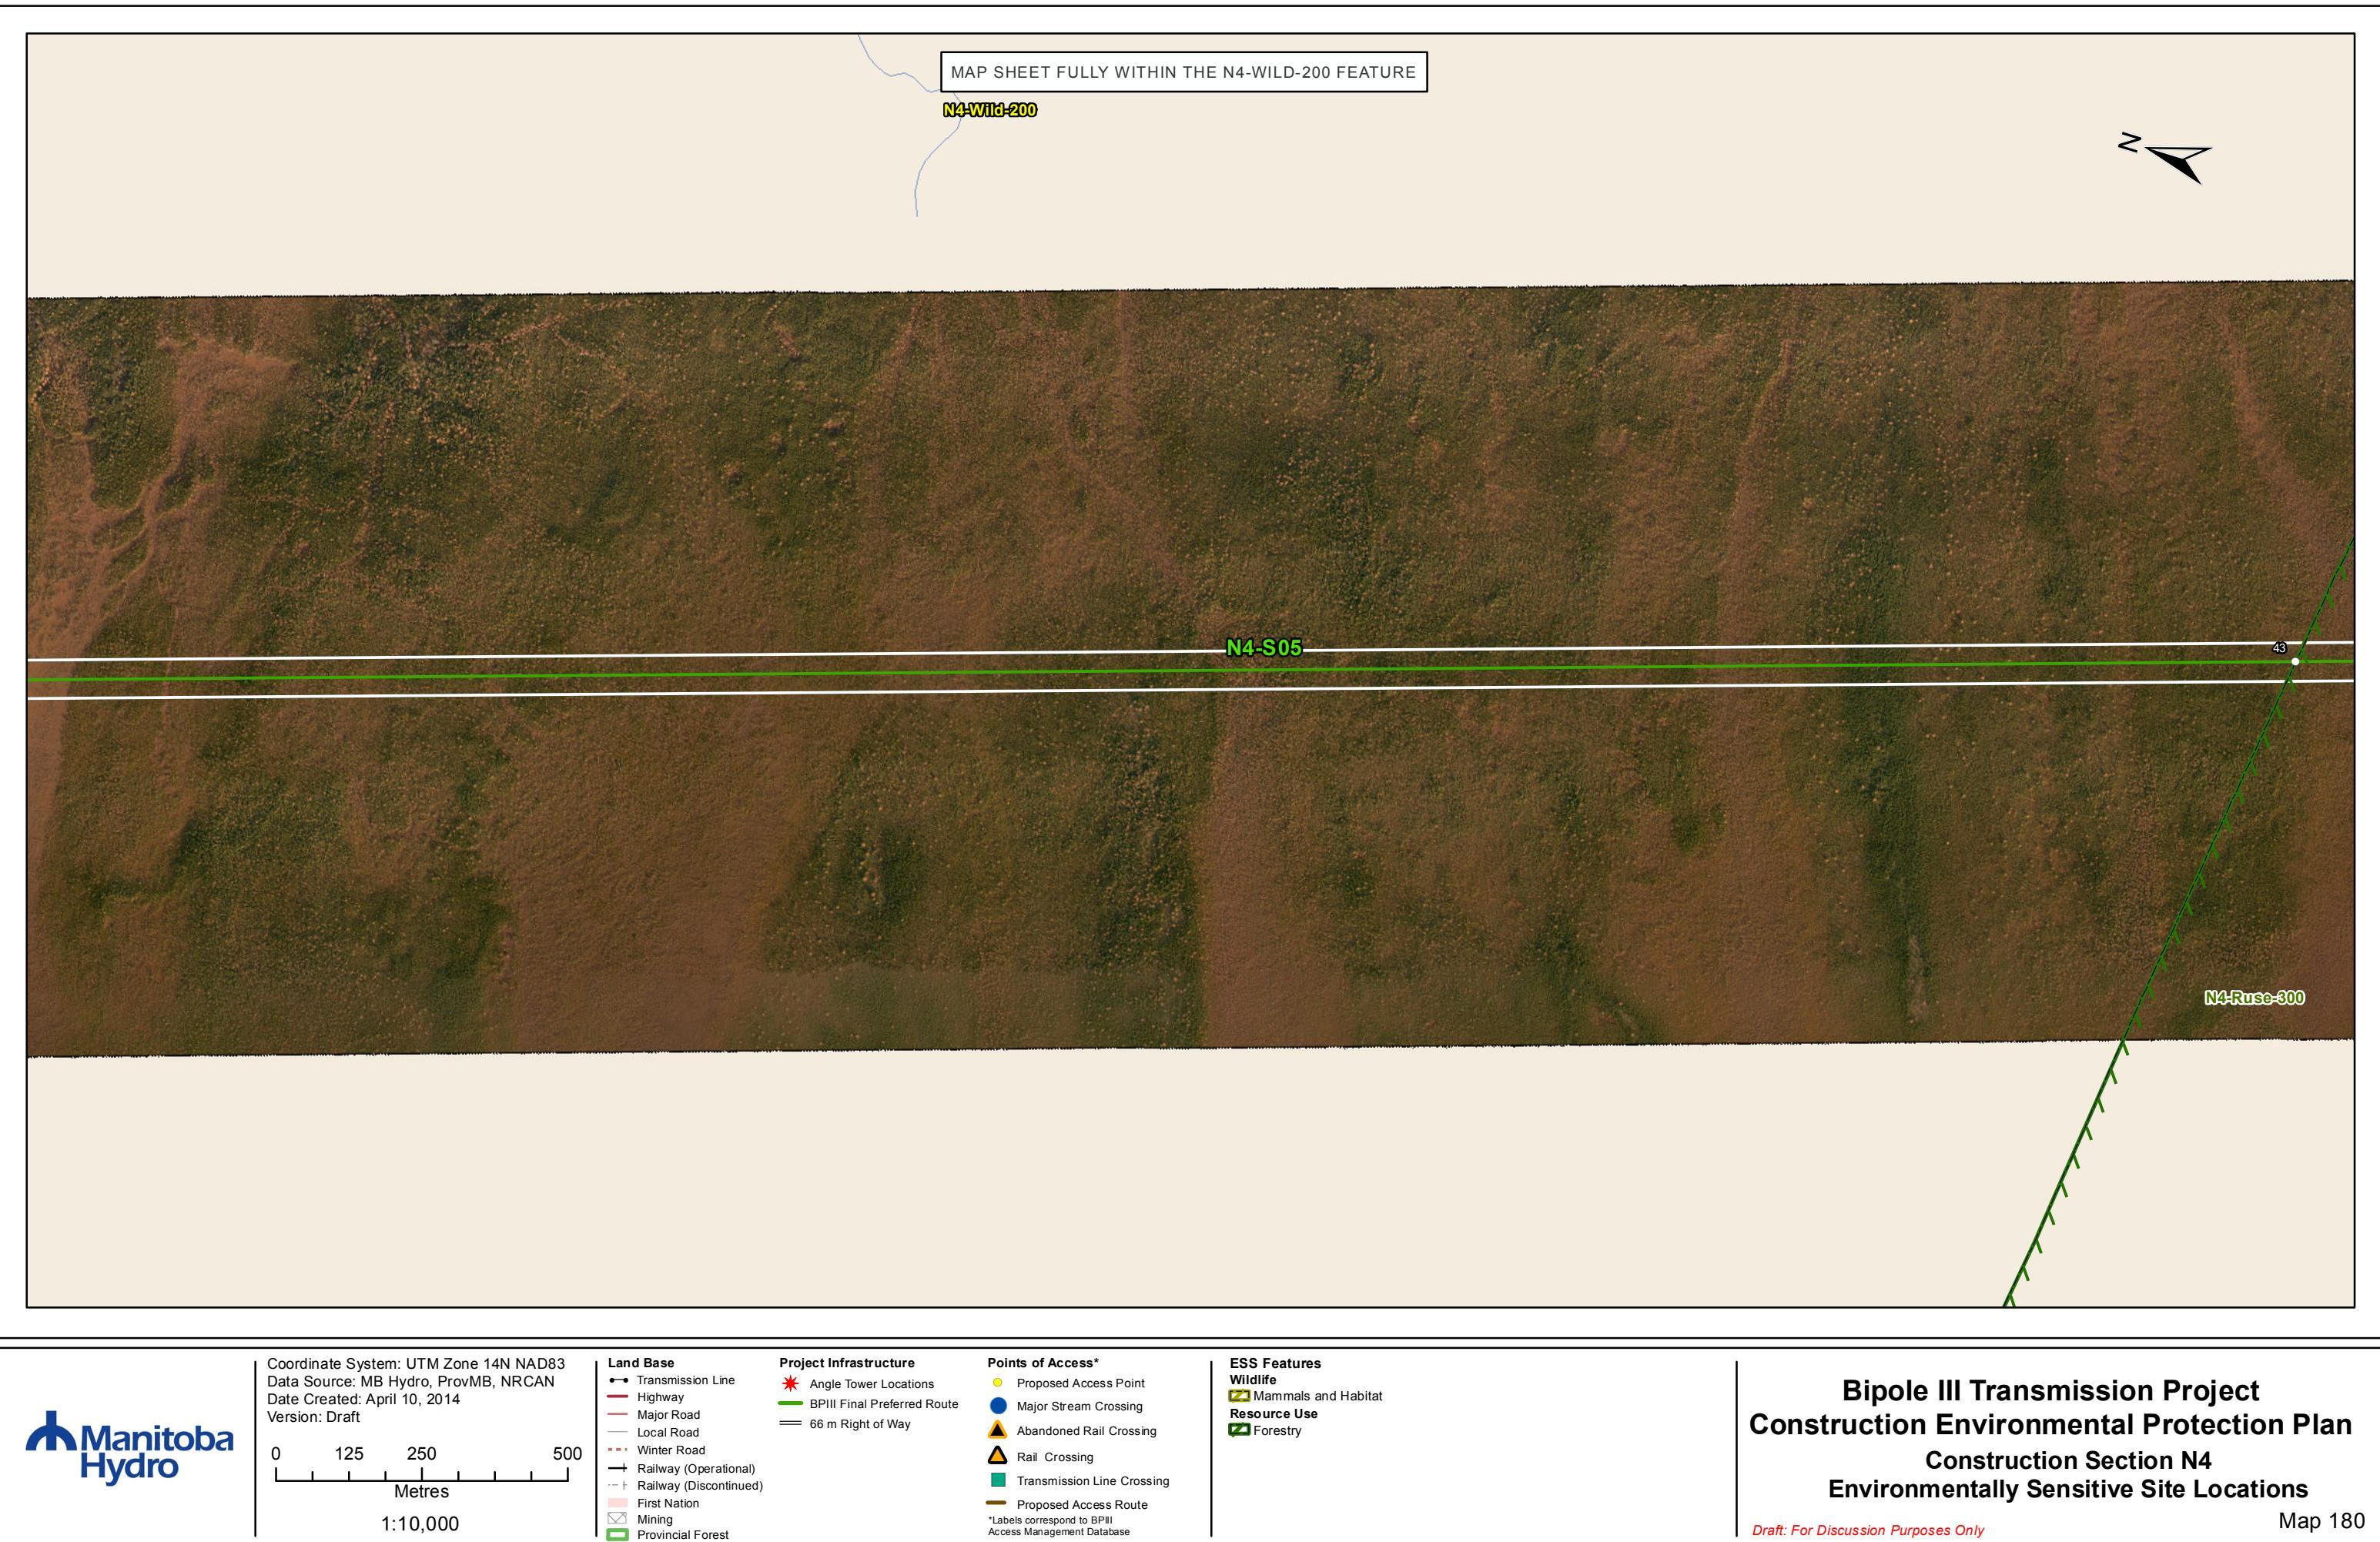
ESS Group: Forestry

Sec-Seg ID	ESS I D	ESS Name	Location	Start	Stop	UTM Zone	Distance
N4-S05	N4-Ruse-300	Fuel Wood	Site: 43 to 44	E-359111 N-5874028	E-362556 N-5863065	14N	11491m
