Metal Concentrations in Surface Soils of Thompson, Manitoba, September 2001

February 2003

Manitoba Conservation Report No. 03-01

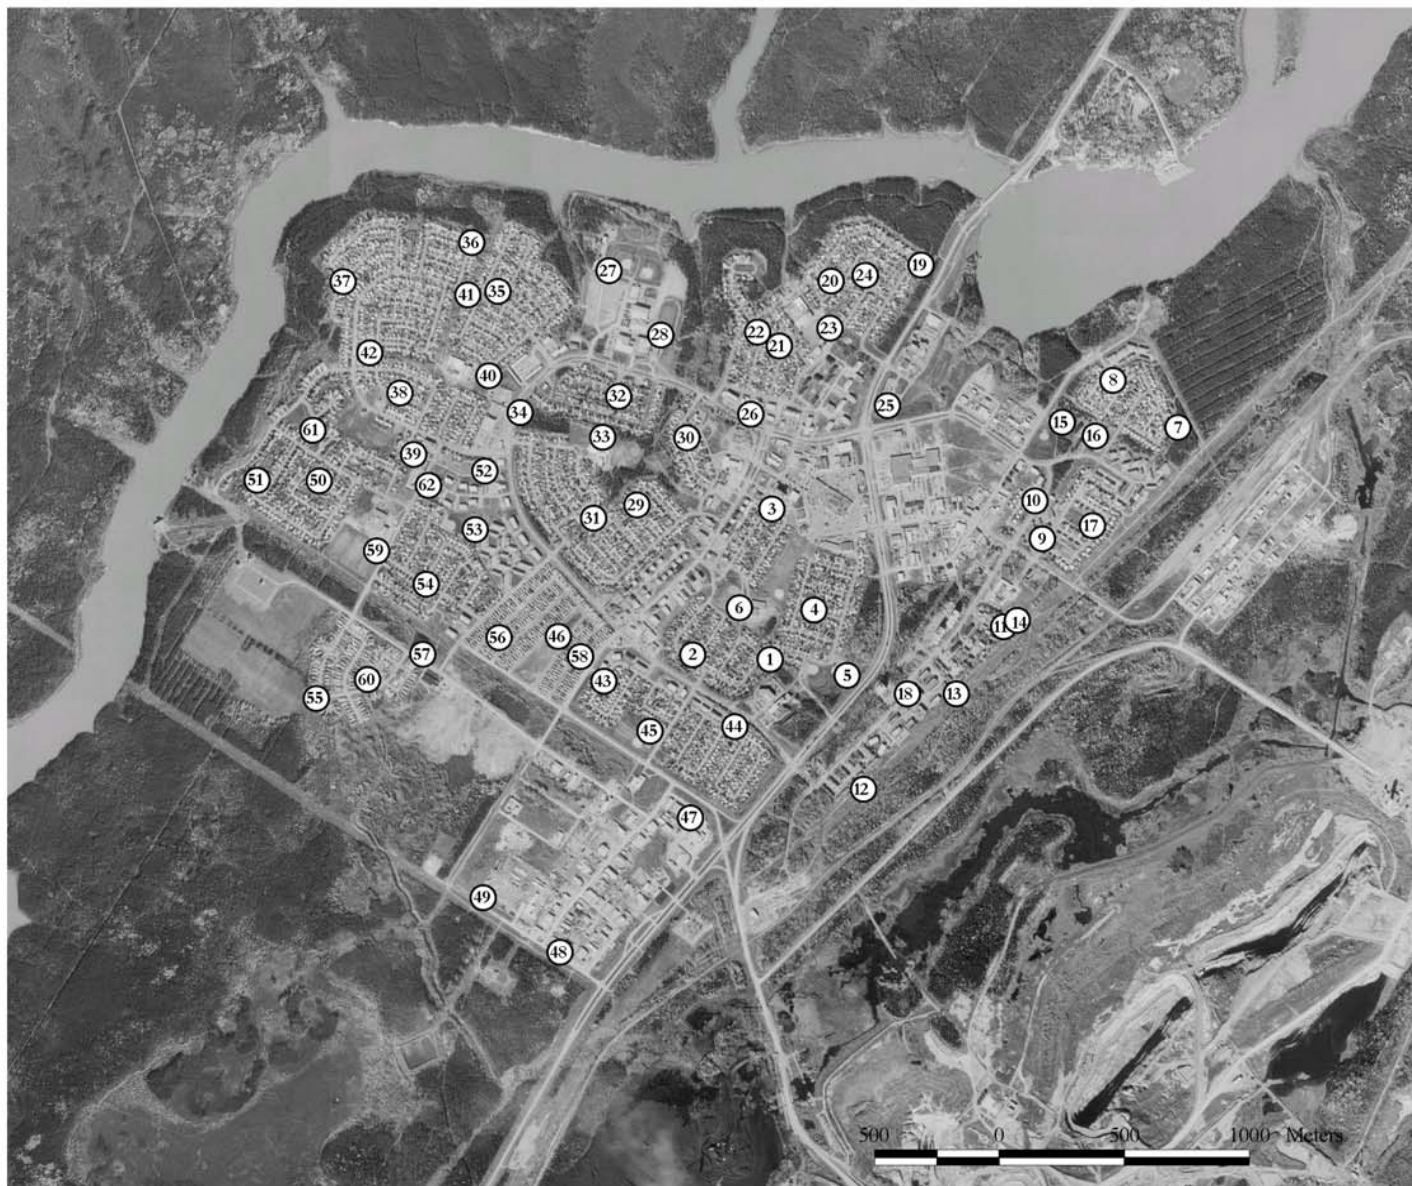
Figure 1. Aerial photograph of Thompson, MB, showing the location of sample sites (labeled with numbers).

Sixty-two sites within the city of Thompson were sampled on September 26 and 27, 2001. The sites were distributed throughout the city and included private residential lots, vacant lots, schoolyards, and playgrounds (Figure 1 and Table 1). Sampling in the city's core business and retail area (downtown) was avoided because of the potential for contamination from other sources within this area.

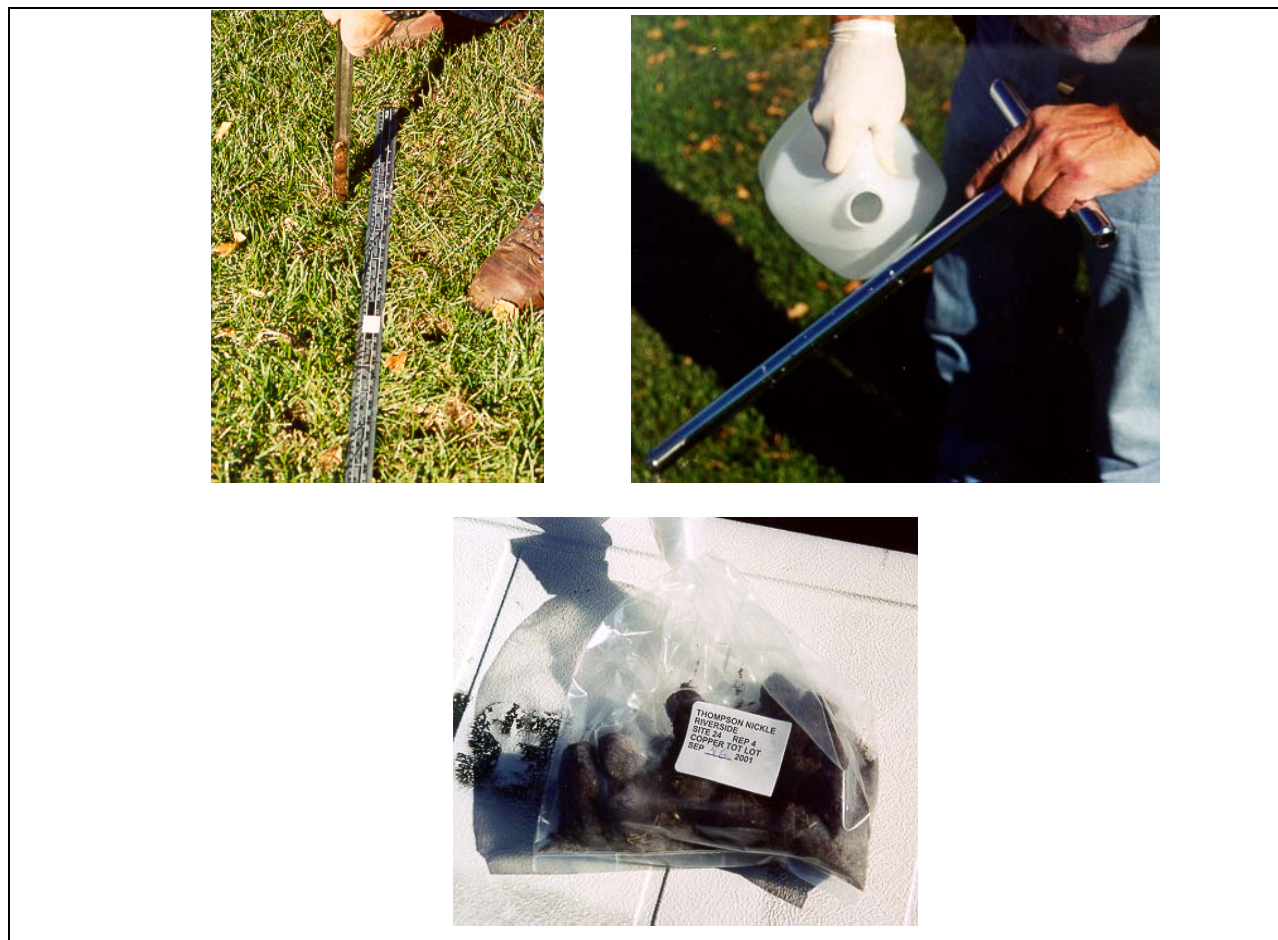
Figure 2. Photographs of soil sampling. Clockwise from upper left: (a) sampling using a small diameter soil coring tool; (b) rinsing equipment with distilled water between sample sites; (c) a replicate sample.

Soil samples were extracted from the top 2 cm of the soil profile using a small diameter (1.5 cm) soil coring tool (Figure 2). To ensure that an adequate amount of material was available for analysis, each replicate sample was a composite of 20 cores. The cores were

extracted at 5 cm intervals along a one metre line (edge of a metre ruler). The metre rule was placed at five random locations on the ground at each sample site to yield five replicate samples per site. The cores for each sample were placed directly into pre-labeled plastic bags (Figure 2).

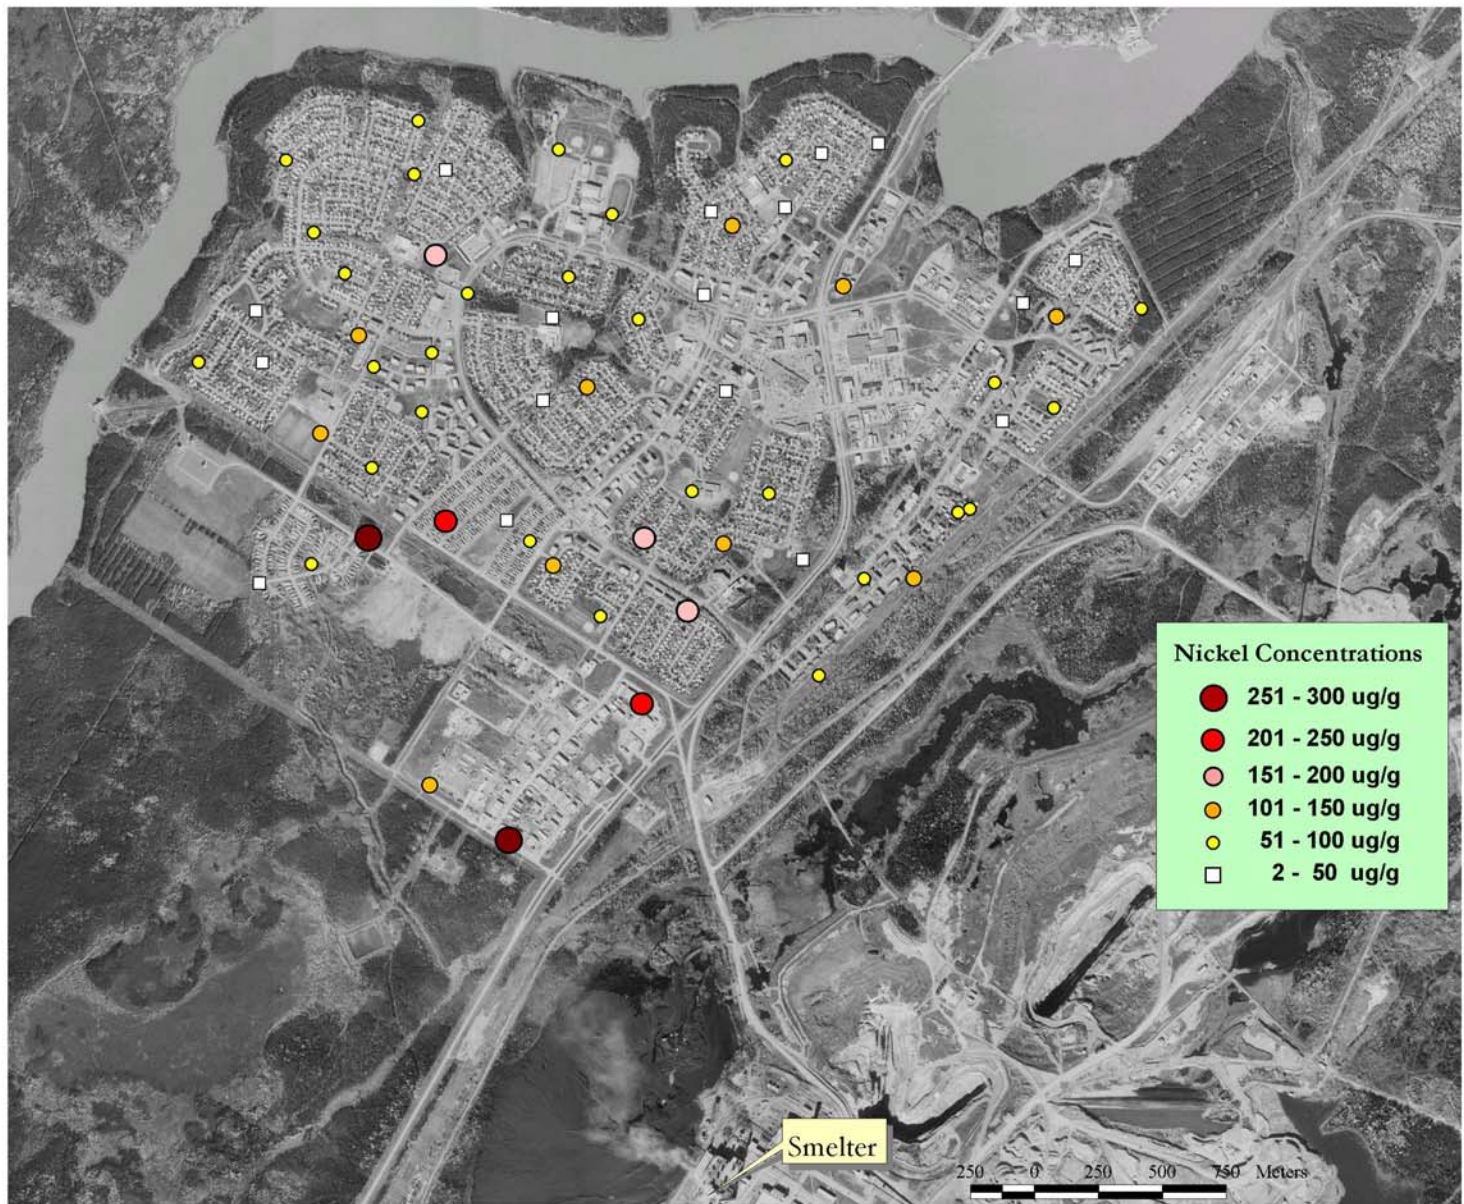
Figure 3. Aerial photograph of Thompson, MB, showing the ranges in Ni concentration in surface soil samples collected at 62 sample sites.

GIS software (*Arcview 3.2*) was used to overlay the mean Ni concentration data on an aerial photo of the community (Figure 3). The resulting map did not reveal any clear relationship between site location and mean Ni concentration in the surface soil, although higher concentrations tended to be in the southern part of the city, which is closer to the smelter. This and the fact that Ni levels were elevated and relatively widely distributed in surface soil across the community implies that emissions from the INCO Ltd. smelter are the main source of Ni in the surface soils in Thompson.

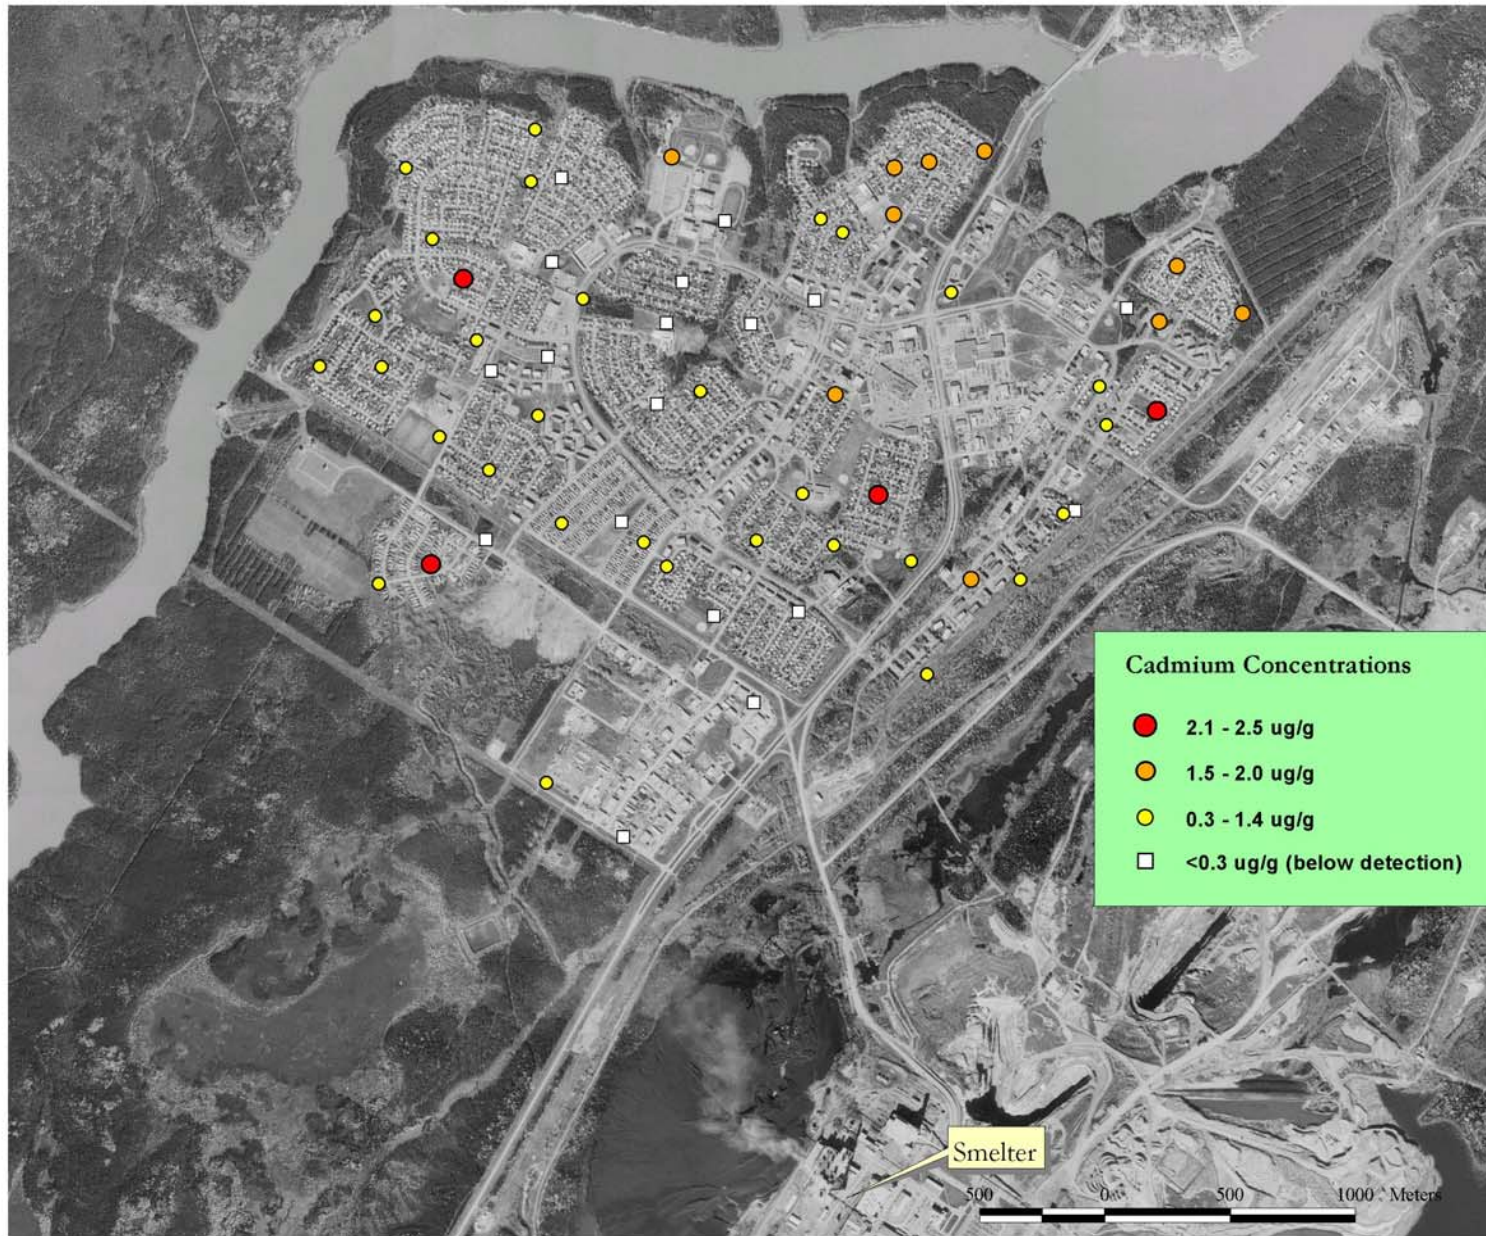
Figure 4. Aerial photograph of Thompson, MB, showing the ranges in Cd concentration in surface soil samples collected at 62 sample sites.
