Terrestrial Standards and Studies, Report 89-1

**Wood Preservative
Residues in Soil
Prendiville Wood
Preservers Ltd.
Neepawa, Manitoba
1985**

Report 89-1
February, 1989

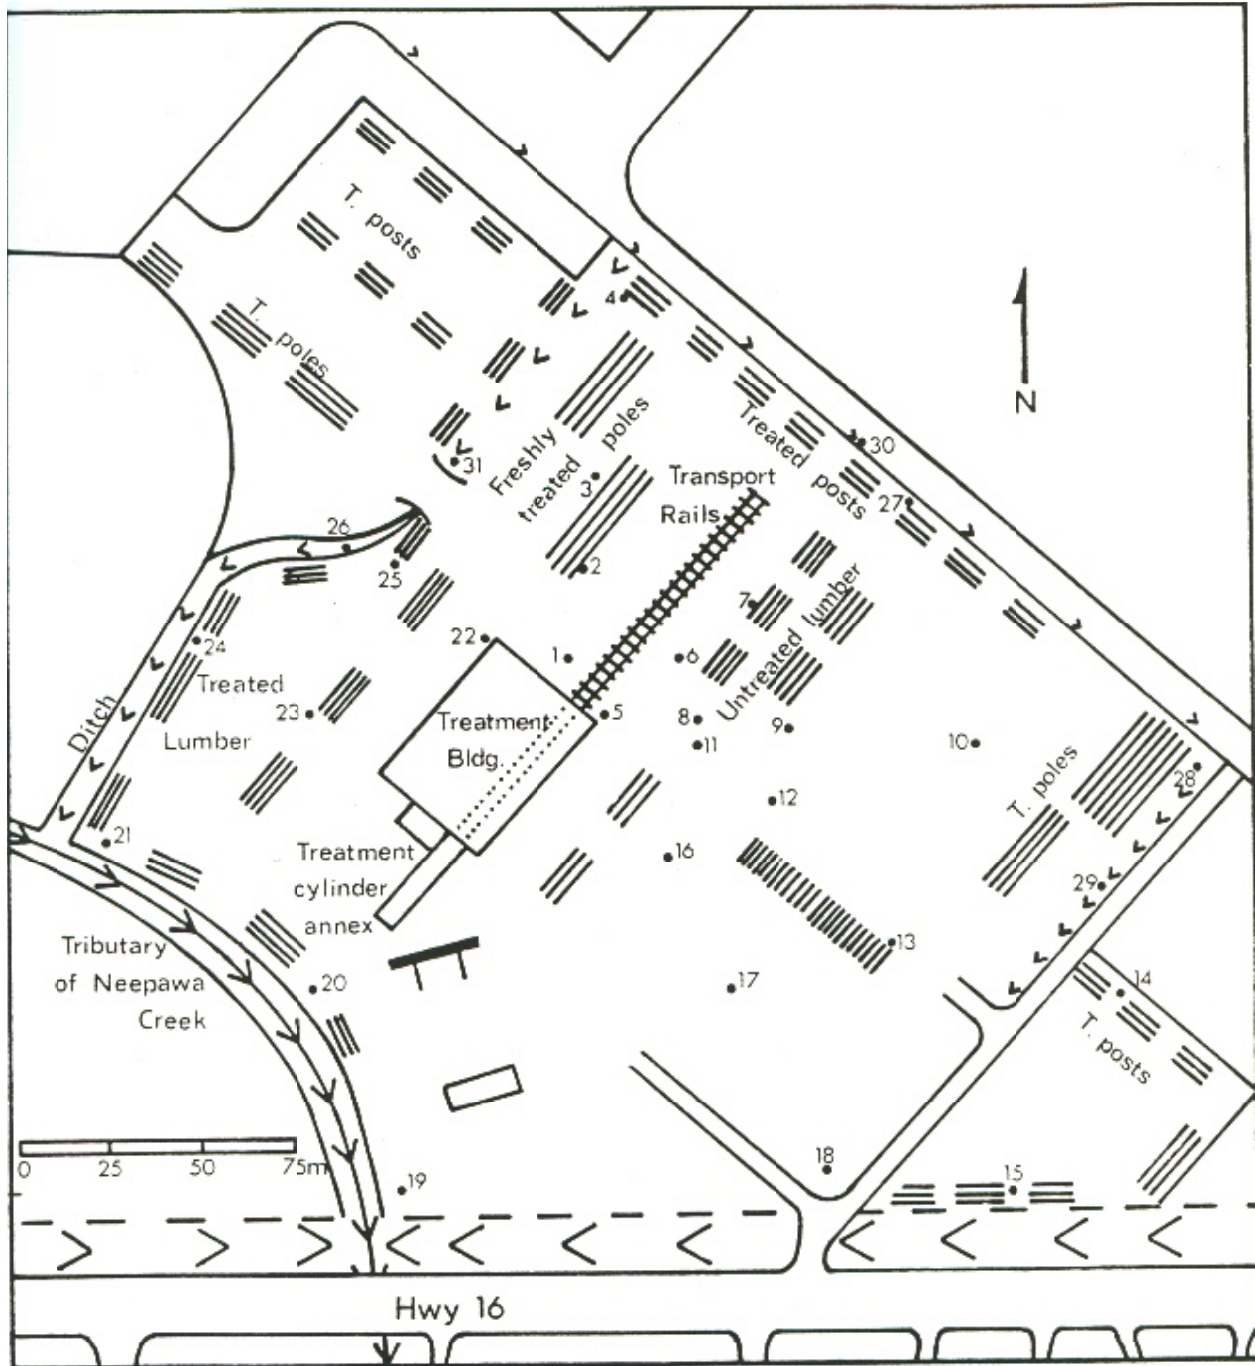
Fig.1: Site map of Prendiville Wood Preservers Ltd. Plant, Neepawa, Manitoba

Thirty-one sampling locations were selected within Prendiville Wood Preservers Ltd. property (Figure 1) and a control was located 1.5 km north. Sites were located along 7 transects radiating from the main loading door of the treatment building. Within 60 m of the building, the sampling locations were spaced 25 m apart and beyond that the spacing was increased to 50 m. Some samples were taken from drainage ditches within the property and along its NE boundary.

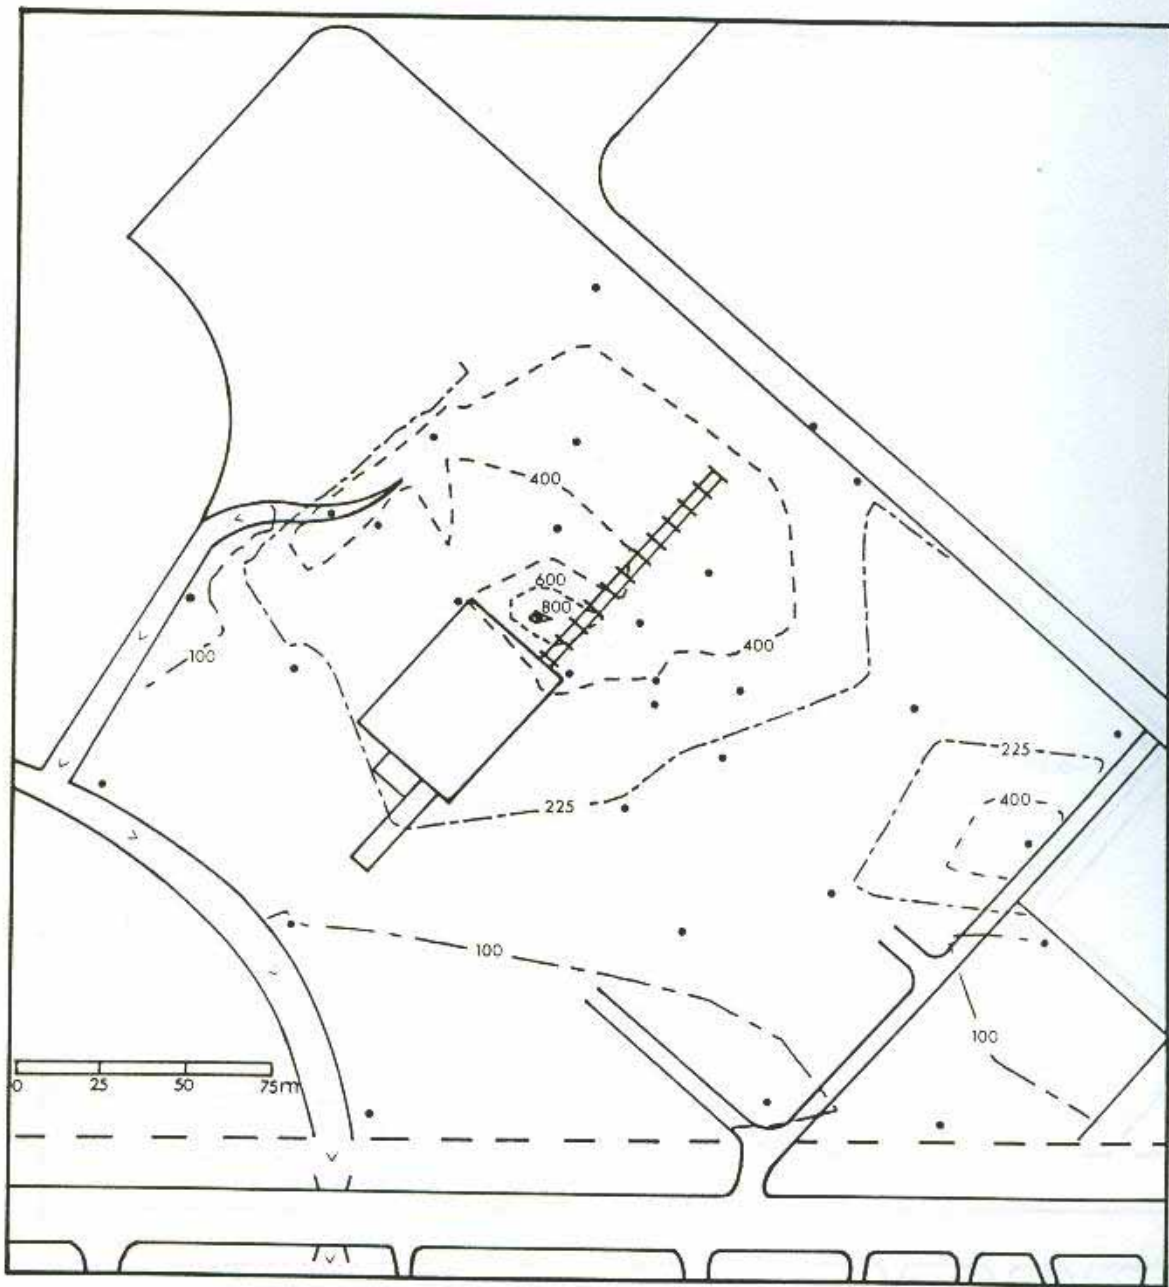
FIG.2: ISOPLETHS OF COPPER CONCENTRATION ($\mu\text{g/g}$) IN SURFACE SOIL AT PRENDVILLE WOOD PRESERVERS LTD., NEEPEAWA, MANITOBA, 1985.

Concentrations of Cu, Cr, and As in the surface and 5 to 10 cm soil layers are presented in Table 1. Isopleth lines showing the concentrations of each element (Cu, Cr and As) in the surface soil are overlaid on a simplified map of the Prendiville property (Figures 2, 3 and 4).

At the Prendiville site in Neepawa, Cu, Cr and As have accumulated in high concentrations in the yard NE, N, and NW of the treatment building. The freshly treated wood is usually placed in that area immediately after being taken out of the treatment cylinder. The concentration was highest at site 1 which was close to the main door and also adjacent to the transport rails. The Cu concentration at site 1 was 865 ug/g, while that of Cr and As were slightly lower at 653 ug/g and 641 ug/g respectively (Table 1). Although no sampling was done within the treatment building, concentrations were probably high there as well. The concentrations decreased with distance away from the transport rails and the main door into the treatment building. Concentrations of Cu, Cr, and As in the surface soil were higher than at the control site (Cu: 15 ug/g; Cr: 10 ug/g; As: 5 ug/g) indicating that there was some contamination over the entire Prendiville property. Although the primary source of contamination was probably drips of preservative from freshly treated wood, yard maintenance such as grading or snow clearing could have moved some of the contaminated soil to other areas of the yard. Wind and water erosion are other agents which have no doubt moved contaminants to other locations.

There is also evidence that runoff water has transported preservative residues into ditches on the Prendiville property. Ditches along the SE and NE sides of the property as well as the one west of the treatment building have accumulated higher amounts of Cu, Cr and As than at adjacent sites on the property. This indicates that off-site movement via sediment transport has occurred. The western drainage ditch is of particular concern because it connects directly to the headwater of a tributary of Neepawa Creek. Sediments should be sampled from this tributary to determine if (or to what degree) it has been contaminated with Cu, Cr, or As.

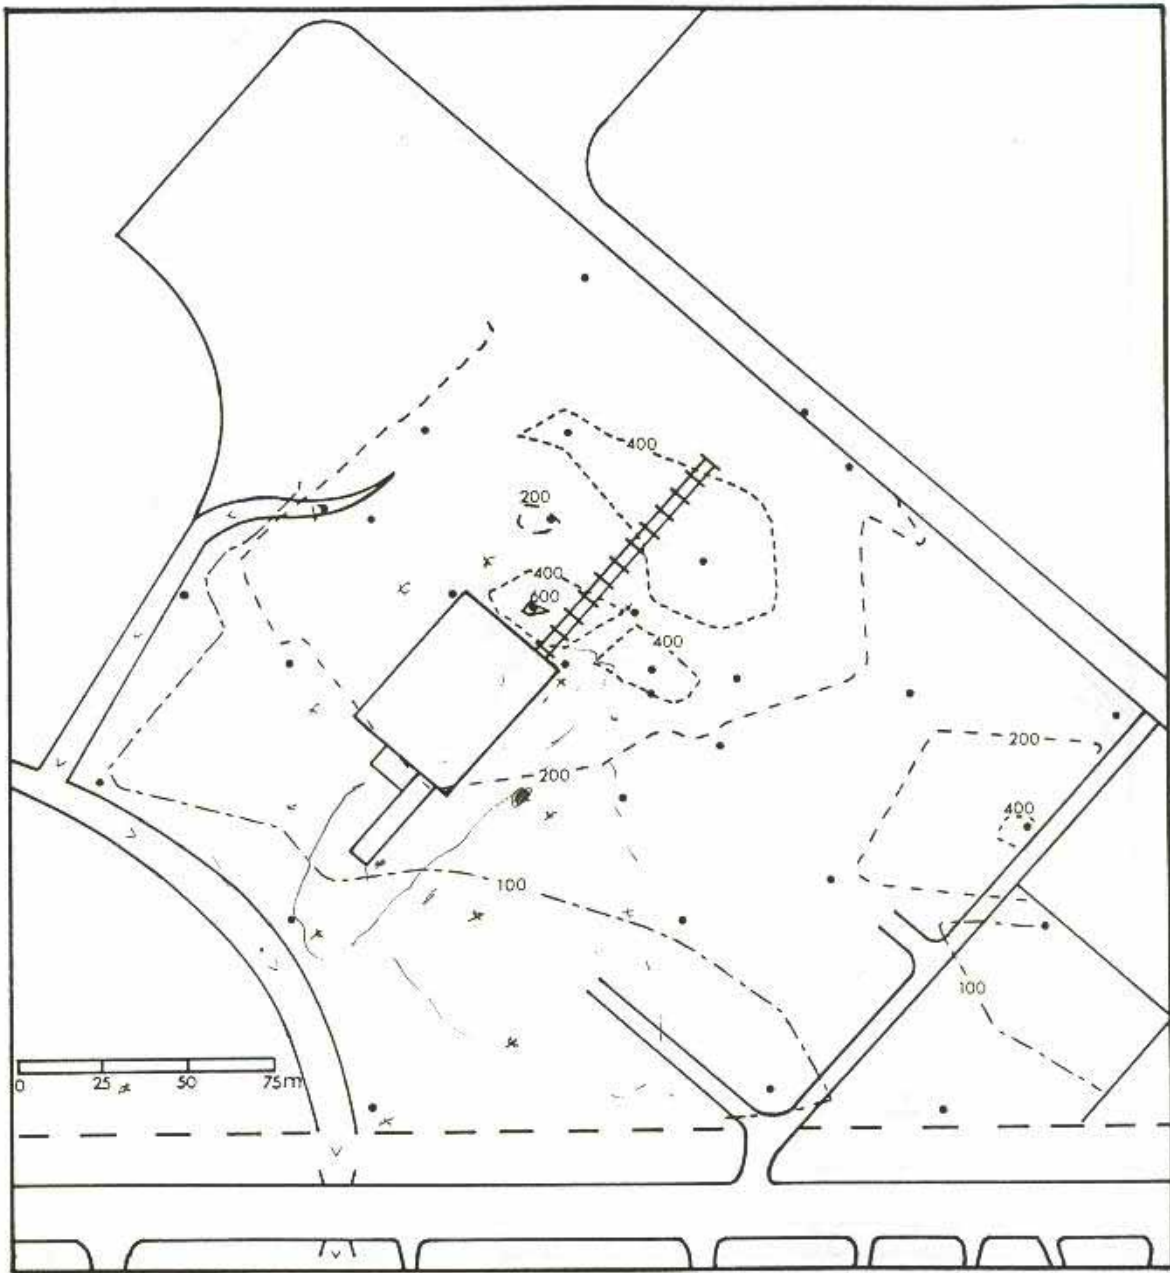
FIG.3: ISOPLETHS OF CHROMIUM CONCENTRATION ($\mu\text{G}/\text{G}$) IN SURFACE SOIL AT PRENDVILLE WOOD PRESERVERS LTD., NEEPAWA, MANITOBA, 1985.

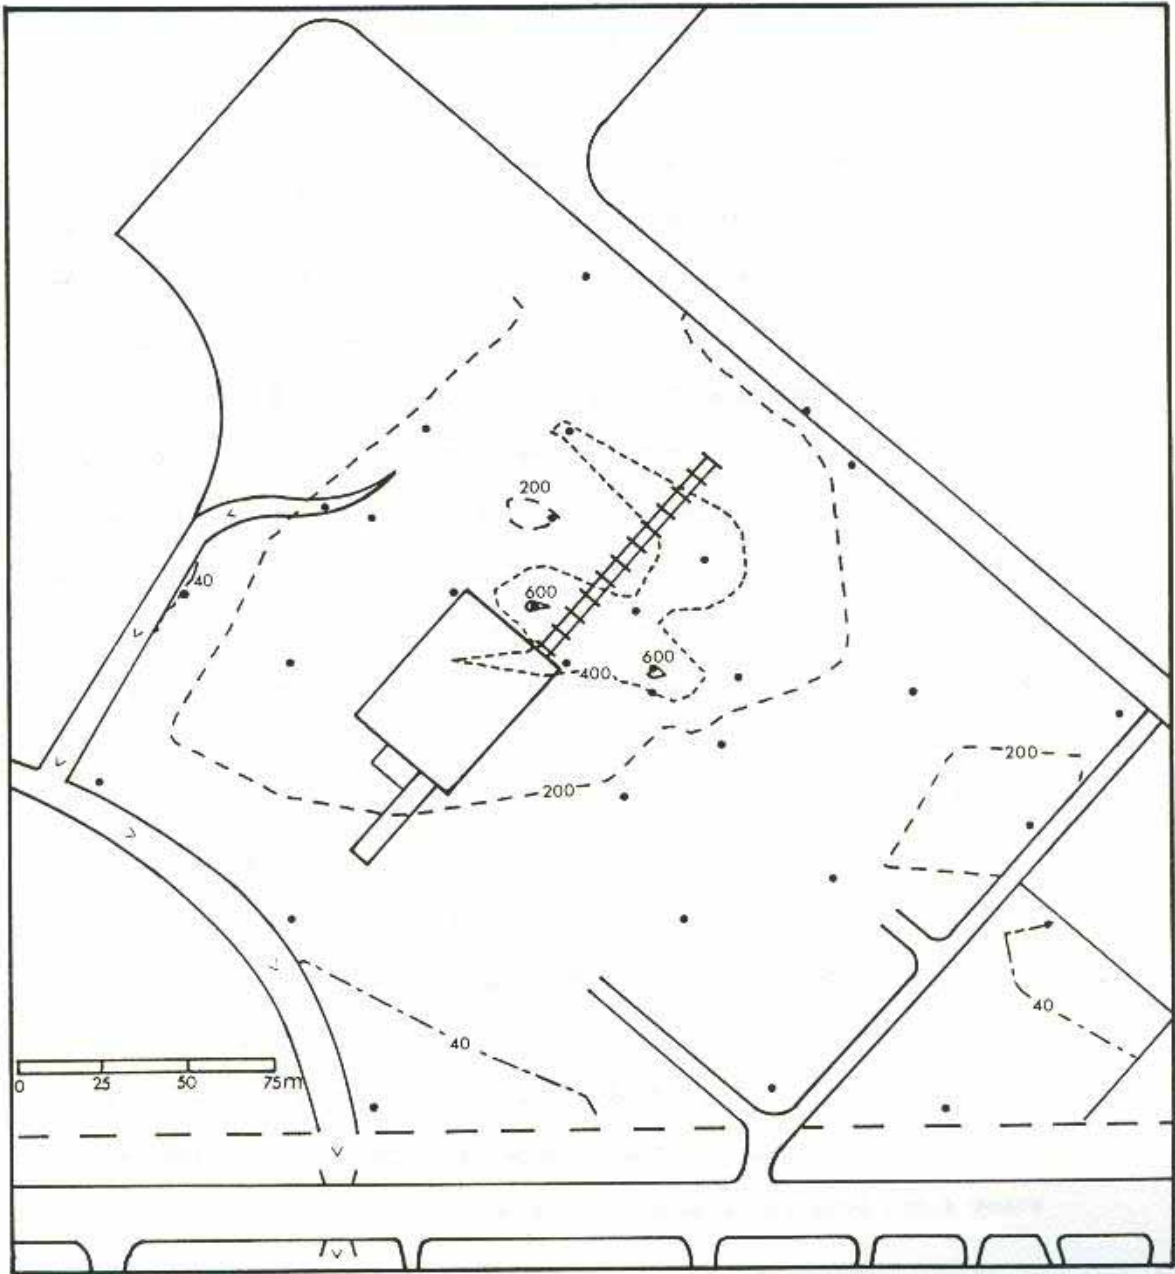
FIG.4: ISOPLETHS OF ARSENIC CONCENTRATION (UG/G) IN SURFACE SOIL AT PRENDMILLE WOOD PRESERVERS LTD., NEEPAWA, MANITOBA, 1985.

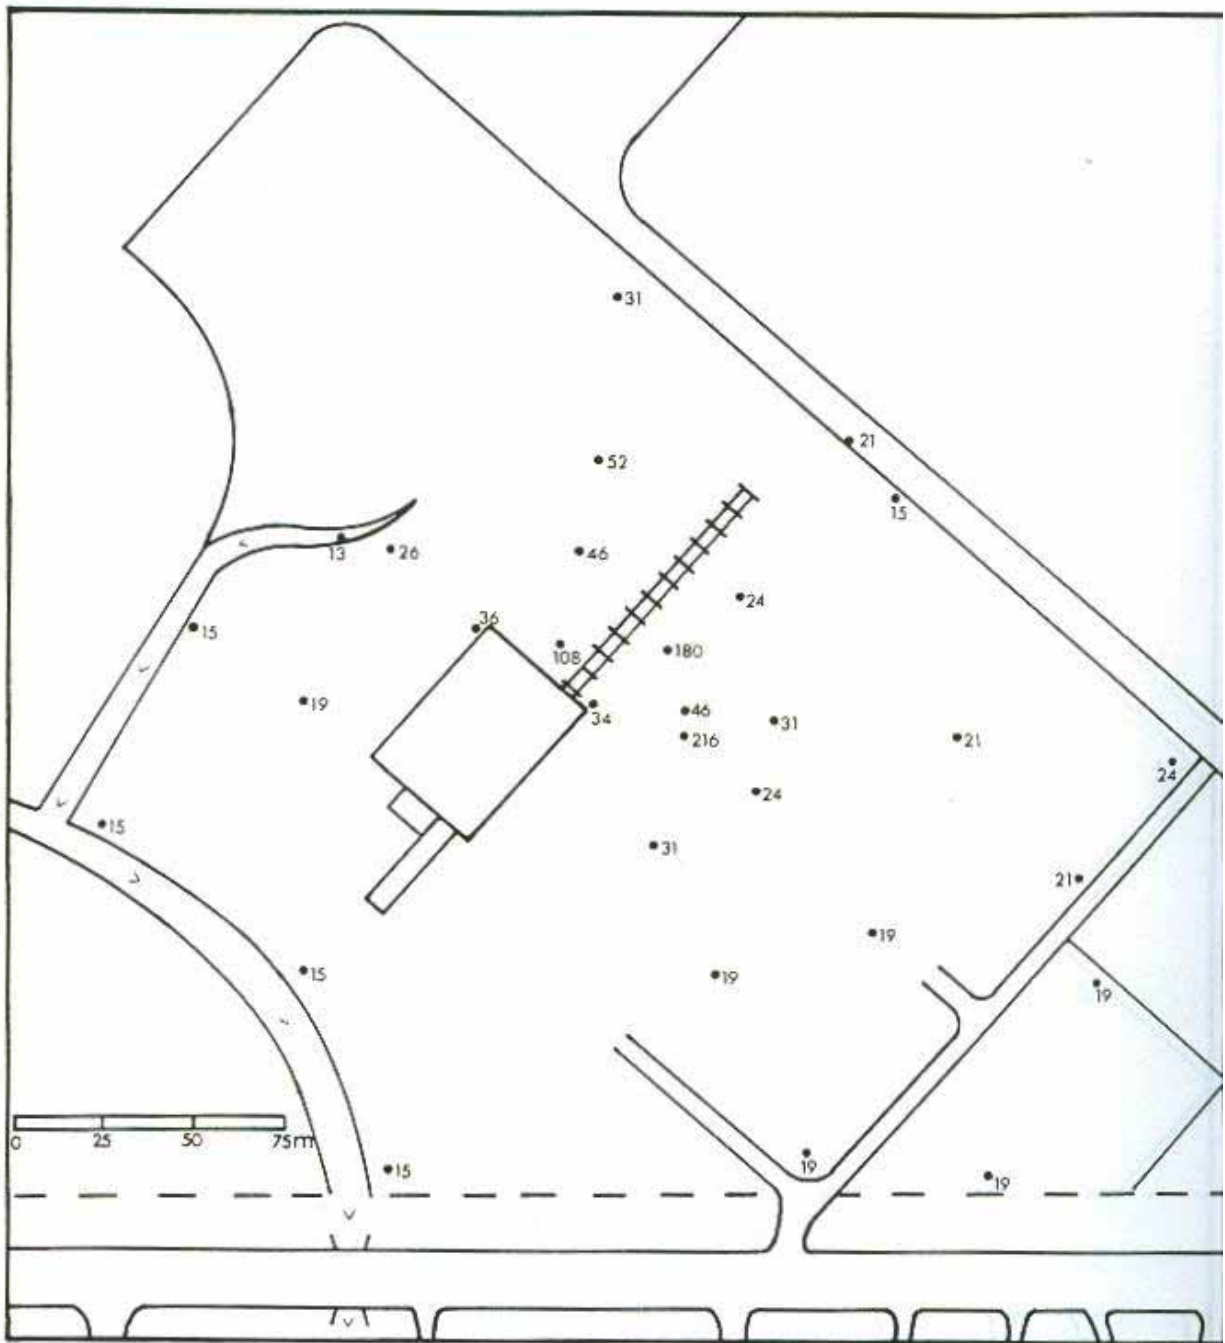
FIG.5: COPPER CONCENTRATION (UG/G) IN 5 TO 10 CM SOIL LAYER AT PRENDMILLE WOOD PRESERVERS LTD., NEEPAWA, MANITOBA, 1985.

Concentrations of Cu, Cr and As in the soil are much lower at the 5 to 10 cm depth (Figures 5, 6 and 7) which suggests that there is good adsorption potential in the surface soil which has limited downward leaching. There were three sample locations with high concentrations of copper in the 5 to 10 cm zone of the soil. These were sites 1, 6, and 11 at 108 ug/g, 180 ug/g, and 216 ug/g, respectively. Concentrations of Cr and As were also high in those three samples. Since sites 6 and 11 had lower surface concentrations than some of the other sites, the concentrations at the 5-10 cm depth were unexpectedly high. It is possible that those samples may have been inadvertently located where the yard was once rutted and subsequent yard grading has filled the ruts with the more highly contaminated surface soil.

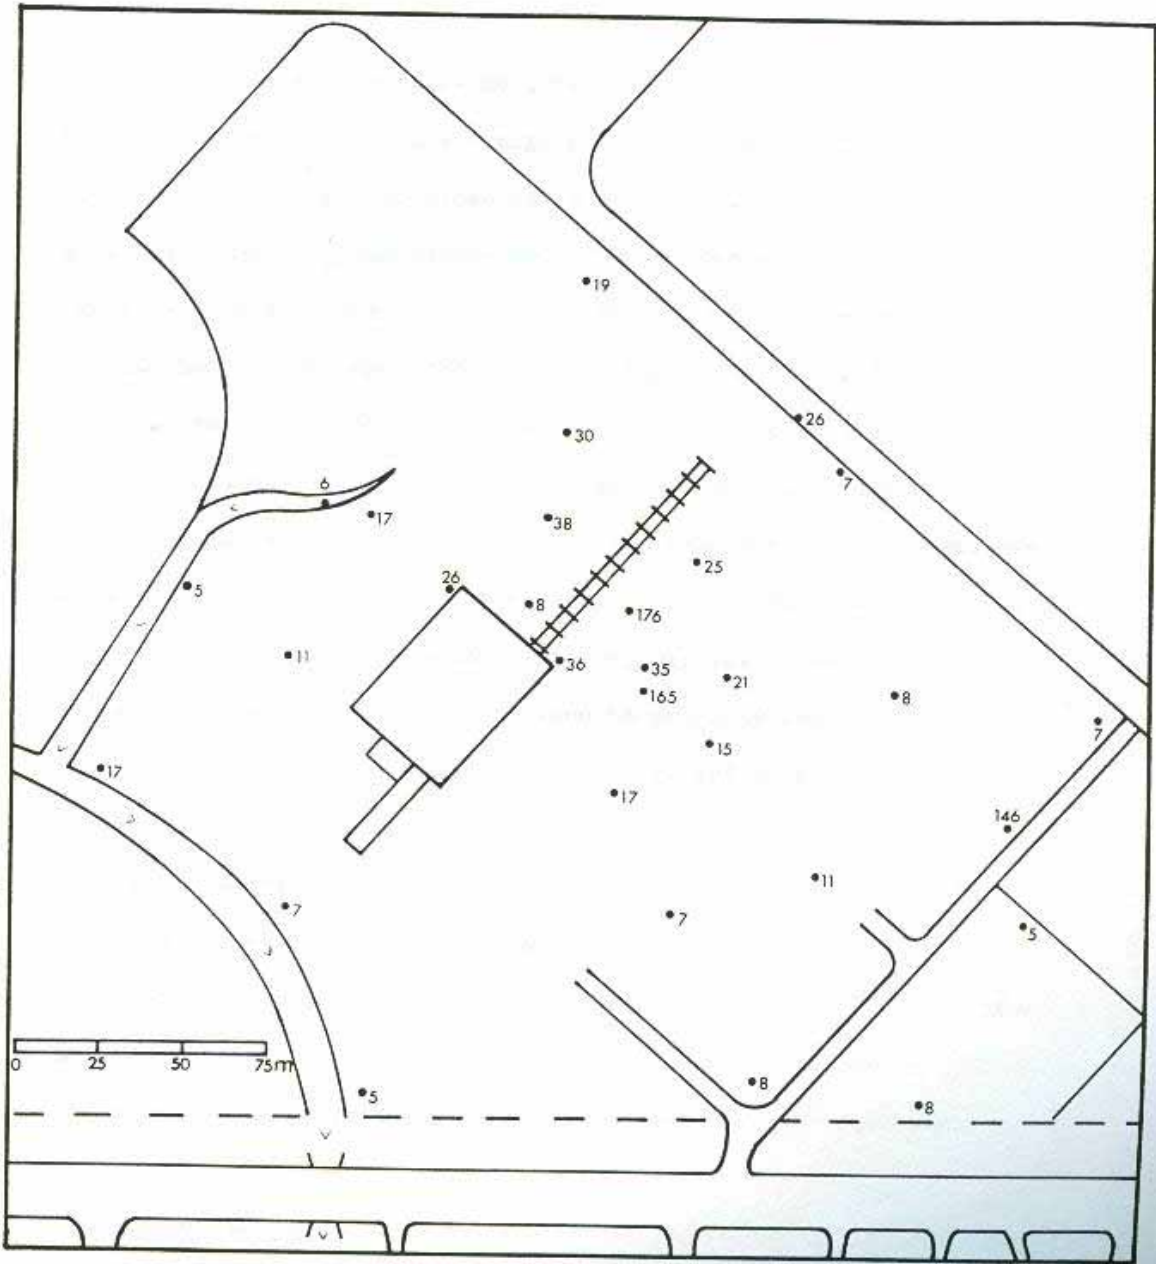
FIG.7: ARSENIC CONCENTRATION (UG/G) IN 5 TO 10 CM SOIL LAYER AT PRENDMILLE WOOD PRESERVERS LTD., NEEPAWA, MANITOBA, 1985.
