PRELIMINARY DESIGN FOR REACH 2 OF THE LAKE ST. MARTIN OUTLET CHANNEL

16-0300-005

Final - Rev 0

June 2017

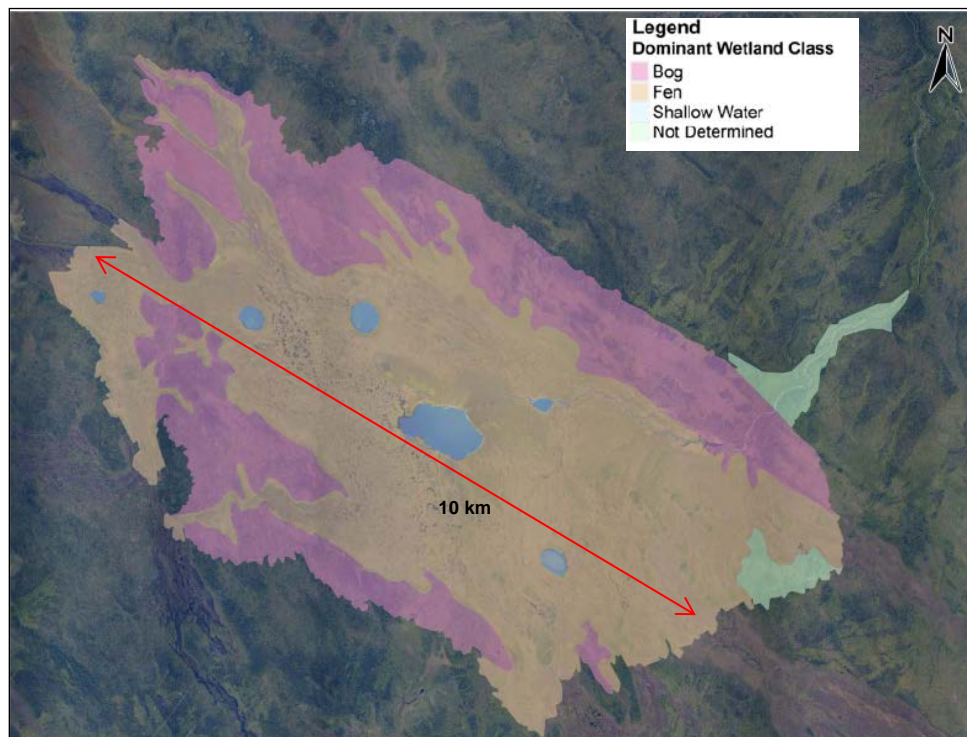
FIGURE 7
DOMINANT WETLAND CLASS SURROUNDING BIG BUFFALO LAKE PRIOR TO LSMEOC

Construction of the LSMEOC and its operation to date have primarily affected pre-existing fens and associated waterbodies. Construction activities removed a very small proportion of the wetlands within the complex. In contrast, available information suggested that operation of the LSMEOC in 2011/2012 and 2014/2015 had flooded about half of the wetland complex during the open water season. It also appeared that only a small proportion of the bog was flooded during the open water season.

Operation of the LSMEOC has reduced the amount of fen in the Buffalo Lakes wetland complex. Flooding and flows have caused some mortality of pre-existing vegetation and/or peat breakdown, as well as mineral sediment deposition on top of the fen. In many locations, tall emergent vegetation (primarily comprised of cattails and common reed) is now growing in mineral sediment deposited on top of former fen (referred to as marsh-like vegetation). This marsh-like vegetation could produce floating marsh islands if Option 1 were implemented.

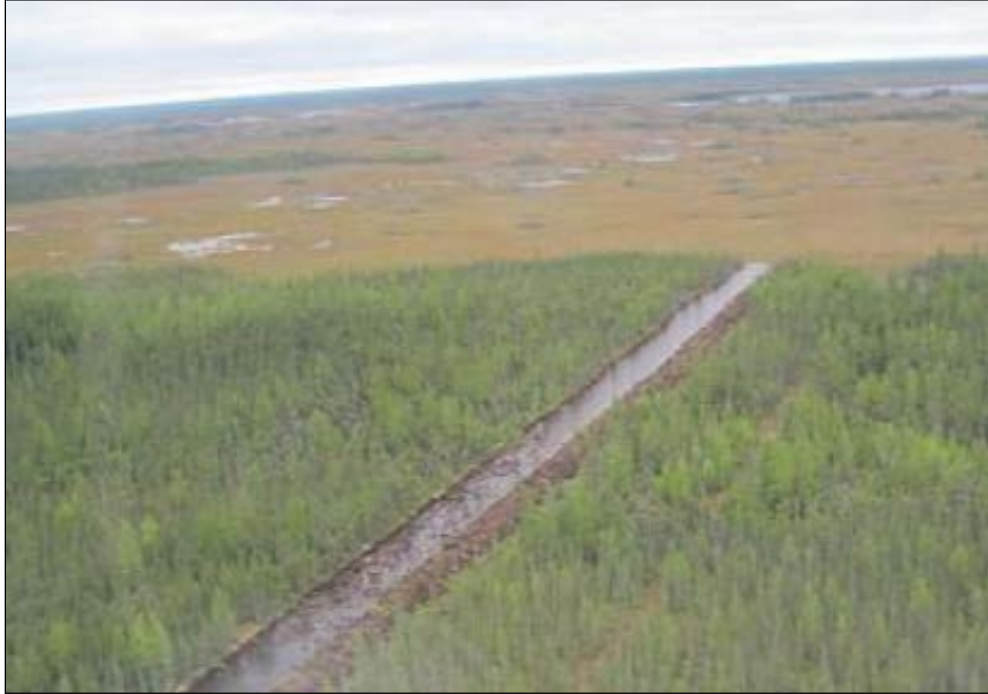
PHOTO 2
DRAINAGE PILOT CHANNEL DURING CONSTRUCTION
OF REACH 1 EMERGENCY CHANNEL

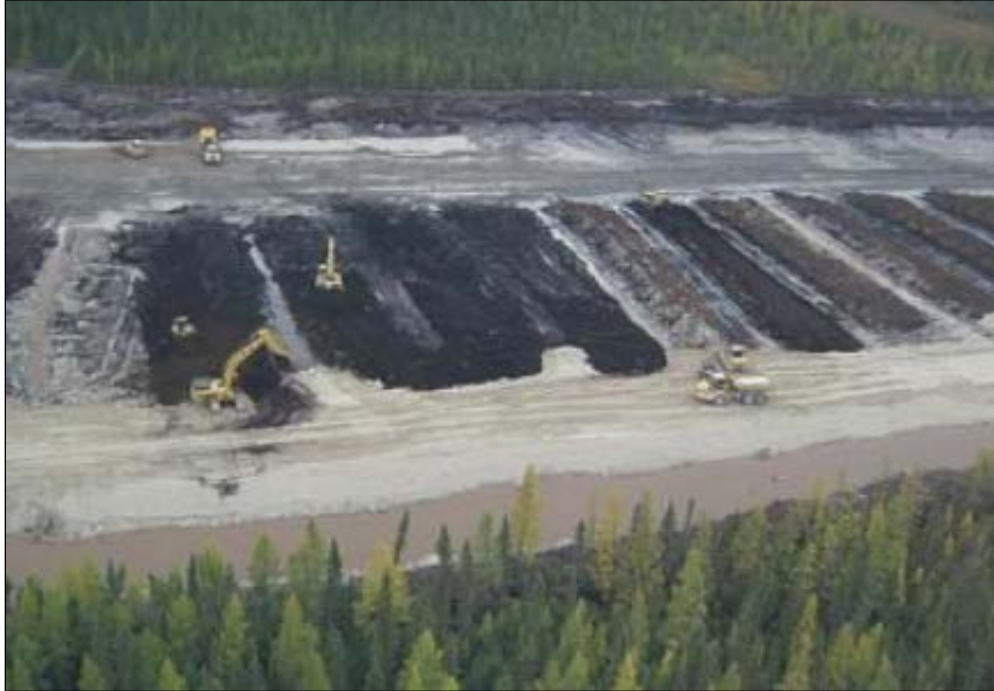
PHOTO 3
EXCAVATION DURING CONSTRUCTION
OF REACH 1 EMERGENCY CHANNEL

Permanent construction will include sufficient time to construct access roads to site at both ends and to allow for construction of pre-drainage ditches parallel to the channel alignment. Nevertheless, it will still likely be necessary to excavate the main channel cell by cell as shown previously on Photo 3.

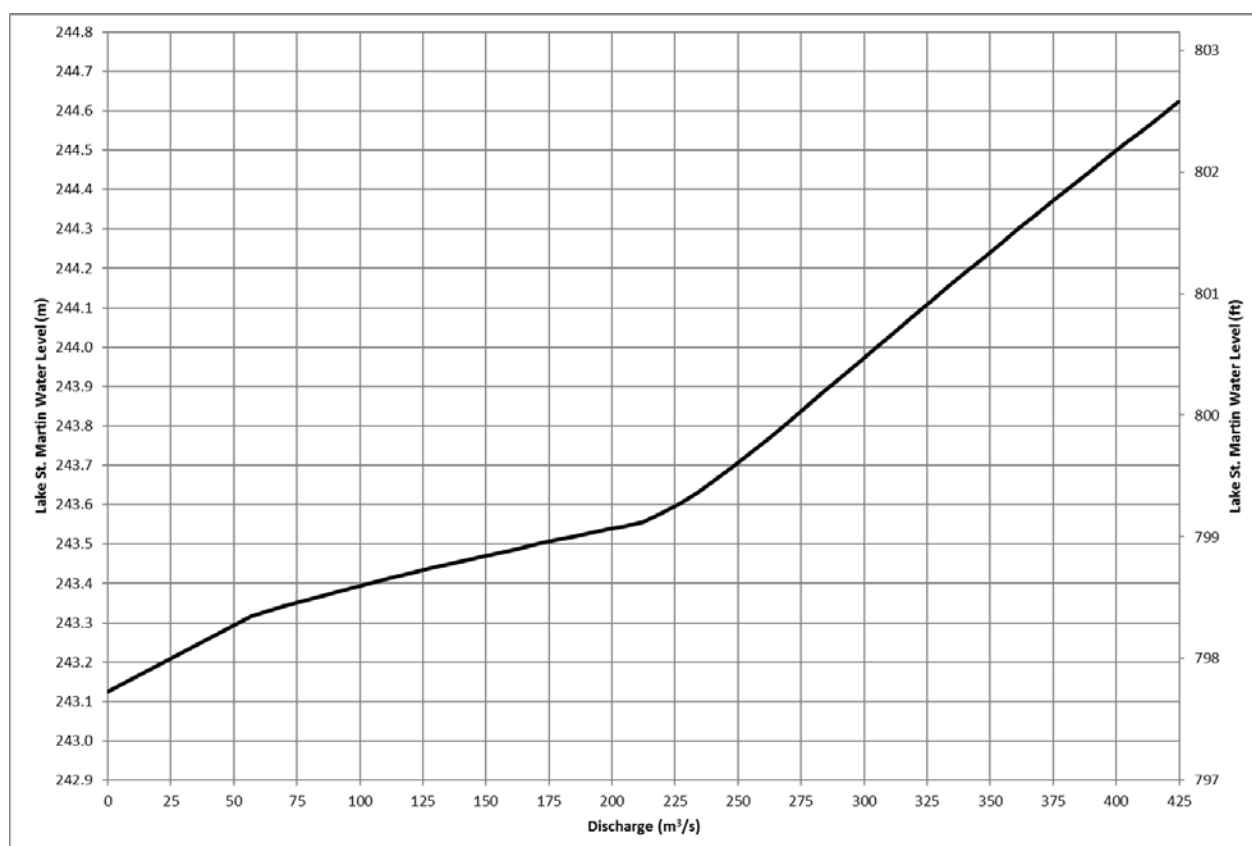
FIGURE 8
LAKE ST. MARTIN OUTLET CHANNEL STAGE DISCHARGE CURVE

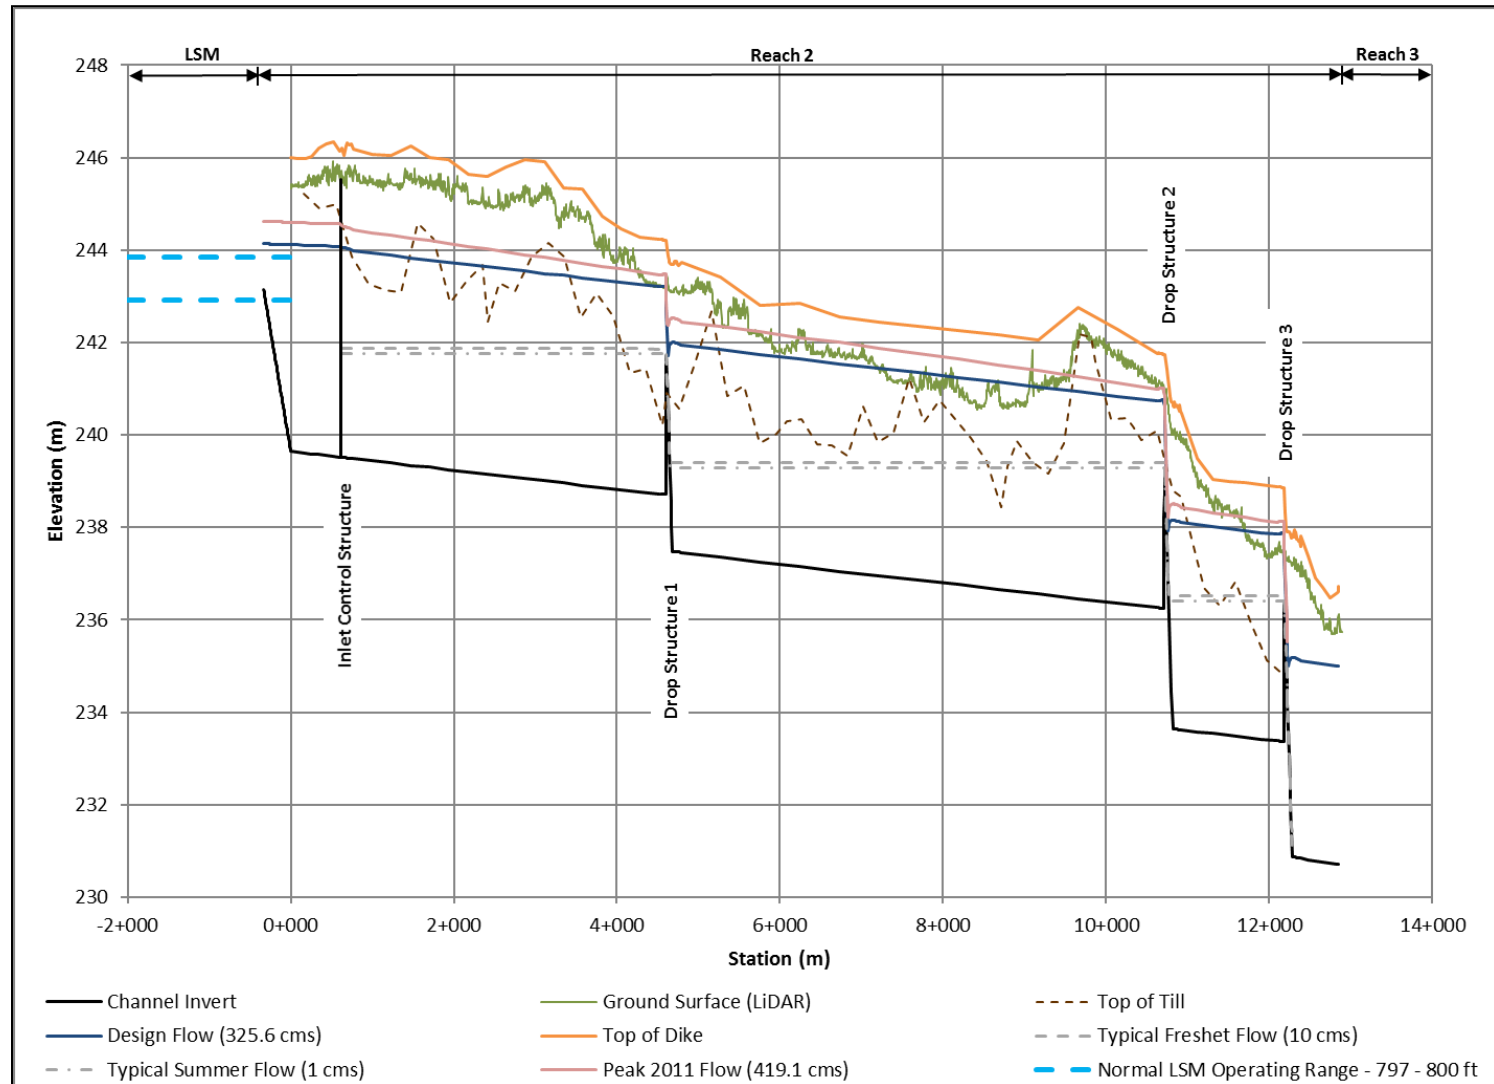
FIGURE 9
PRELIMINARY DESIGN PROFILE OF REACH 2 OF THE LAKE ST. MARTIN OUTLET CHANNEL

The location of the structures within the channel was selected to achieve two objectives. The first was to limit the volume of excavation for the channel by maintaining the water surface profile under the design flow condition as close to prairie level as possible throughout the channel. The second objective was to limit the amount of vegetation that tends to grow in the channel. Limitation of the vegetation growth was intended to be achieved by maintaining a water depth of 1 m or more at all times.

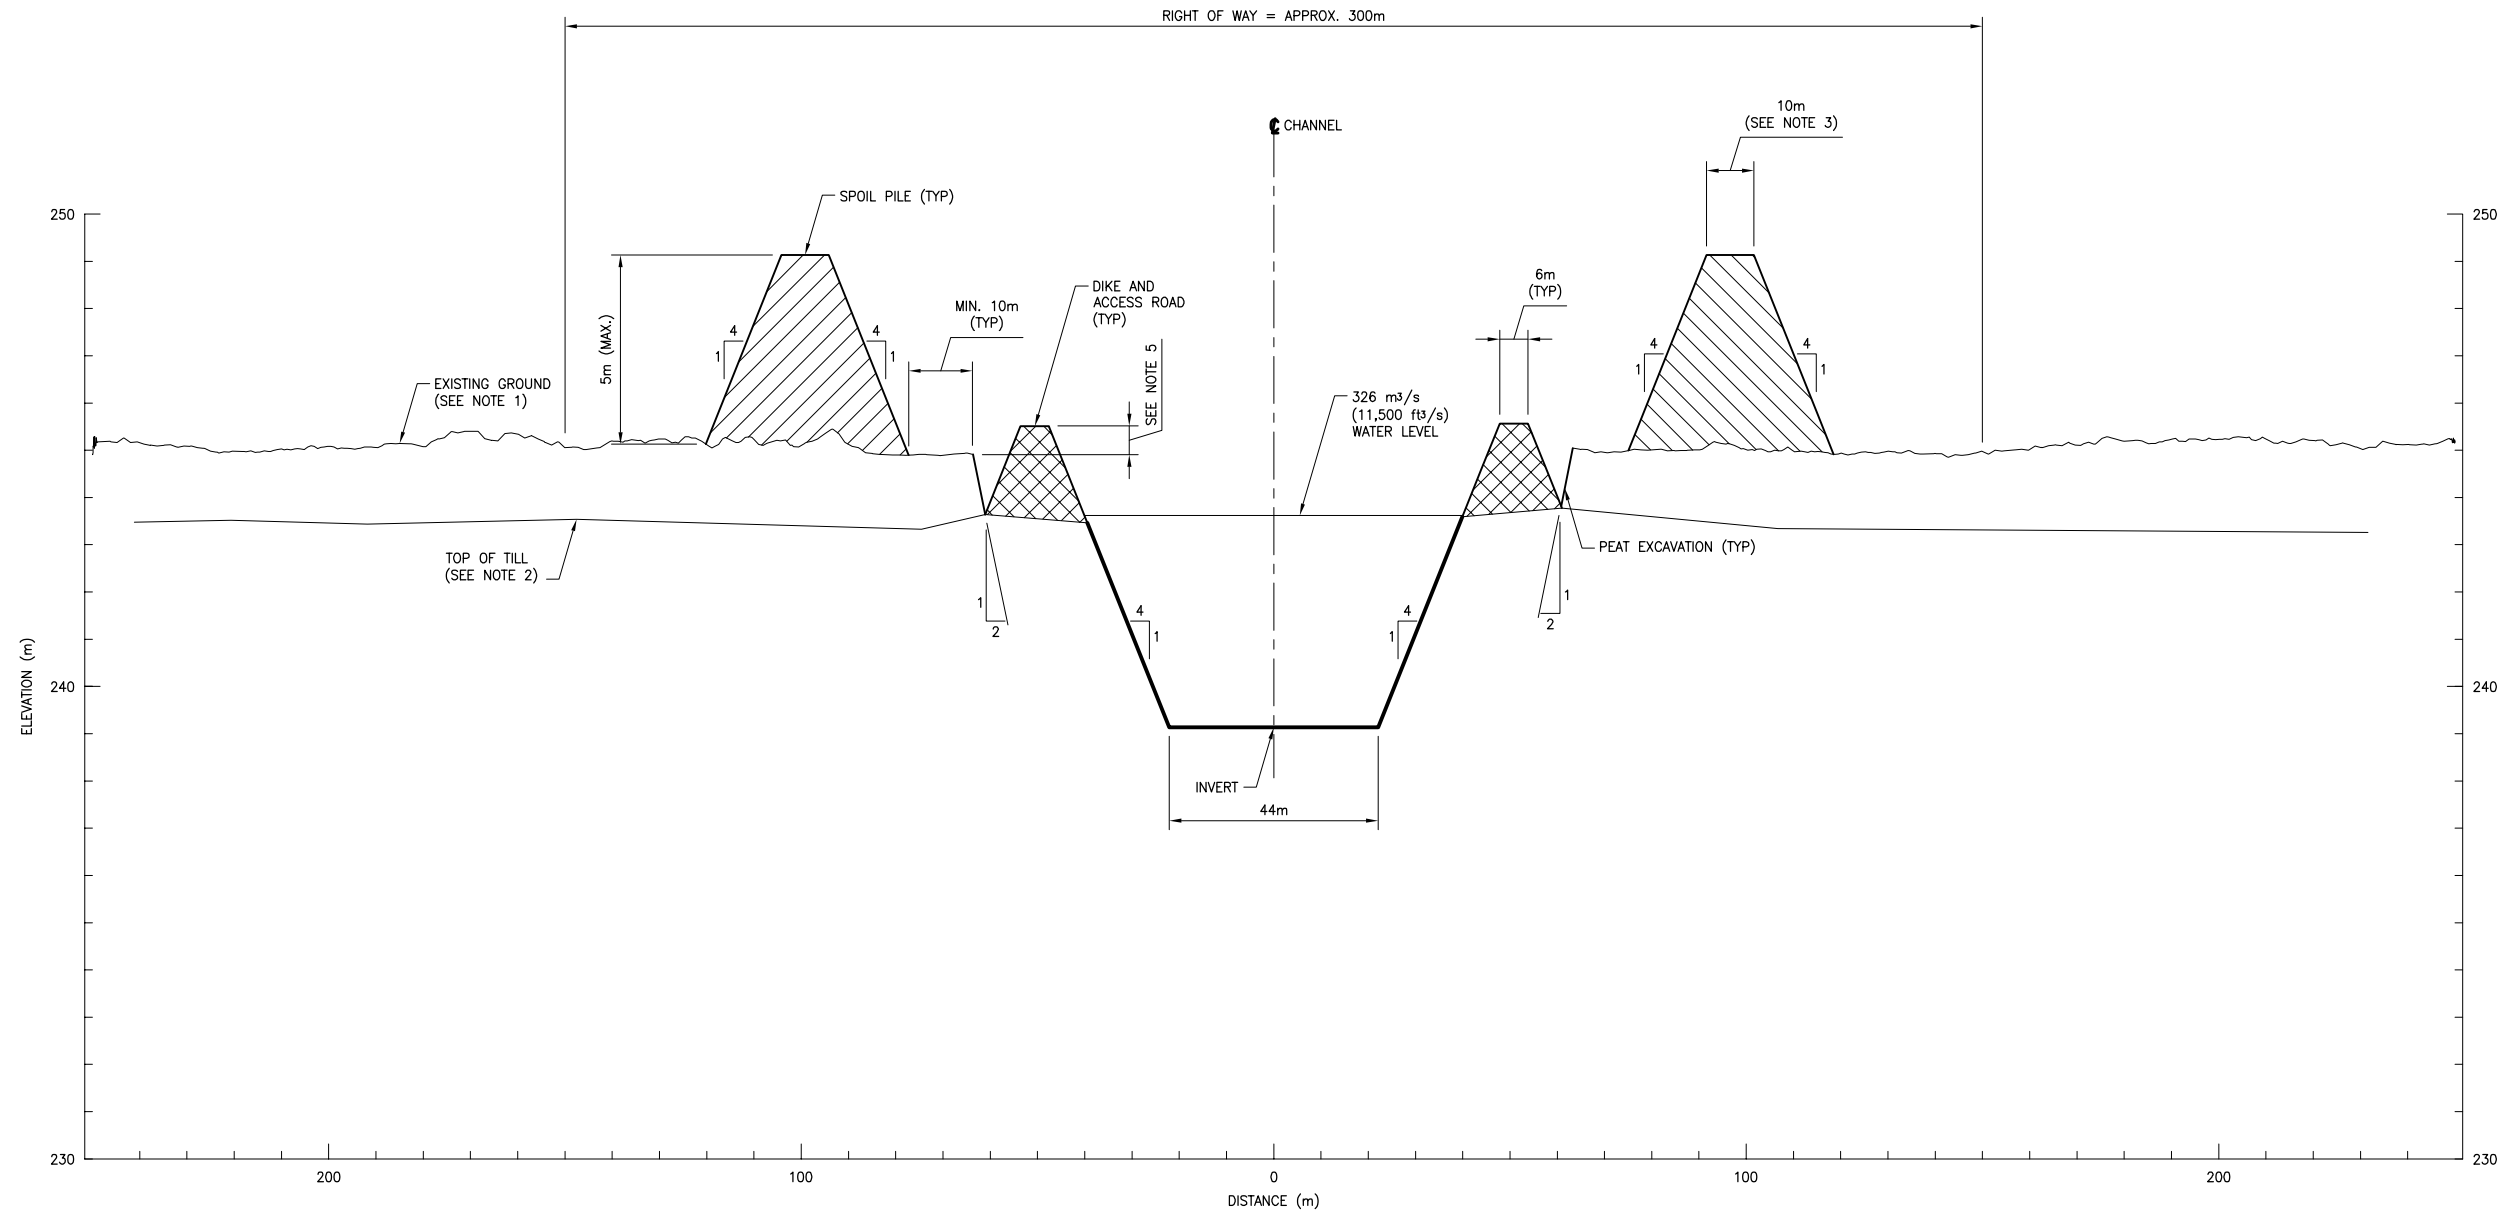
CROSS SECTION (STA 2+500)
1:800 HOR SCALE
1:80 VER SCALE

- NOTES:**
- EXISTING GROUND SURFACE BASED ON LIDAR (2011).
 - TOP OF FILL APPROXIMATE AND BASED ON 2016 PEAT PROBE SURVEY PROJECTED TO CHANNEL CENTERLINE.
 - SPOIL PILE SHOWN DOES NOT INCLUDE ADJUSTMENTS FOR MATERIAL HANDLING AND ASSUMES CONSTANT WIDTH AND HEIGHT ALONG ENTIRE CHANNEL LENGTH.
 - ALL UNITS ARE METRIC AND IN METRES UNLESS OTHERWISE SPECIFIED. TRANSVERSE MERCATOR PROJECTION, AND 1983 CSRS, ZONE 14. ELEVATIONS ARE IN METRES ABOVE SEA LEVEL (MSL) AND ARE REFERENCING CANADIAN GEODETIC VERTICAL DATUM 1928 (CGVD28).
 - TOP OF DIKE BUILT TO MINIMUM 0.6 m ABOVE TOP OF PEAT OR MINIMUM 1.0 m ABOVE DESIGN WATER LEVEL, WHICHEVER IS GREATER.

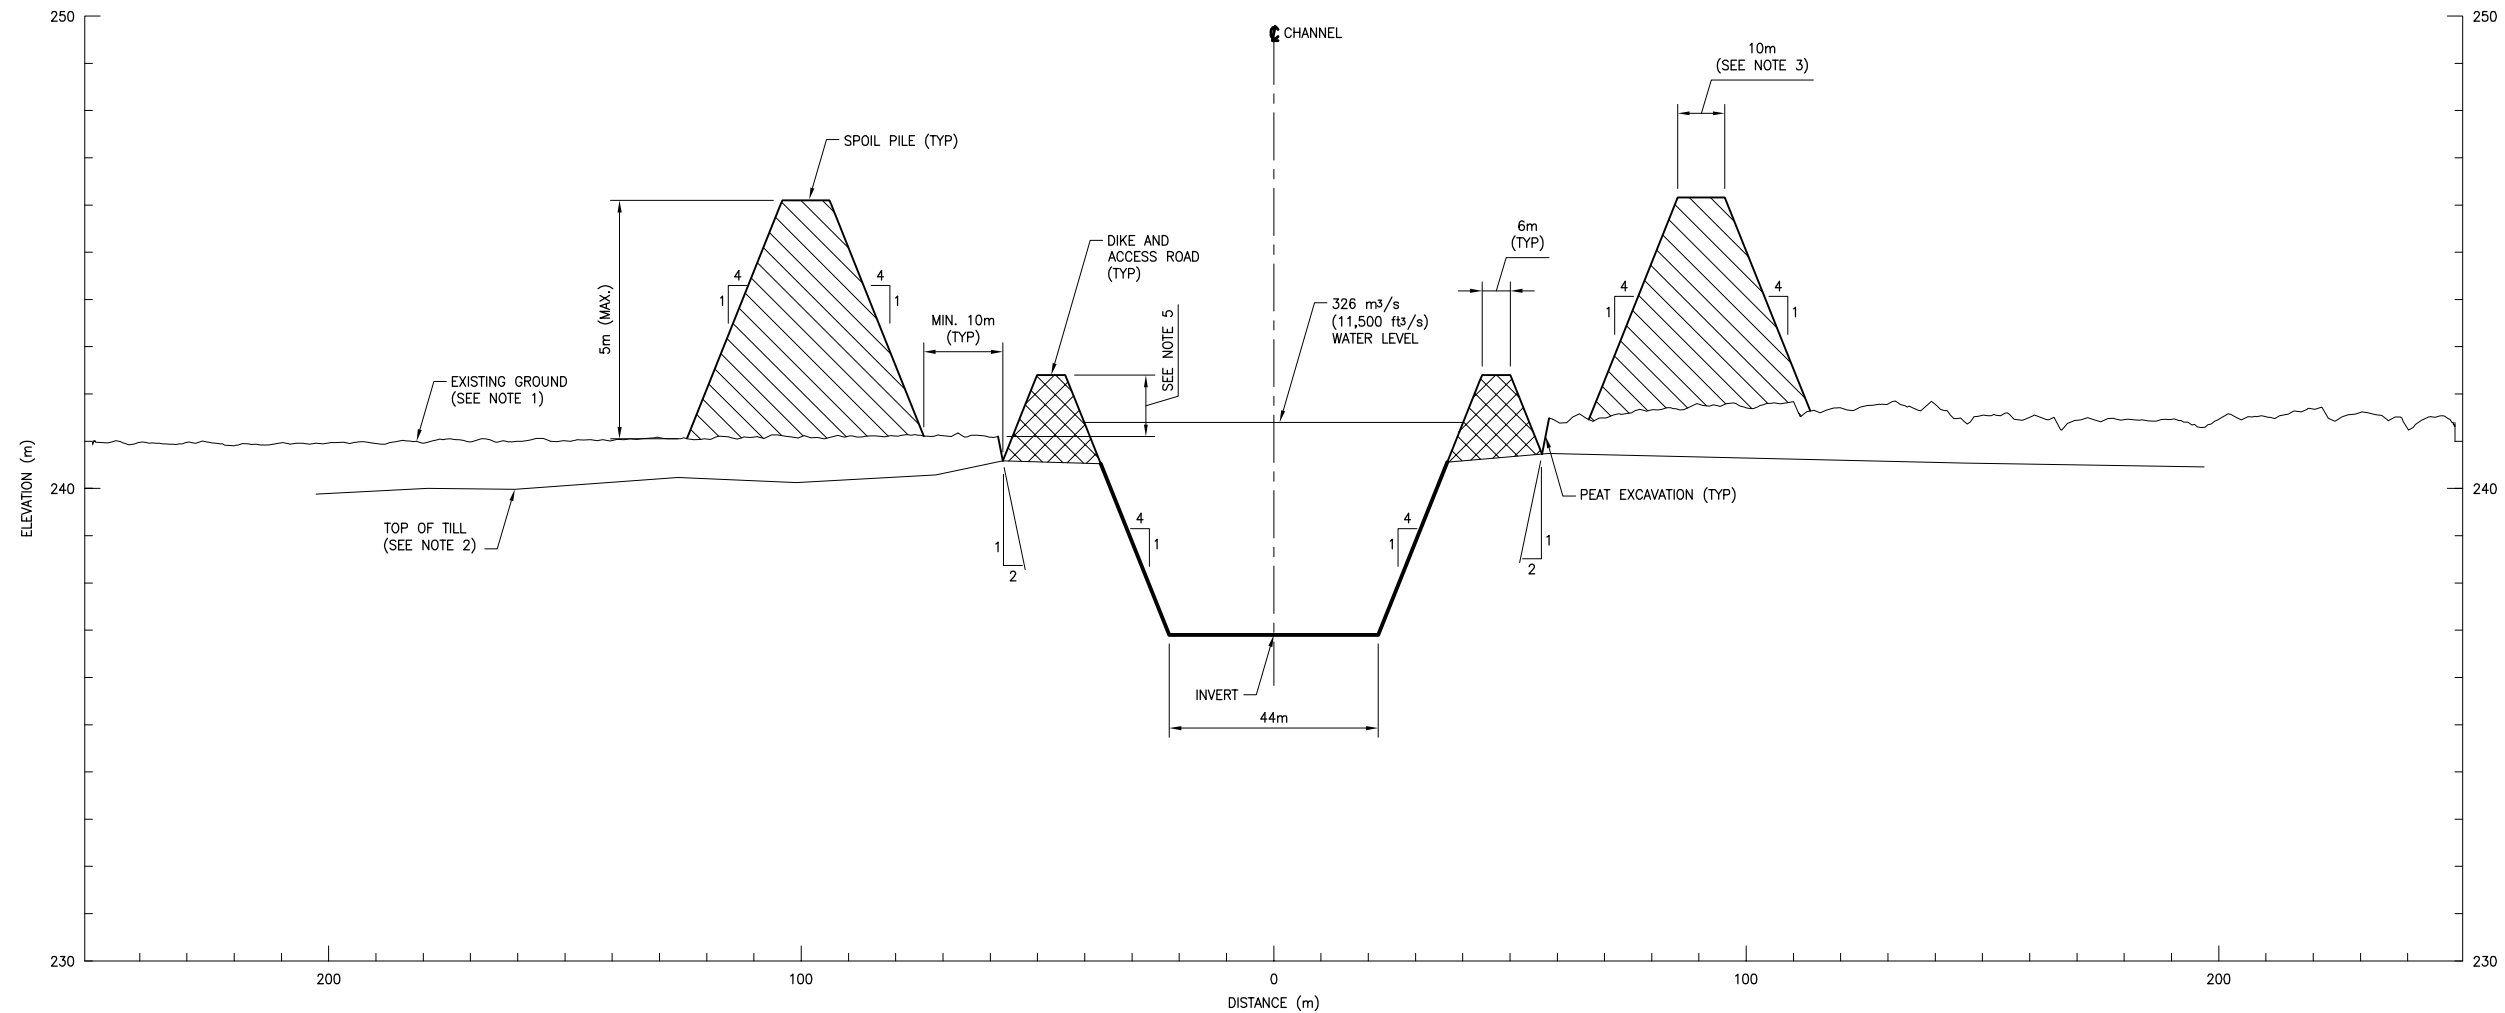
SECTION (STA 7+500)
1:800 HOR SCALE
1:80 VER SCALE

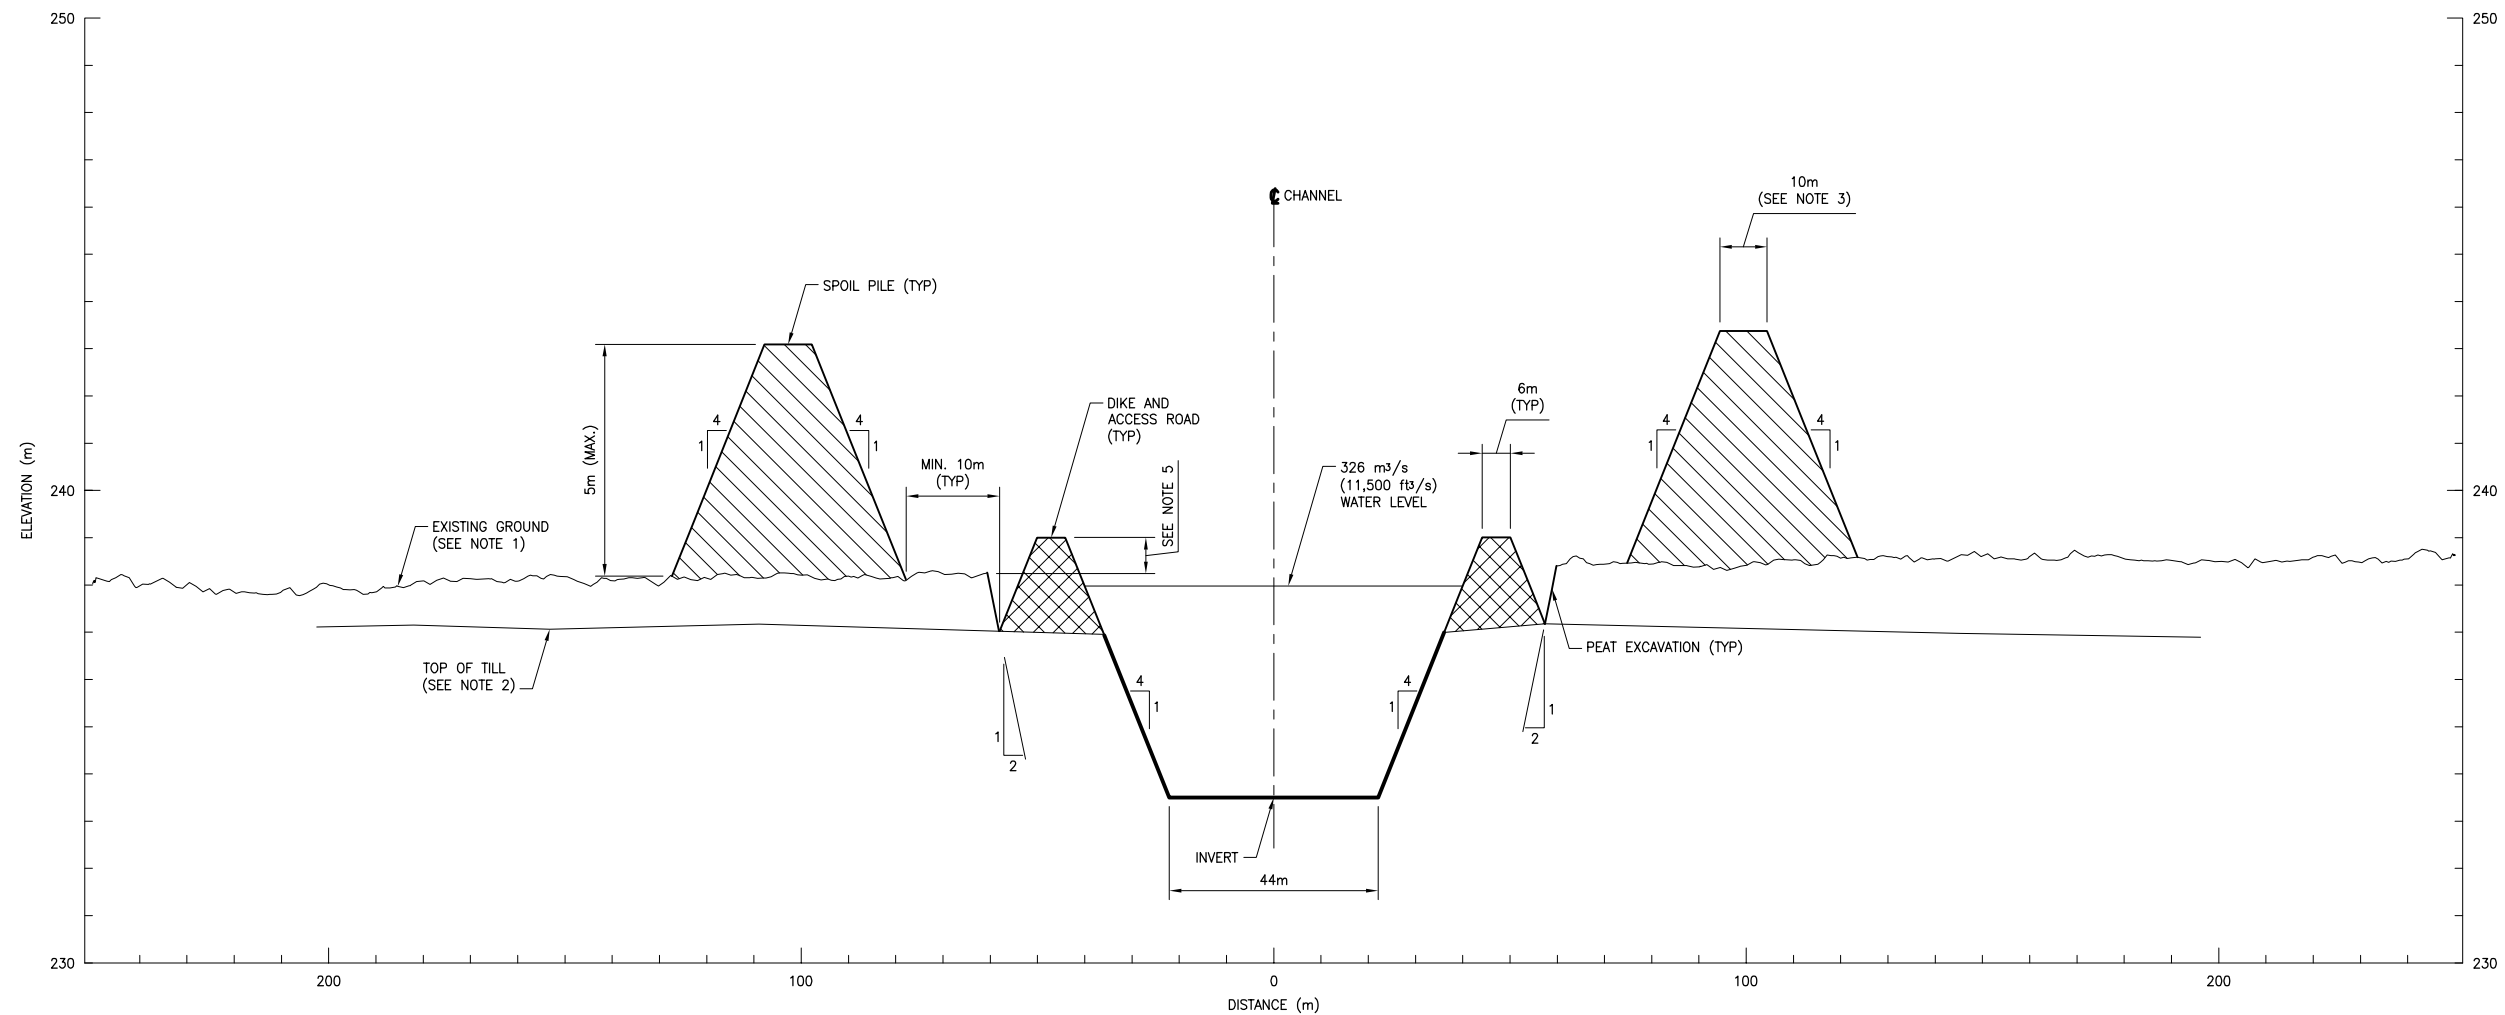
SECTION (STA 11+500)
1:800 HOR SCALE
1:80 VER SCALE

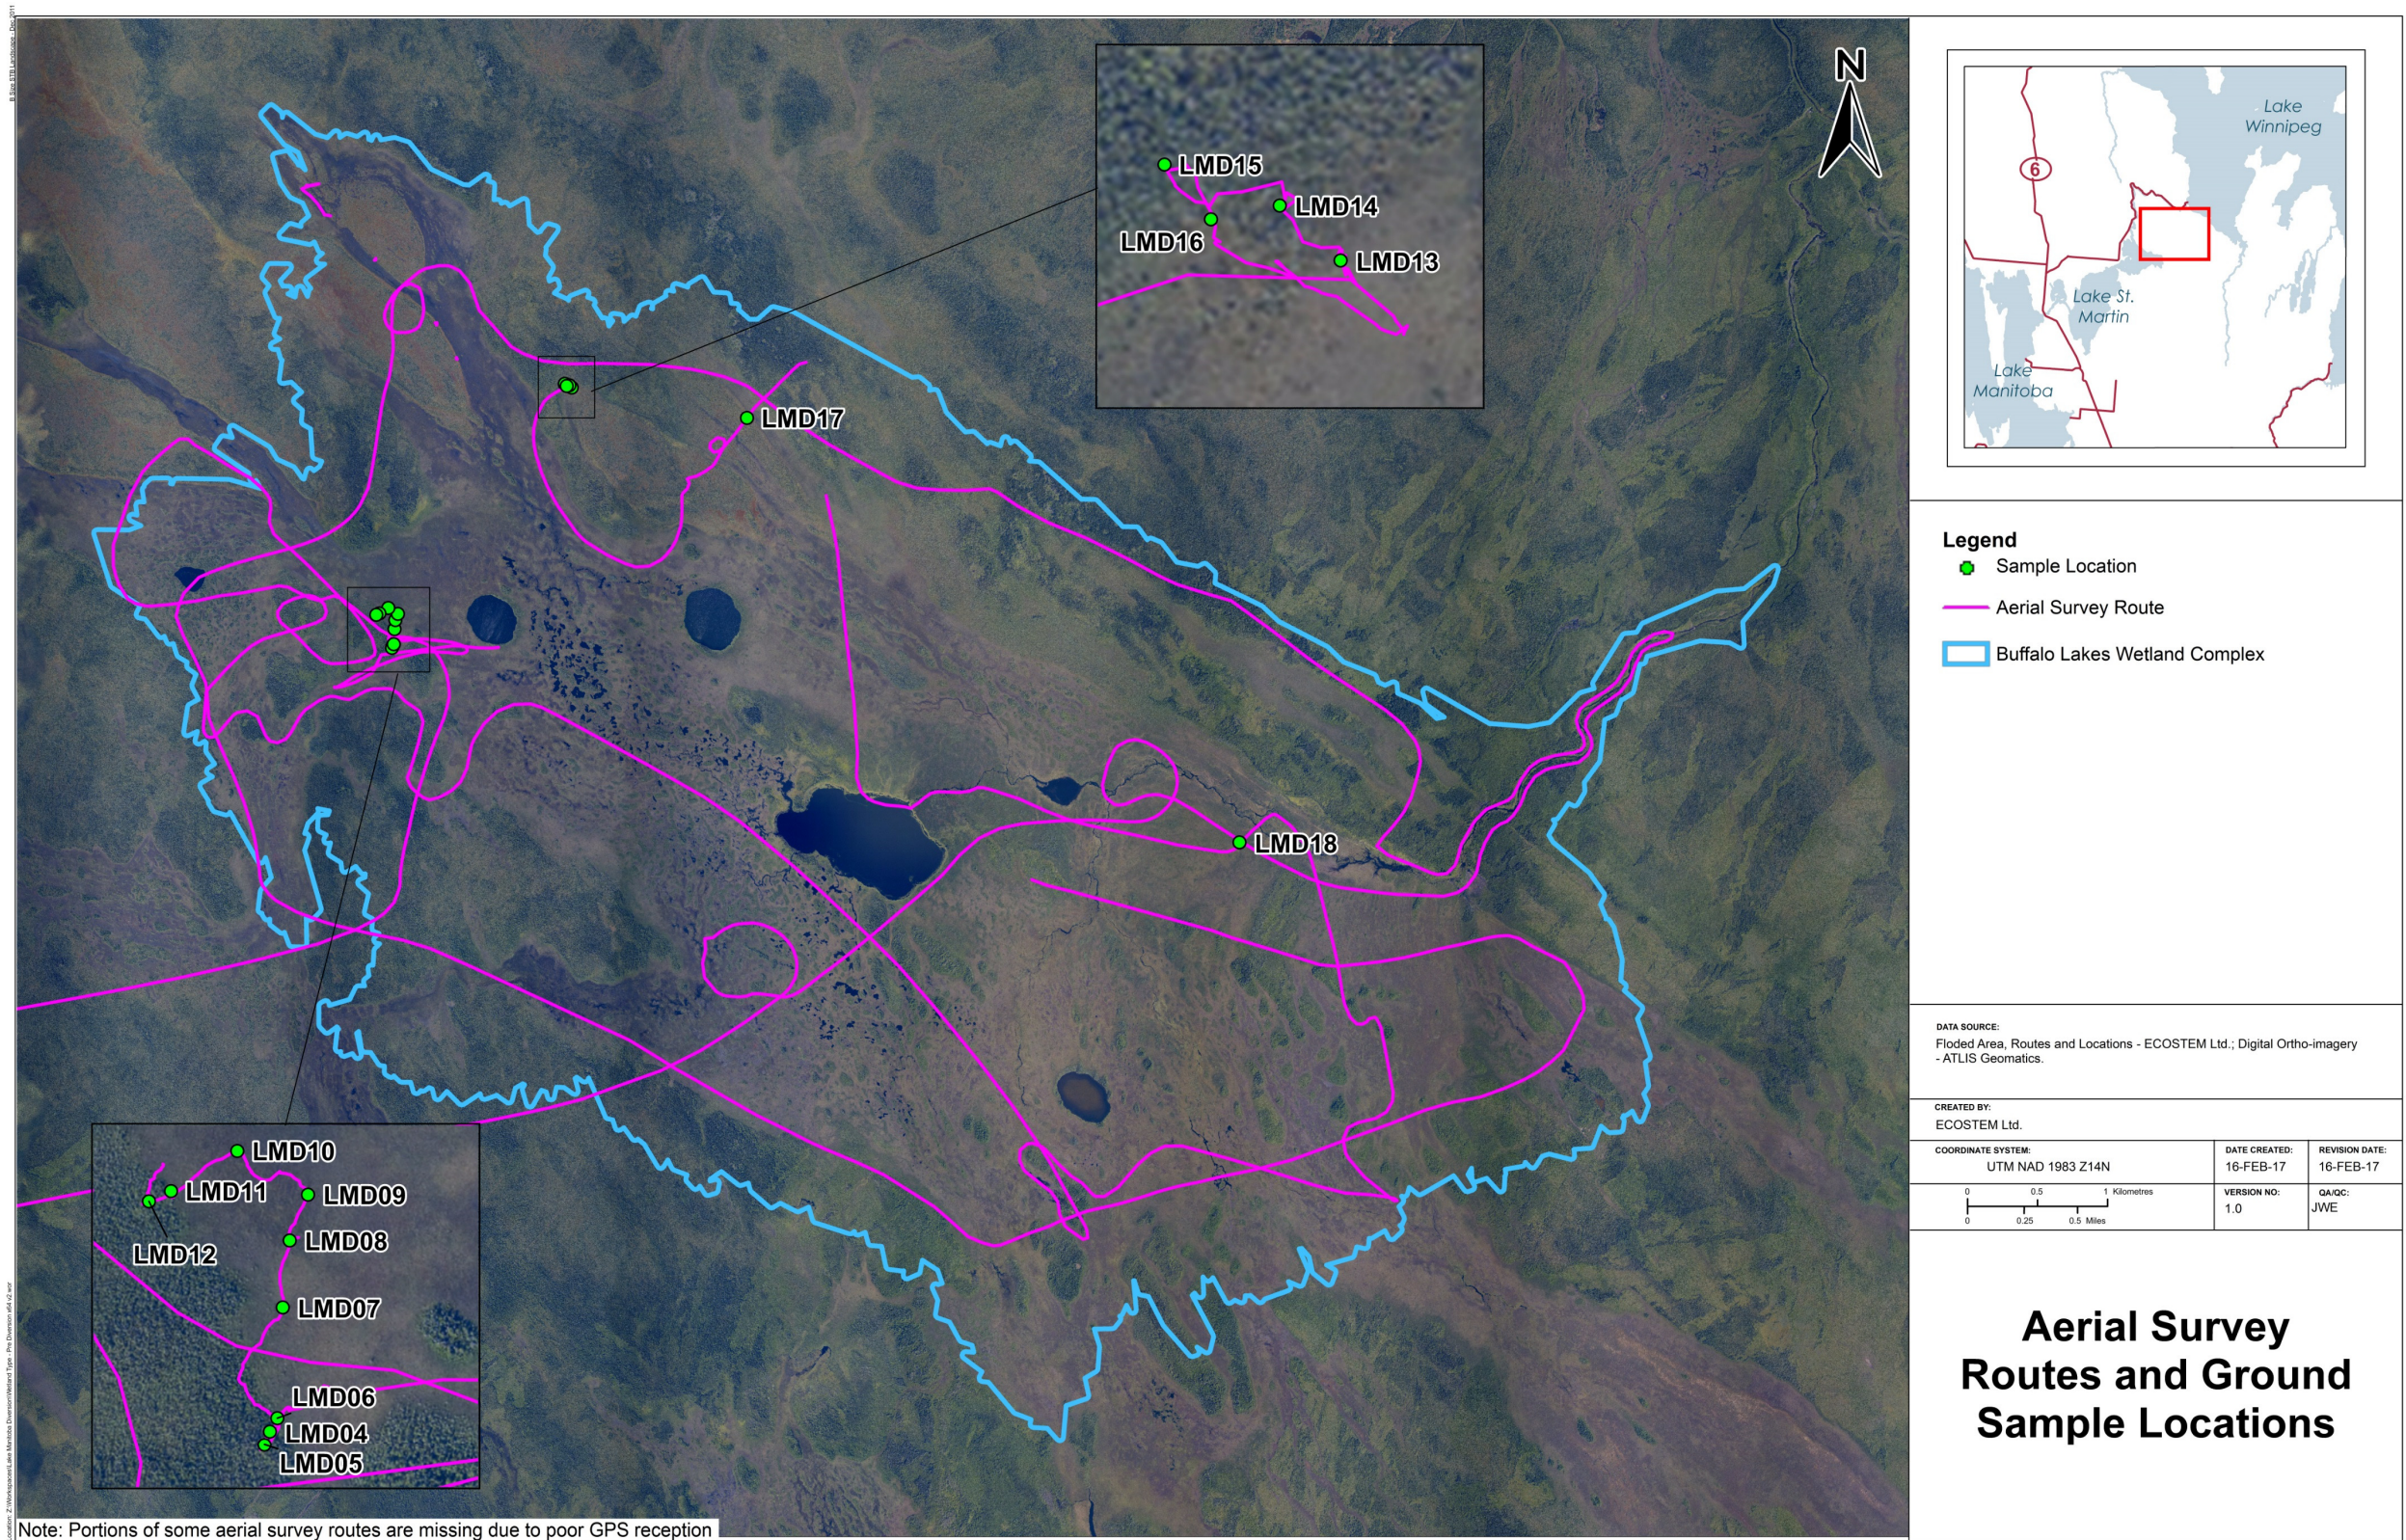
Map 1: Aerial survey routes and soil stratigraphy sample locations

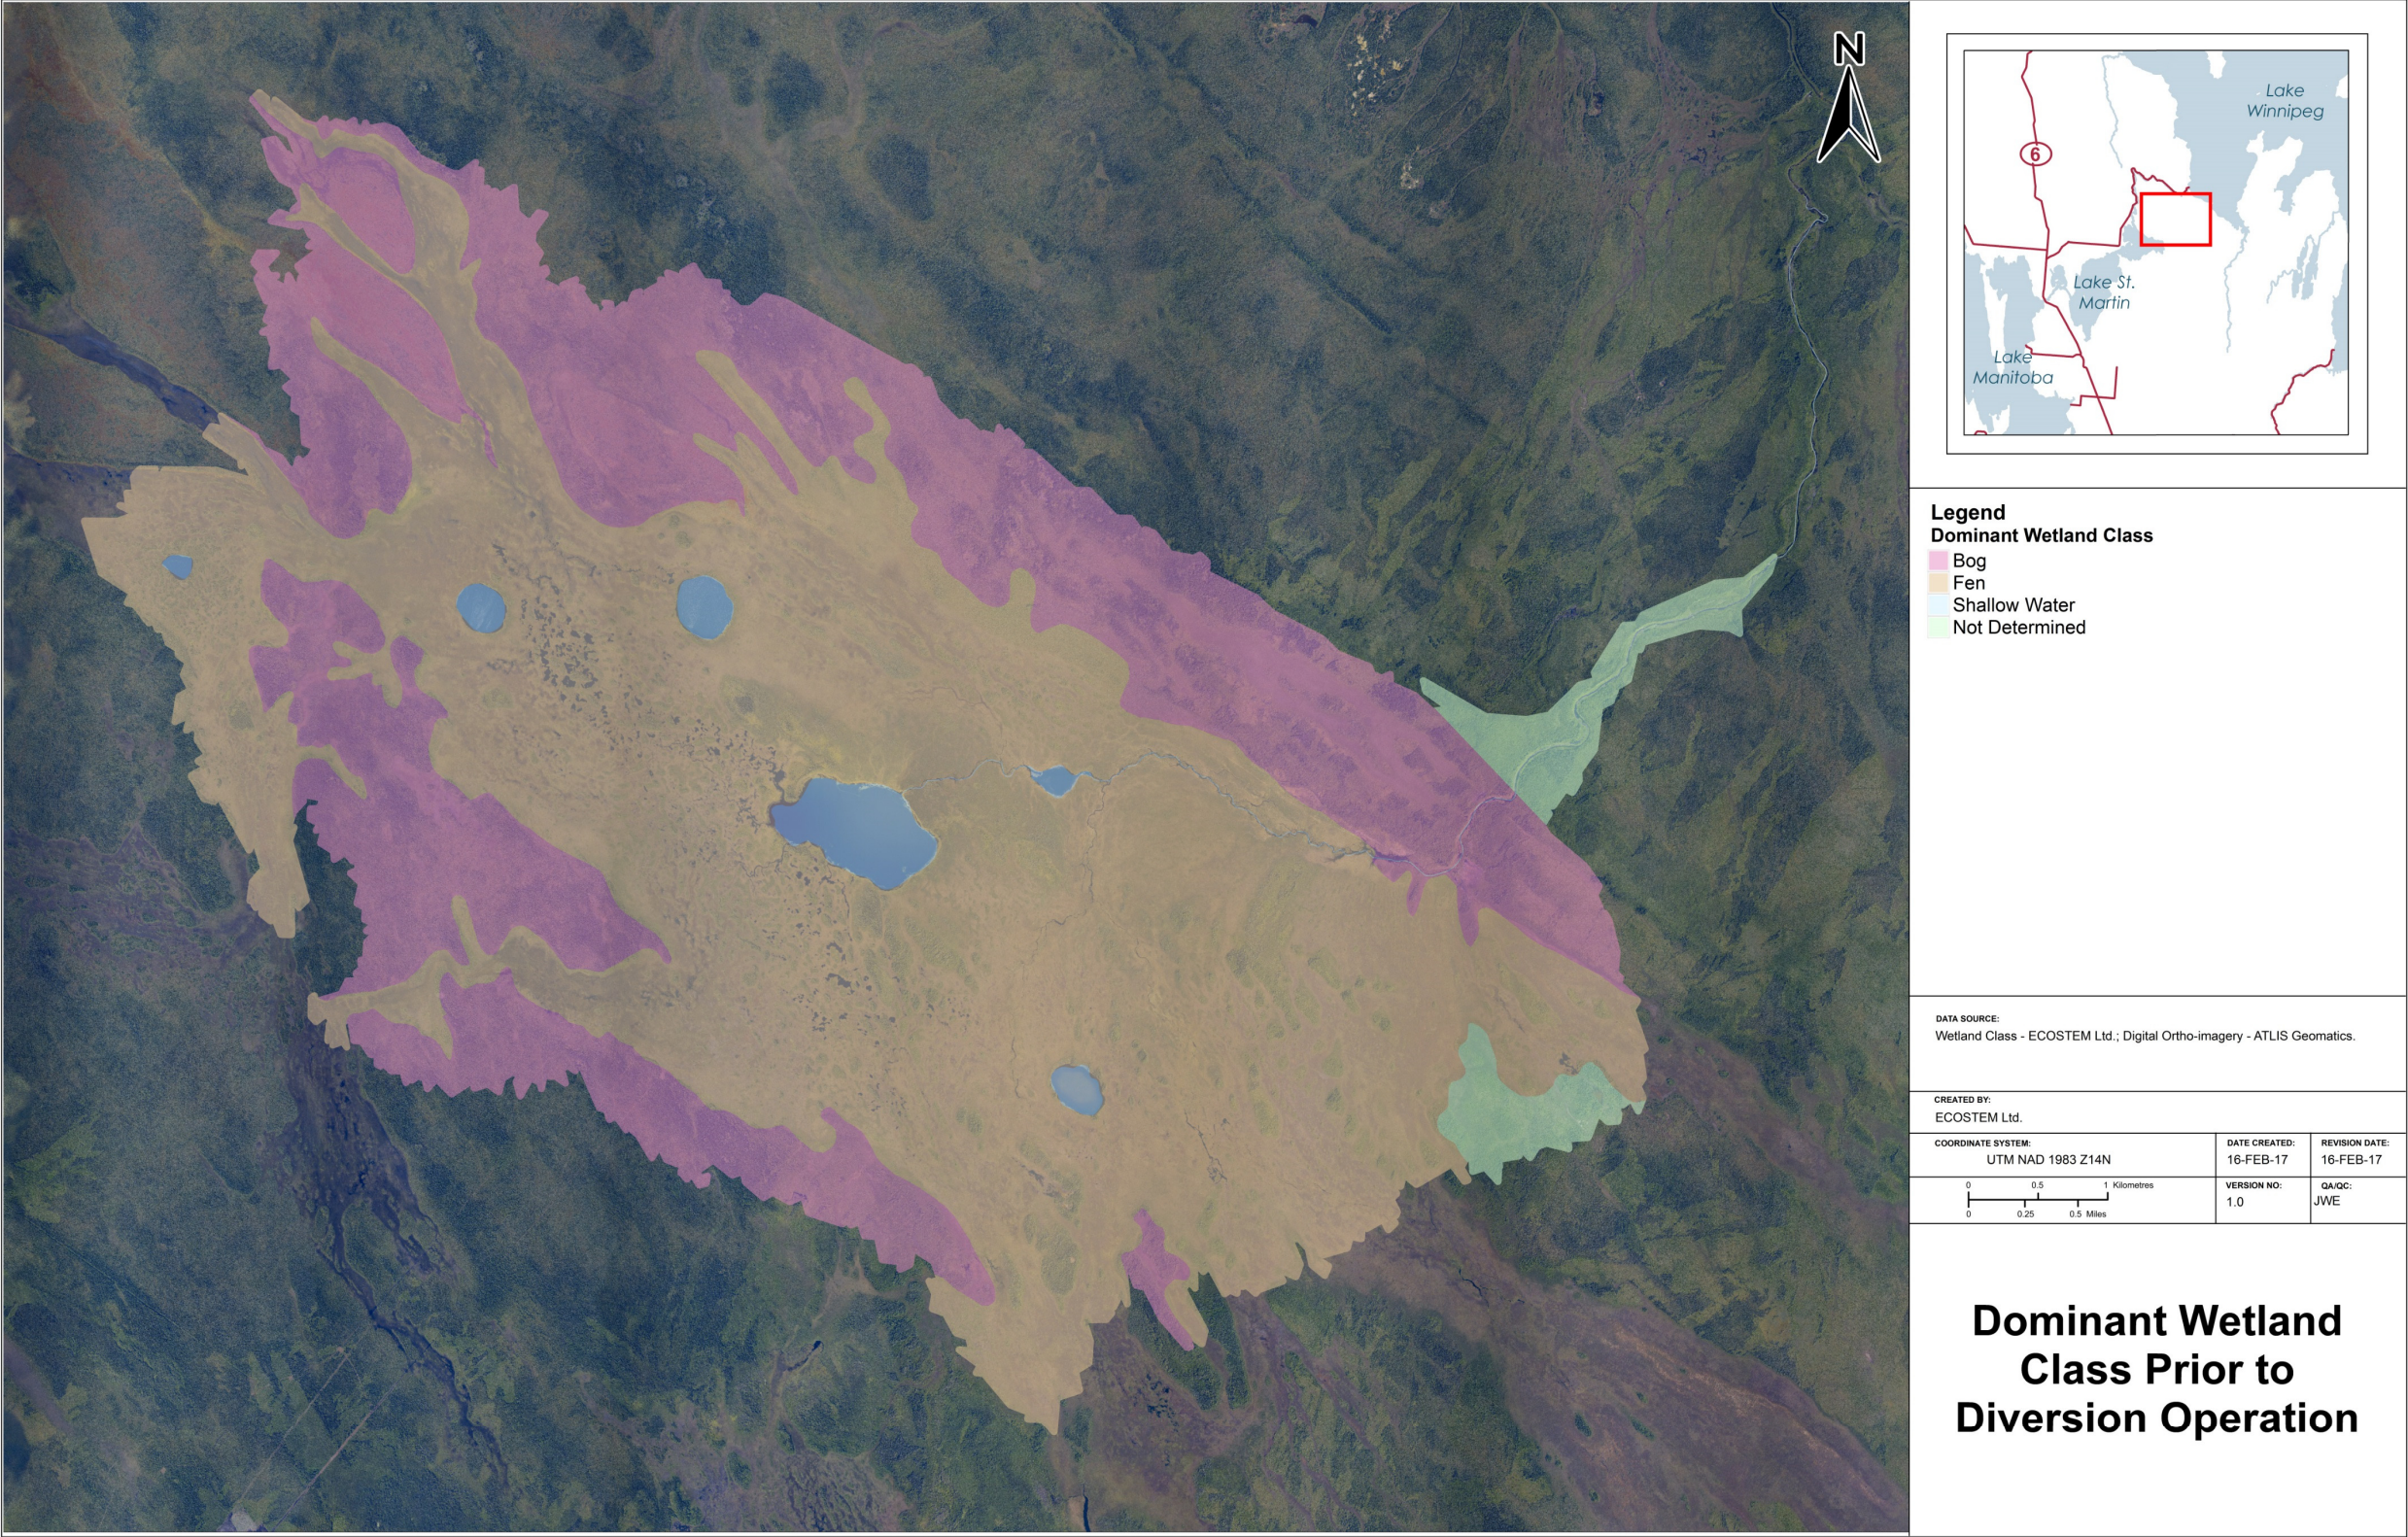
Map 2: Generalized wetland class in the Buffalo Lakes wetland complex prior to LSMEOC construction and operation.

String fen was also observed, but largely outside of the wetland complex. String fens typically indicate high unconfined groundwater flows. The observed fens, combined with the surface elevation provided by the DEM, suggest that unconfined groundwater flows have created and maintained the Buffalo Lakes wetland complex prior to LSMEOC operation.
