PRELIMINARY DESIGN FOR REACH 2 OF THE LAKE ST. MARTIN OUTLET CHANNEL

16-0300-005

Final - Rev 0

June 2017

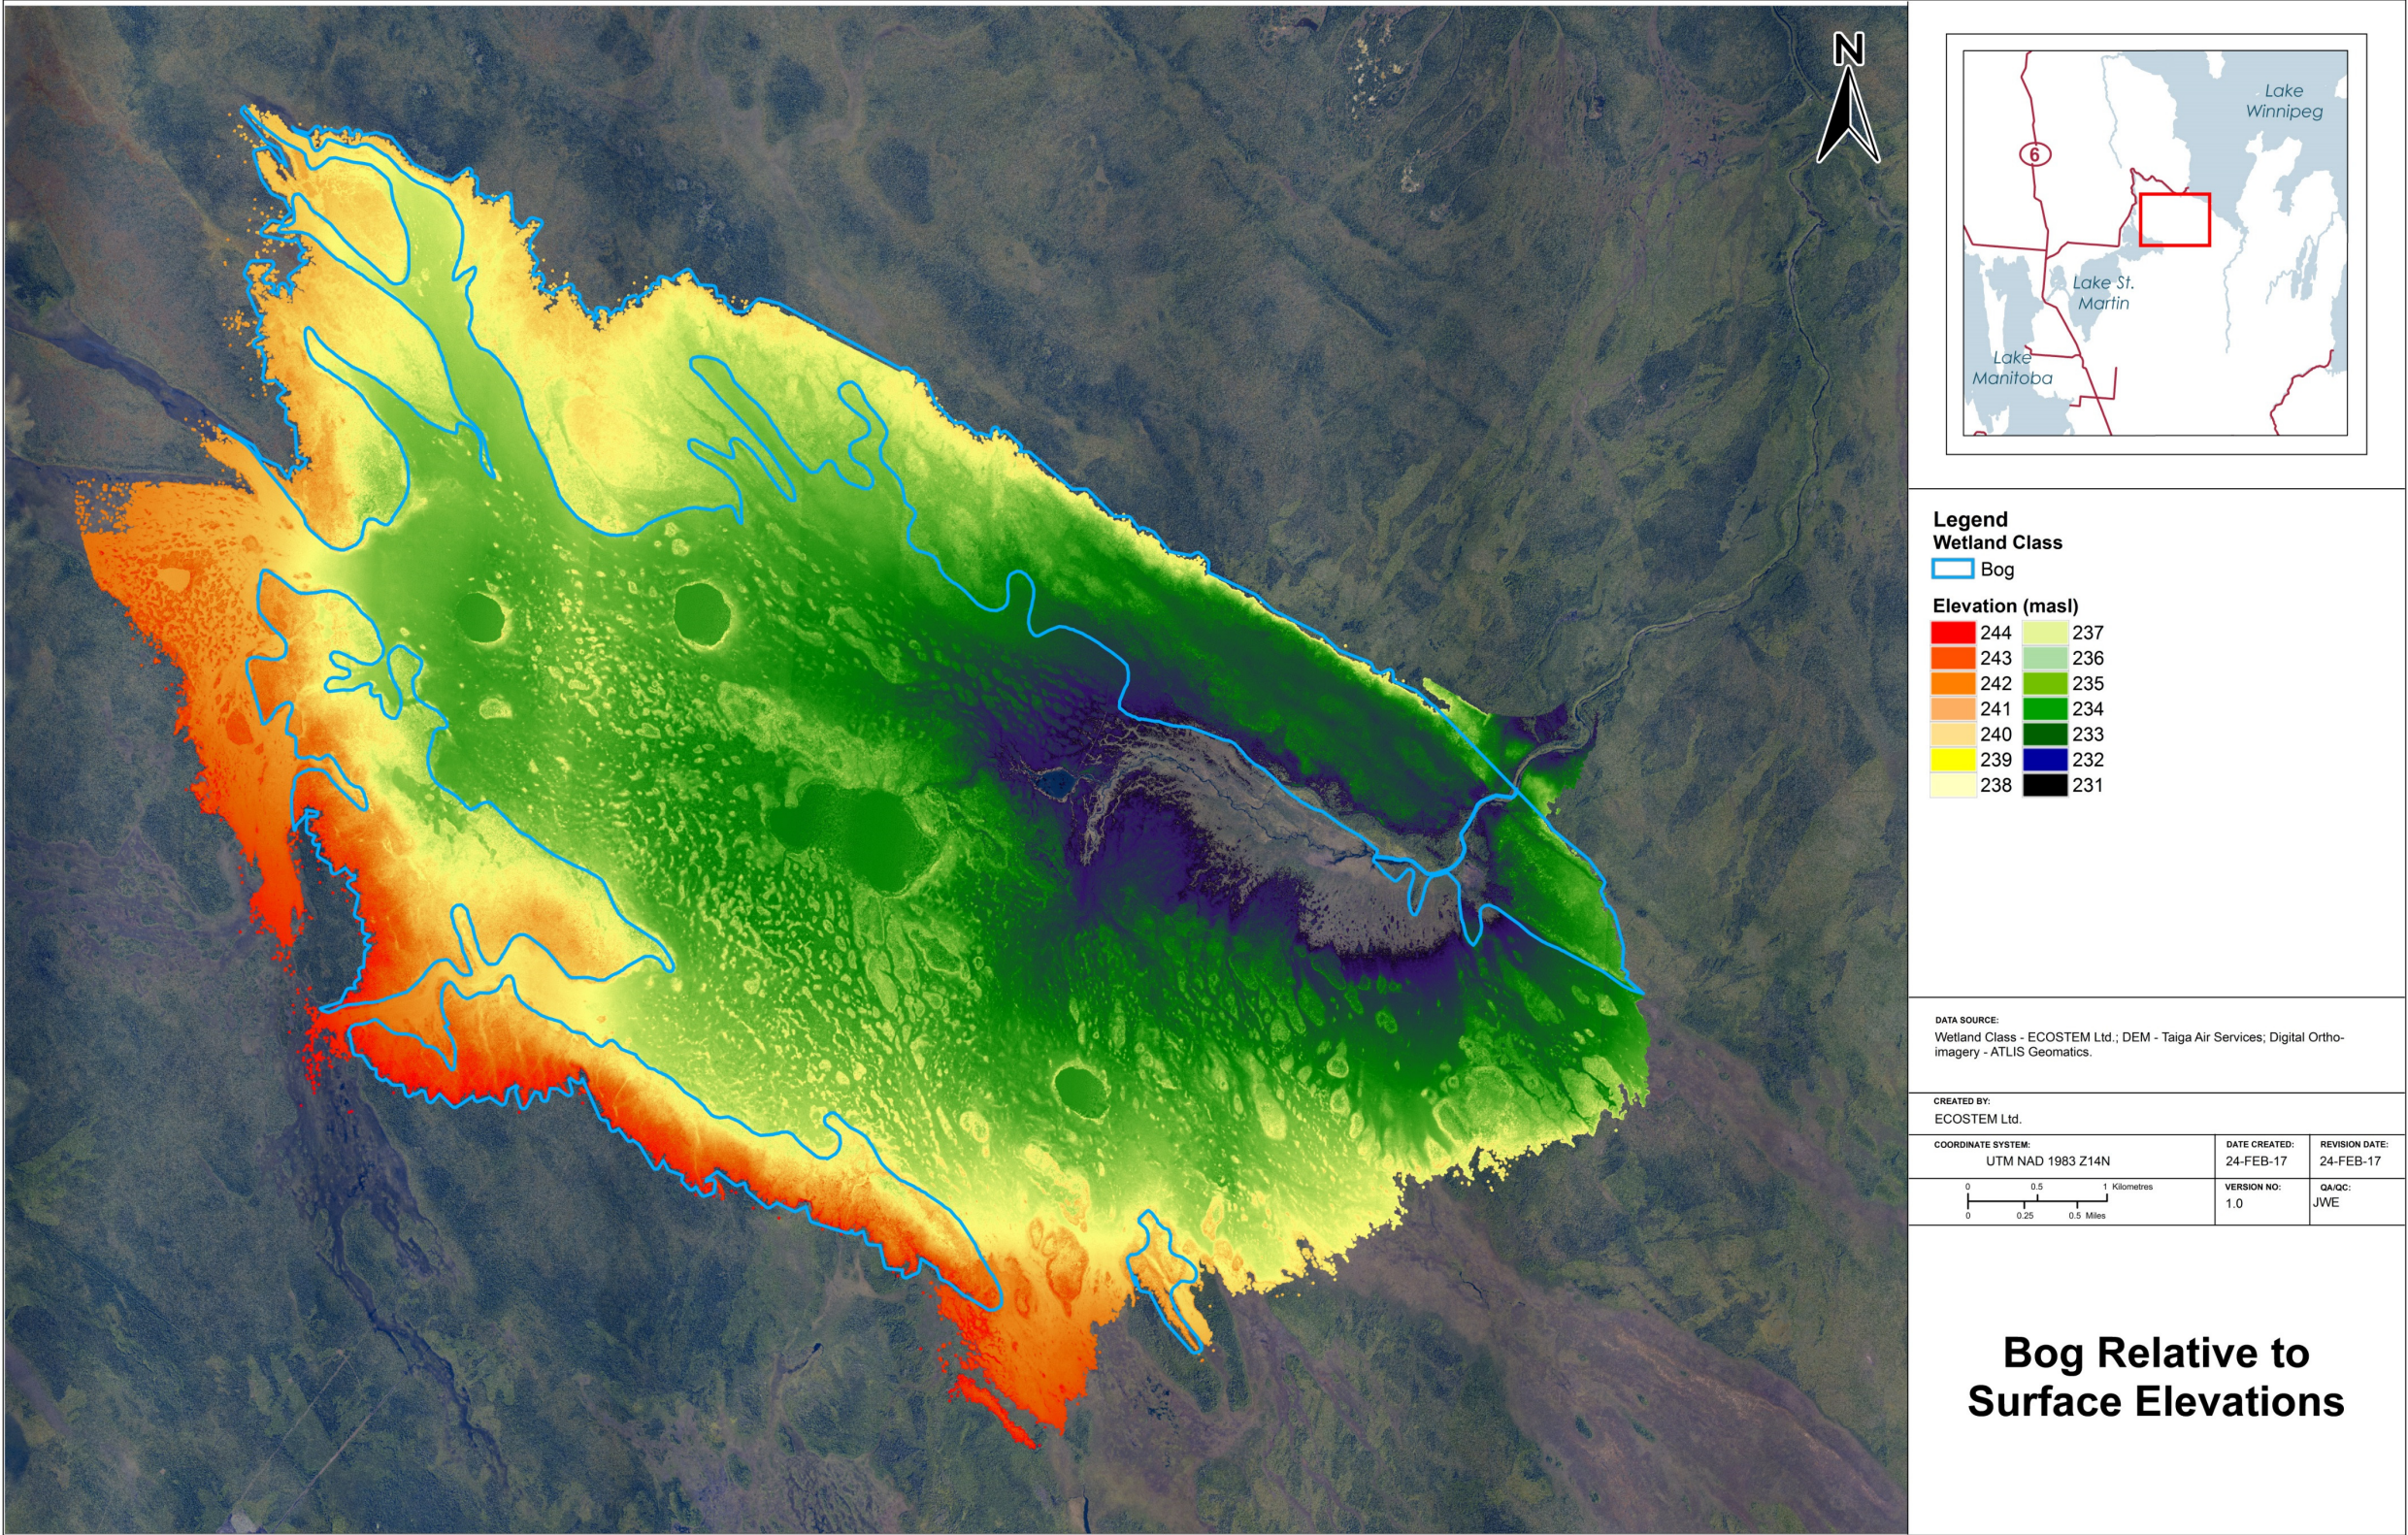
Map 3: Location of pre-LSMEOC bogs relative to surface elevations.

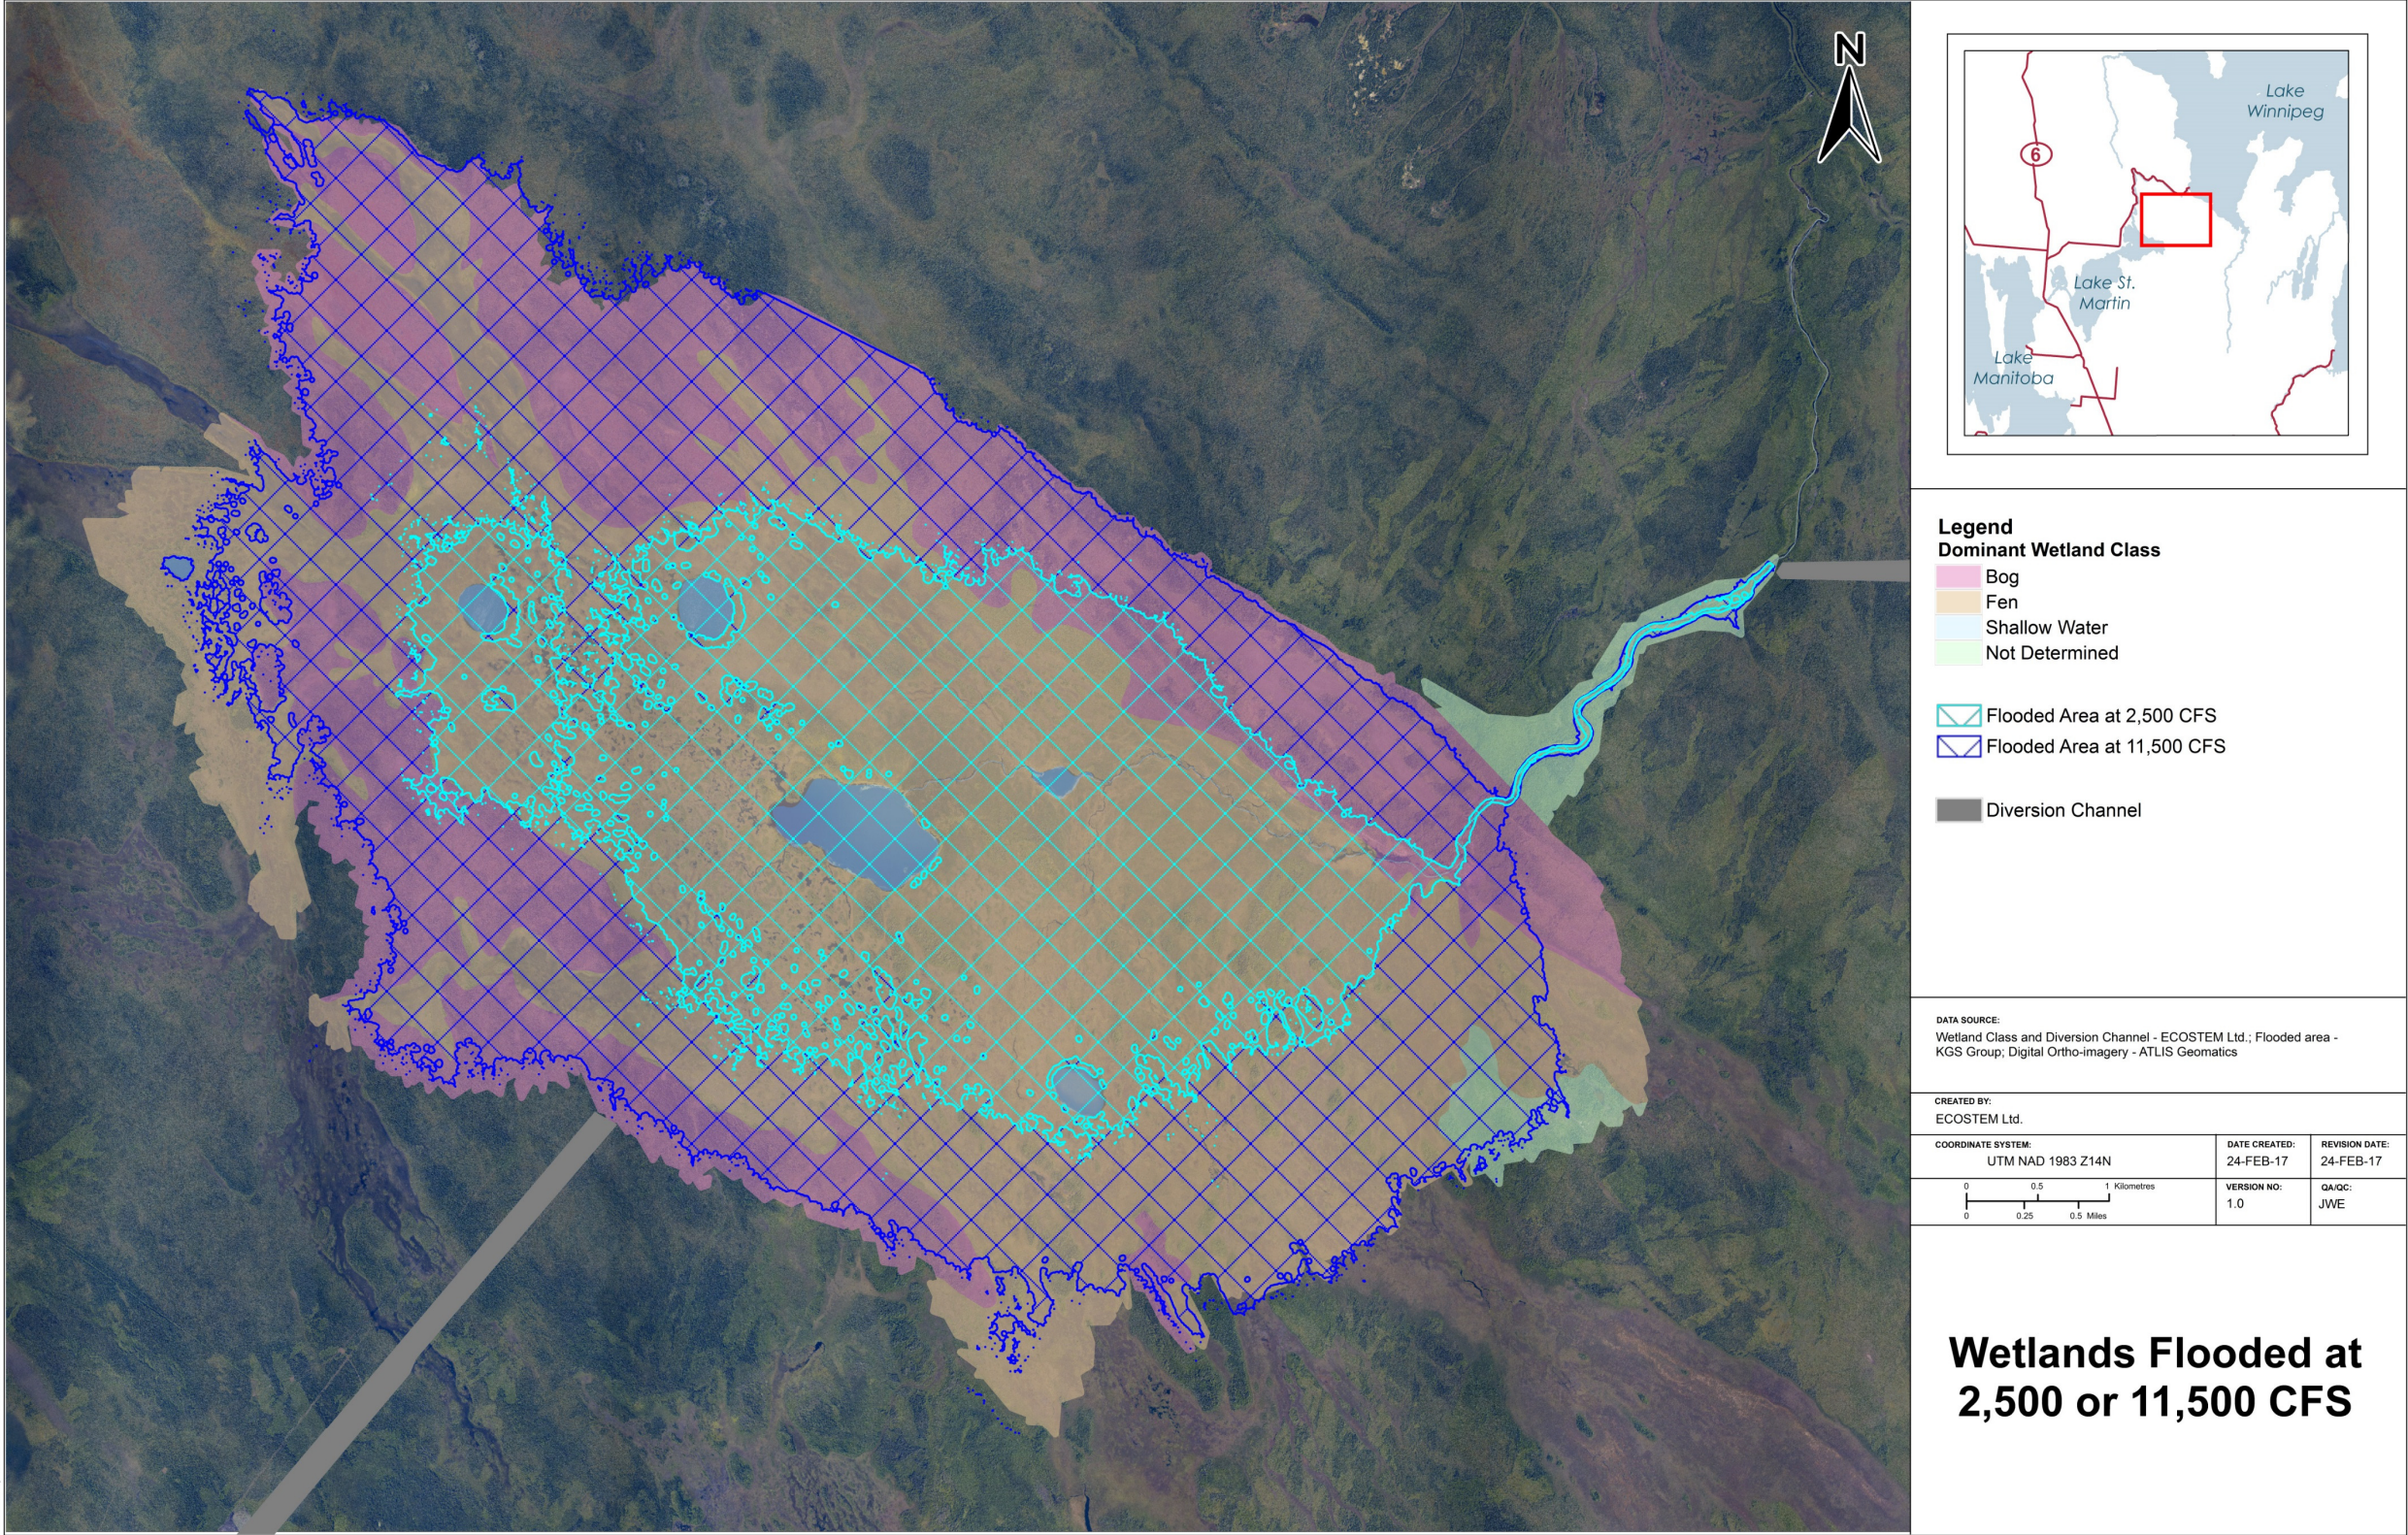
Map 4: Wetlands flooded when modeled outlet channel flows are 2,500 or 11,500 cfs in Option 1.

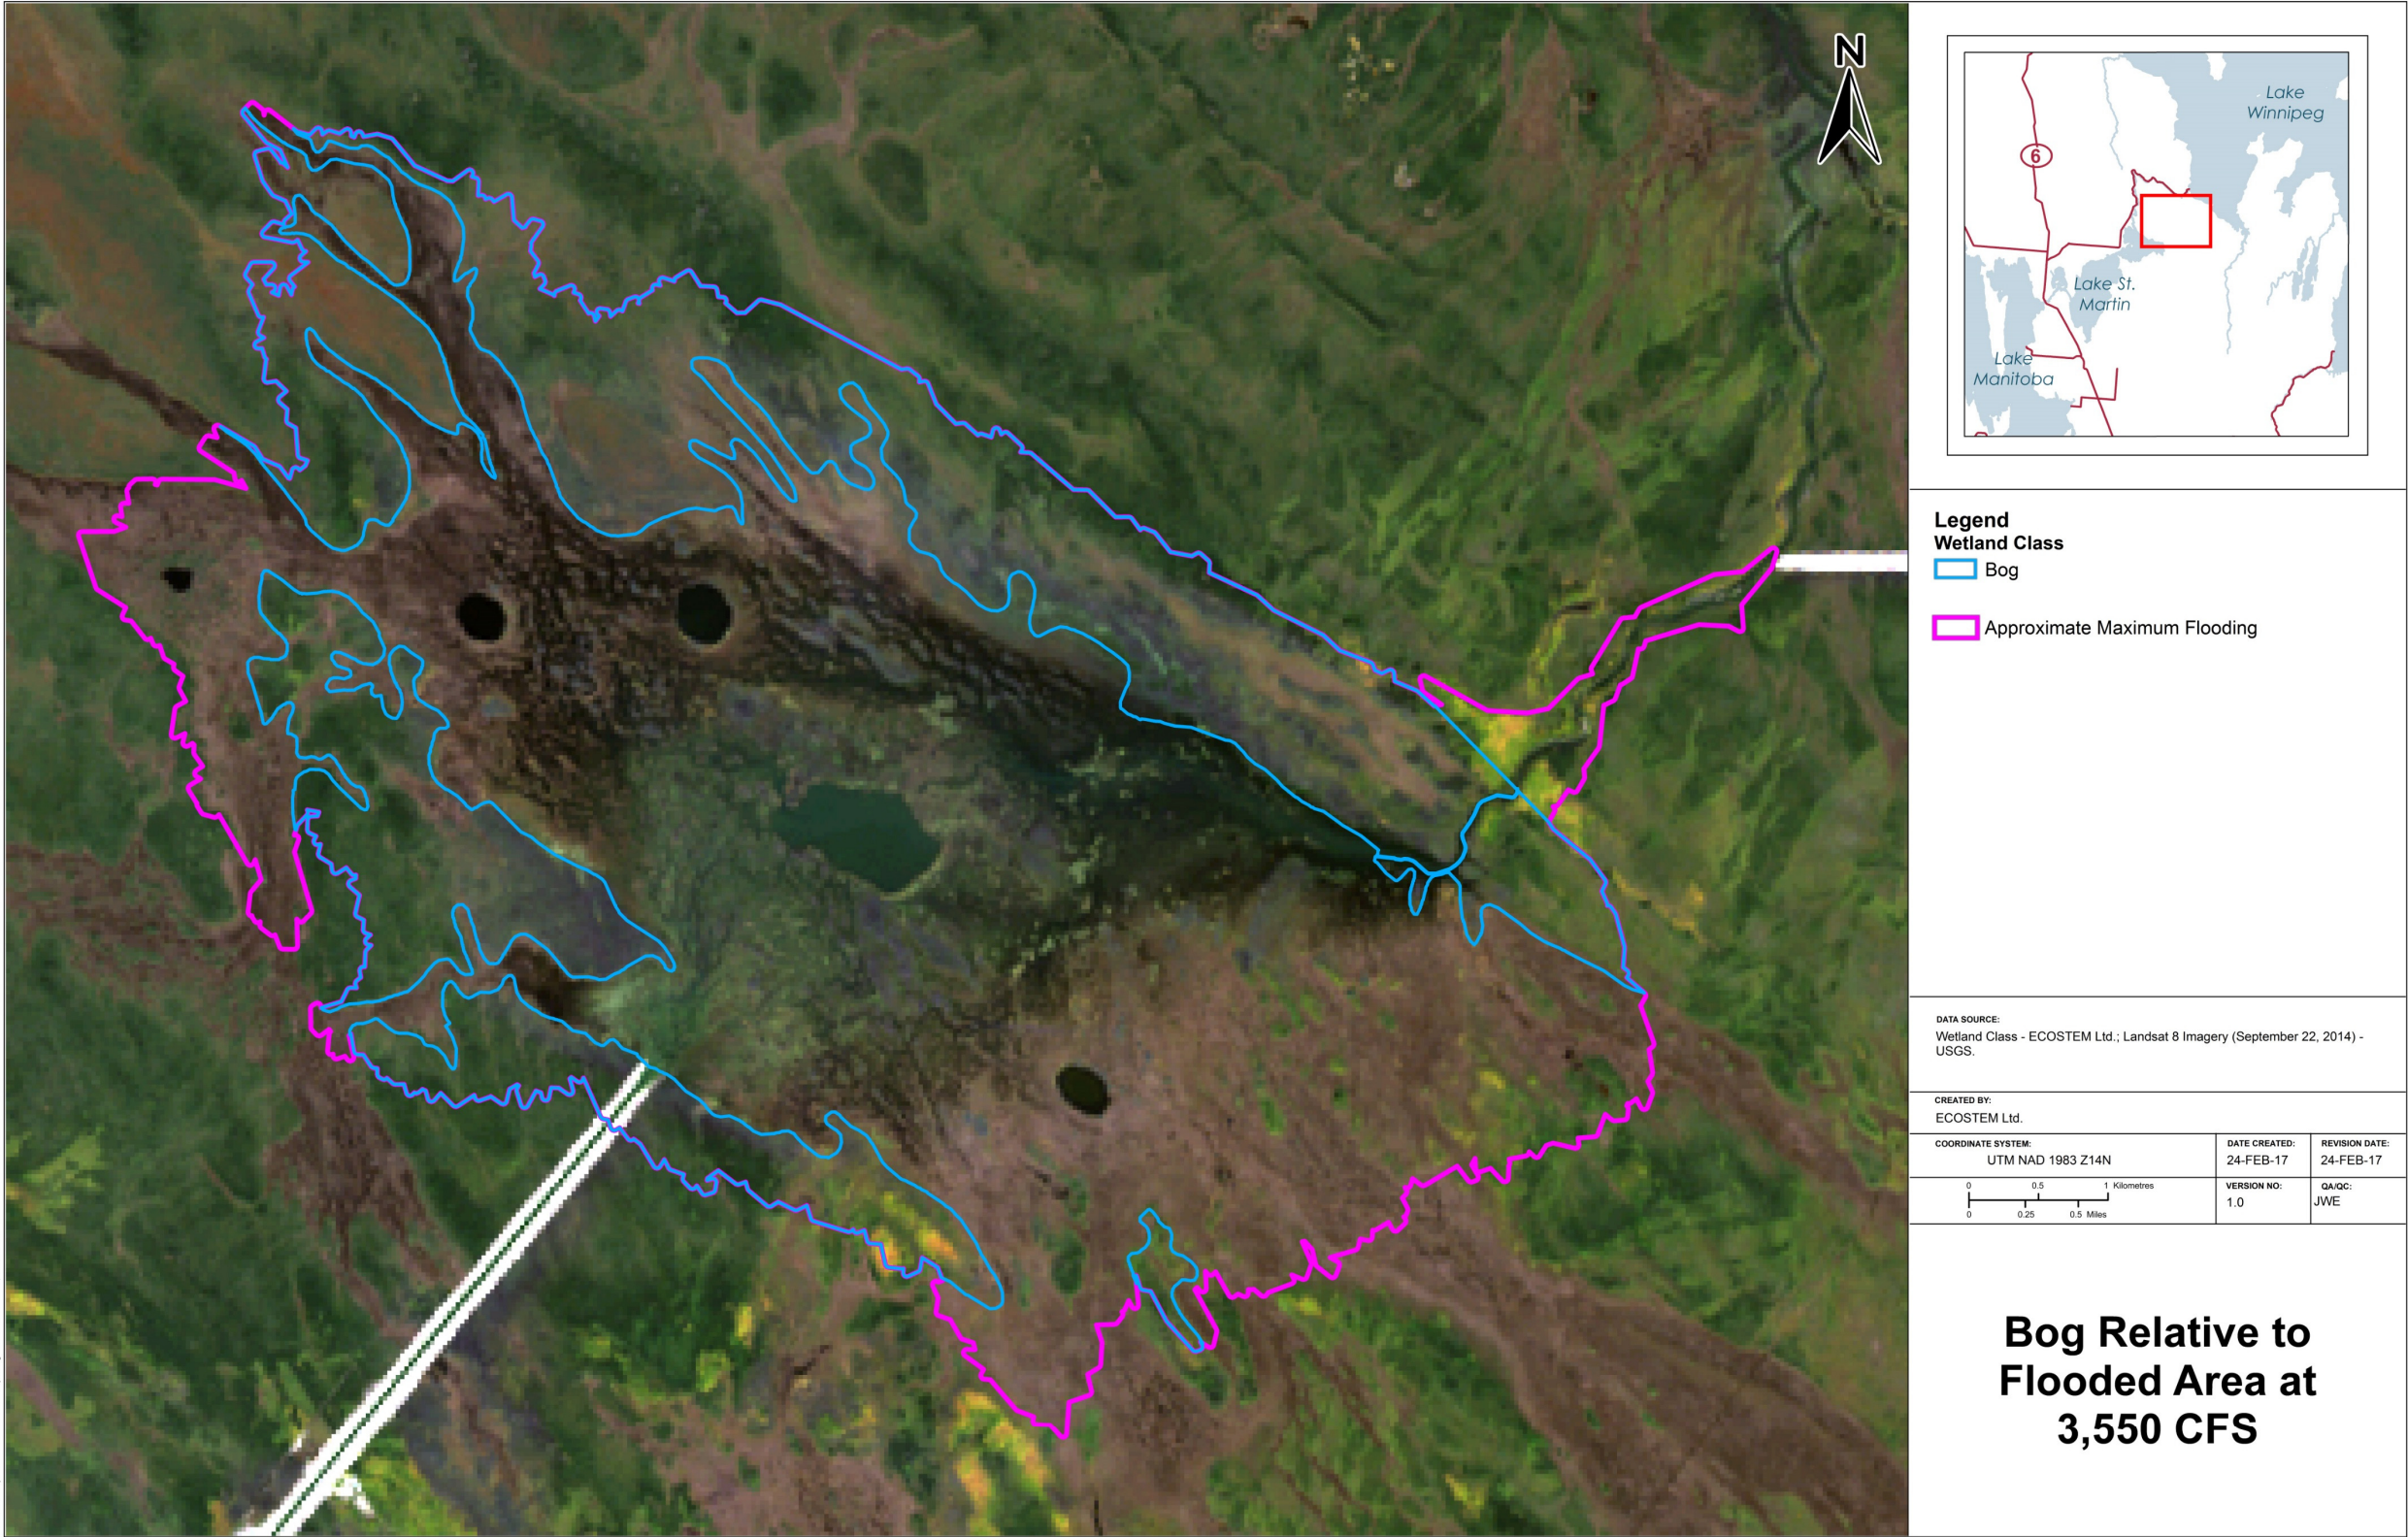
Map 5: Location of bog relative to flooded area in Landsat imagery on September 22, 2014, at outlet channel flows of 3,550 cfs.

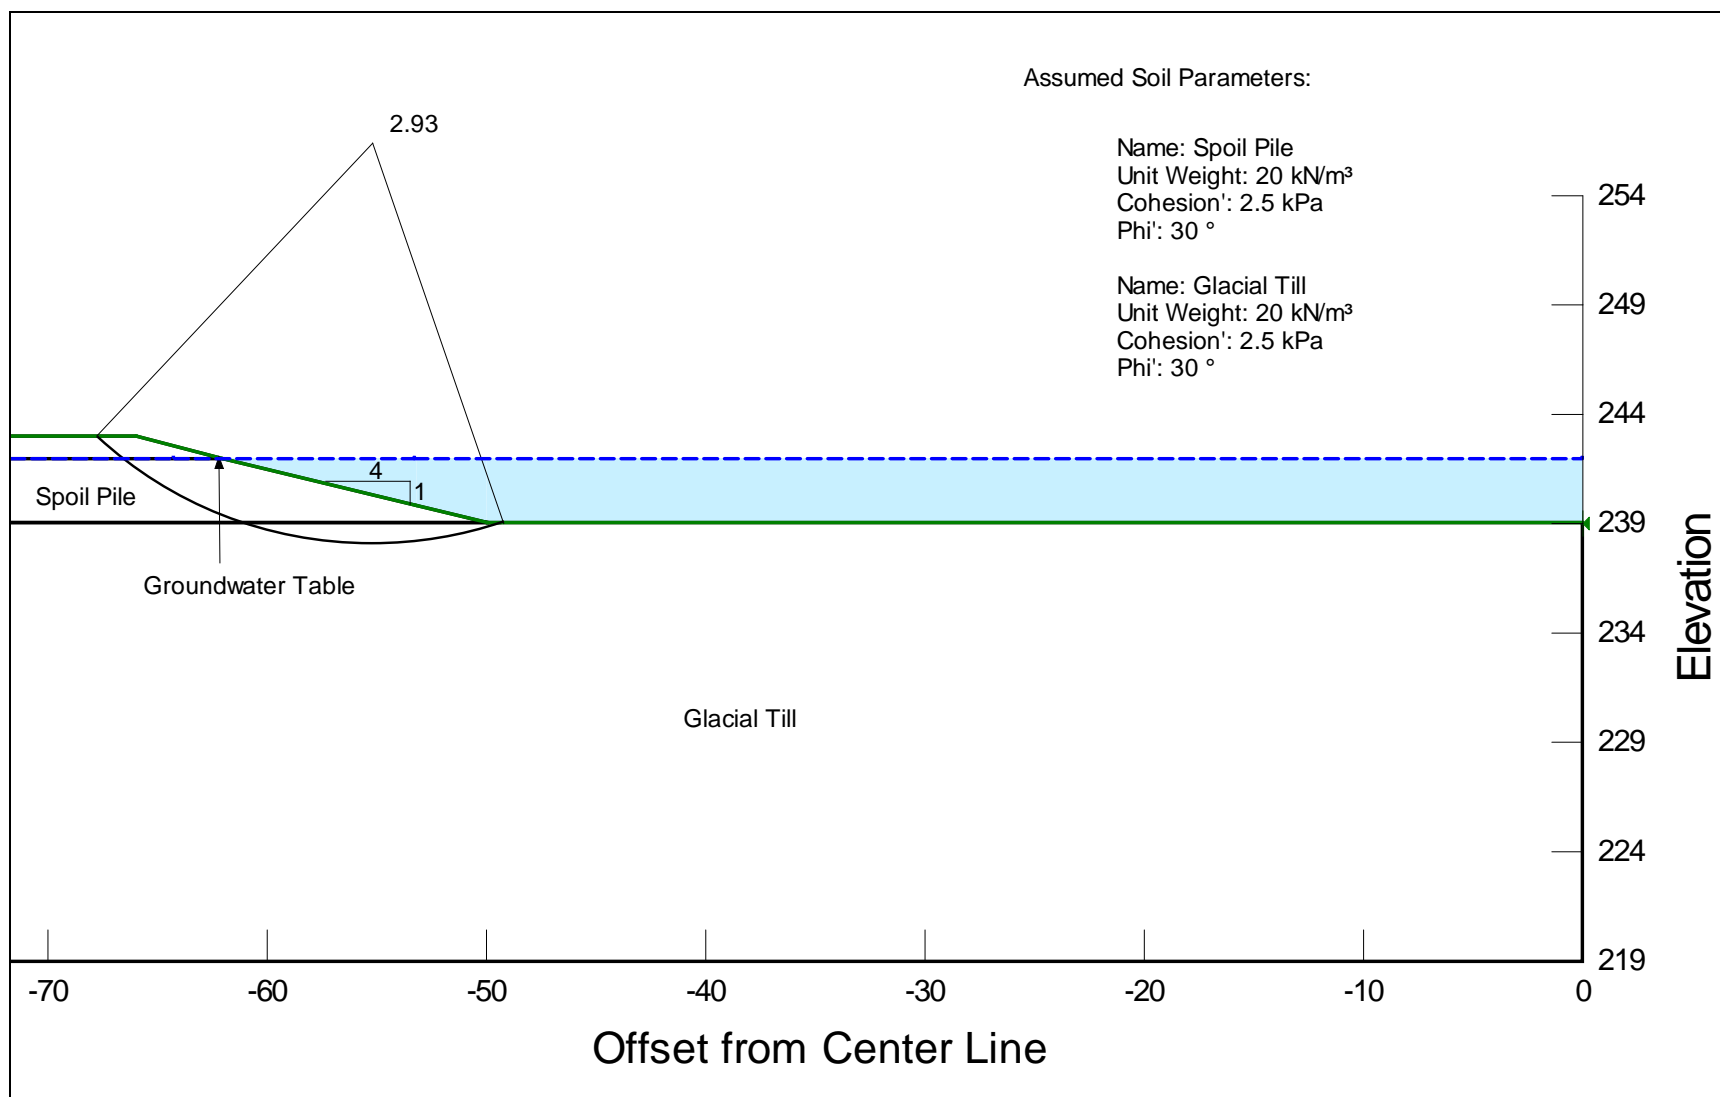
FIGURE H – 5
OPTION 4 – STATION 2+500. Case (3i)

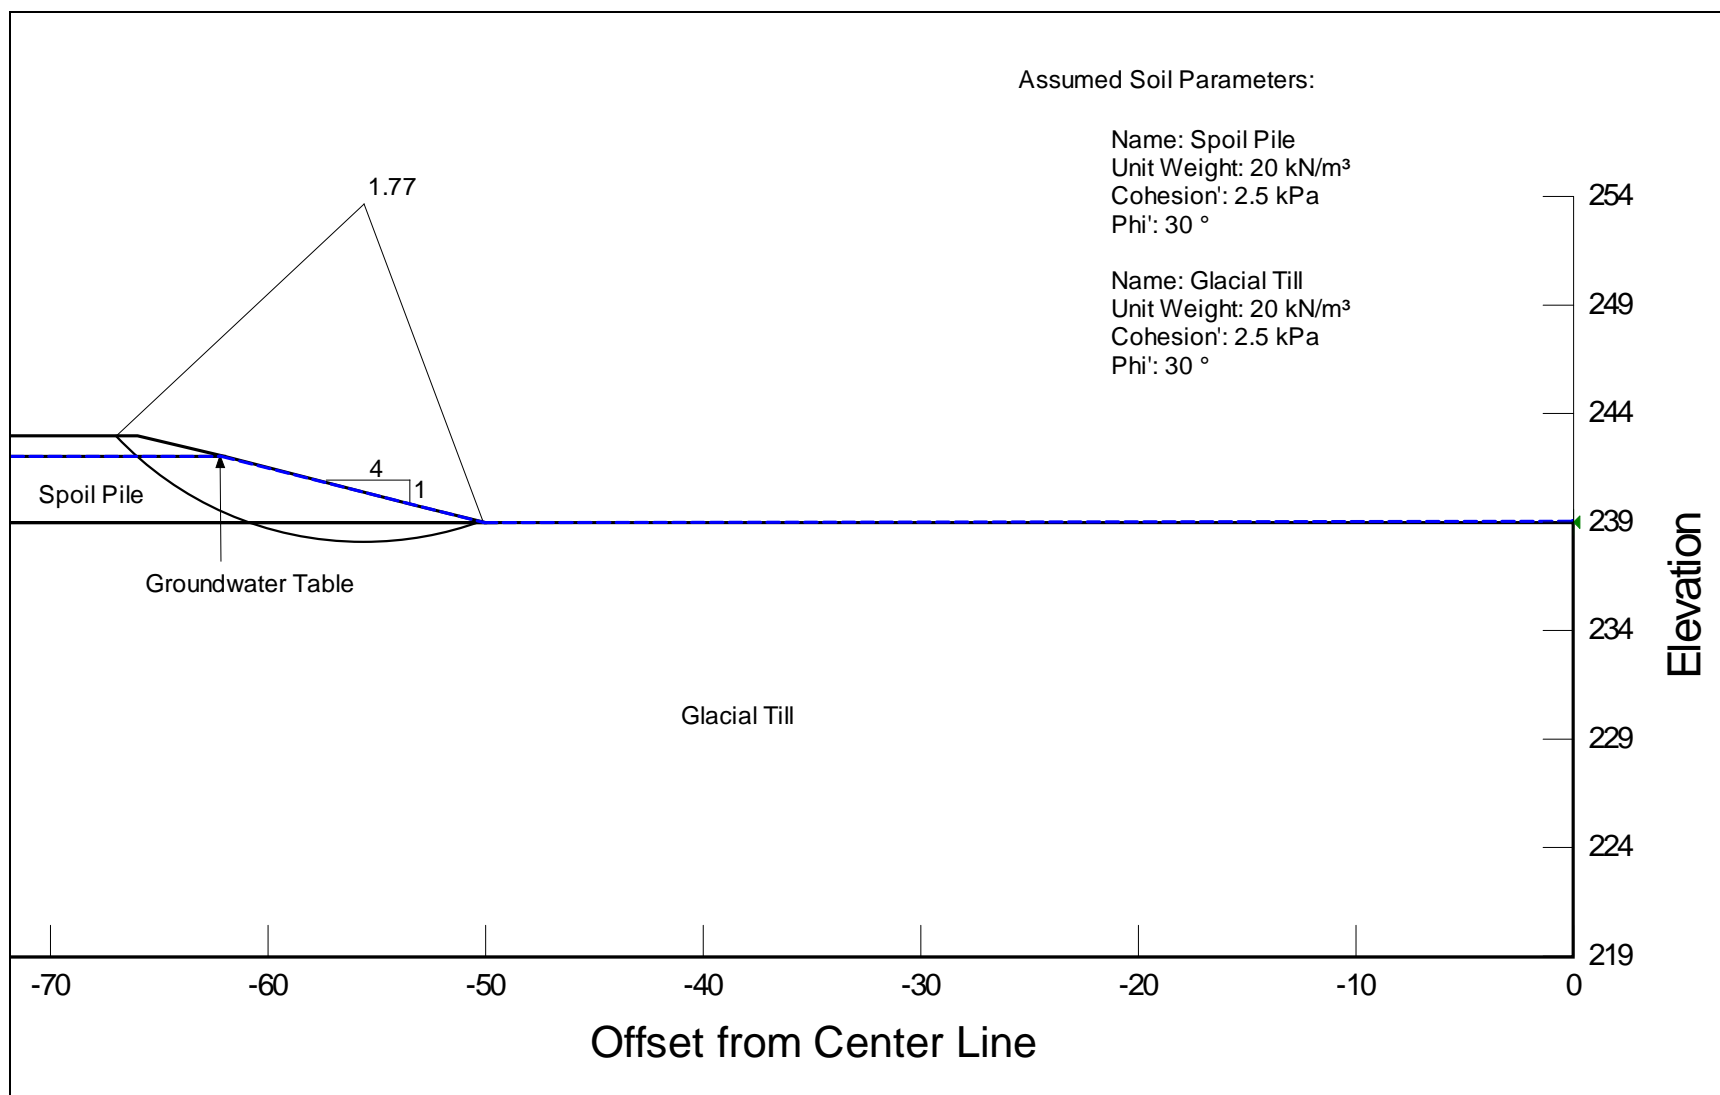
FIGURE H – 6
OPTION 4 – STATION 7+500. Case (1)

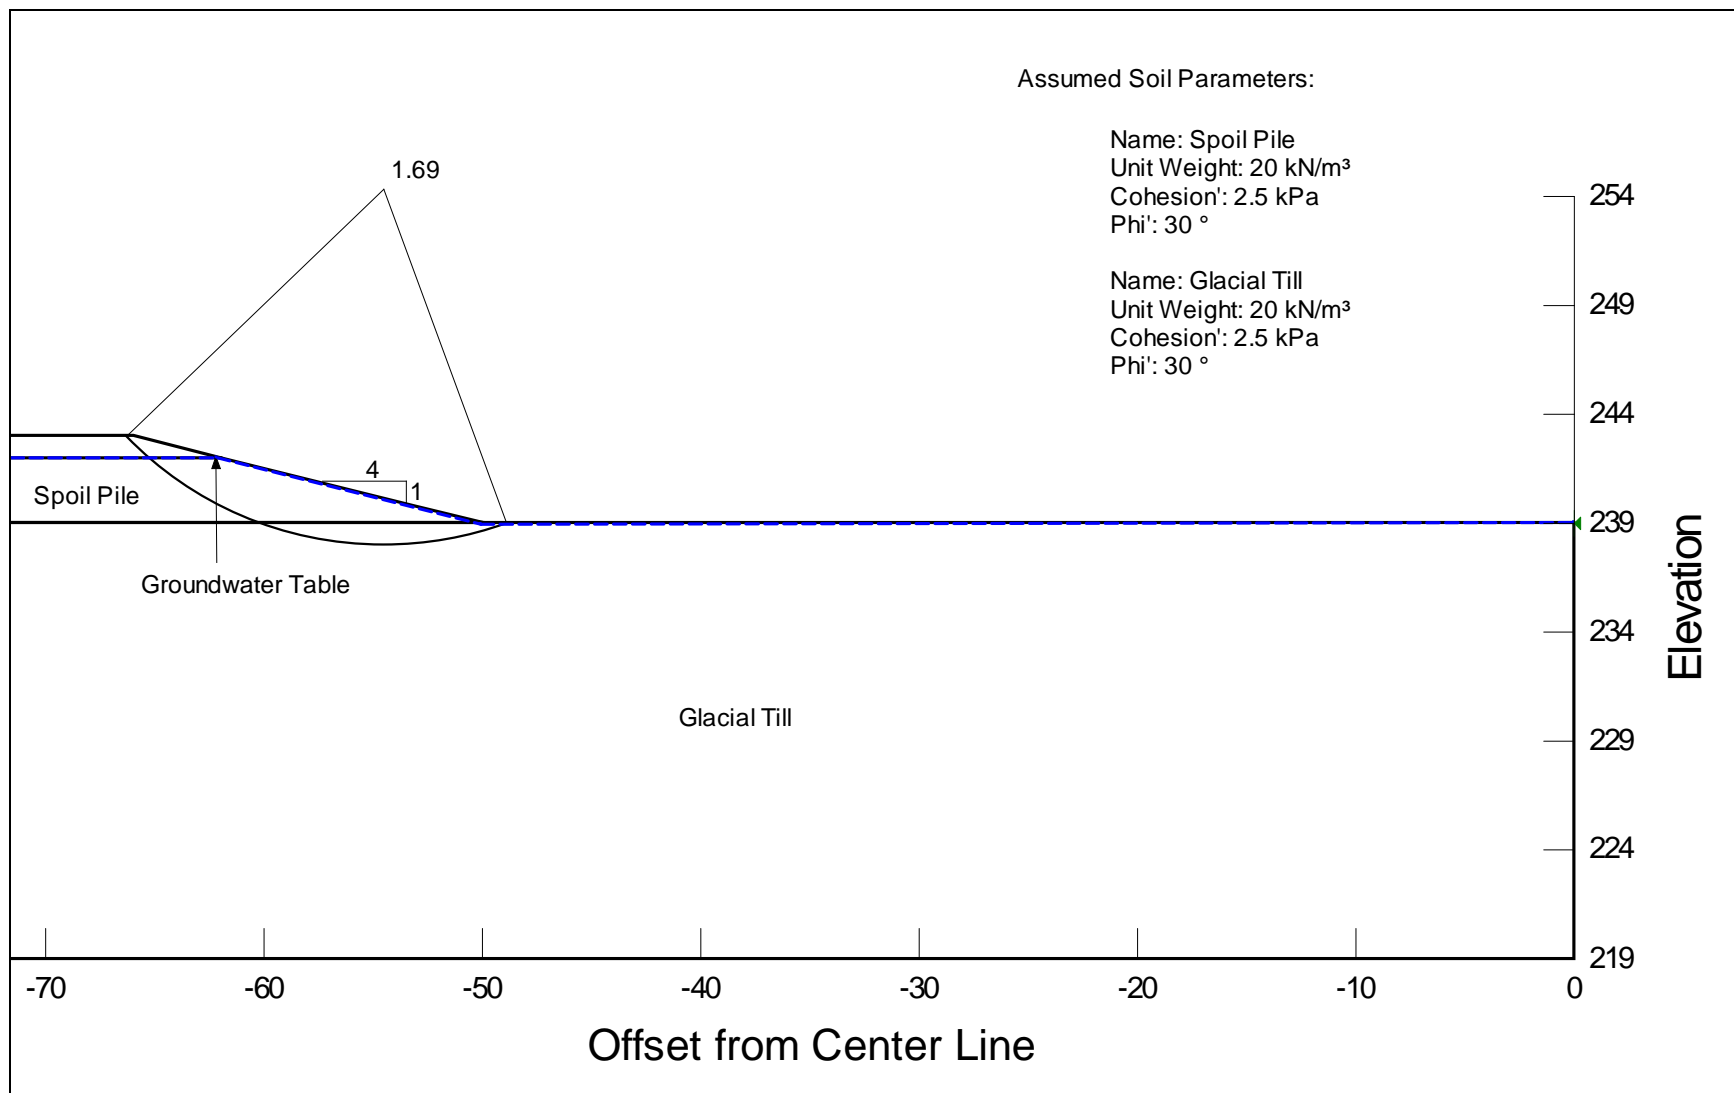
FIGURE H – 7
OPTION 4 – STATION 7+500. Case (2)
